Inspection Photos
Operator: Hilcorp Energy
API: 067-09370
Date: 2/11/2021

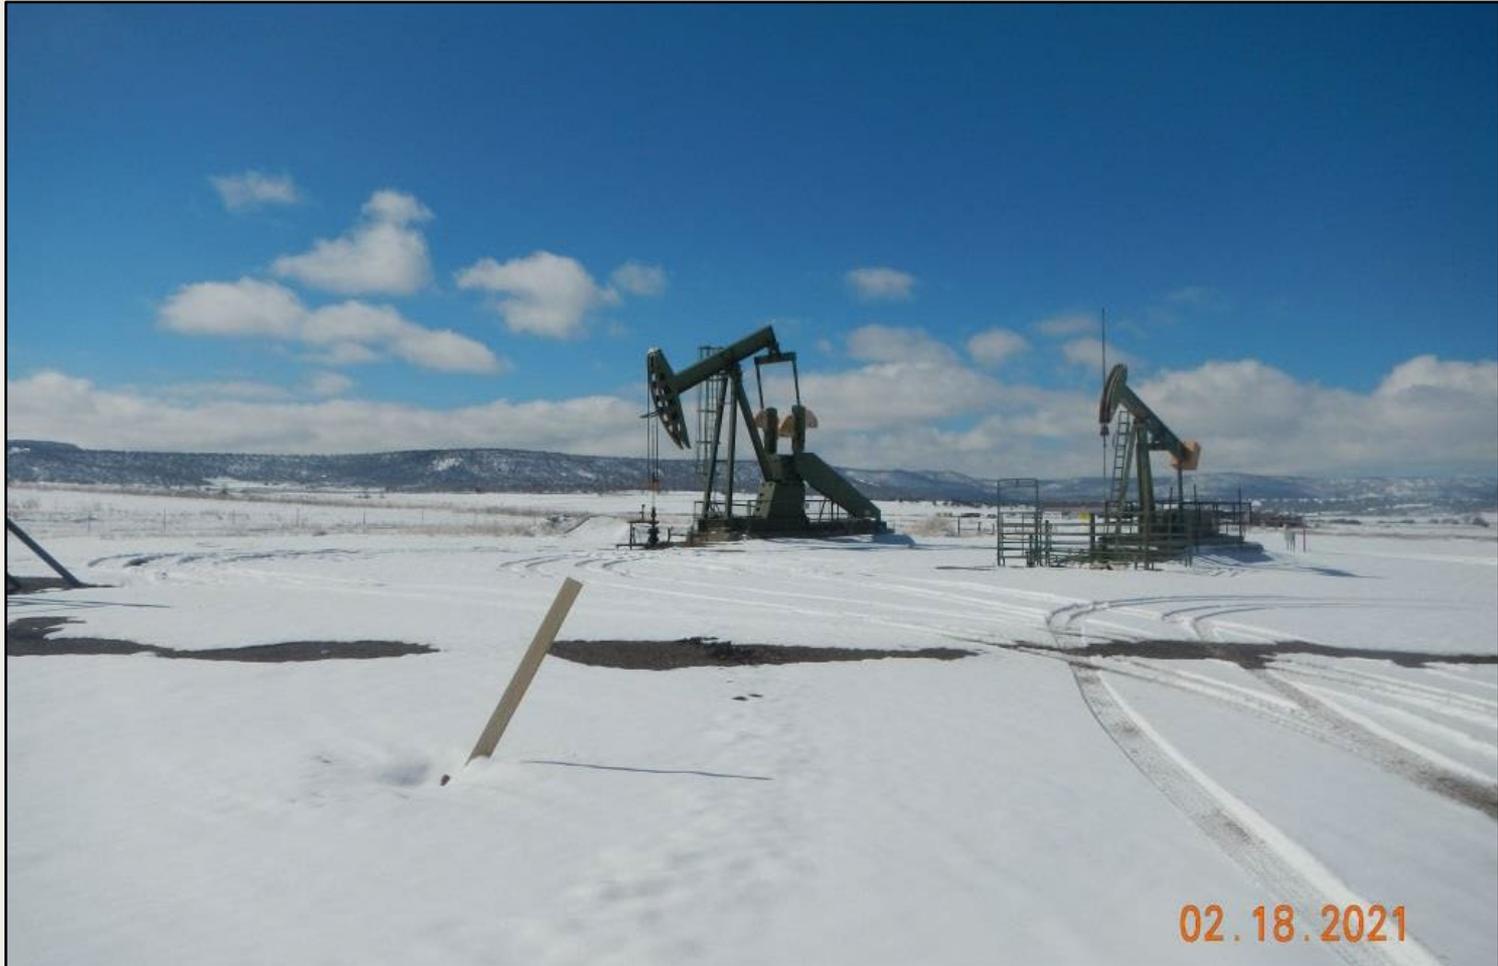
Photo 1. View of the project area from the well pad entrance facing center.

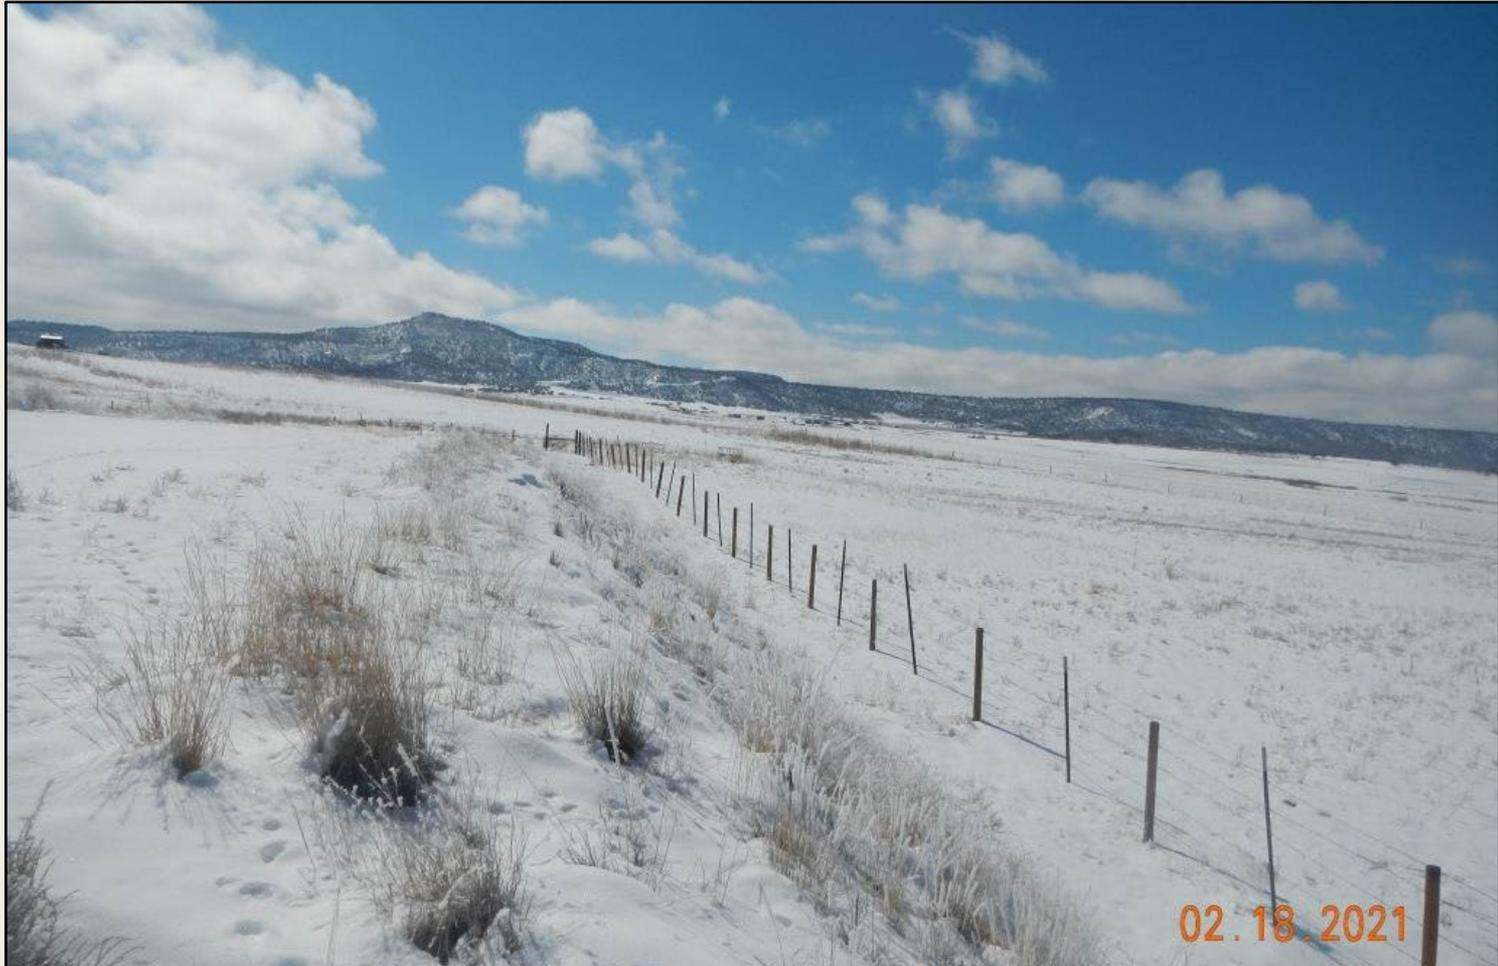
Photo 2. View of the western fill slope from the northwestern corner facing southward. Revegetation appears to be progressing with western wheatgrass and crested wheatgrass observable.

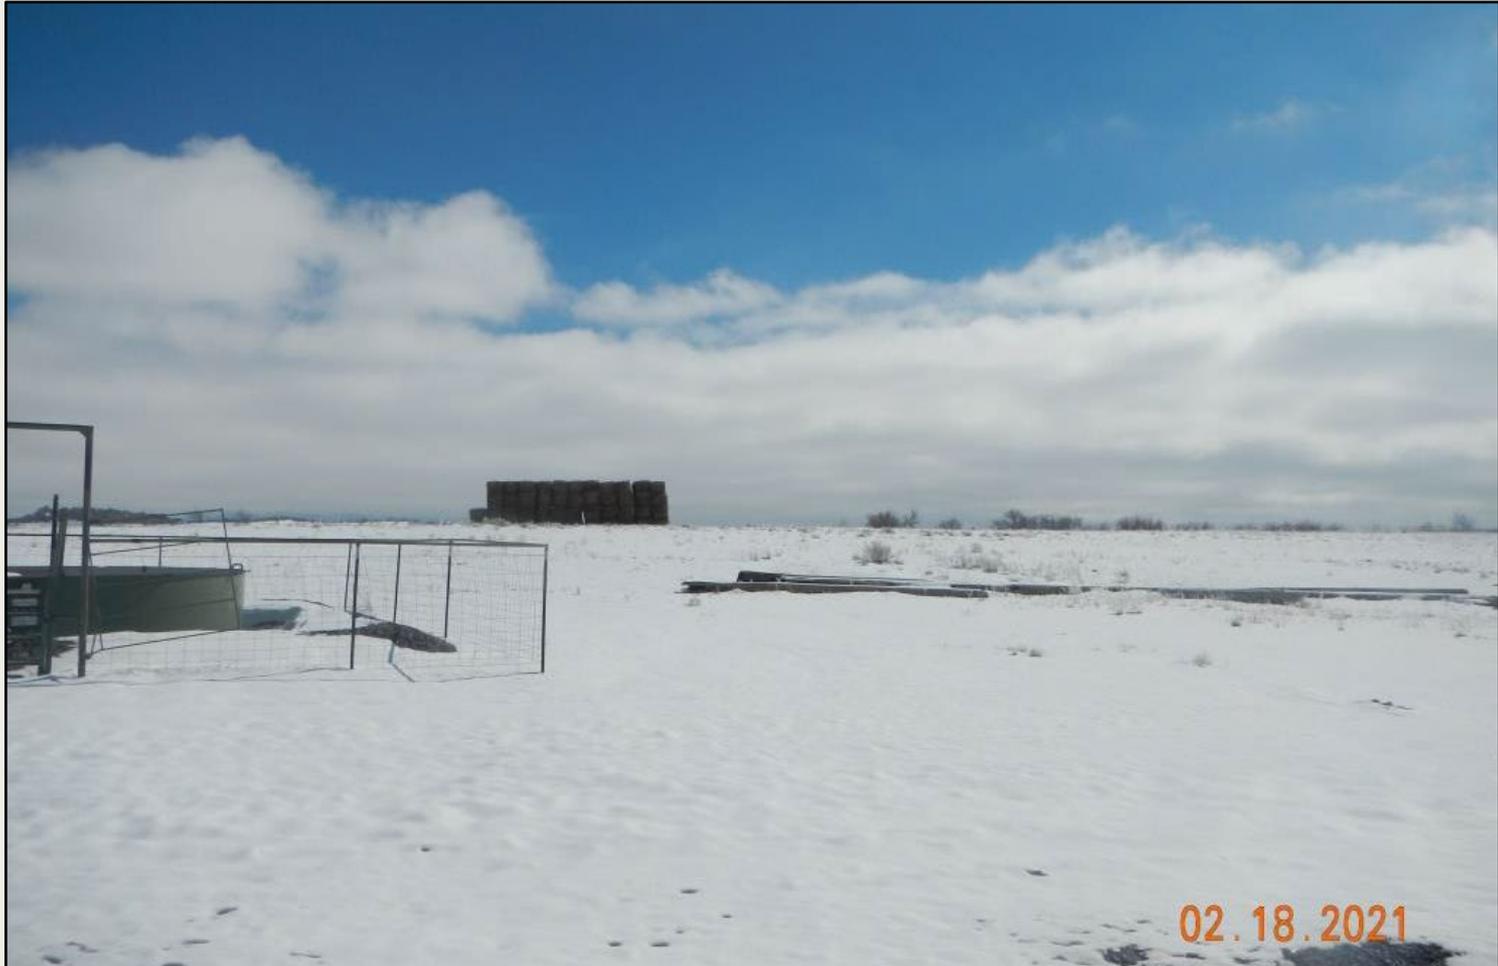
Photos 3. View of the southern interim reclamation area, surface owner equipment appears to be moved off of the reclamation area.

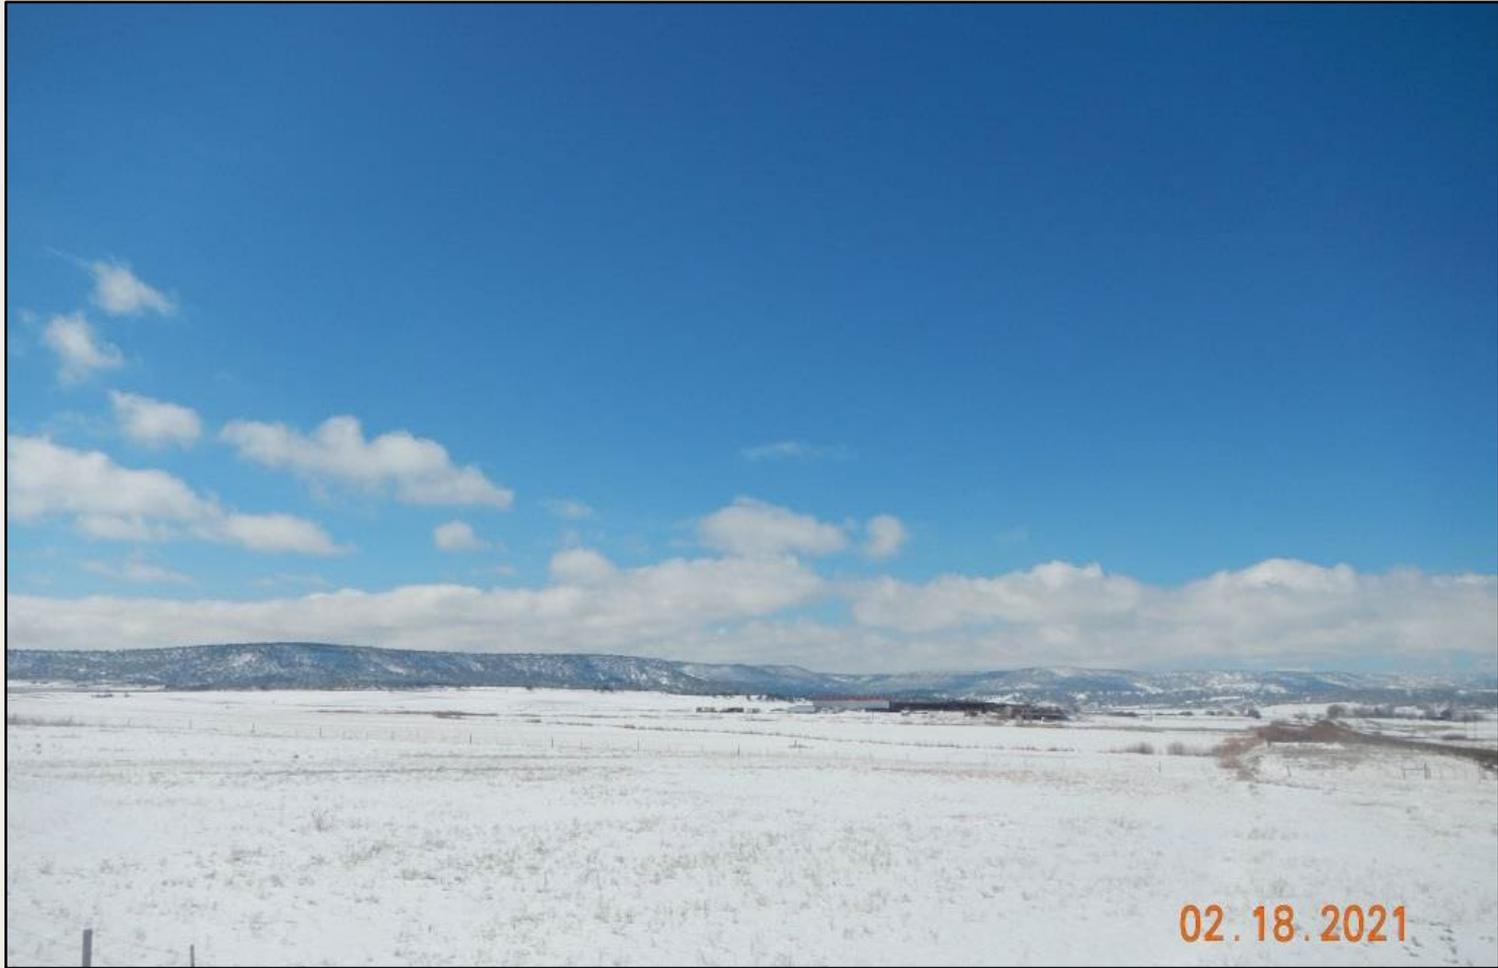
Photo 4. View of the reference area comprised of irrigated grass fields, with smooth brome observable.
