Inspection Photos

Operator: Rim Operating
API: 067-09277
Date: 2/11/2021

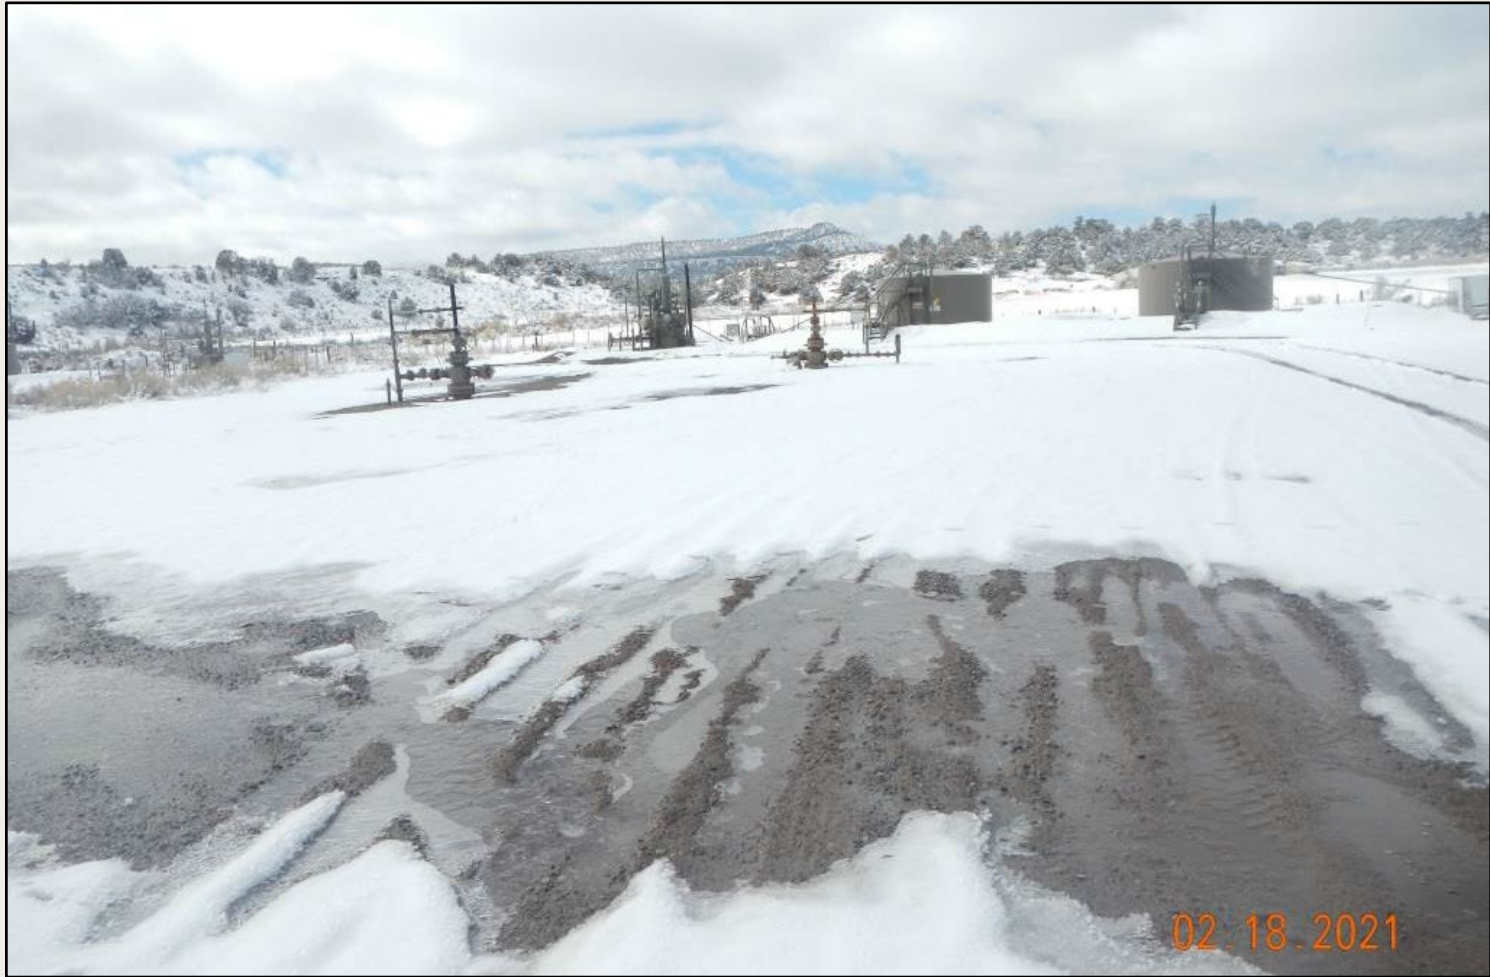
Photo 1. View of the project area from the well pad entrance facing center.

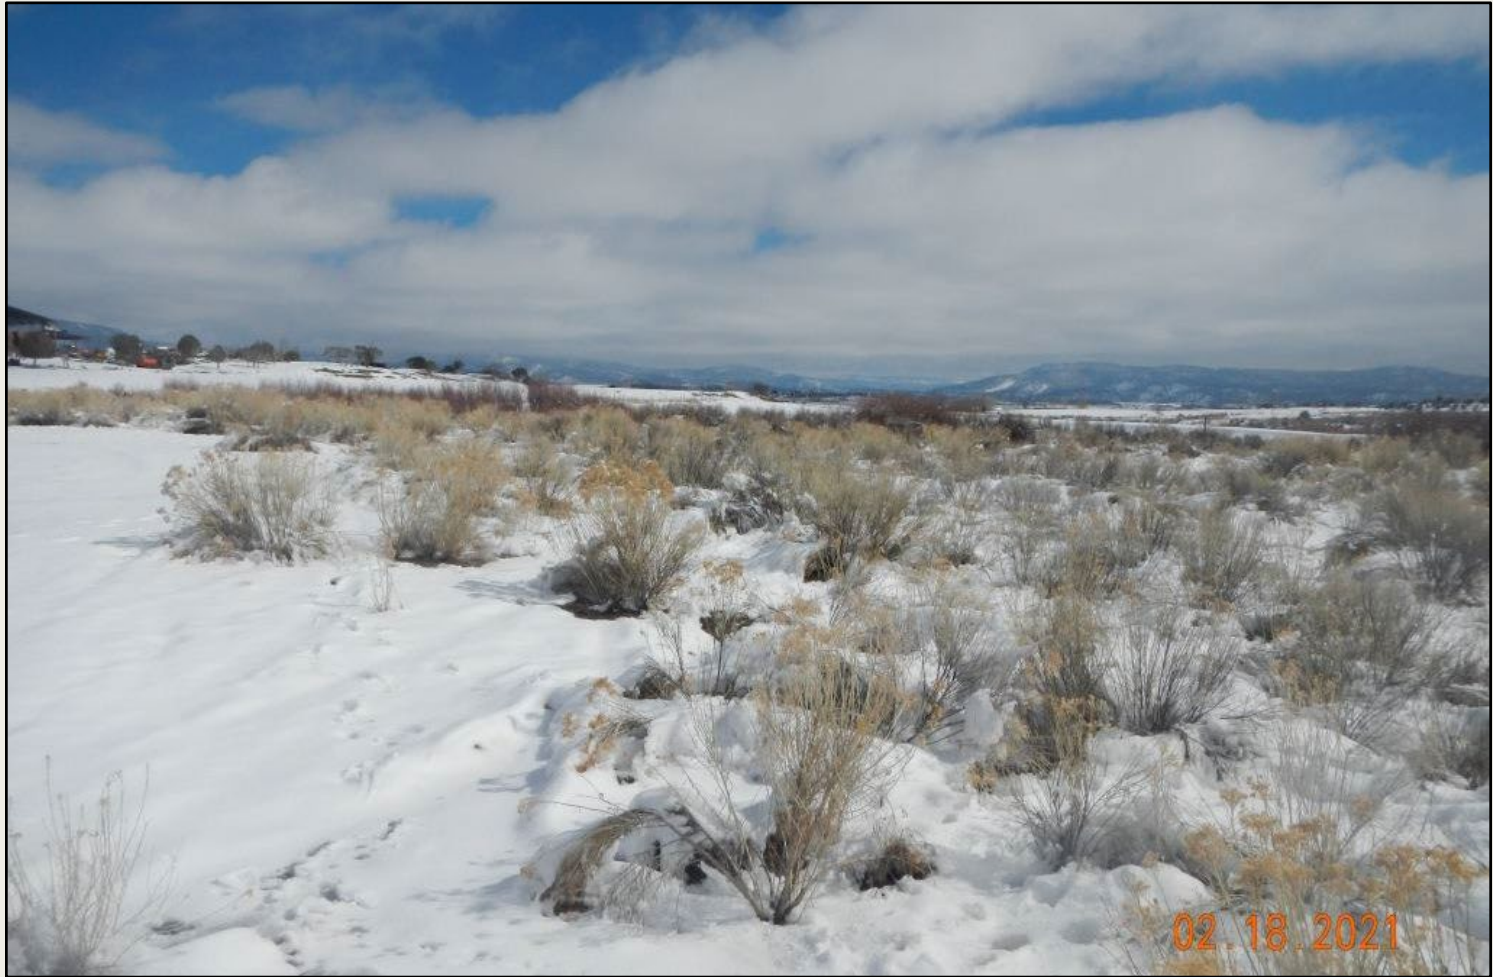
Photo 2. View of the southern fill slope facing westward. Reclamation areas are vegetated with rubber rabbitbrush and crested wheatgrass.

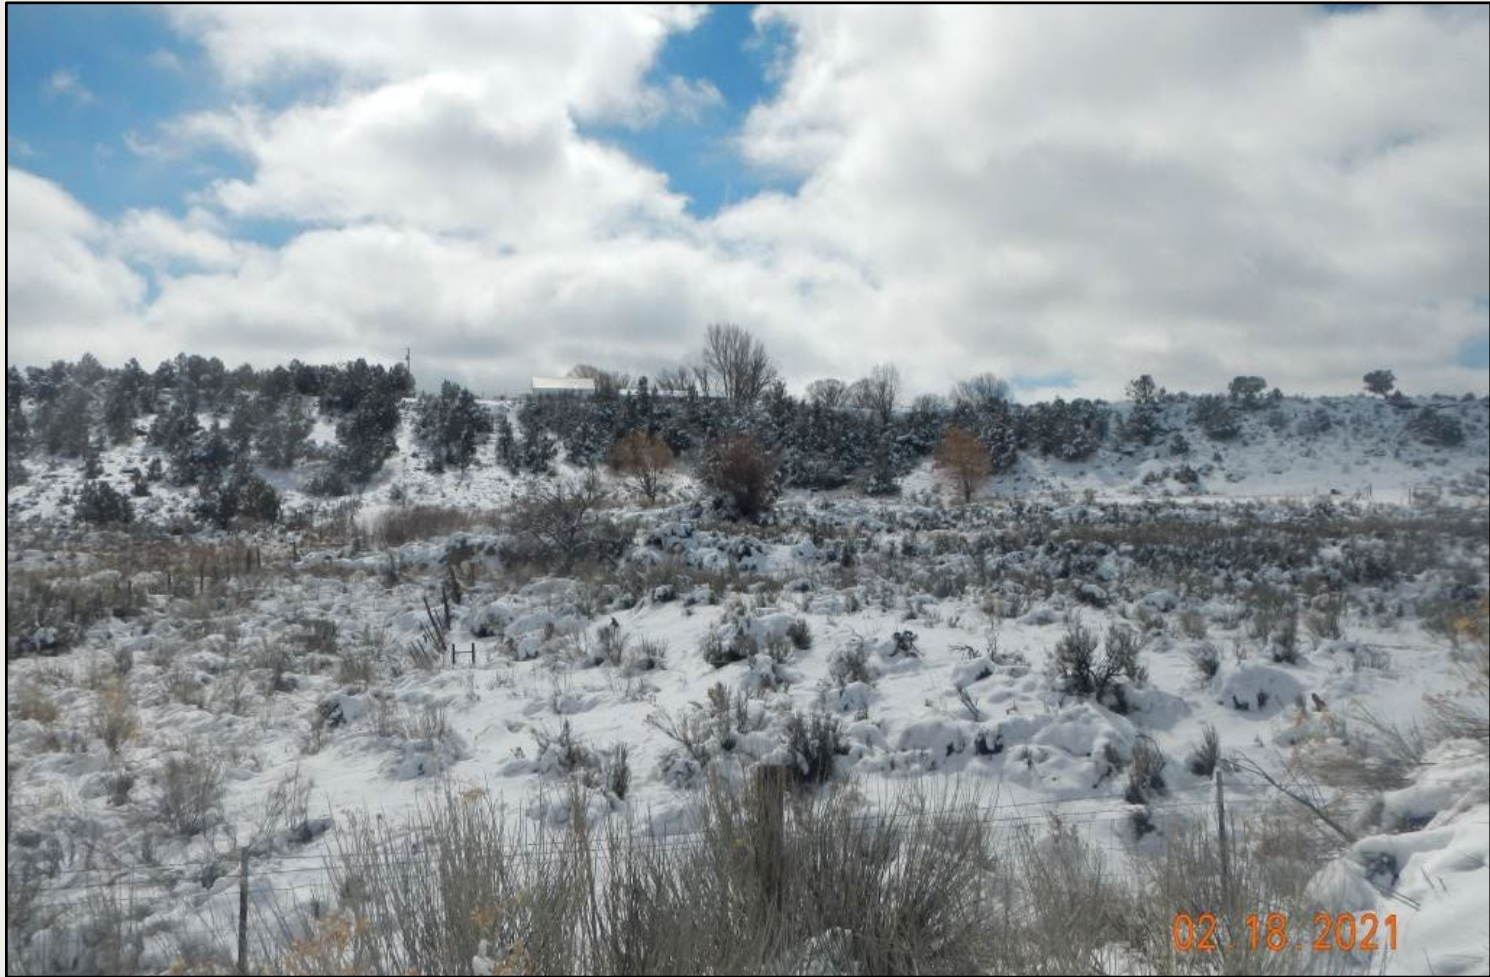
Photo 3. View of the reference area comprised of sagebrush shrubland. Understory vegetation not observable at this time.
