Inspection Photos  
Operator: Simcoe  
API: 067-06663  
Date: 2/11/2021

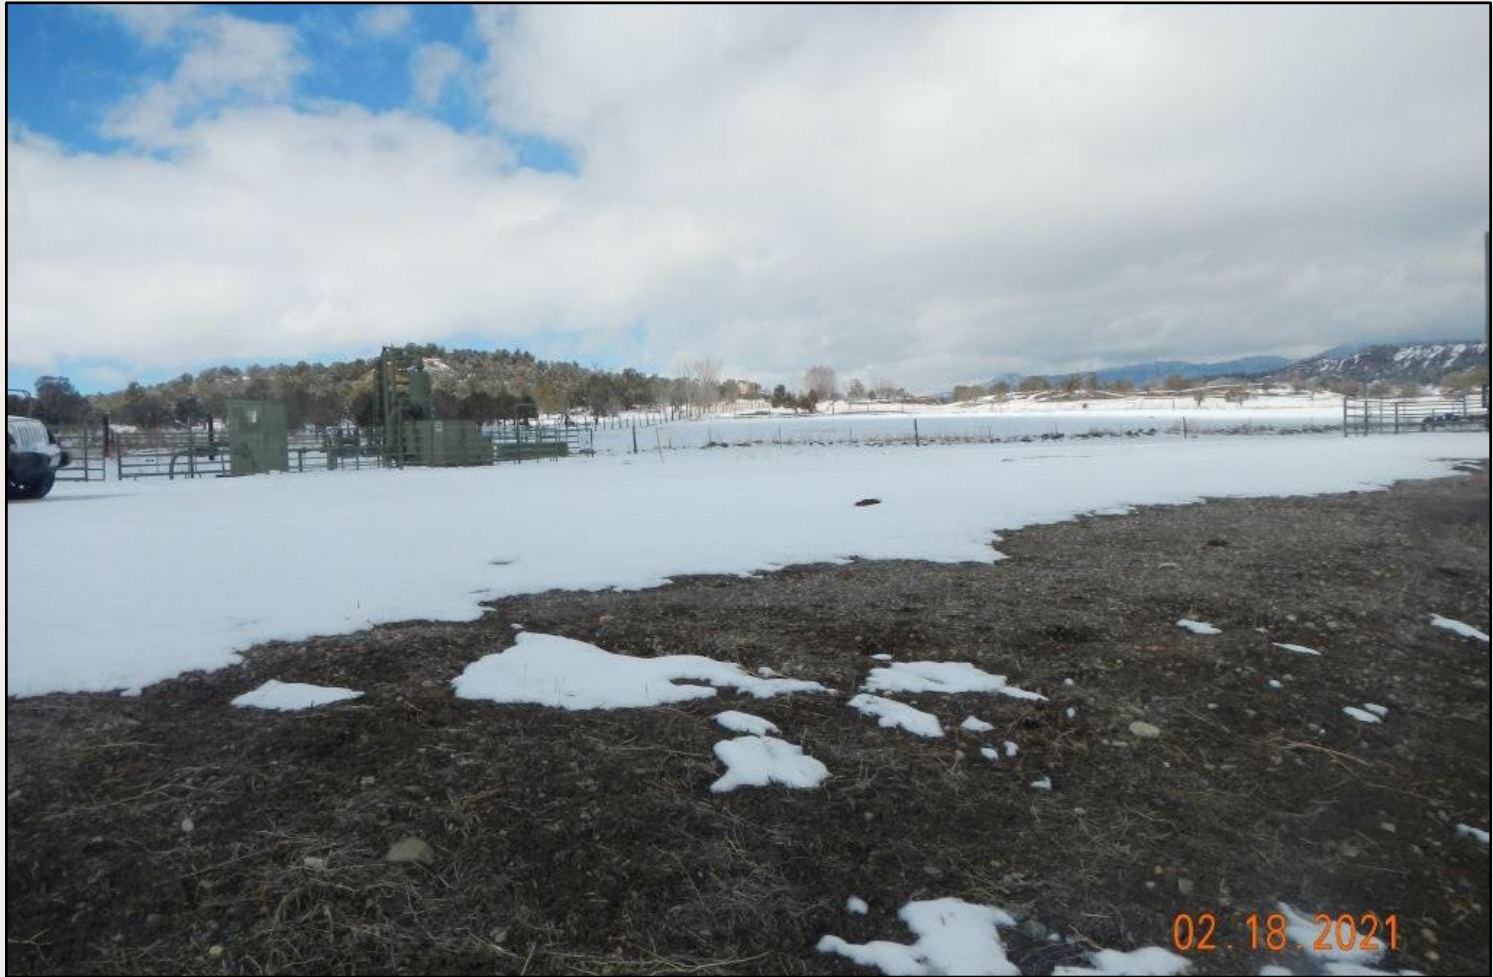
Photo 1. View of the project area from the southern corner facing center.

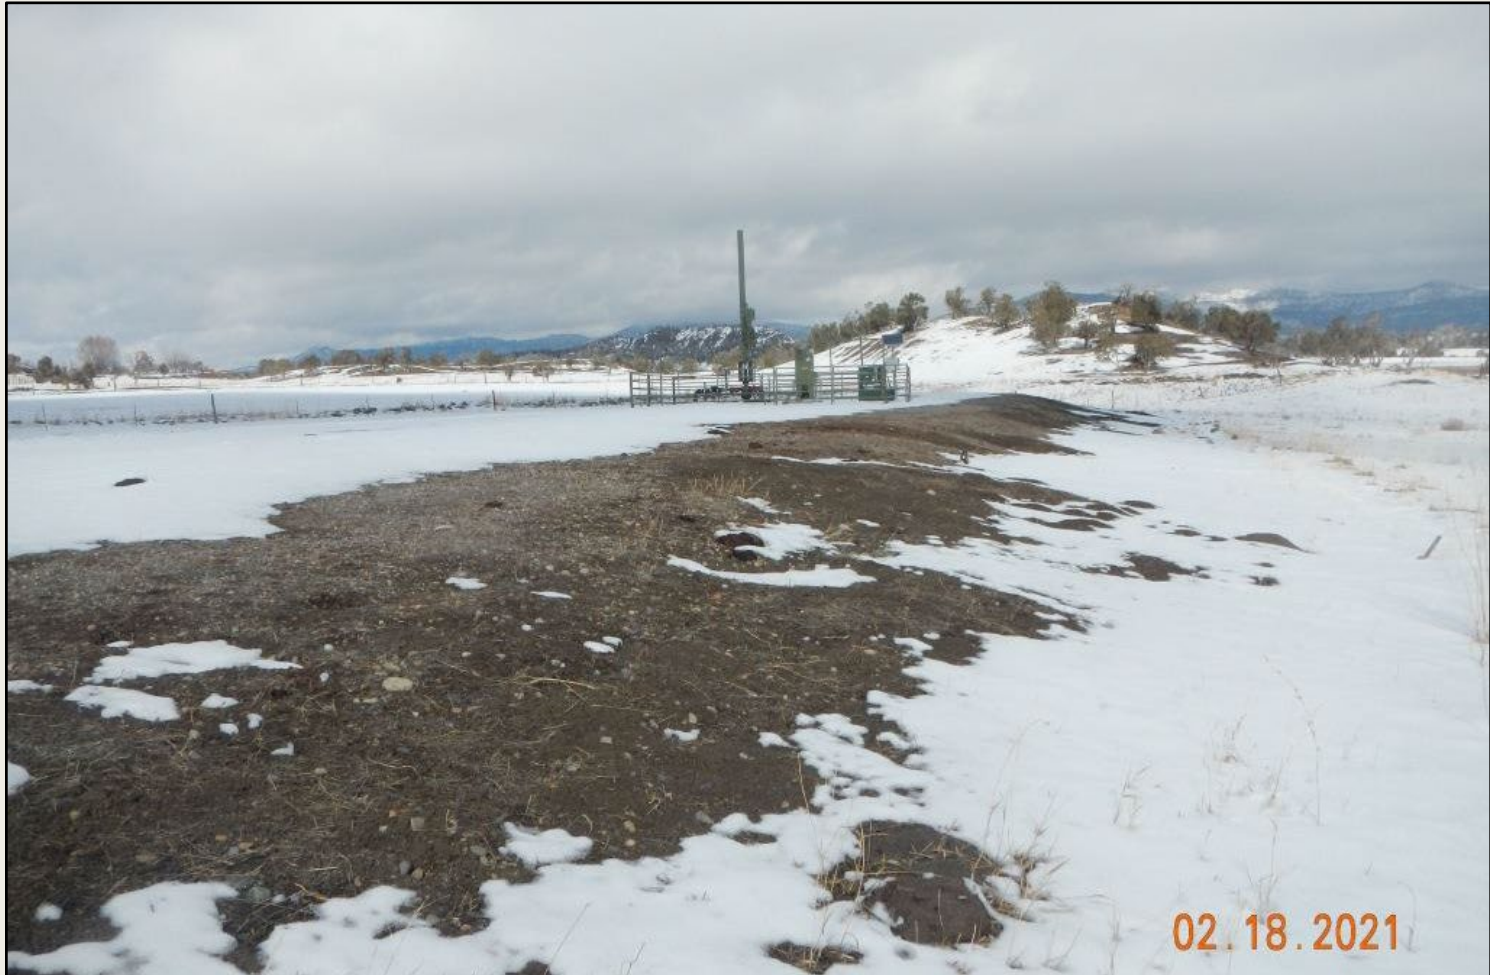
Photo 2. View of the southern fill slope facing eastward. Revegetation is grazed and dormant at this time. However, it is evident that portions of the fill slope are bare. Revegetation needs to be monitored during the active growing season and seeding conducted where vegetation is not becoming established.

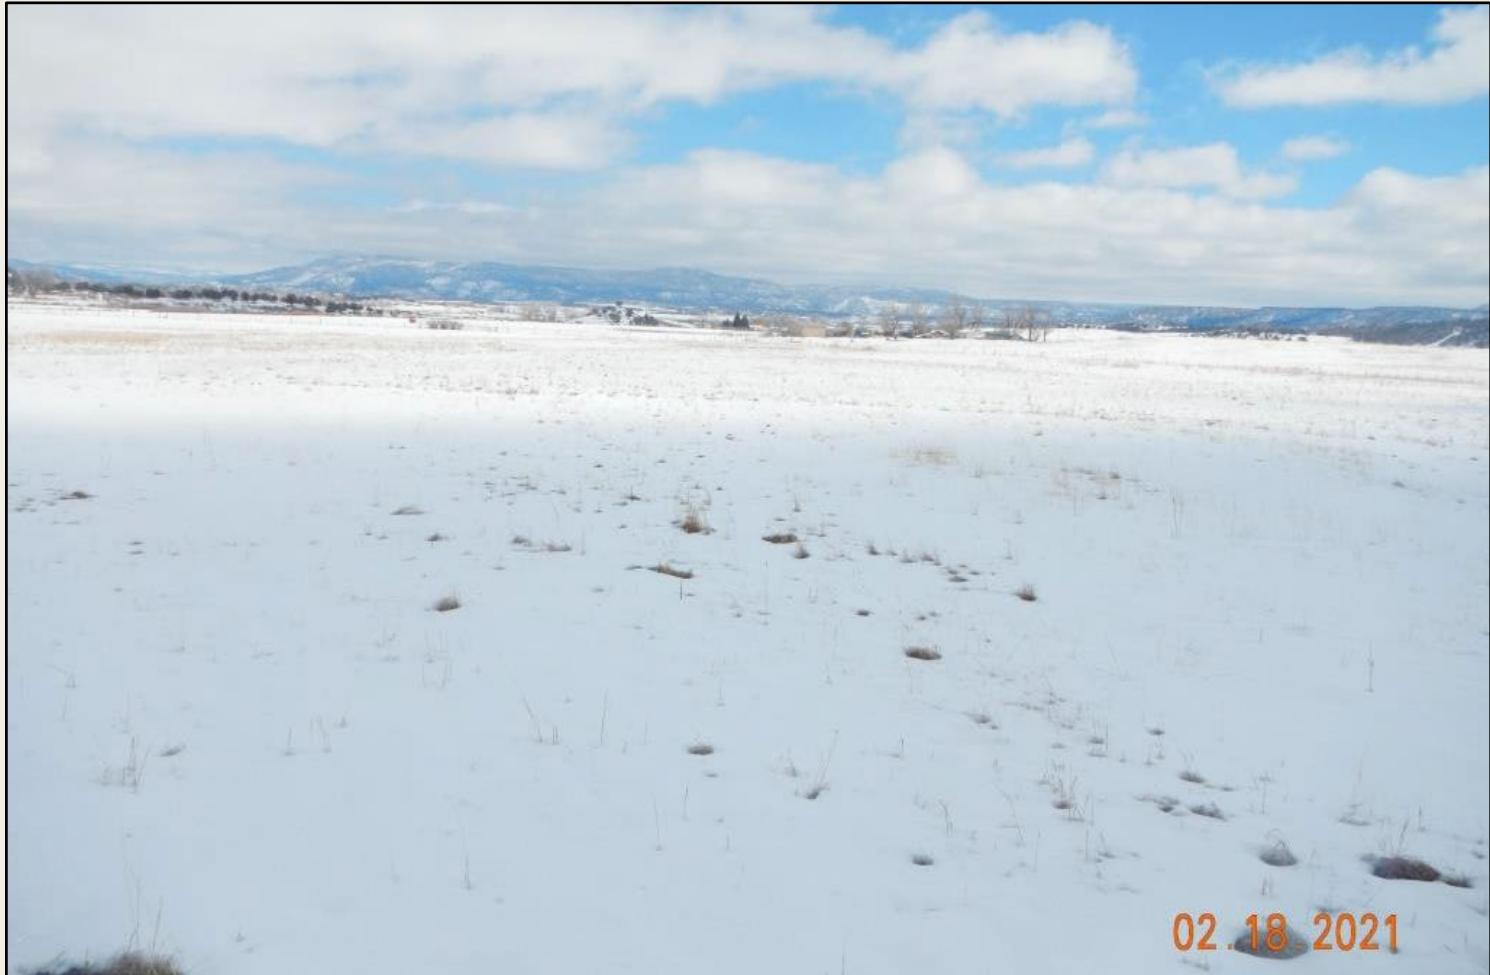
Photo 3. View of the reference area comprised of open grass field, largely snow covered at this time.

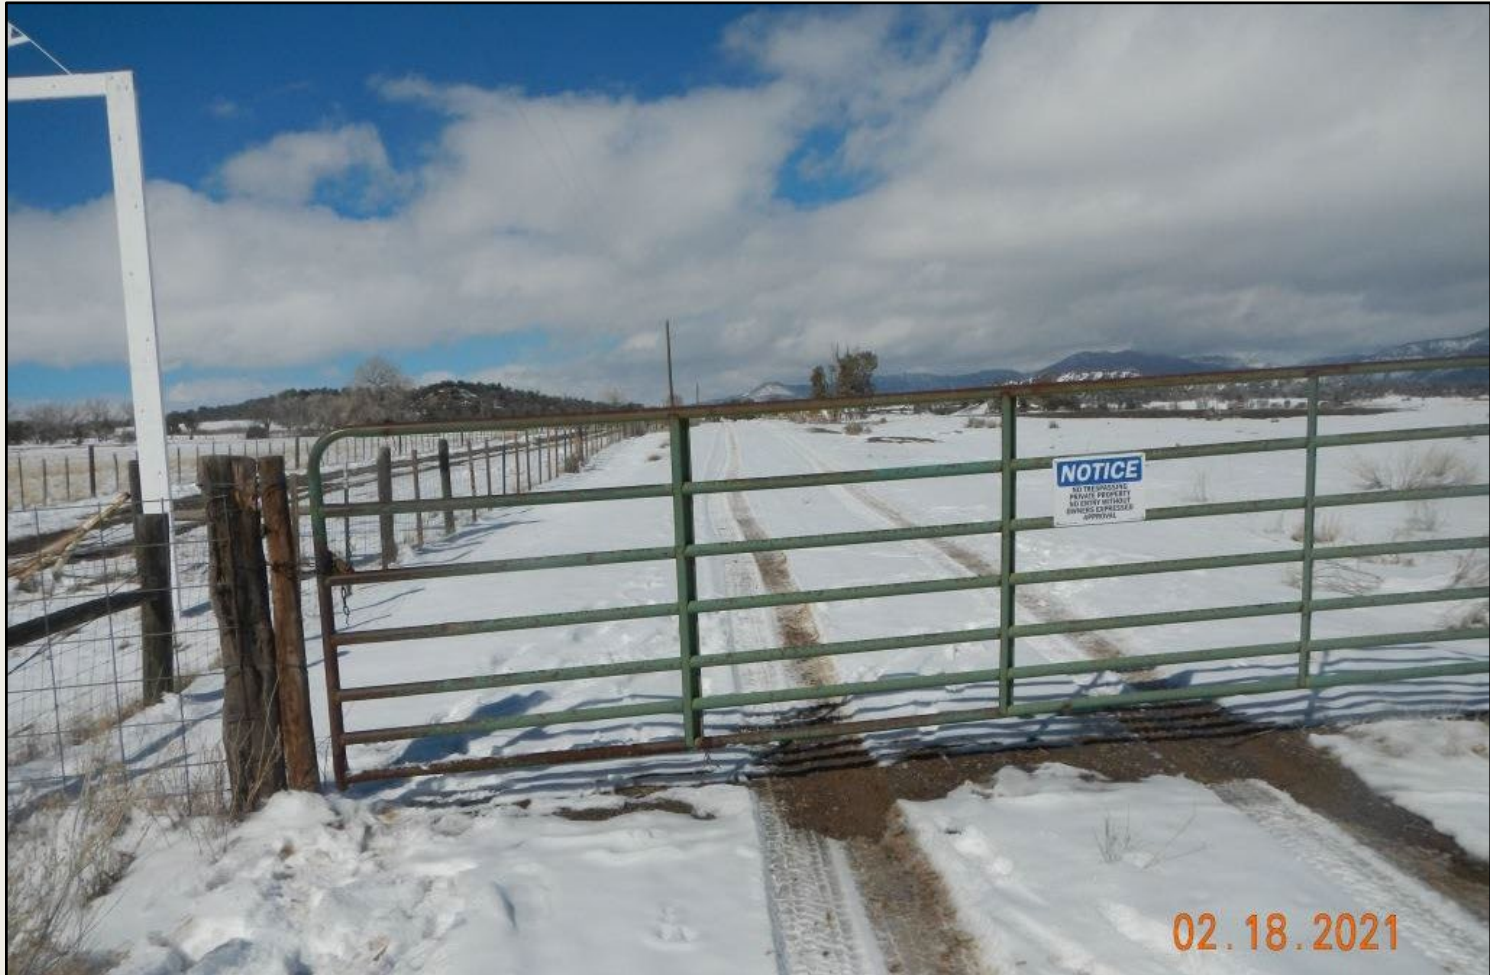
Photo 4. View of closed gate after leaving location.
