## Inspection Photos

Location Name: CAERUS PICEANCE LLC BENTLY-67S95W /11SESE

Location ID: 324238

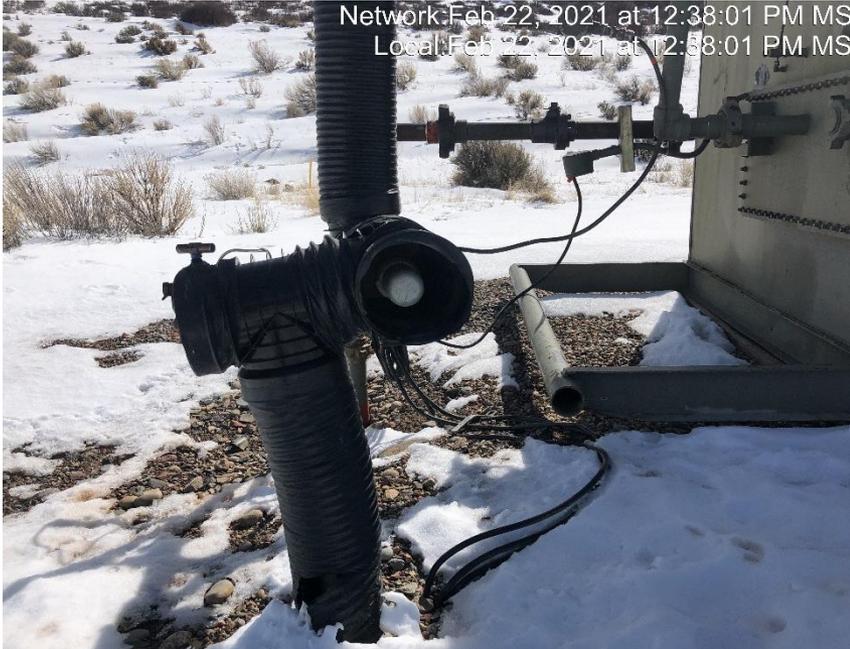
**Photo #2944 Multiple flow line heating insulation open ended and not capped.**

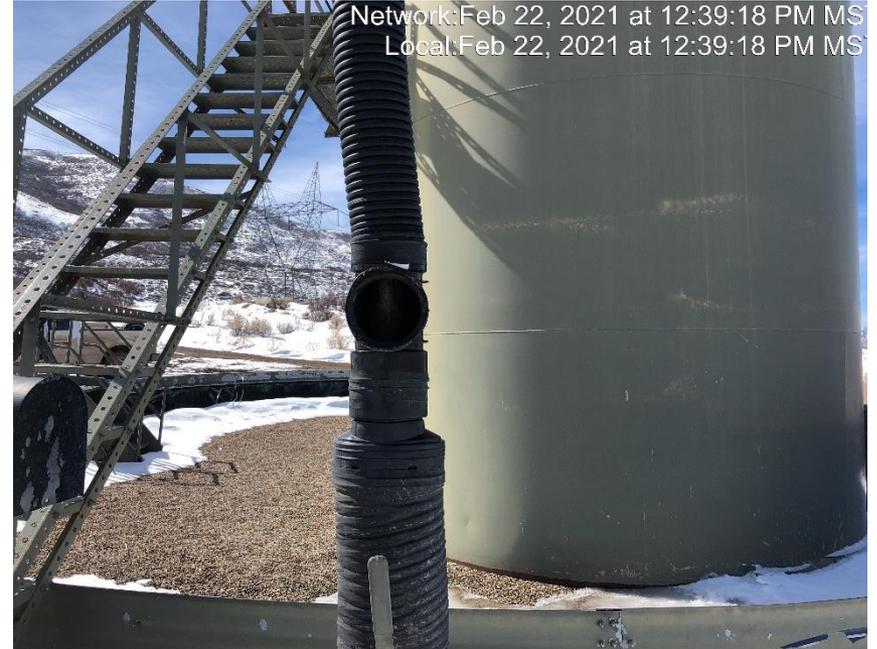
**Photo #2945 Multiple flow line heating insulation open ended and not capped.**
