Inspection Photos

2/19/2021

Operator: CHEVRON USA INC - 16700

Location ID: 398284

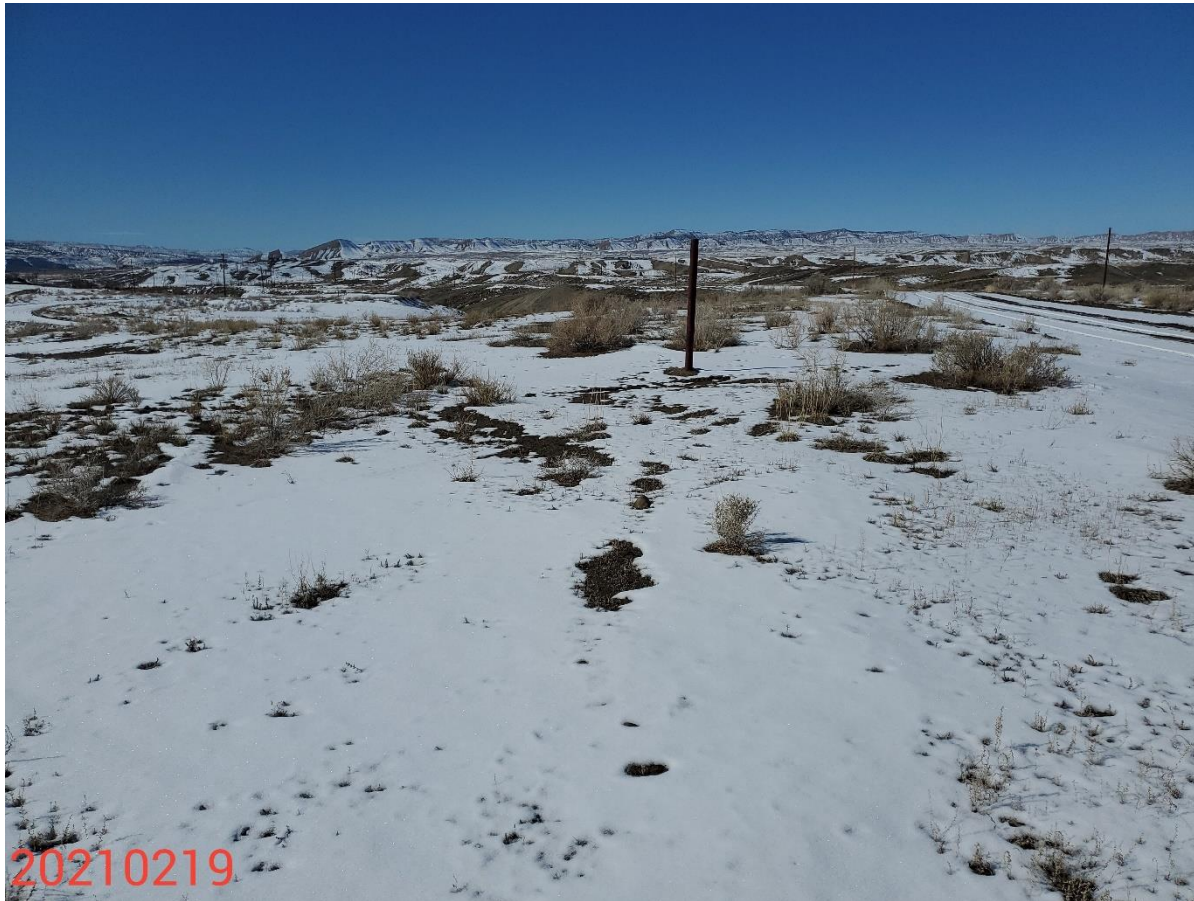
Photo 1: Photo taken east of the well site, facing west. Photo shows well marker.

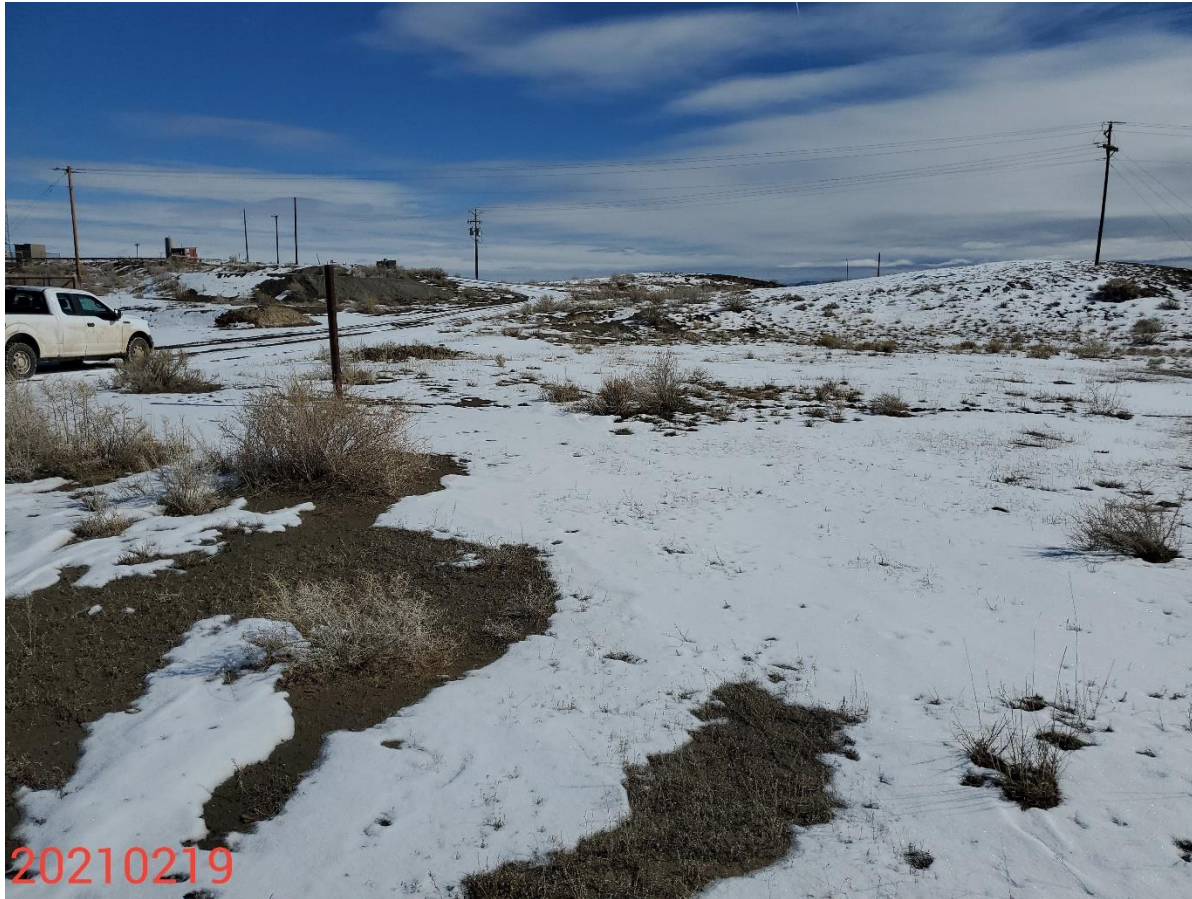
Photo 2: Photo taken west of the well site, facing east. Photo shows well marker and Location.

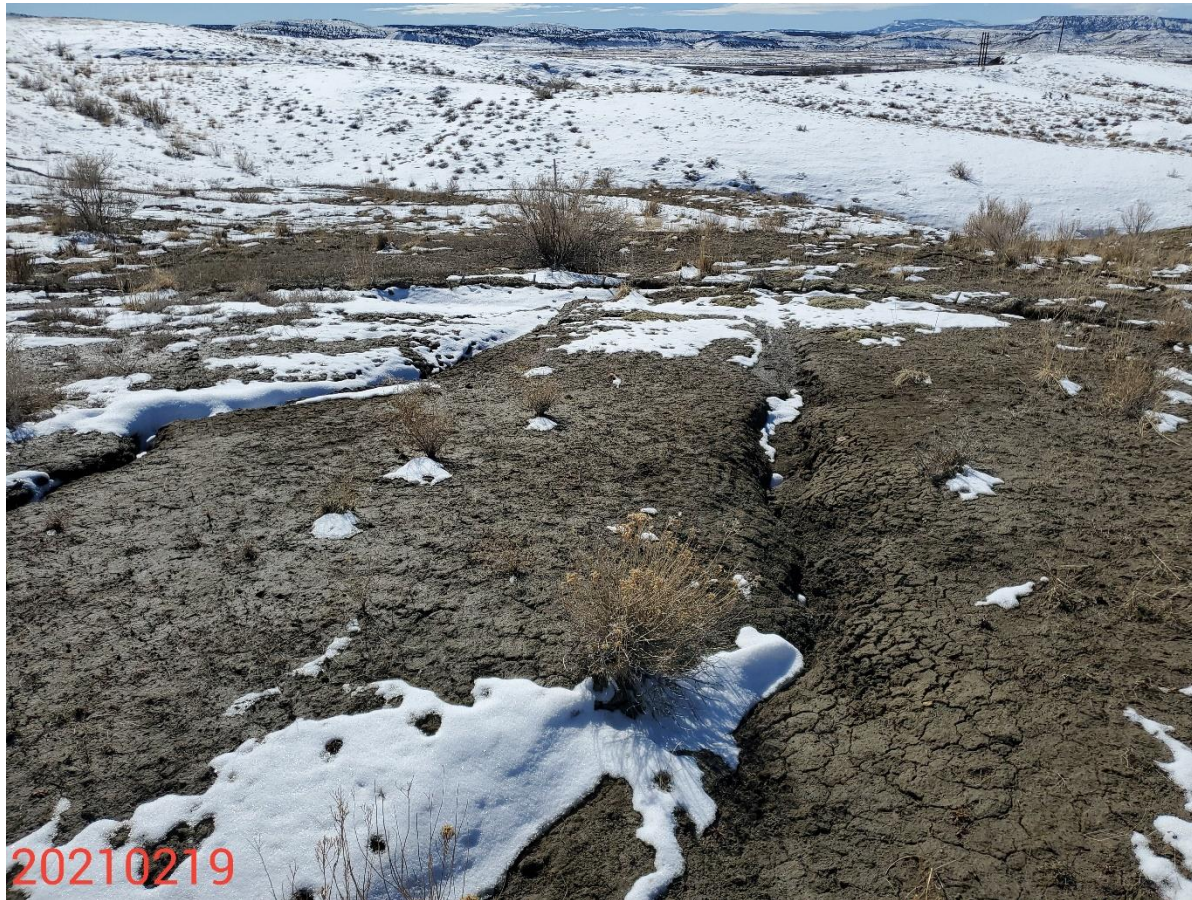
Photo 3: Photo taken from the southern areas of the Location, facing south. Photo shows areas of the Location where vegetative establishment is not occurring, and stormwater and erosion control measures are missing or insufficient to stabilize soils.

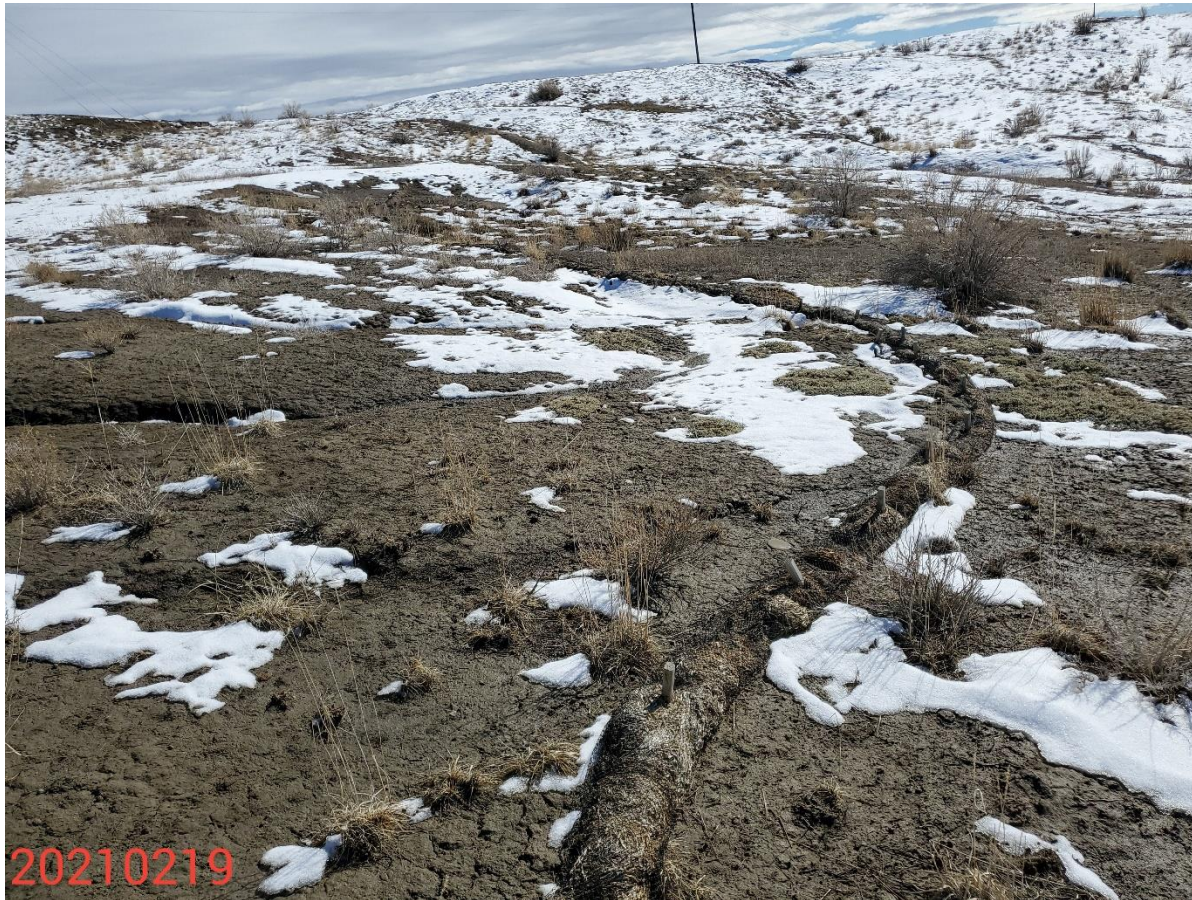
Photo 4: Photo taken from the southern areas of the Location, facing east. Photo shows stormwater and erosion control measures are missing or insufficient to stabilize soils.

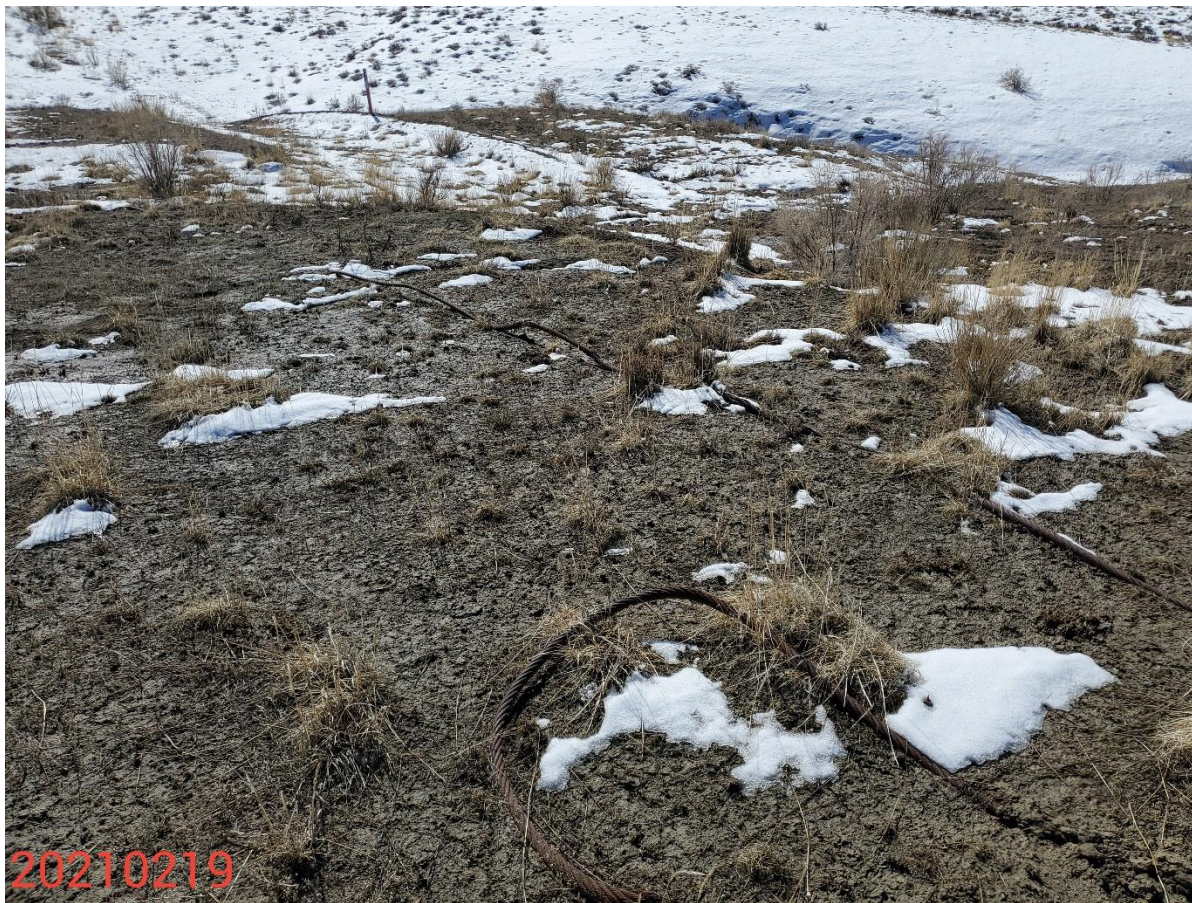
Photo 5: Photo taken from the southwestern areas of the Location, facing southwest. Photo shows cable debris remaining on the Location.

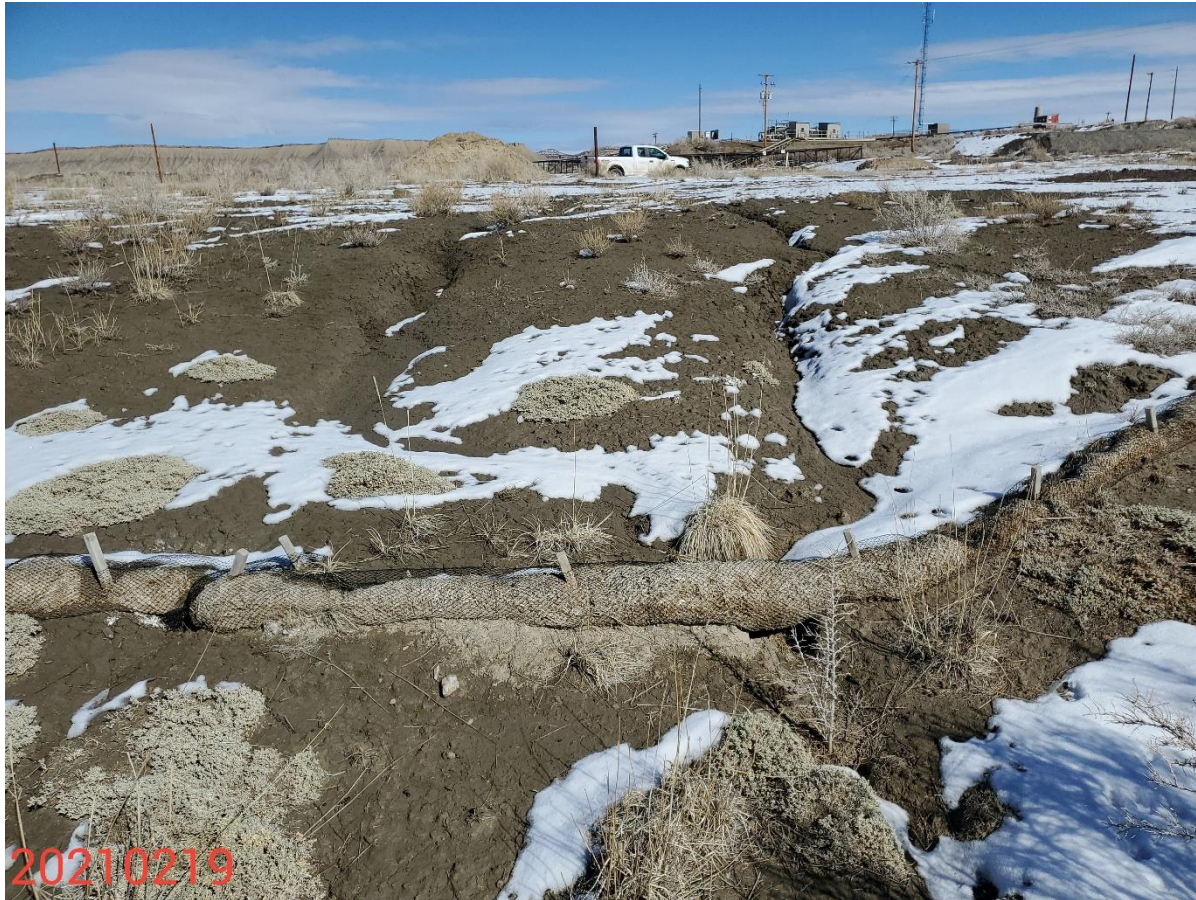
Photo 6: Photo taken from the southern areas of the Location, facing north. Photo shows stormwater and erosion control measures are missing or insufficient to stabilize soils.

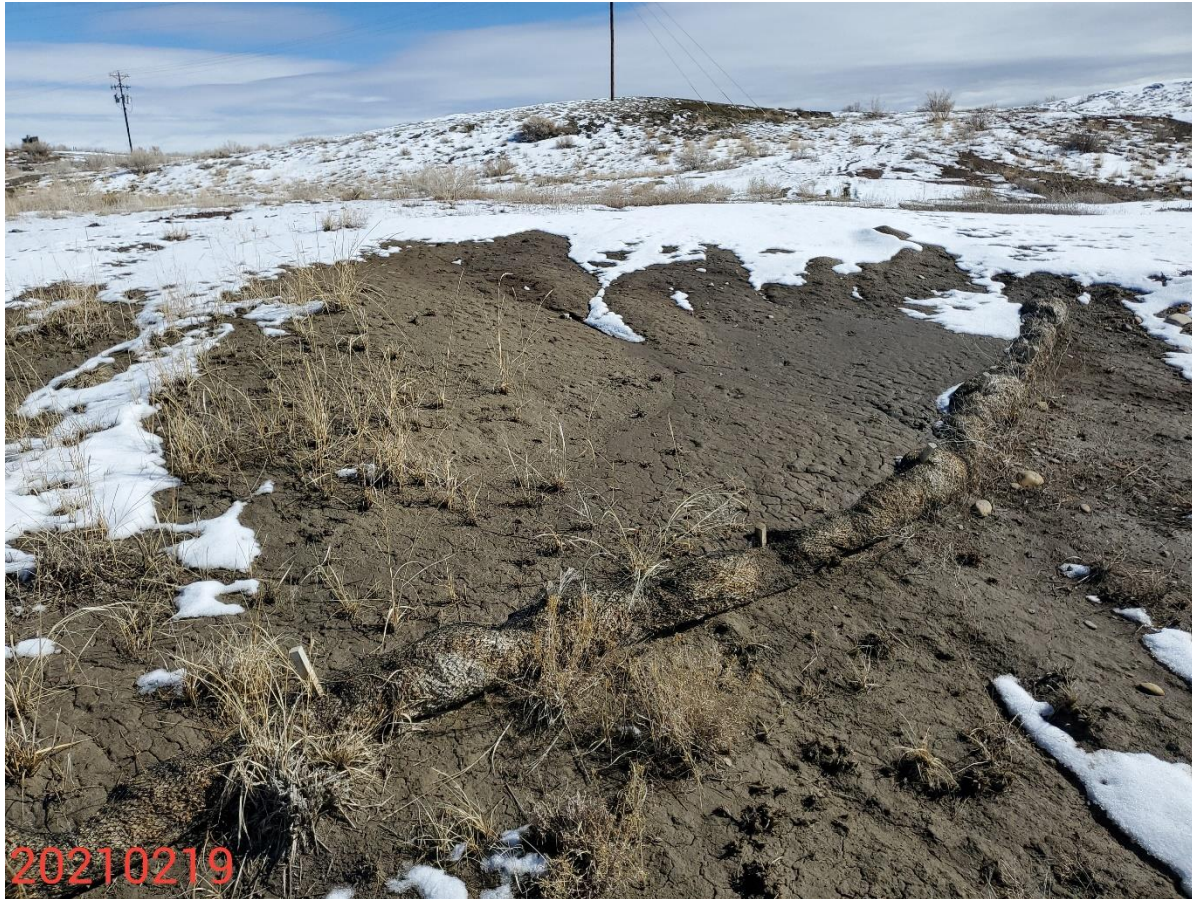
Photo 7: Photo taken from the southern areas of the Location, facing east. Photo shows stormwater and erosion control measures are missing or insufficient to stabilize soils.

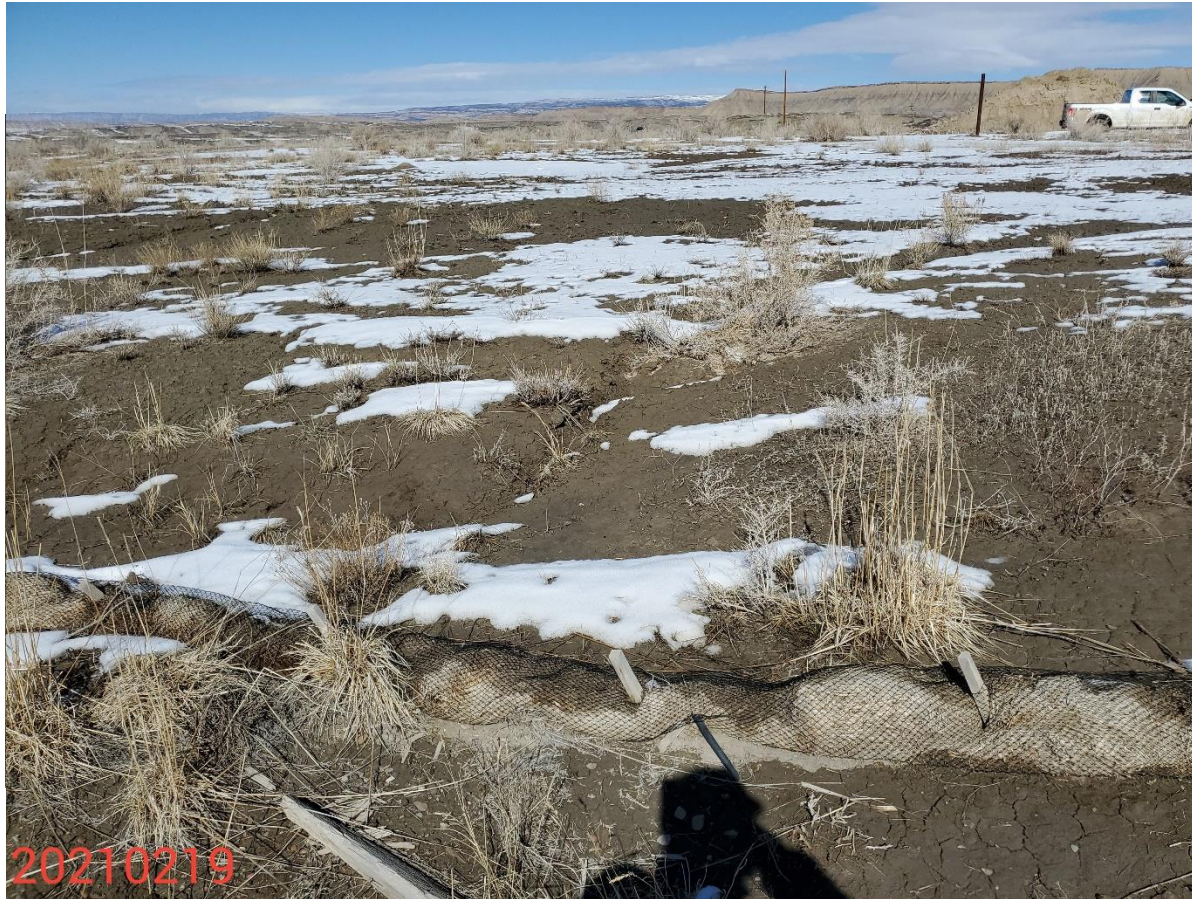
Photo 8: Photo taken from the southern areas of the Location, facing north. Photo shows stormwater and erosion control measures are missing or insufficient to stabilize soils.

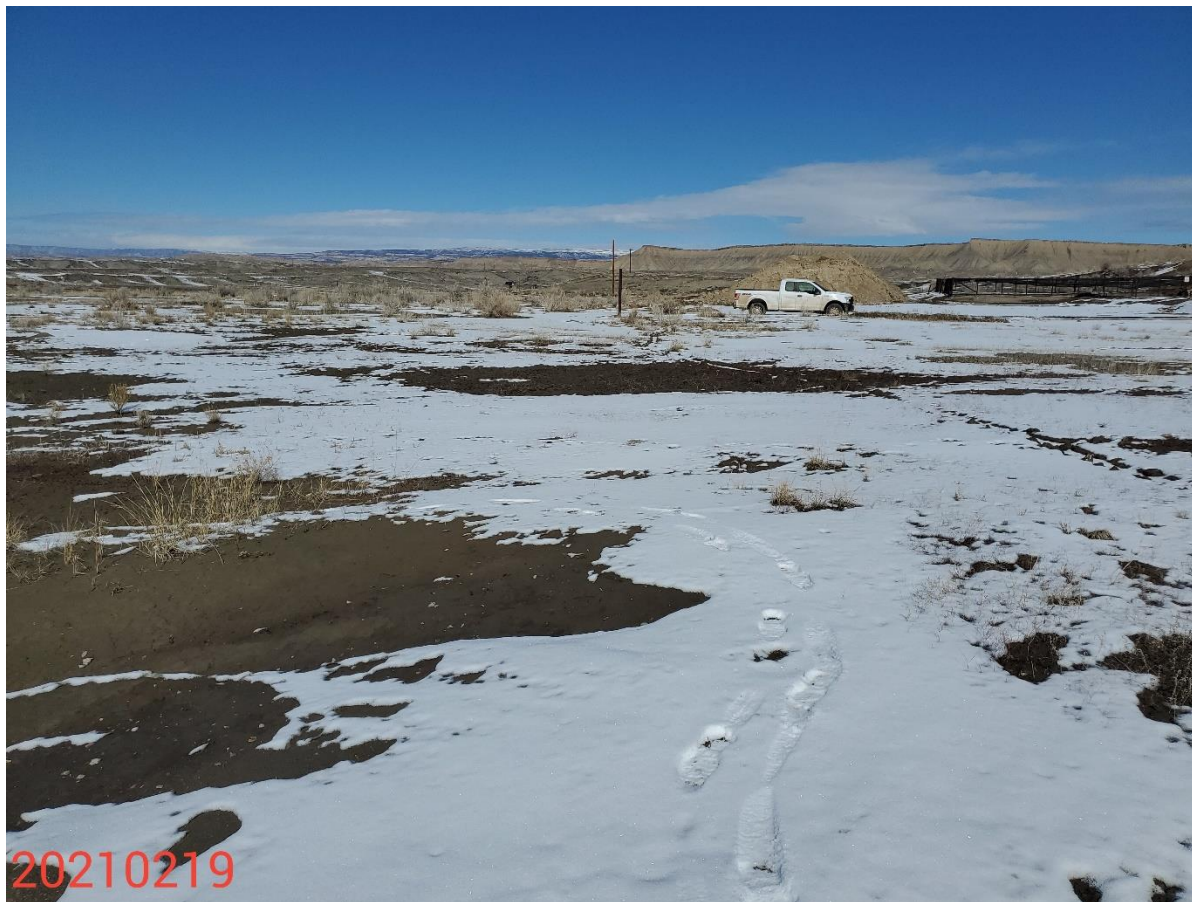
Photo 9: Photo taken from the southern areas of the Location, facing north. Photo shows large areas of the Location where desirable vegetative establishment is not evident.
