Inspection Photos

2/19/2021

Operator: CHEVRON USA INC - 16700

Location ID: 314658

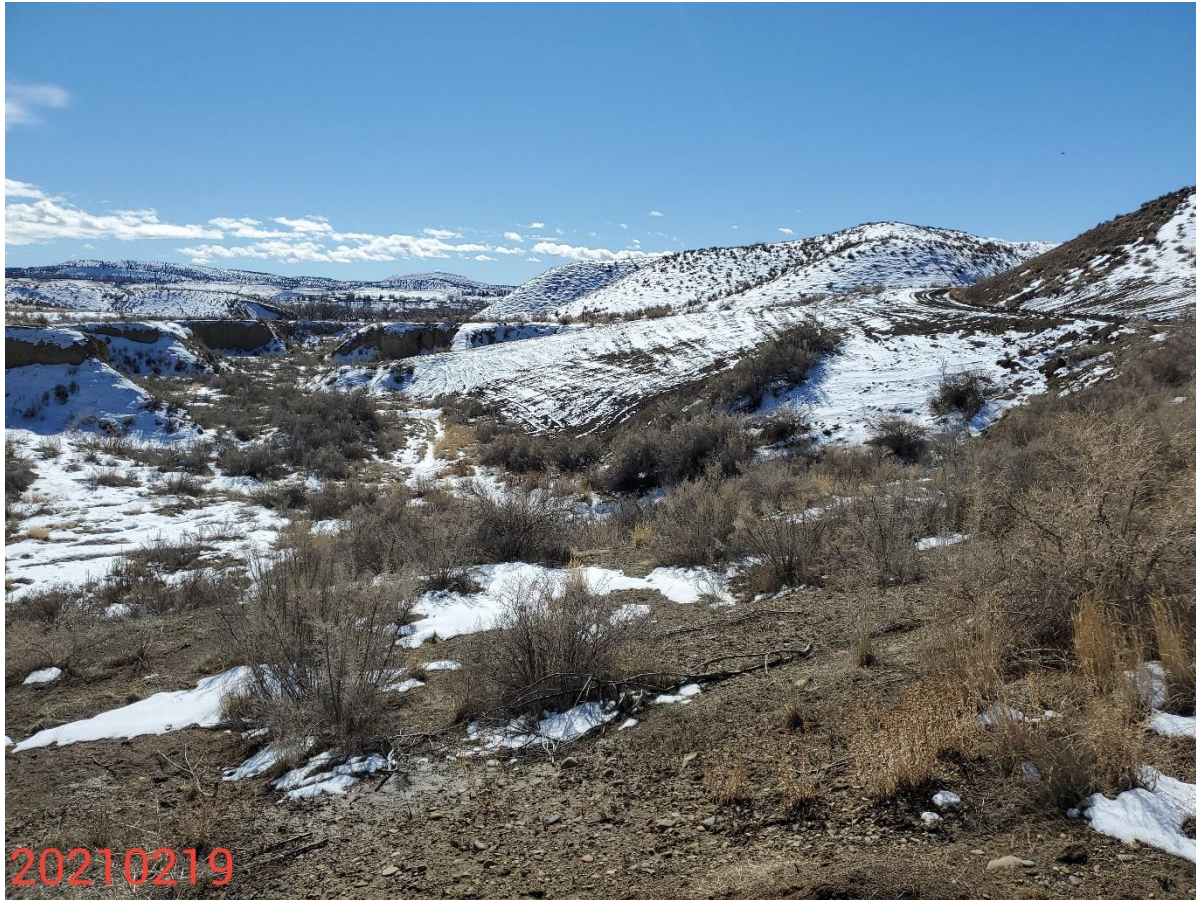
Photo 1: Photo taken from the access road north of the Location, facing south. Photo provides and overview of the Location/reclamation area.

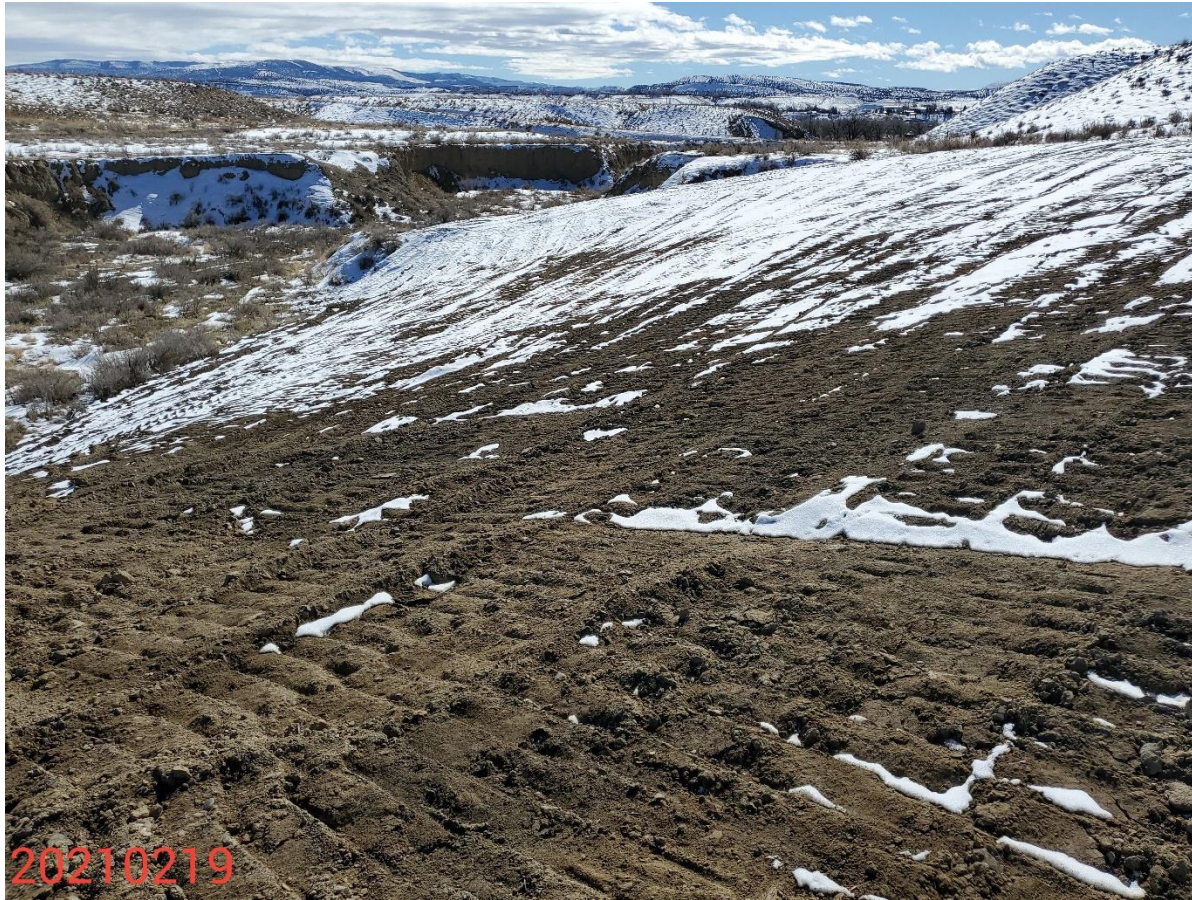
Photo 2: Photo taken from the north end of the Location, facing southeast. Photos 2-4 provide an overview of the Location from southeast, south to southwest.

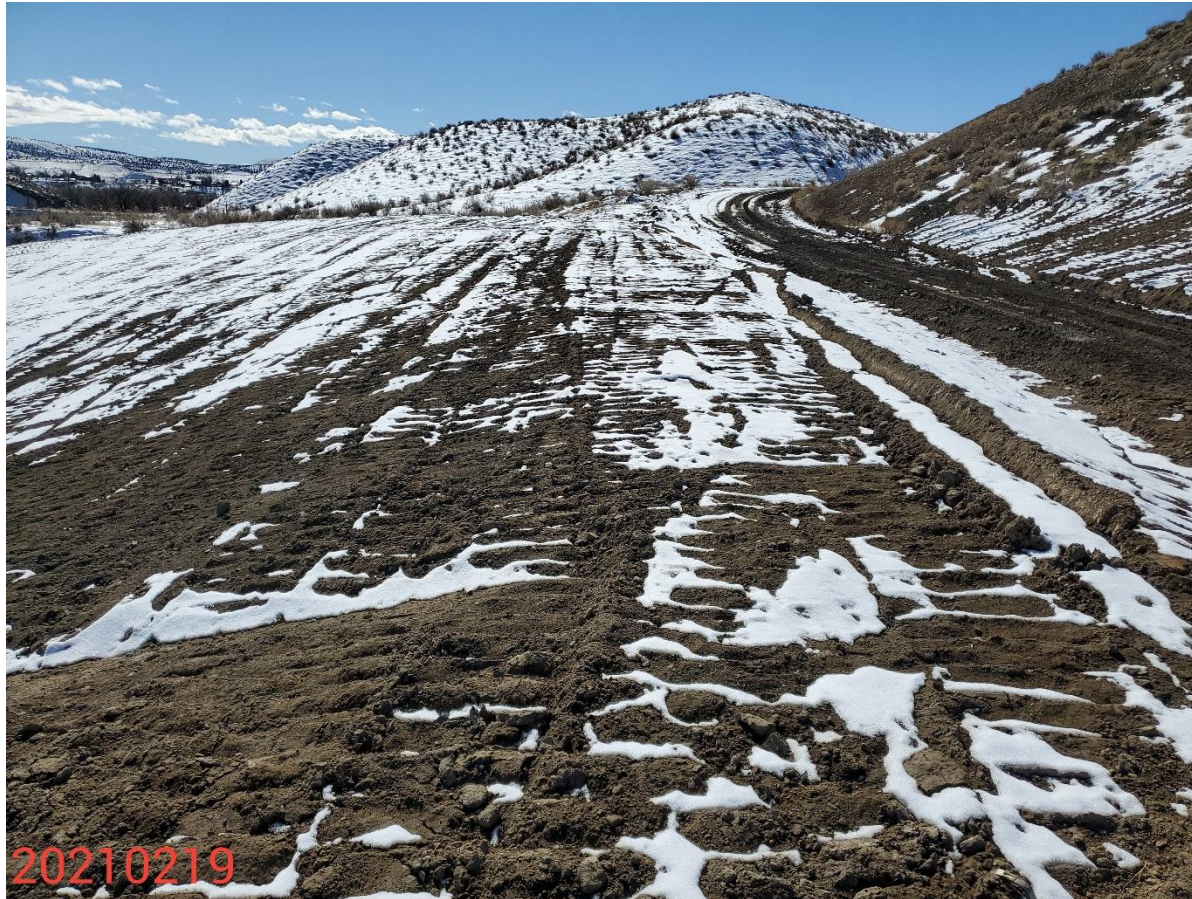
Photo 3: See comments under photo 2

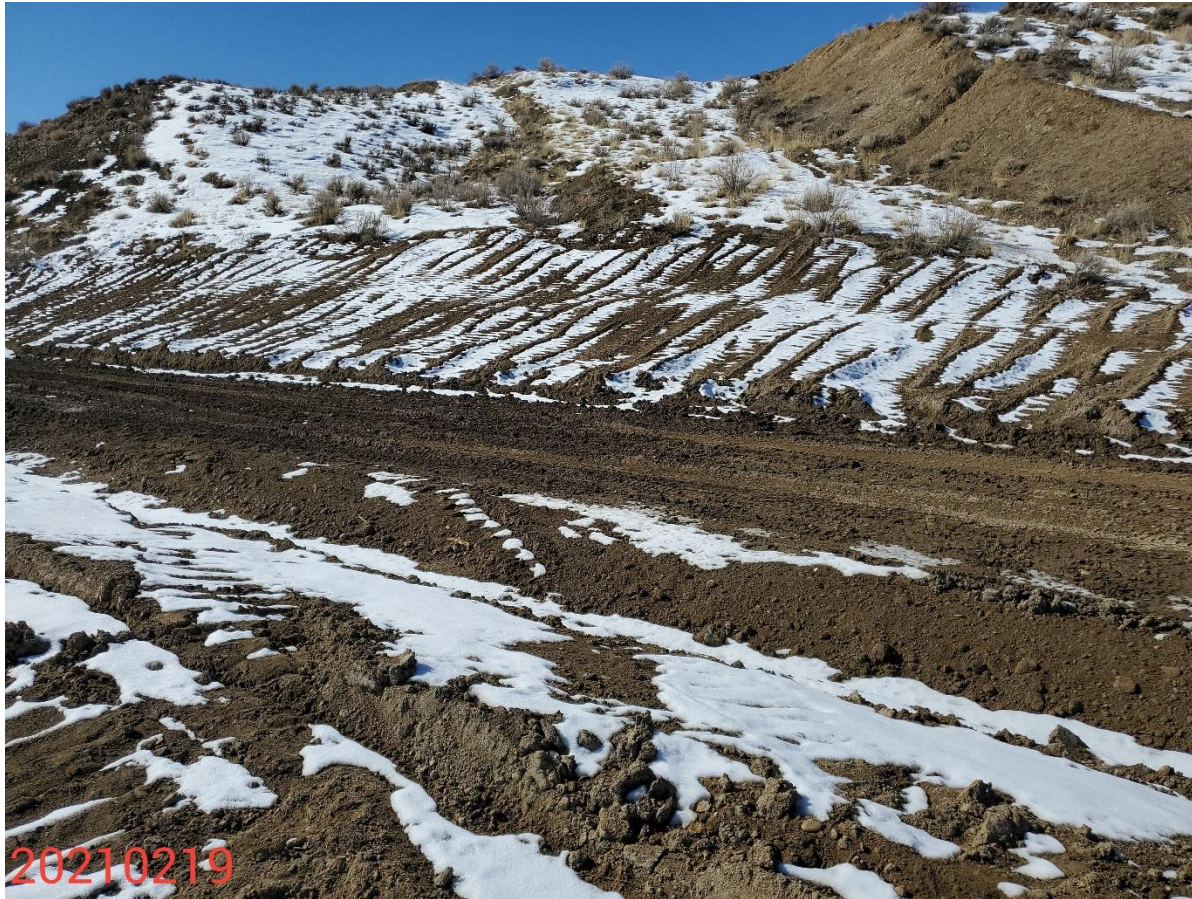
Photo 4: See comments under photo 2.

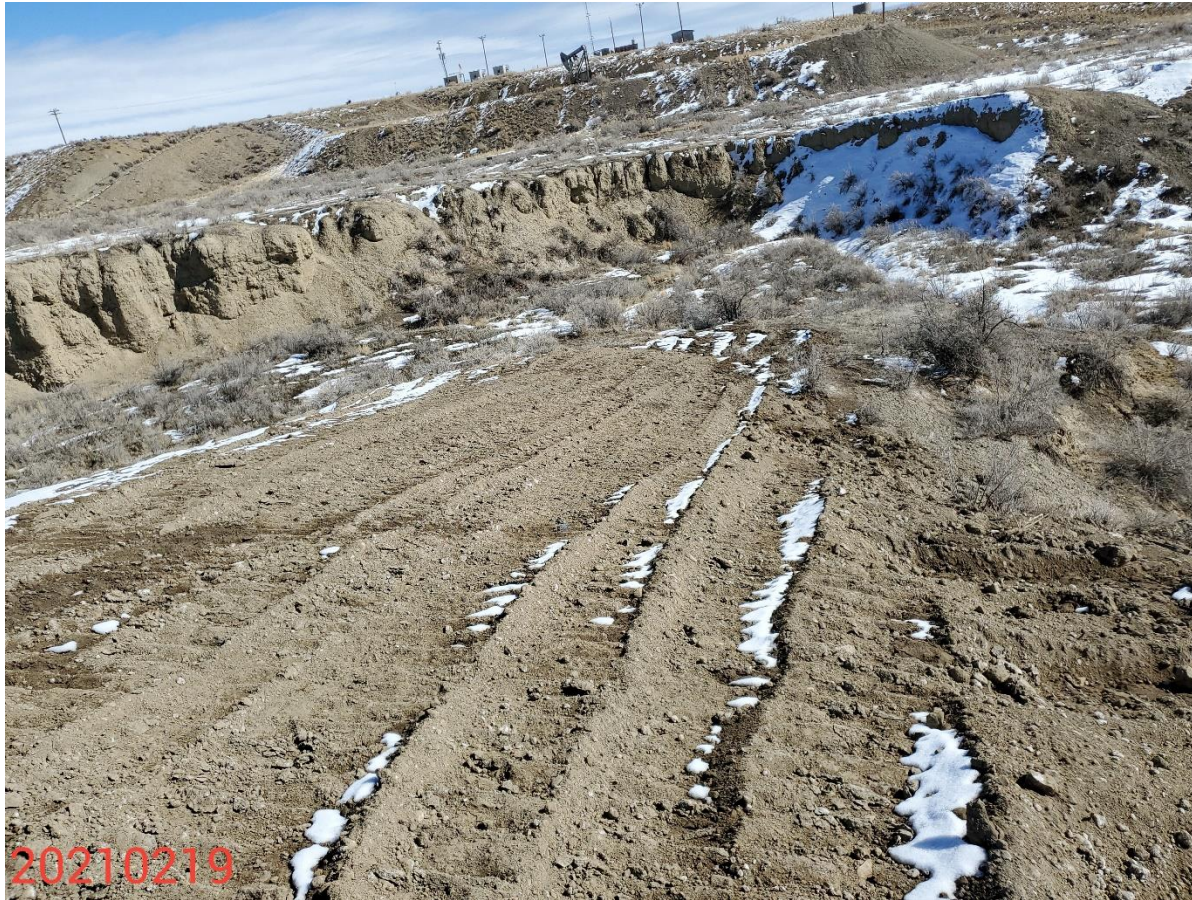
Photo 5: Photo taken from the southwest end of the Location, facing east. Photo shows stormwater and erosion control measures are missing, or insufficient to stabilize the soils and manage runoff from the Location.

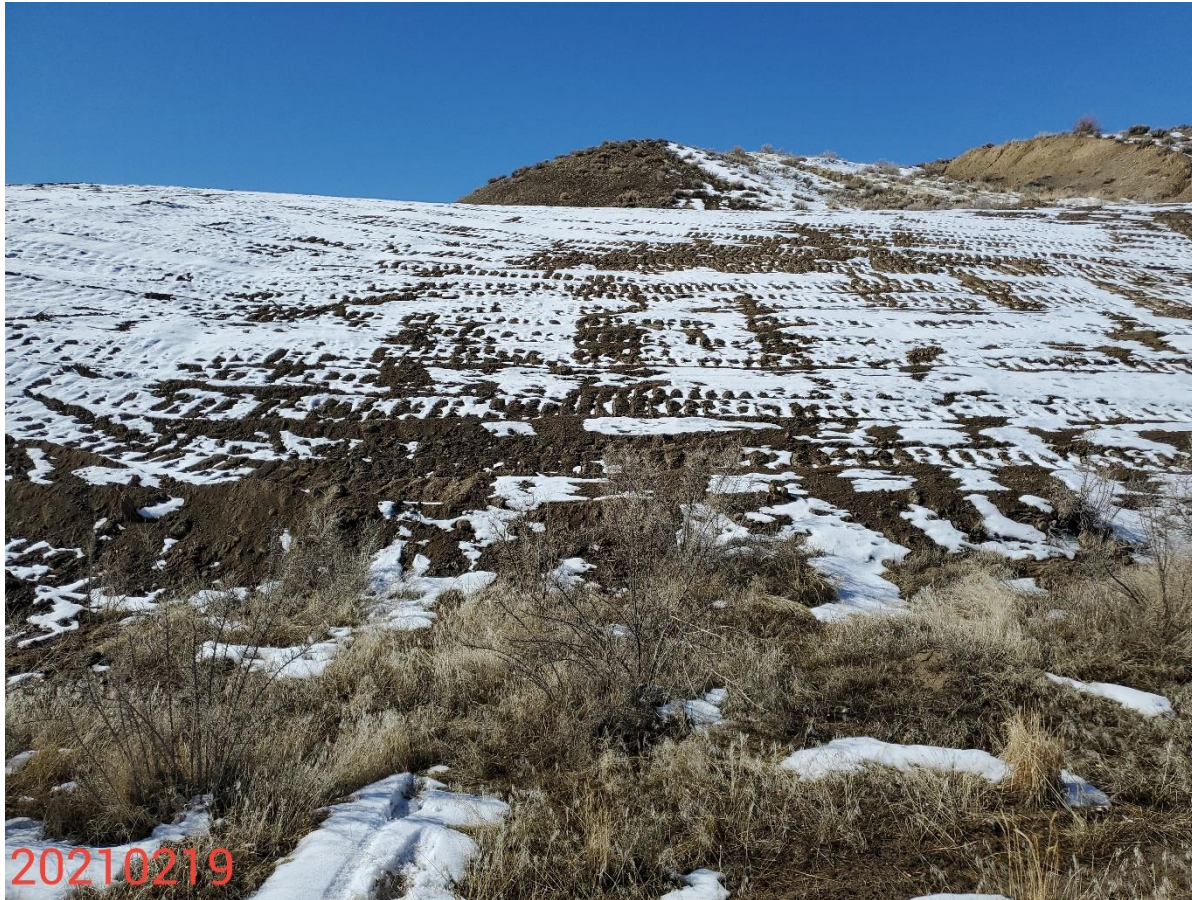
Photo 6: Photo taken from the east end of the Location, facing west. Photo shows stormwater and erosion control measures are missing, or insufficient to stabilize the soils and manage runoff from the Location; Operator appears to have only installed surface roughening (tracking) on the Location, no additional BMPs have been installed in conjunction with surface roughening; photo also shows that tracking has been installed perpendicular to the contours of the land, and not parallel in accordance with good engineering practices.

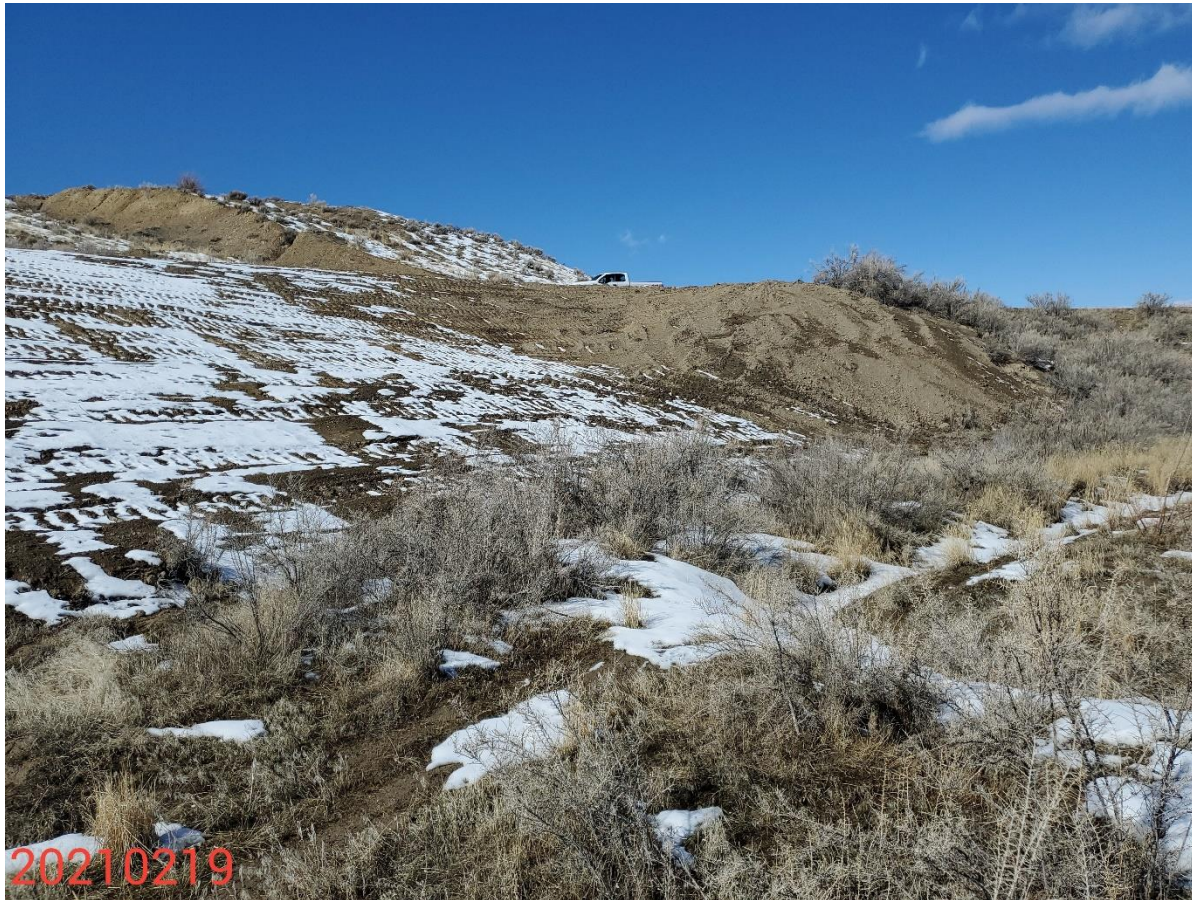
Photo 7: Photo taken from the reast end of the Location, facing north. Photo shows stormwater and erosion control measures are missing, or insufficient to stabilize the soils and manage runoff from the Location.

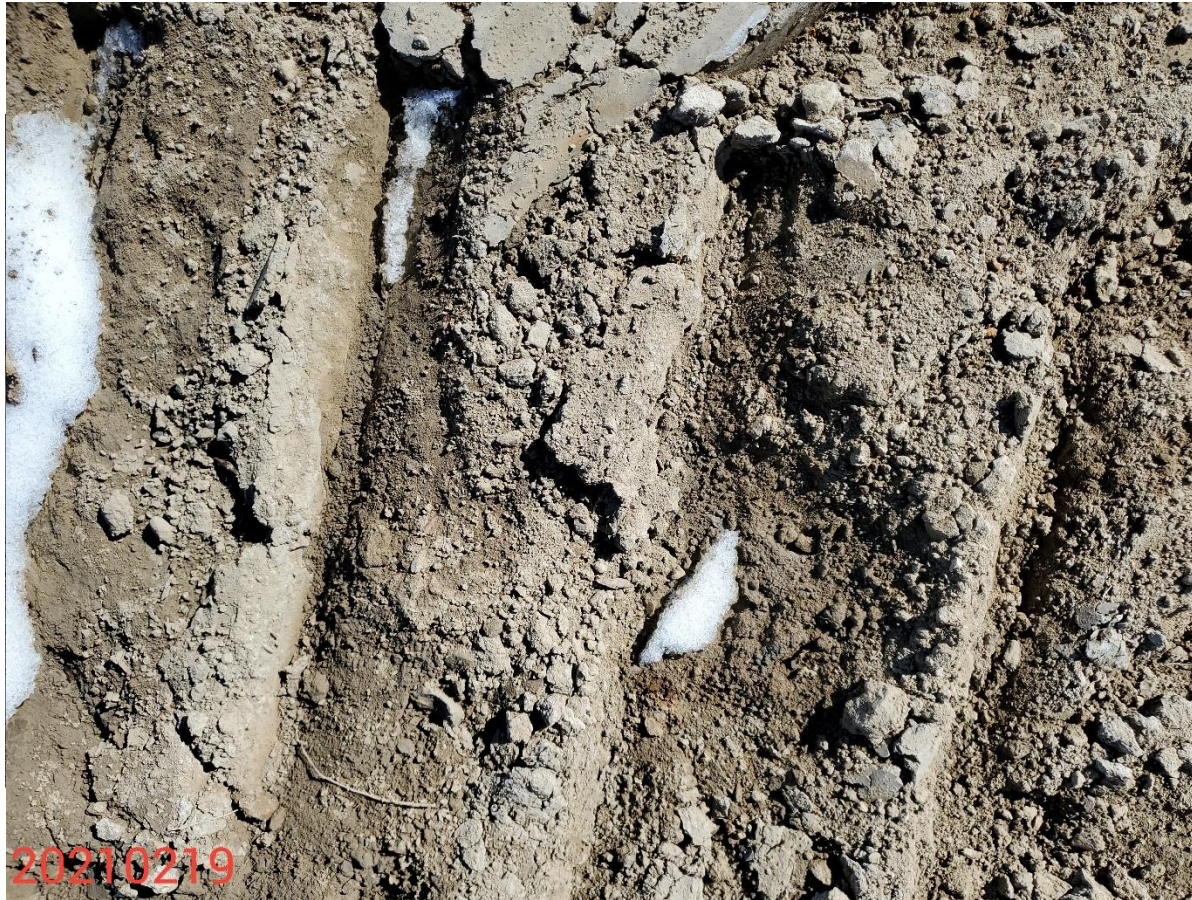
Photo 8: Close up photo of the soil surface of the Location. Unable to find evidence that seeding activates have been conducted.

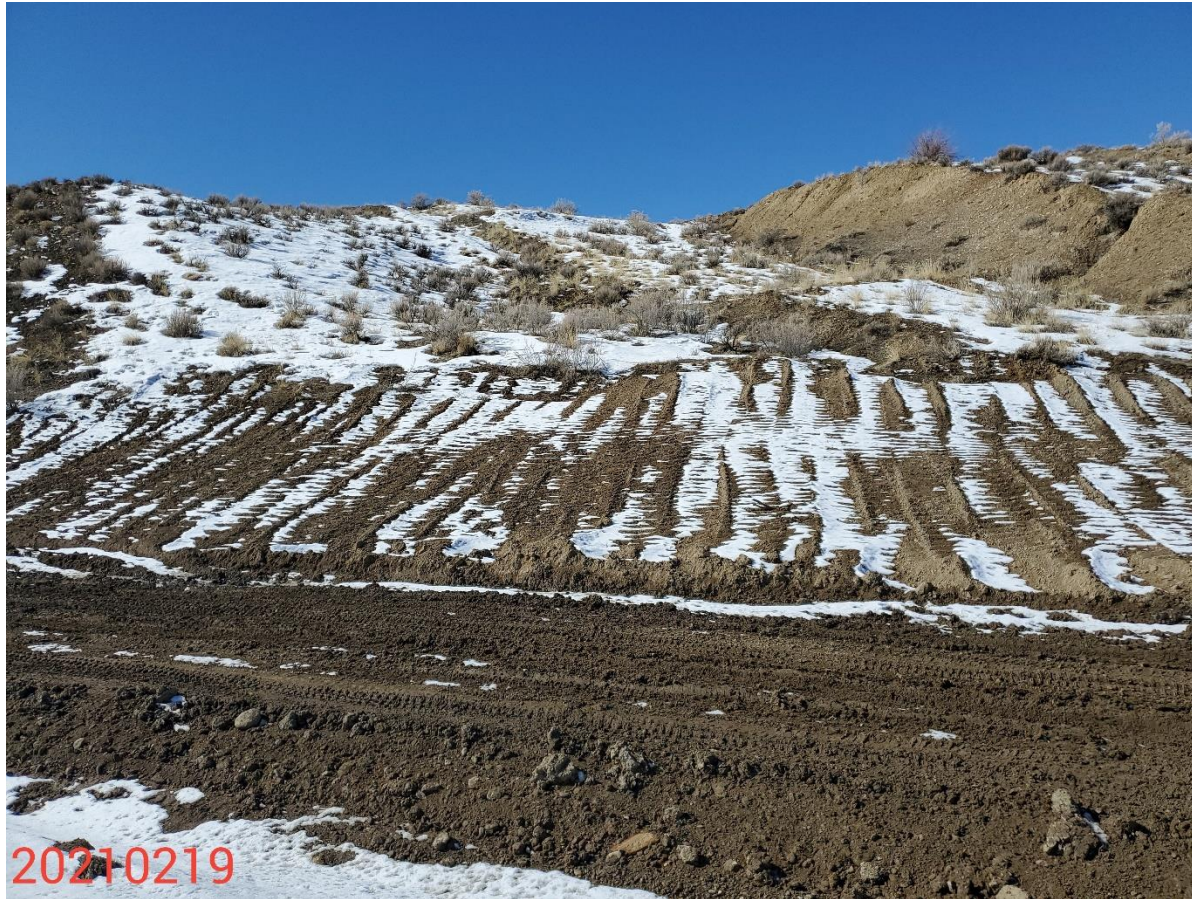
Photo 9: Photo taken from the west end of the Location, facing west. Photo shows operator has installed surface roughening (tracking) along the western slopes. Tracking has been installed in accordance with good engineering practices (parallel to the contours). However tracking is a temporary measure that should be used in conjunction with other erosion and sediment controls; no other erosion and sediment control measures observed on Location.
