# Inspection Photos

2/19/2021

Operator: CHEVRON USA INC - 16700

Location ID: 314707

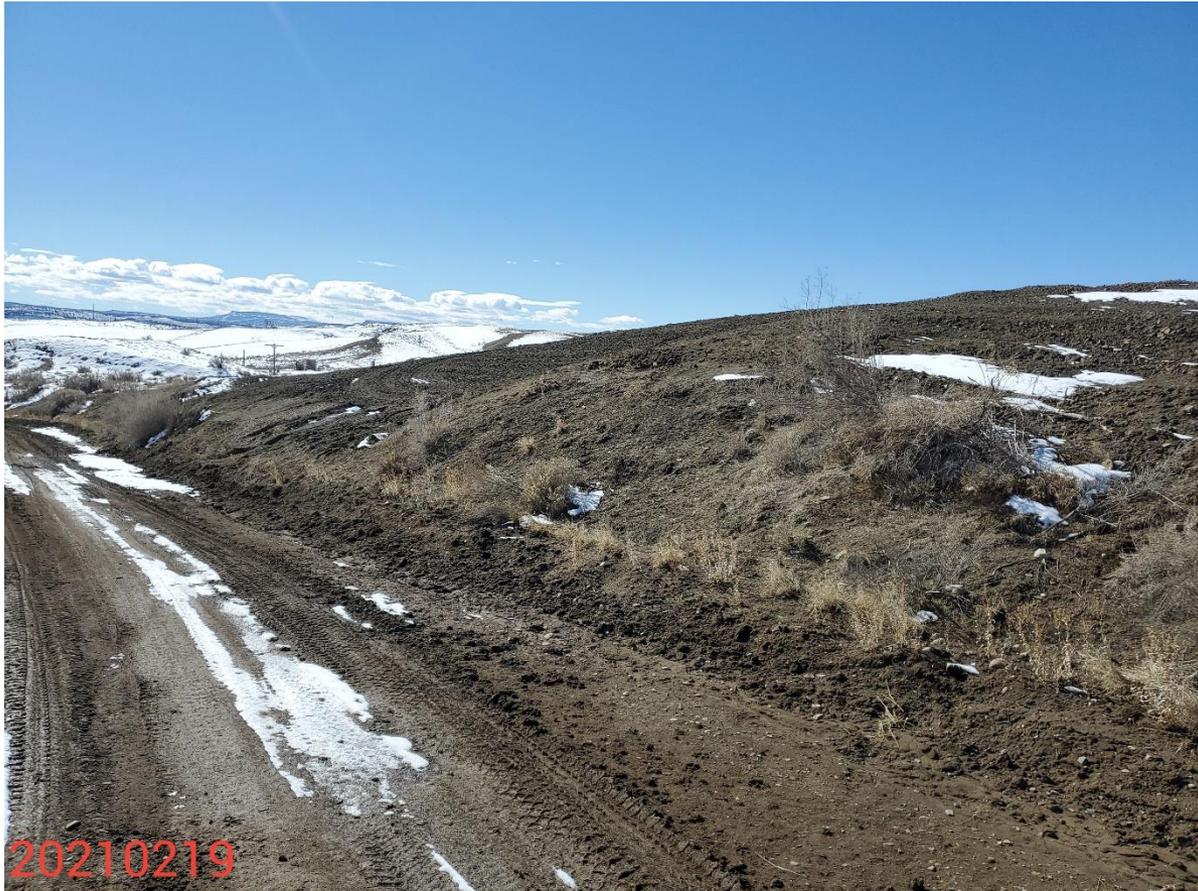
**Photo 1:** Photo taken from the access road east of the Location, facing southwest. Photo 1-3 provide an overview of the Location/reclamation area from southwest to northwest.

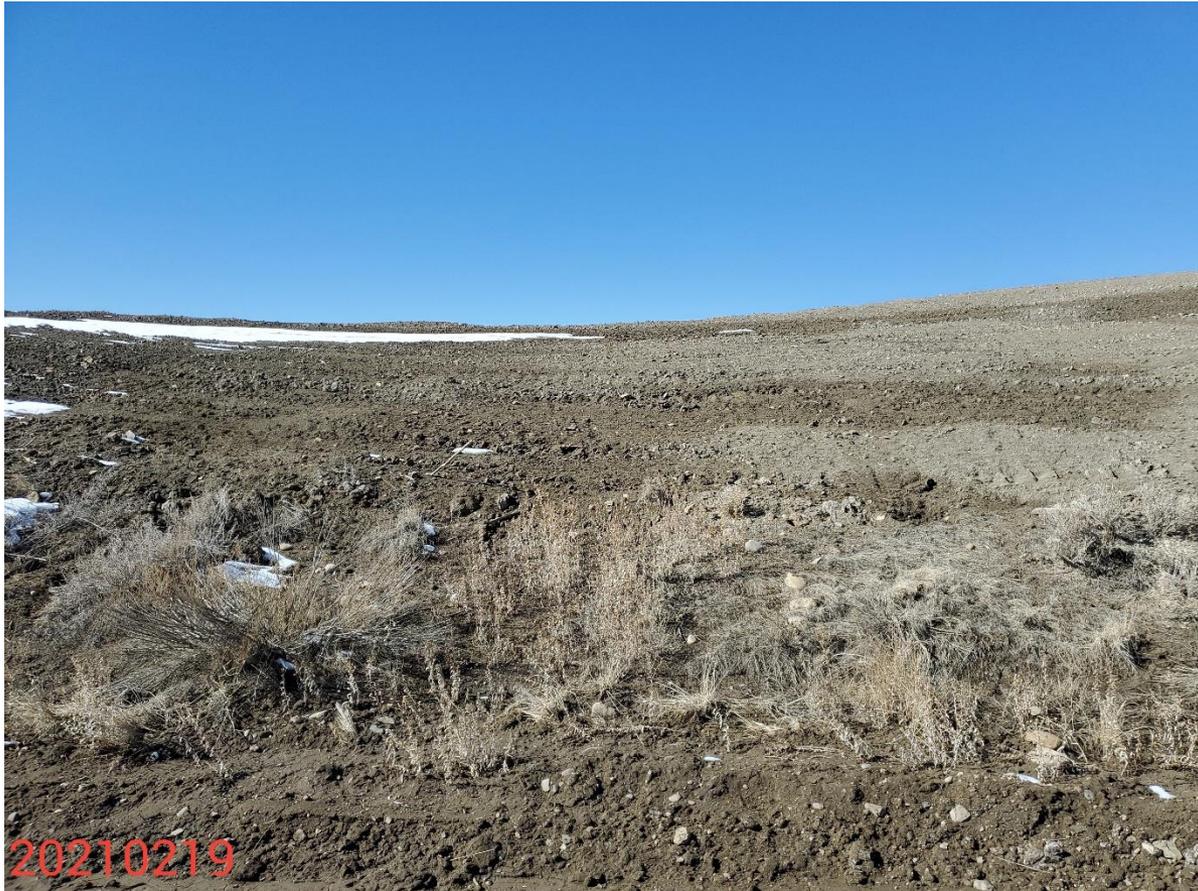
**Photo 2:** See comments under photo 1.

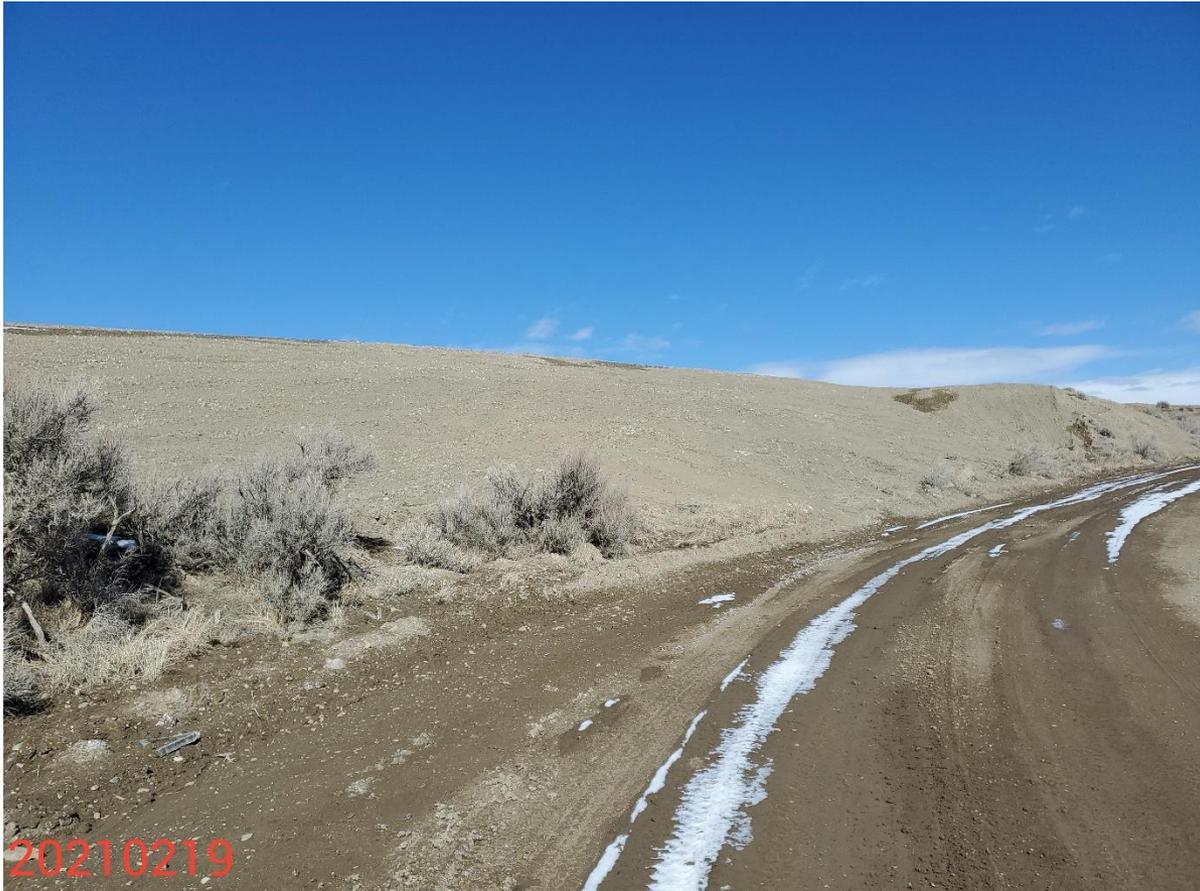
**Photo 3:** See comments under photo 1.

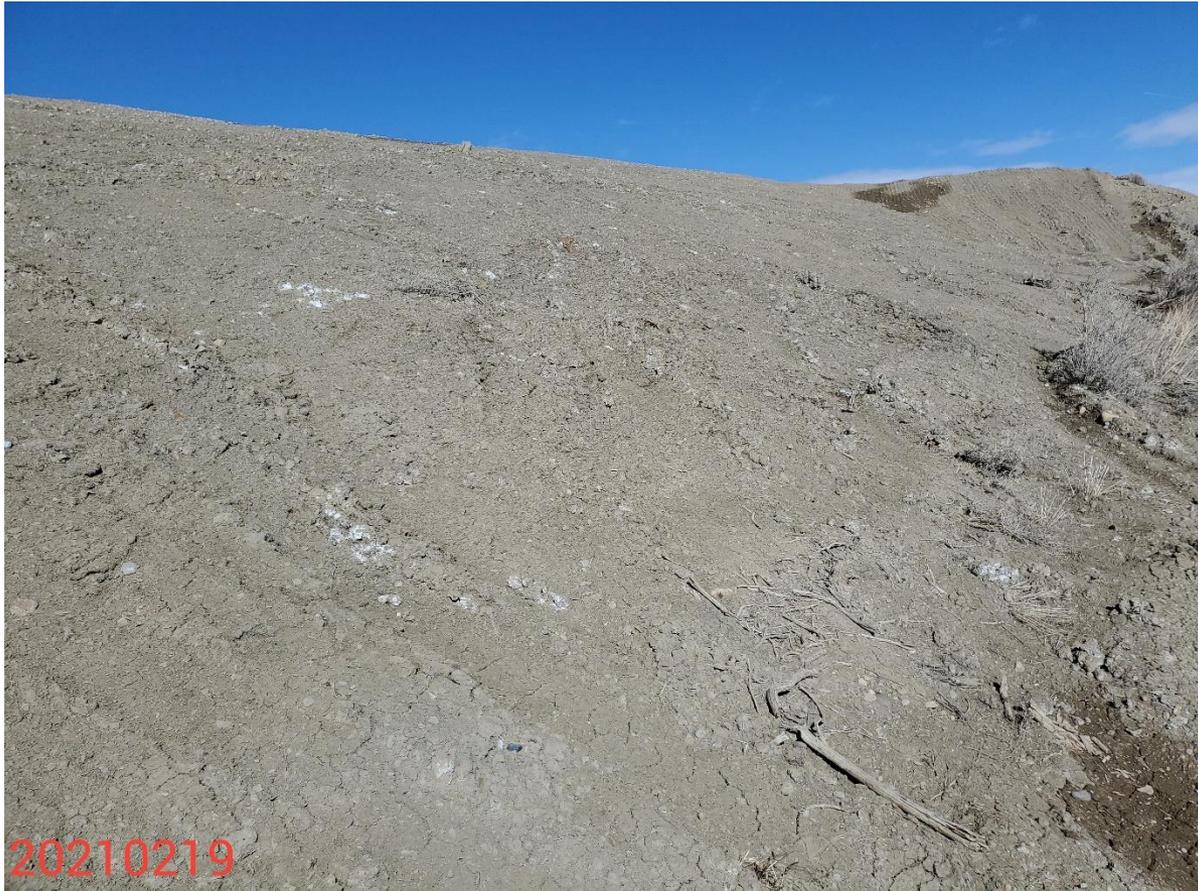
**Photo 4:** Photo taken from the slopes on the east end of the disturbance area/Location. It was observed that drill seeding appears to have been conducted on the Location. Photo shows an example of slopes observed on the Location where drill seeding, or broadcast seeding is not evident; uniform revegetation activities do not appear to have been conducted. Photo also shows that stormwater and erosion control measures are missing, or insufficient to stabilize the soils and manage runoff from the Location.

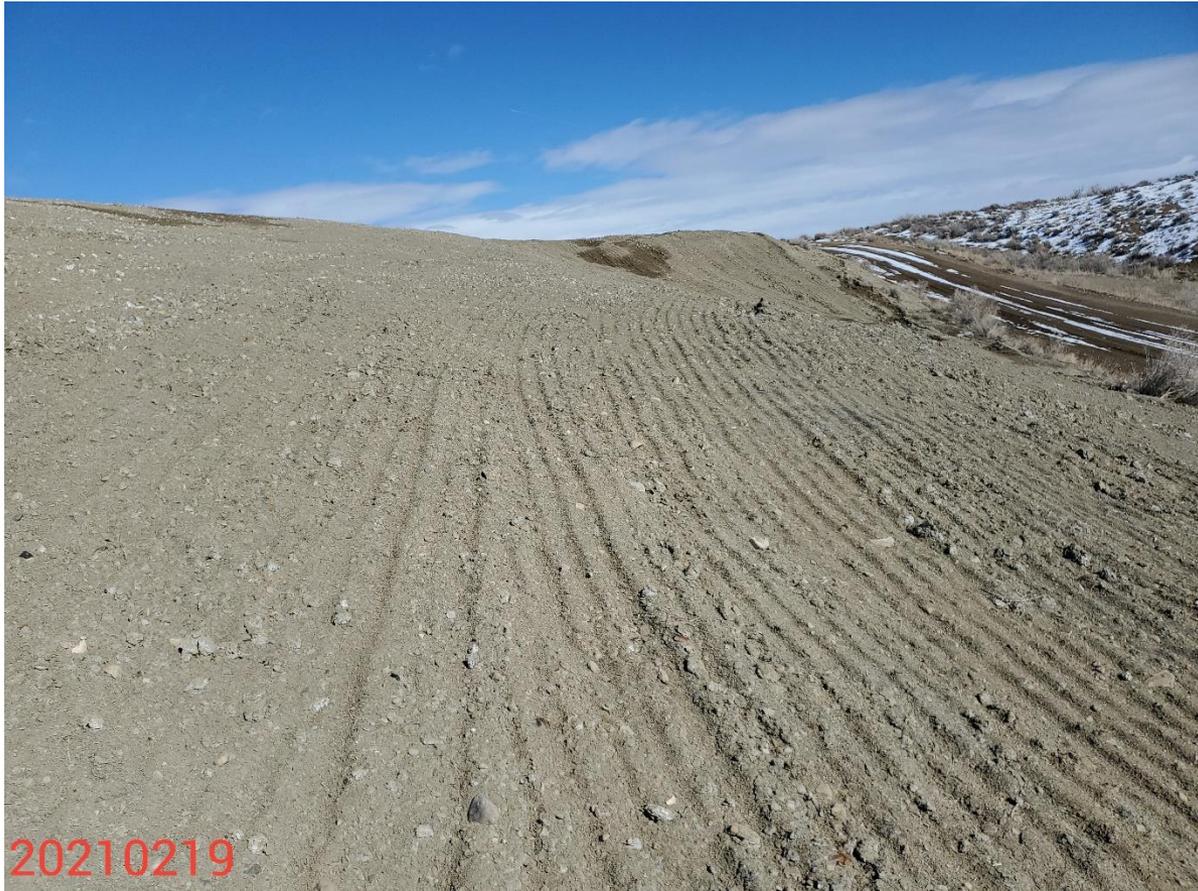
**Photo 5:** Photo taken upslope/northwest of photo #4. Photo shows evidence of drill seeding on the Location. Photo also shows that stormwater and erosion control measures are missing, or insufficient to stabilize the soils and manage runoff from the Location.

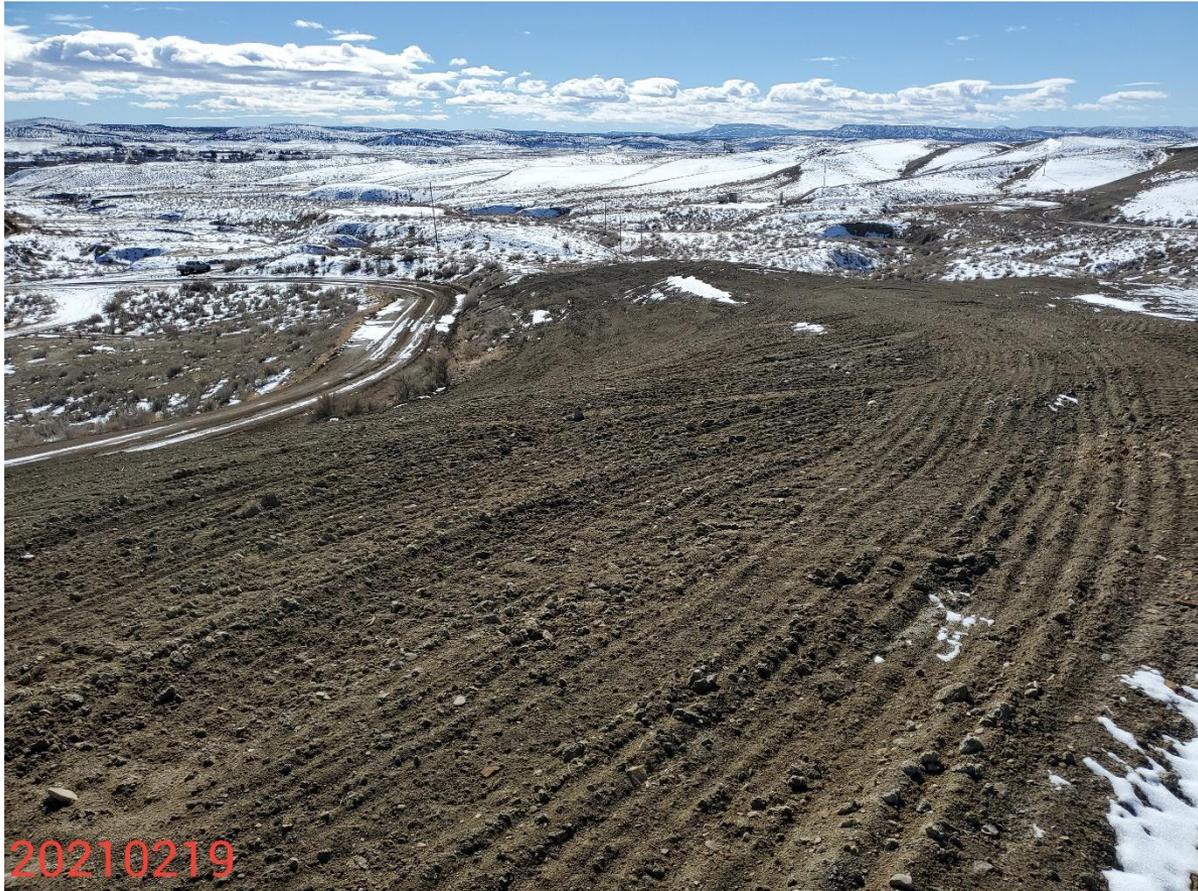
**Photo 6:** Photo taken from the northeast end of the Location, facing southwest. See comments under photo 6.

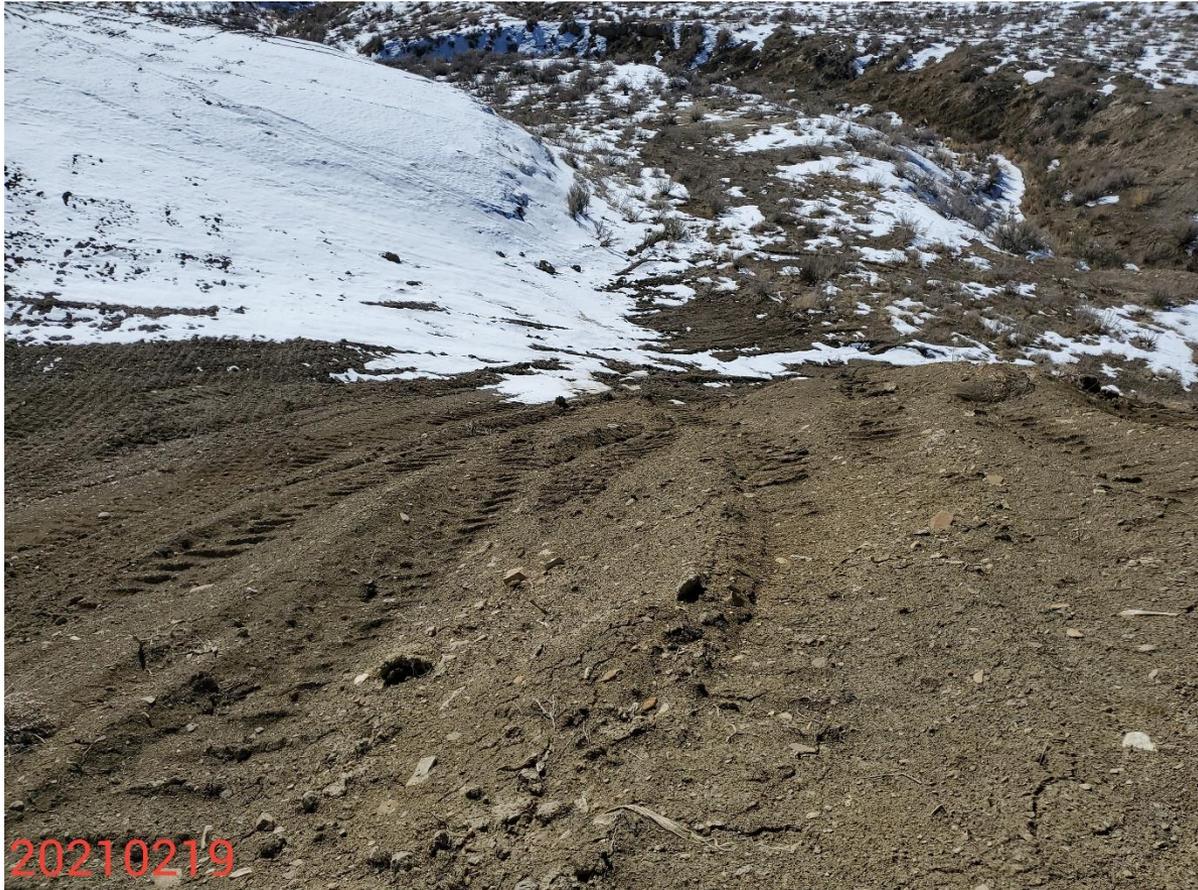
**Photo 7:** Photo taken from the west end of the Location, facing southwest. See comments under photo #4 regarding uniform revegetation activities and stormwater/erosion control management.

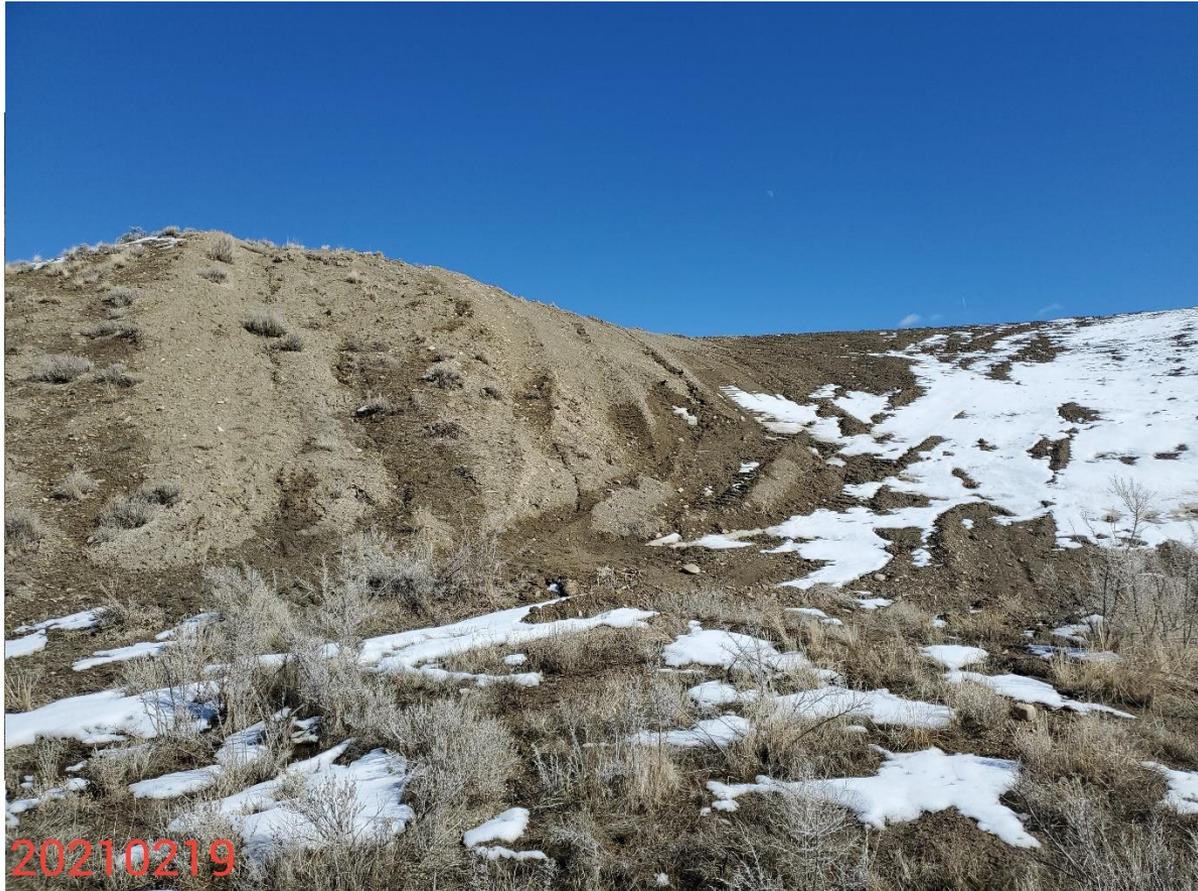
**Photo 8:** Photo taken from the west end of the Location, facing east. Photo looking up the slopes in photo #7. See comments under photo #4 regarding uniform revegetation activities and stormwater/erosion control management.

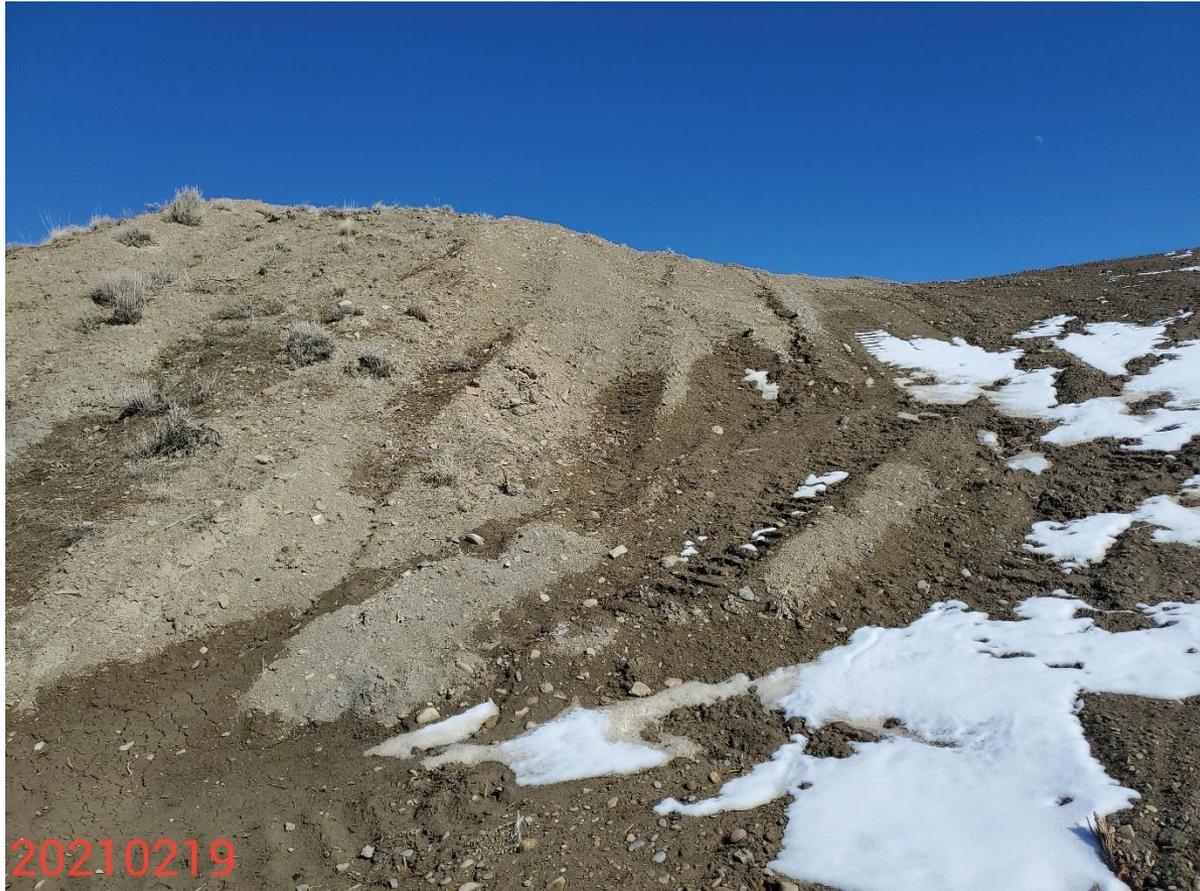
**Photo 9:** Continued from photo #8. See comments under photo #4 regarding uniform revegetation activities and stormwater/erosion control management.

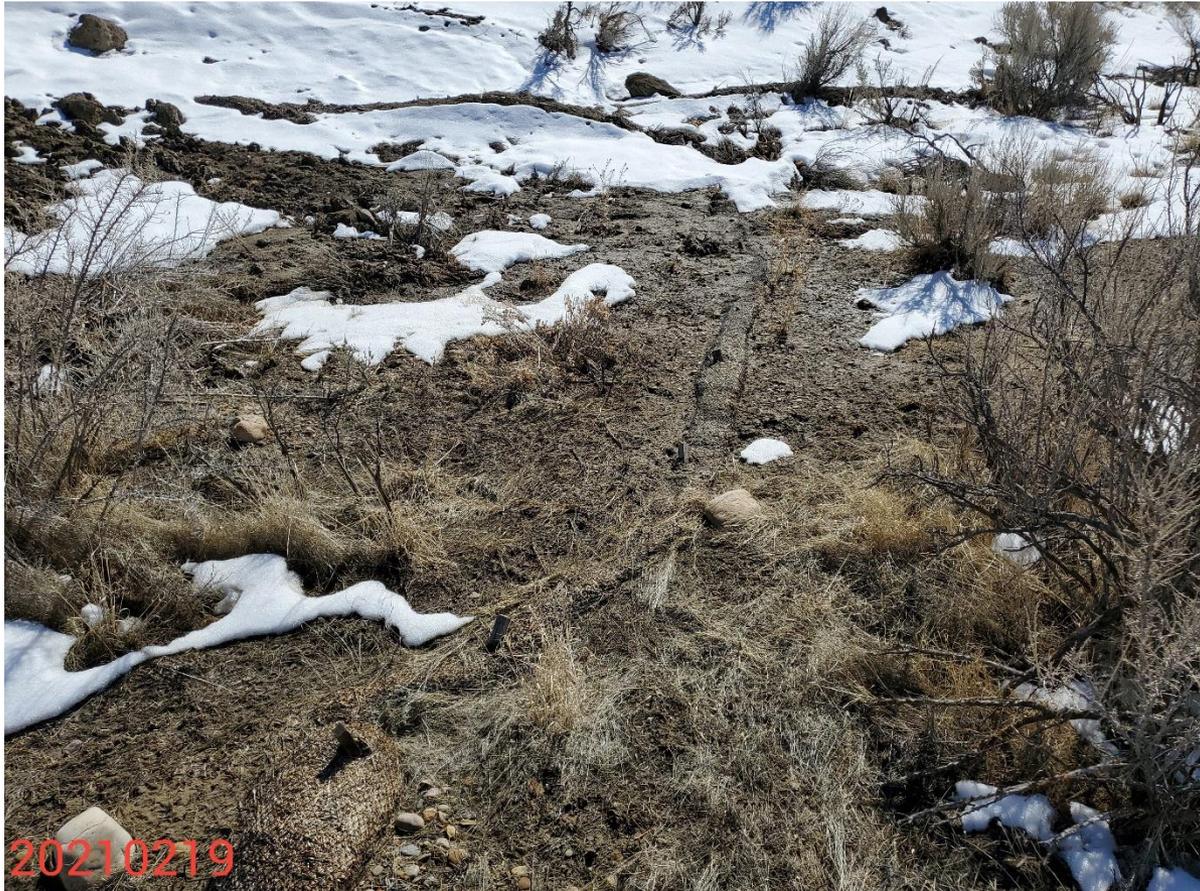
**Photo 10:** Photo shows stormwater runoff controls (straw wattles) observed on the western perimeter of the Location. BMPs are no longer in proper functioning condition. Stormwater and erosion control measures are missing, or insufficient to stabilize the soils and manage runoff from the Location.

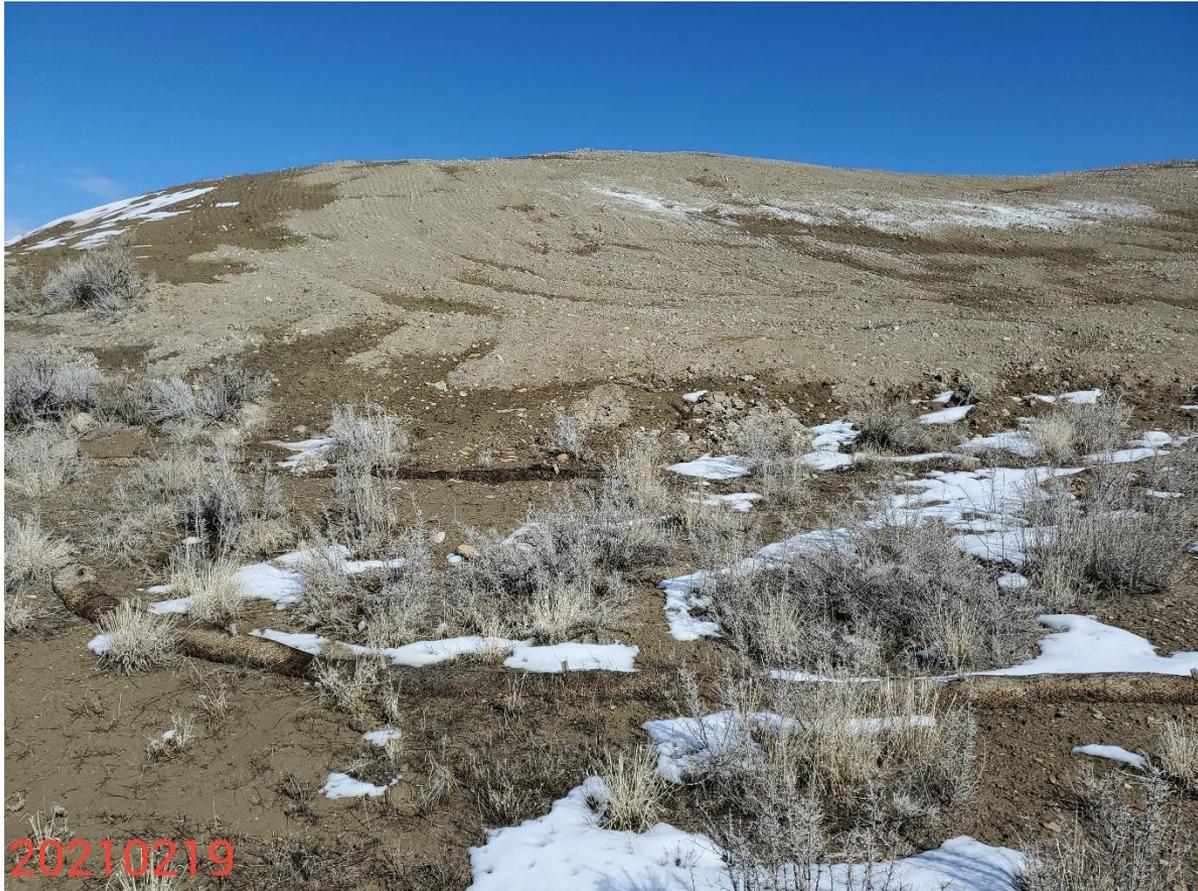
**Photo 11:** Photo taken southwestern end of the Location/disturbance area, facing northeast. Photo shows that stormwater and erosion control measures are missing, or insufficient to stabilize the soils and manage runoff from the Location.

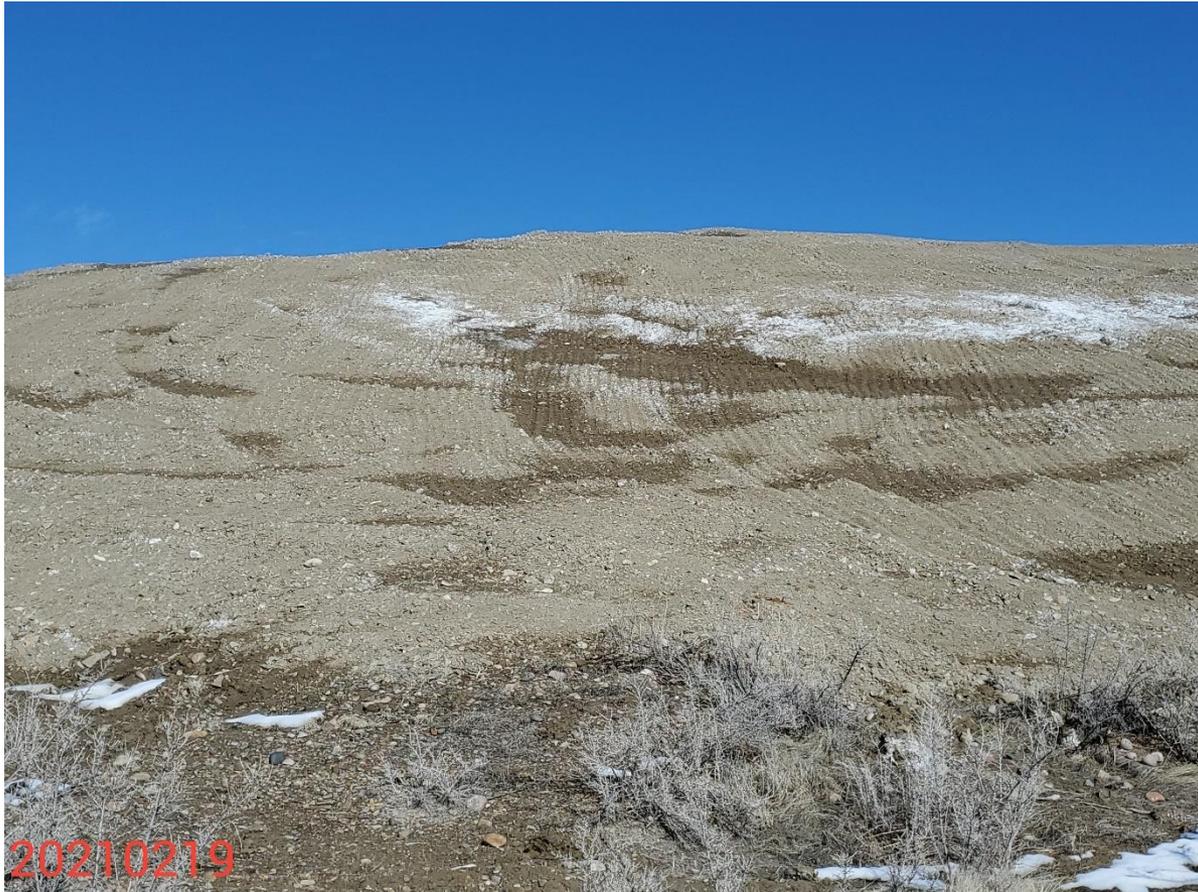
**Photo 12:** Continued from photo 11. Photo shows areas of the Location where drill seeding was performed up the slope, rather than along the contour; seeding has not been performed in accordance with good engineering practices; stormwater and erosion control measures are missing, or insufficient to stabilize the soils and manage runoff from the Location.

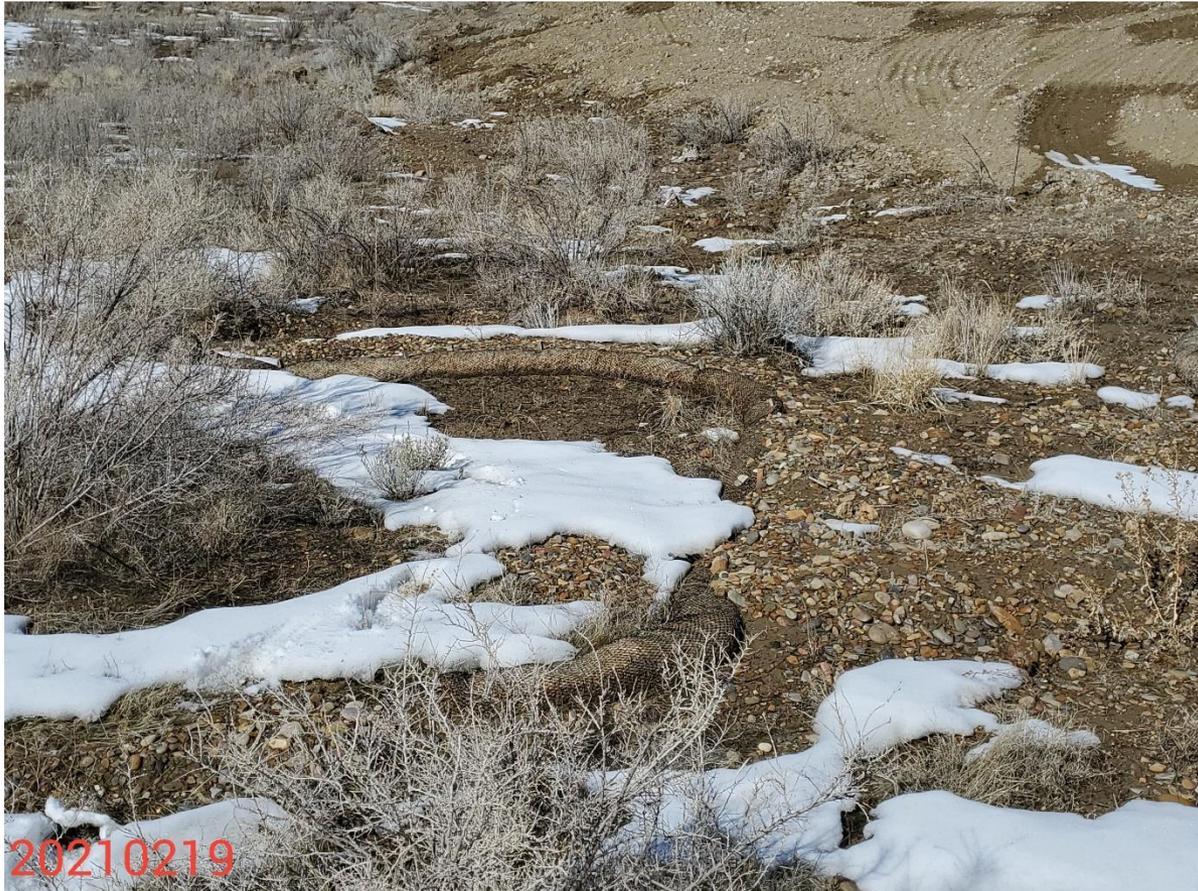
**Photo 13:** Photo shows stormwater runoff controls (straw wattles) observed on the southwestern perimeter of the Location. BMPs are no longer in proper functioning condition. Stormwater and erosion control measures are missing, or insufficient to stabilize the soils and manage runoff from the Location.

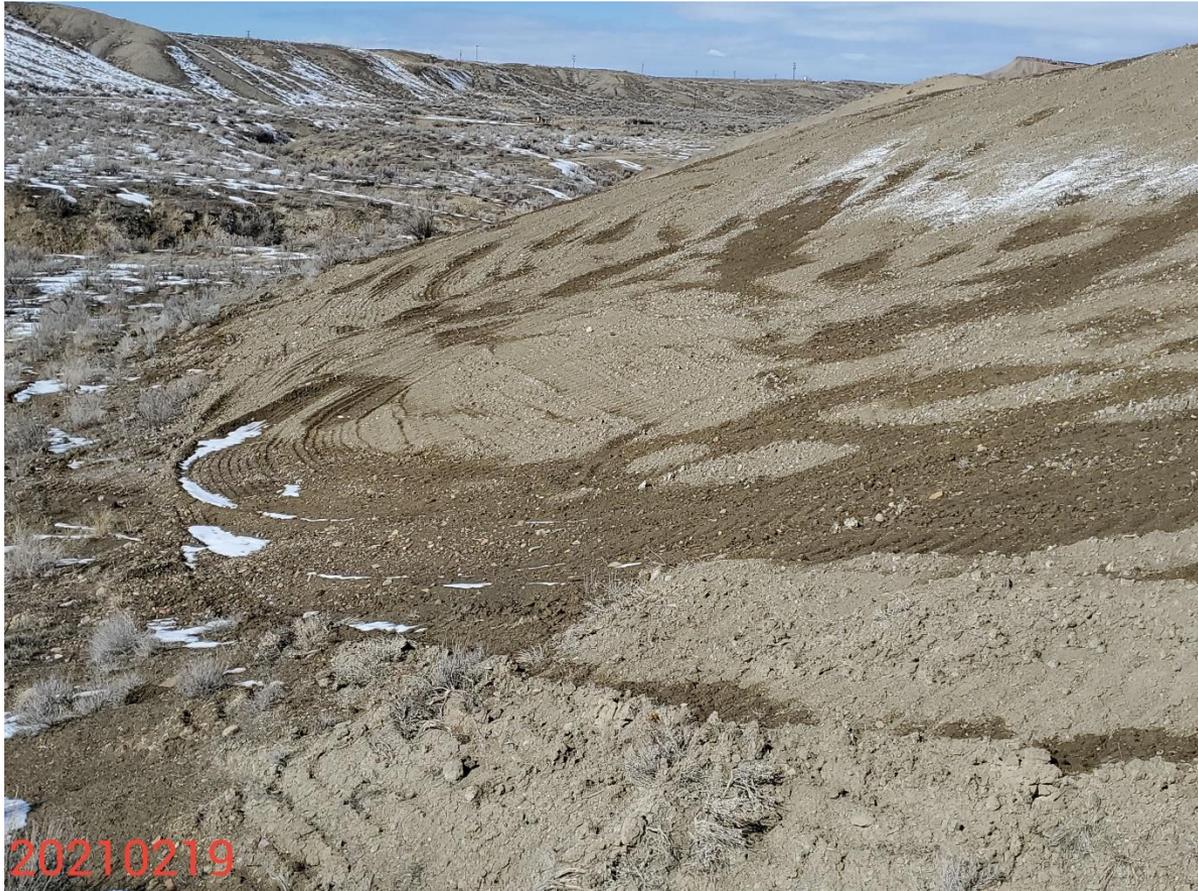
**Photo 14:** Photo taken southwestern end of the Location/disturbance area, facing north. Photo shows that stormwater and erosion control measures are missing, or insufficient to stabilize the soils and manage runoff from the Location.
