Whiting Oil & Gas Corporation

WILDHORSE 06-0634H CORRECTIVE ACTION INSPECTION PHOTOS

Location ID: 427410

Section 6 T9N R59W

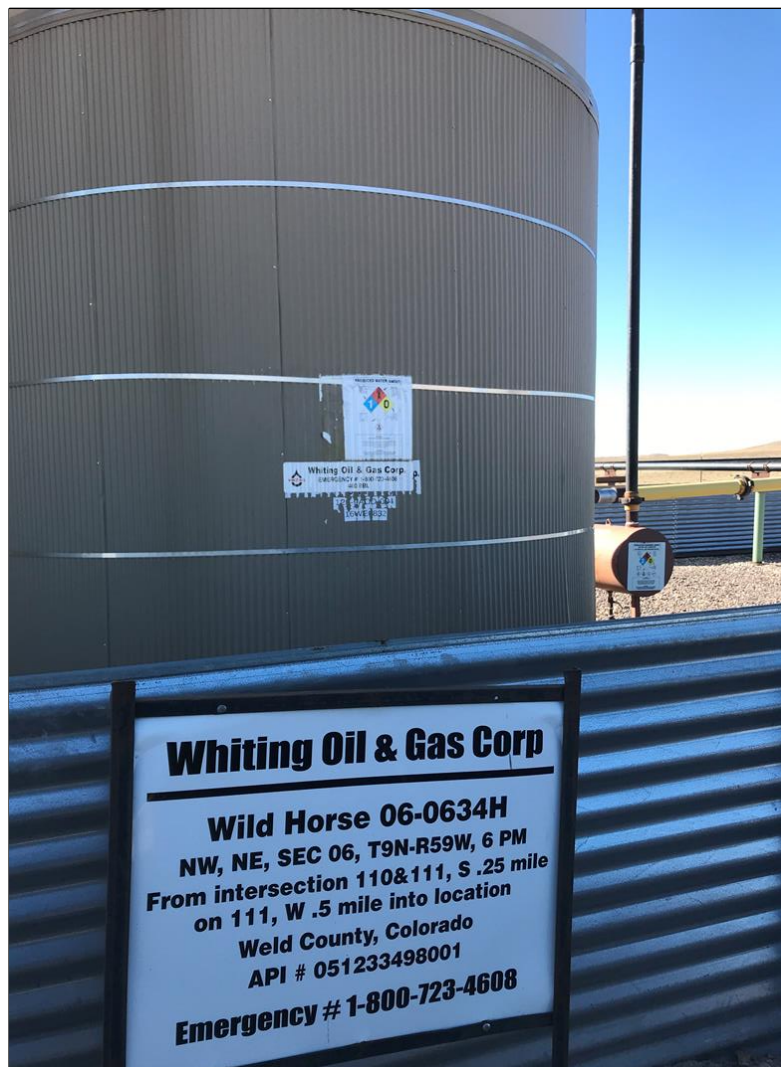
Label Installed on Production Water Tank
