# Interim Reclamation and Stormwater Inspection

February 23, 2021

Operator: EDGE ENERGY II LLC- 10671

Location ID: 460397

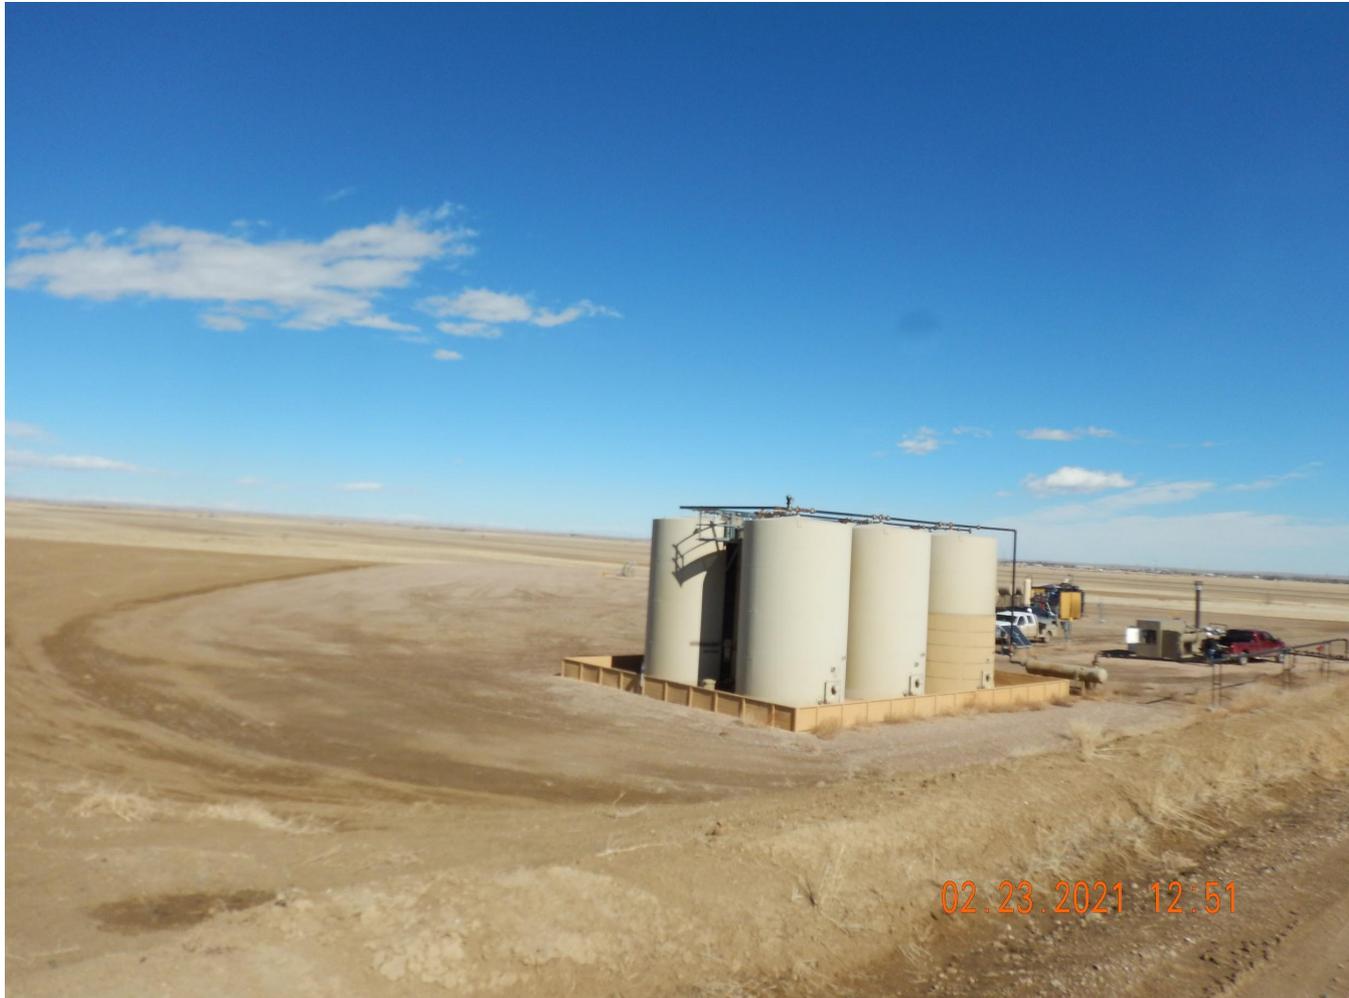
**Photo 1.** Photo taken south of the location, facing Northeast. Photo illustrates the Operator has initiated interim reclamation activities to reduce disturbance areas only needed for production operations. However, Operator has failed to complete interim reclamation activities (i.e., seed).

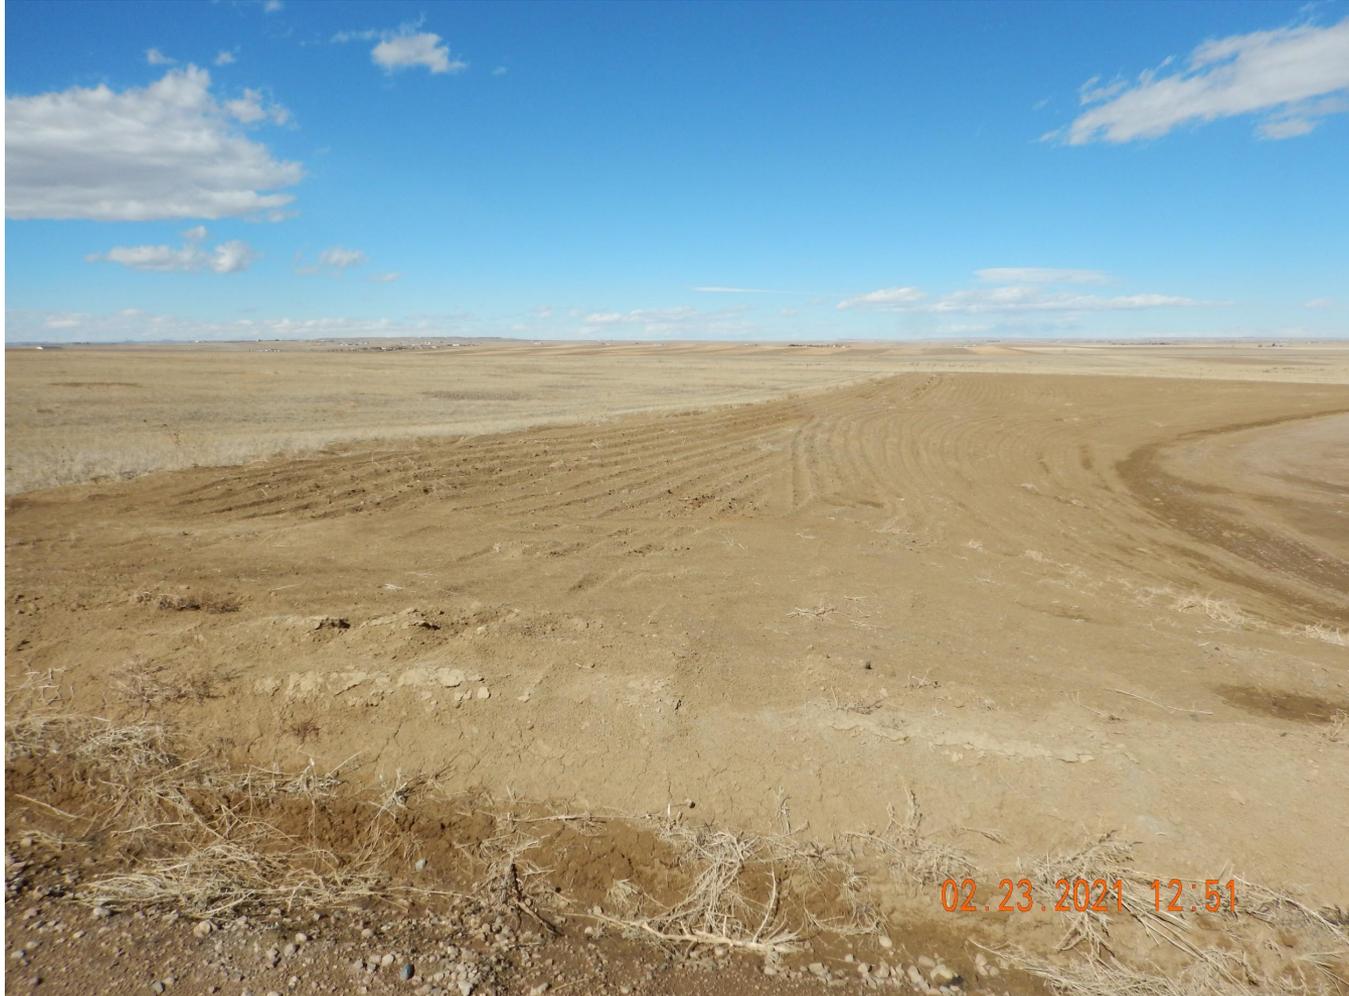
**Photo 2.** Photo taken south of the location, facing North. See comment under Photo 1.

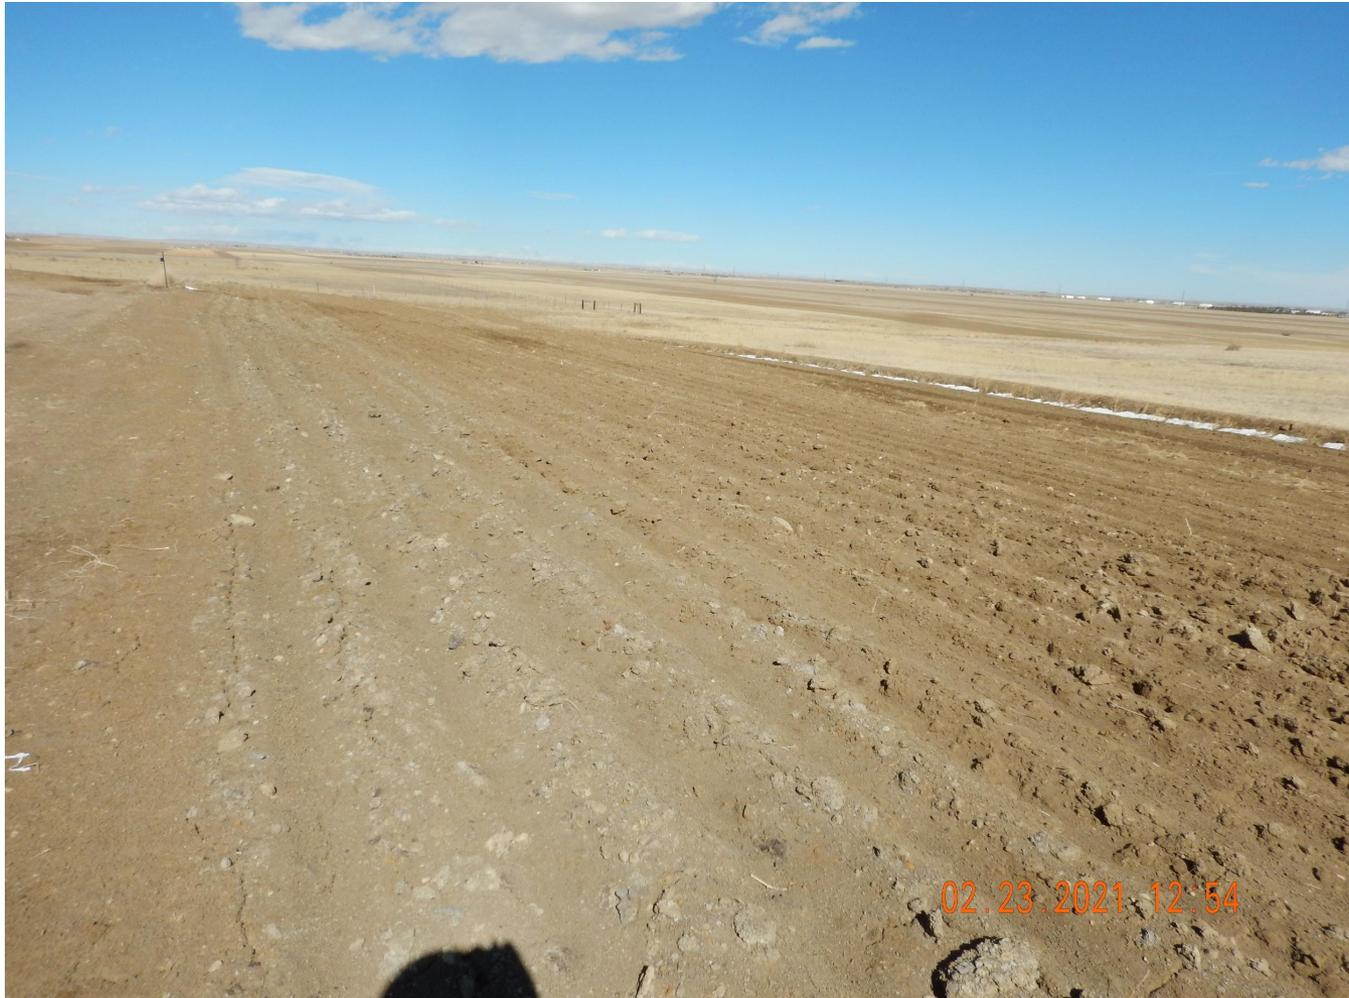
**Photo 3.** Photo taken from the eastern location, facing North. See comment under Photo 1.

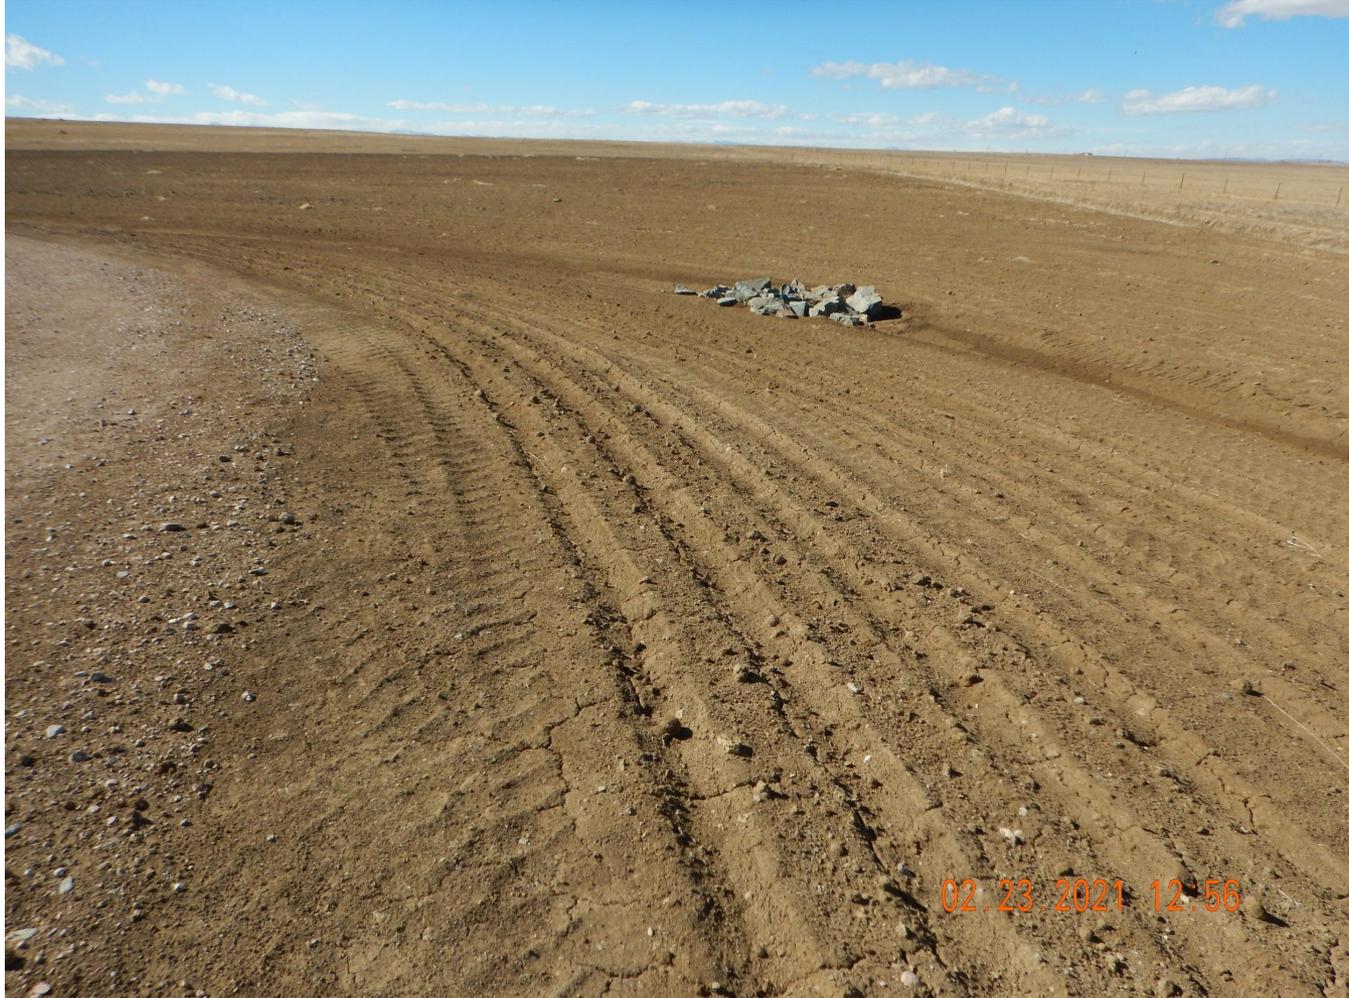
**Photo 4.** Photo taken from the northern location, facing West. See comment under Photo 1. Photo illustrates rip-rap functioning as a check dam.

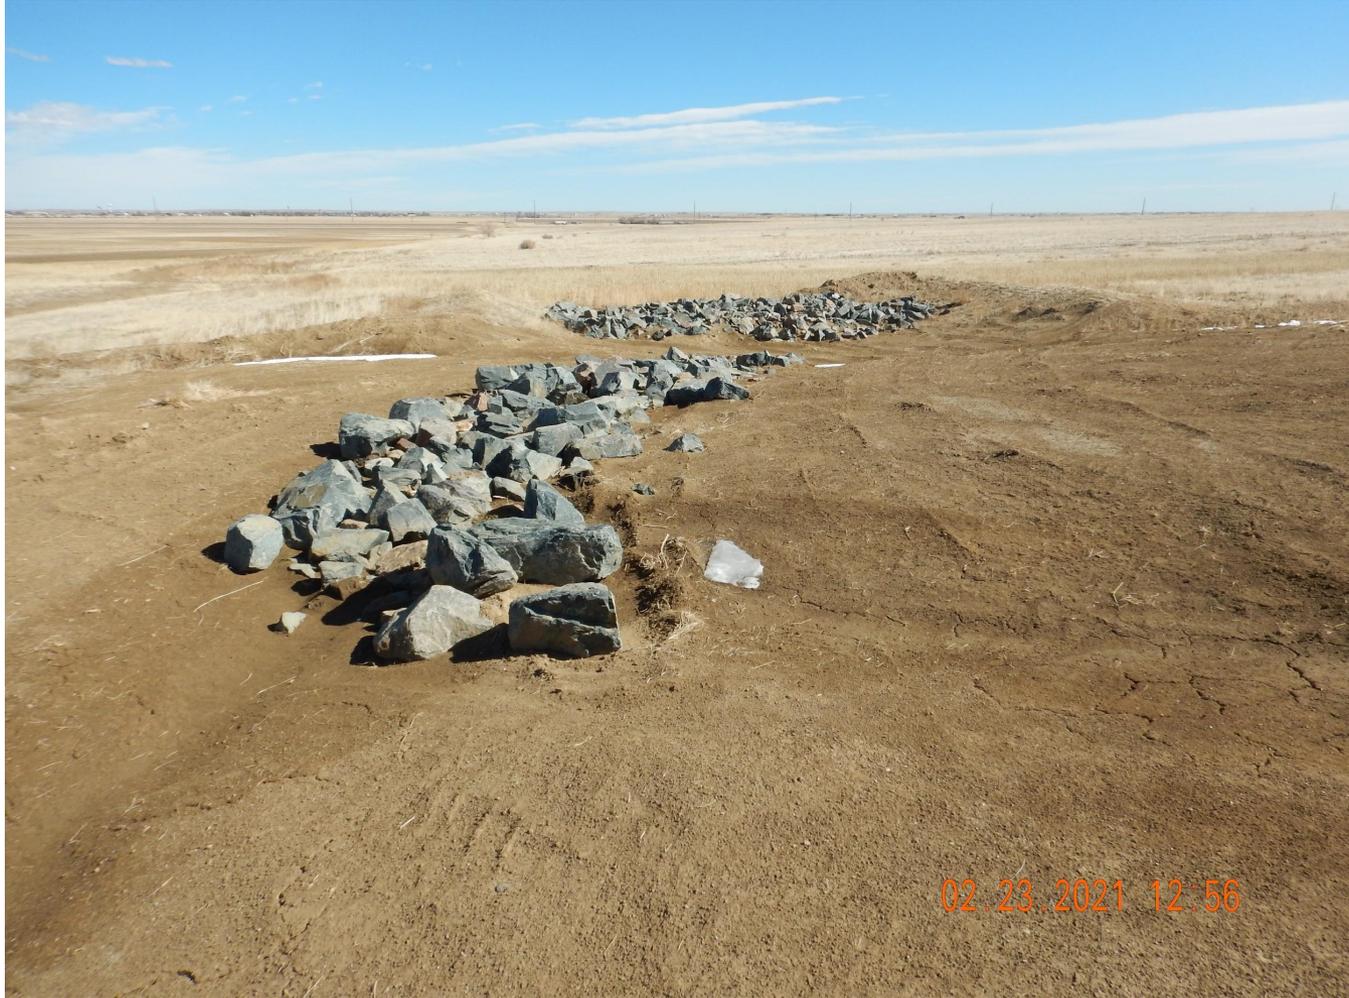
**Photo 5.** Photo taken from the northeastern location, facing East. Photo illustrates rip-rap functioning as a check dams, which is directed to a stabilized outlet.

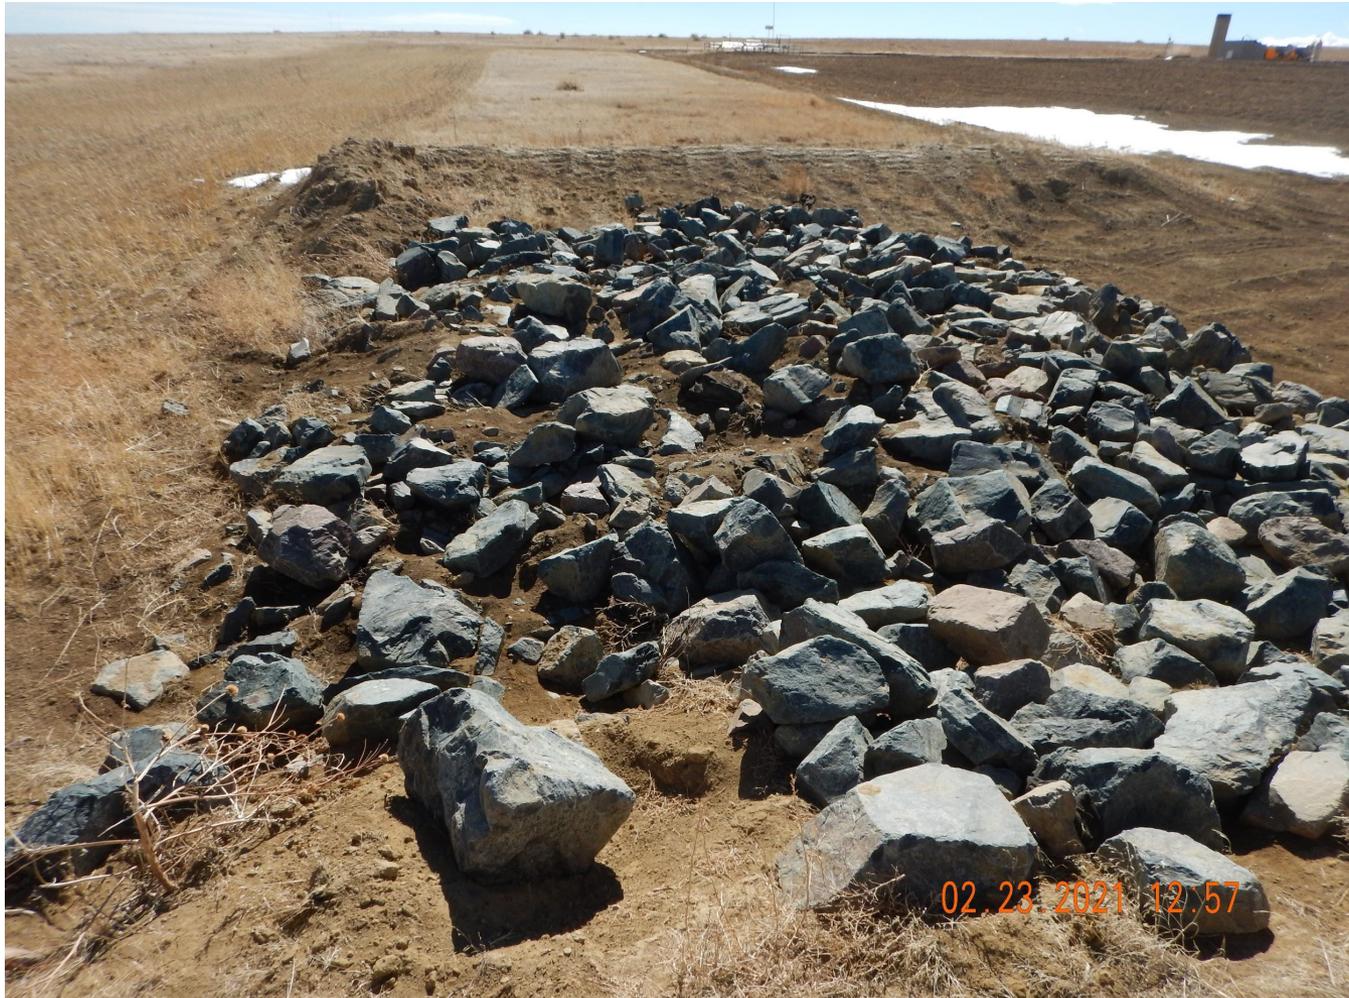
**Photo 6.** Photo taken from the northeastern location, facing South. Photo illustrates the stabilized outlet, which appears to be in need of maintenance with the accumulation of sediment within the rip-rap material.

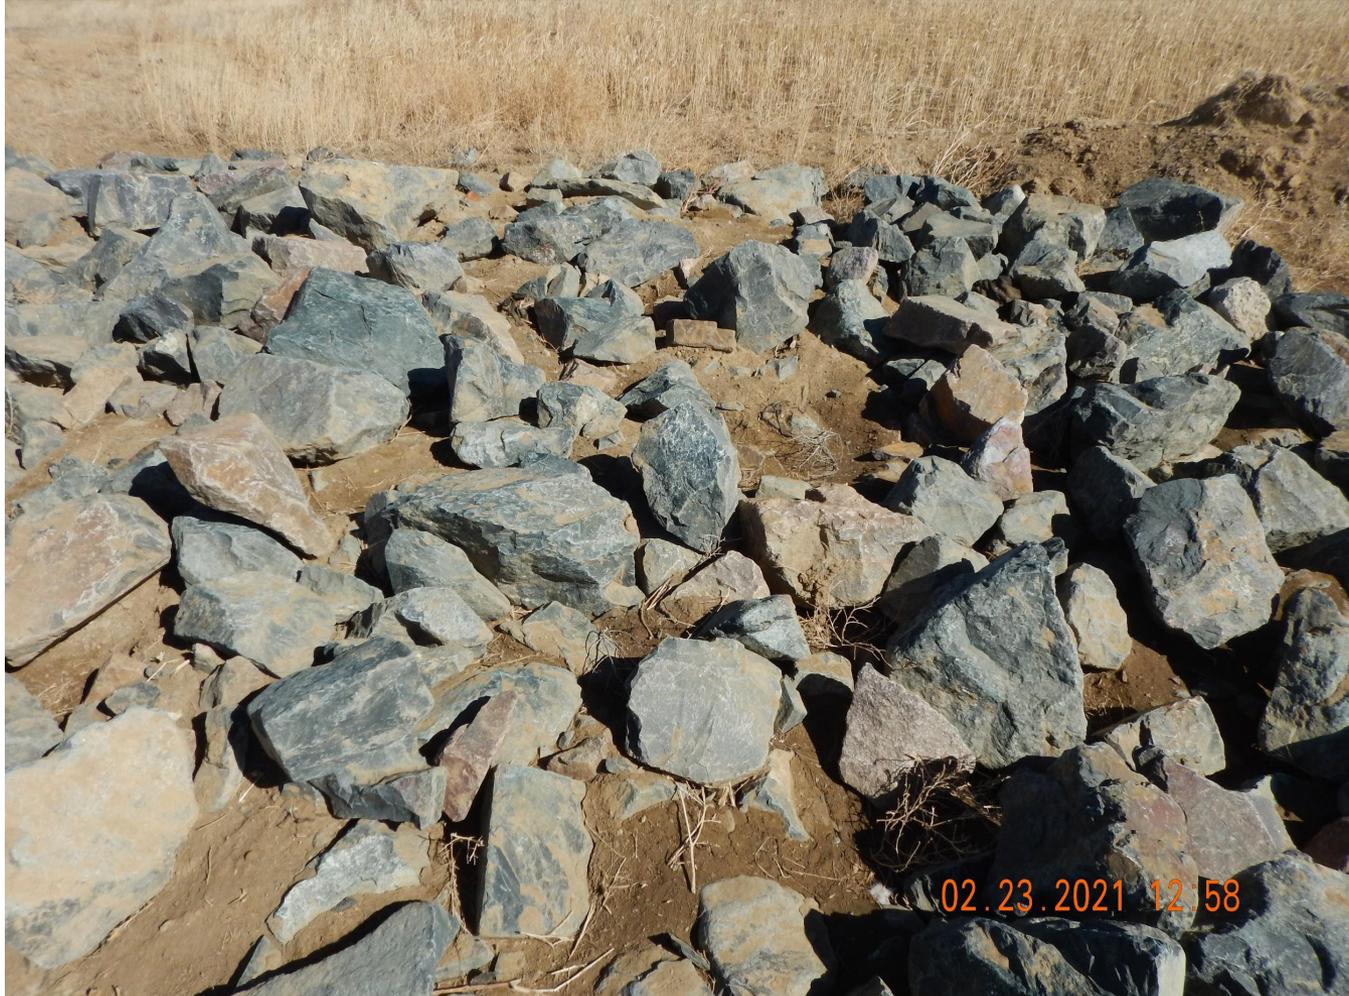
**Photo 7.** Photo taken from the northeastern location, facing East. See comments under Photo 6.
