**Inspection Photos**  
**Location Name: Paul Heinze #1 Flowline**  
**Spill ID: 479232**

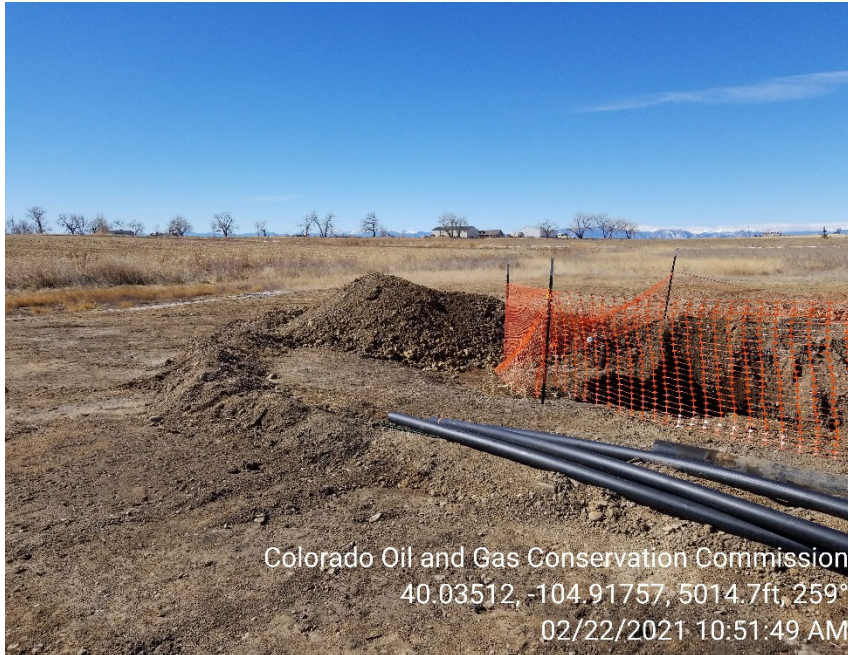
**Photo 1 – Spill excavation area. Fencing present around open excavation.**

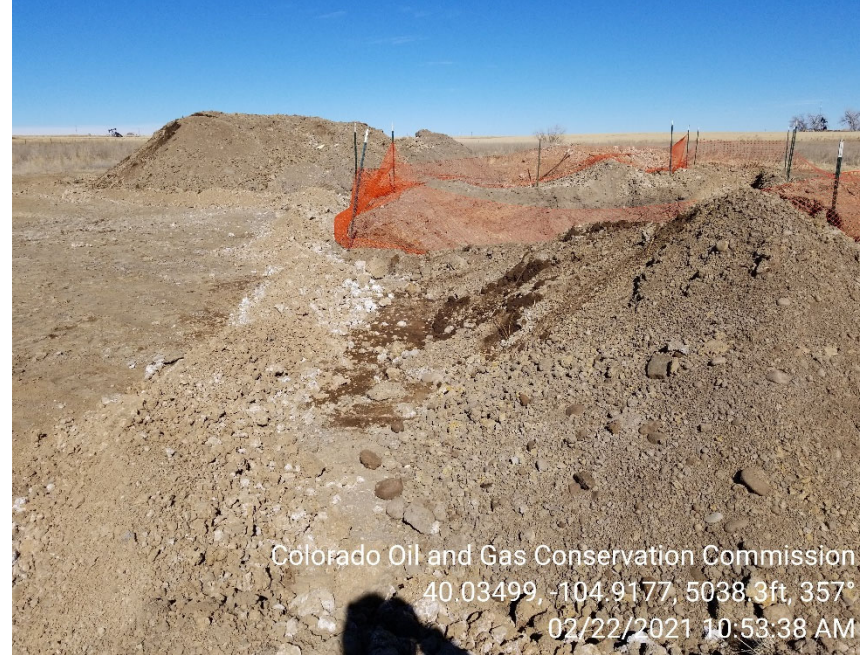
**Photo 2 – Spill excavation area. Fencing present around open excavation. Soils stored on site.**

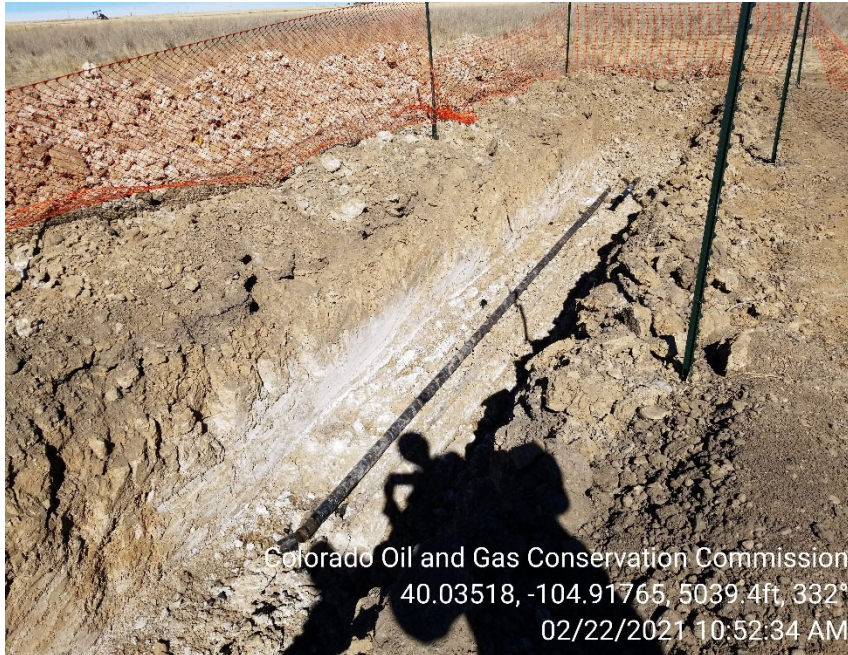
**Photo 3 – Excavation for flowline repair.**

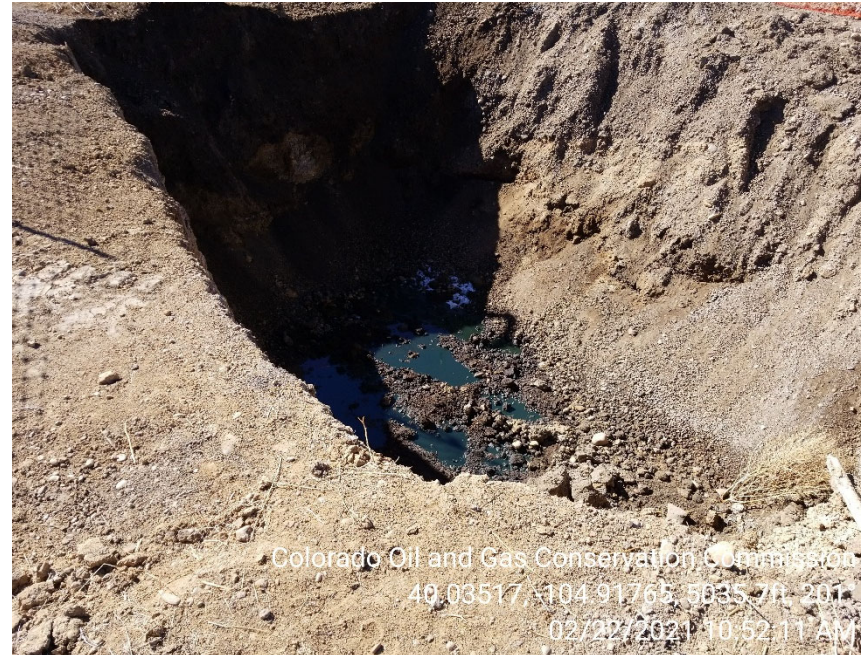
**Photo 4 – Free product present in open excavation.**

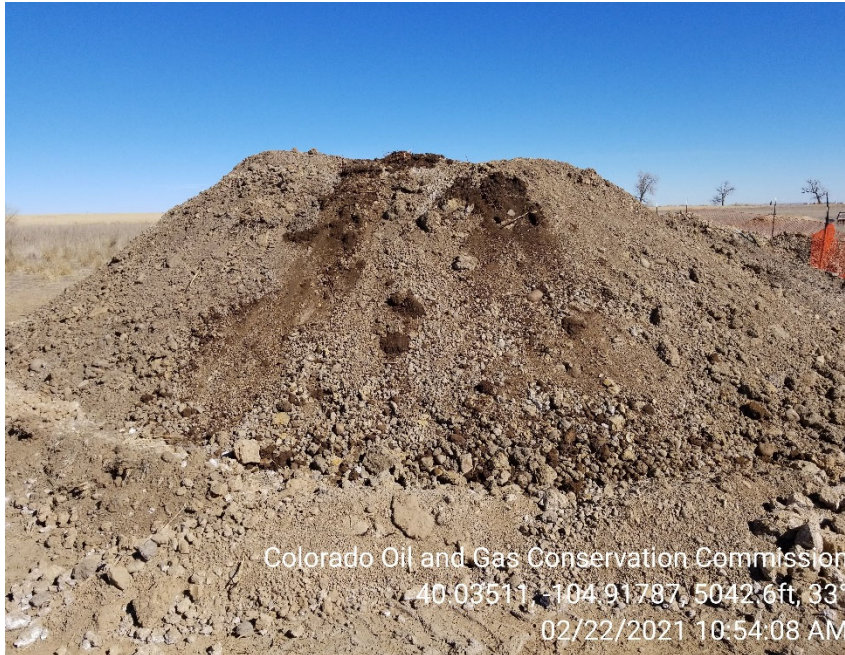
**Photo 5 – Impacted Soils stored on site.**

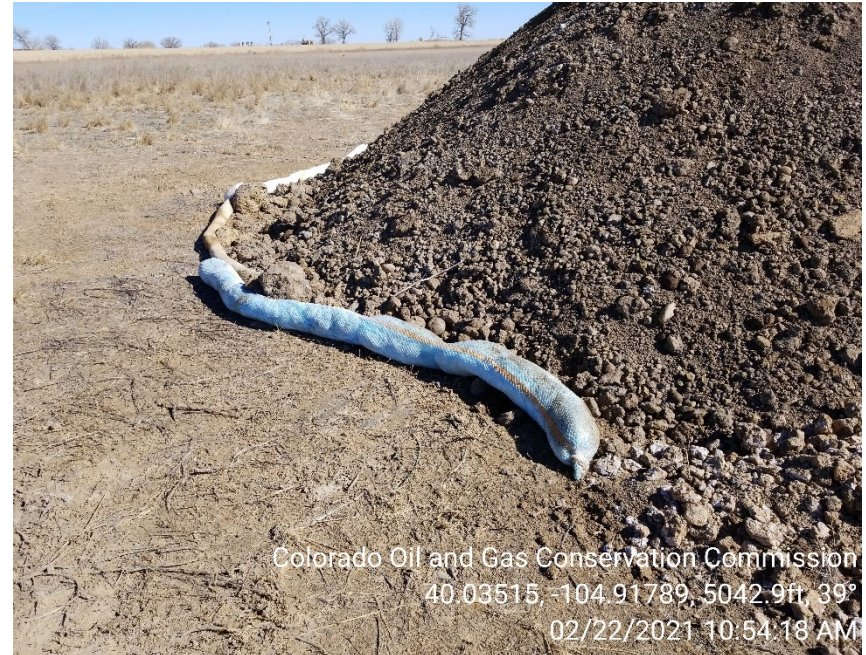
**Photo 6 –BMPs inadequate to prevent contamination of stormwater, surface water, Groundwater, and soil**

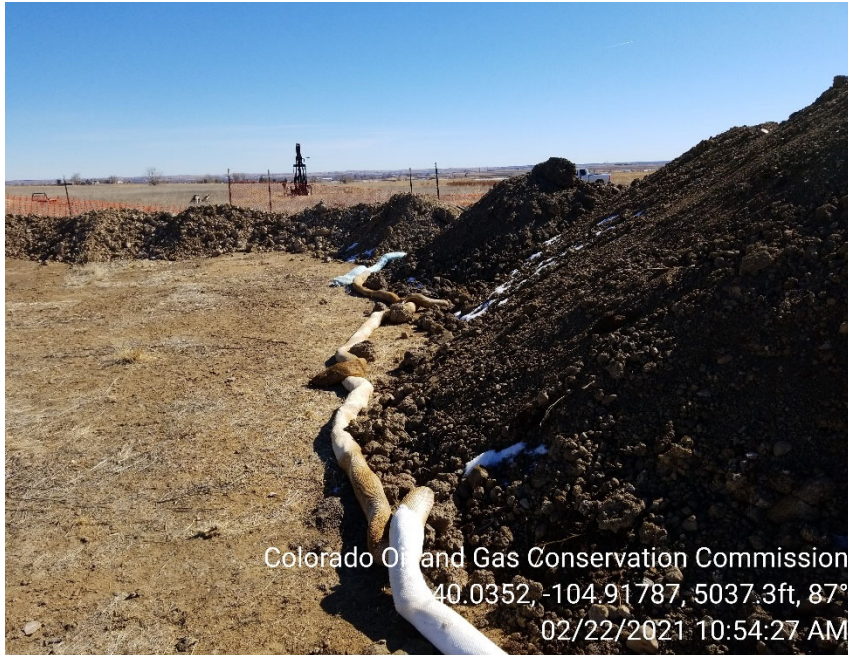
**Photo 7 – BMPs inadequate to prevent contamination of stormwater, surface water, Groundwater, and soil**

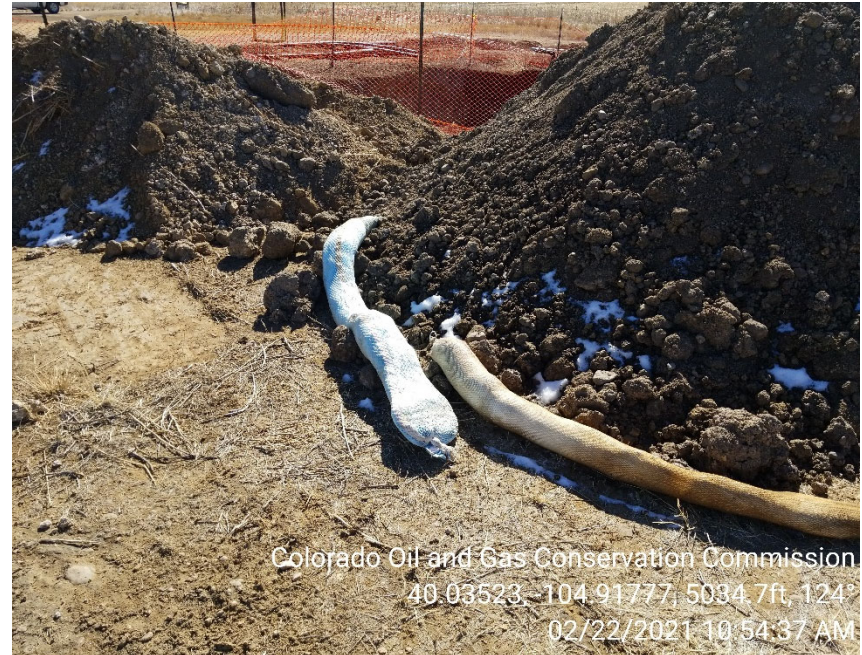
**Photo 8 – BMPs inadequate to prevent contamination of stormwater, surface water, Groundwater, and soil**
