**Inspection Photos**  
**Location Name: Suckla-Brown Unit 17 Header**  
**Spill ID 478370**

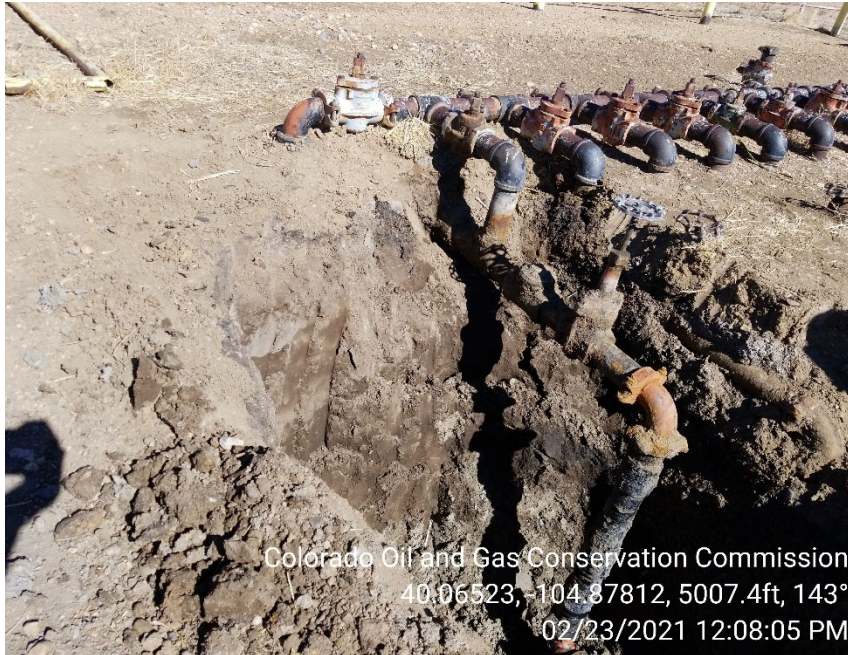
**Photo 1 – Spill excavation with exposed flowline.  
Impacts still visible insitu.**

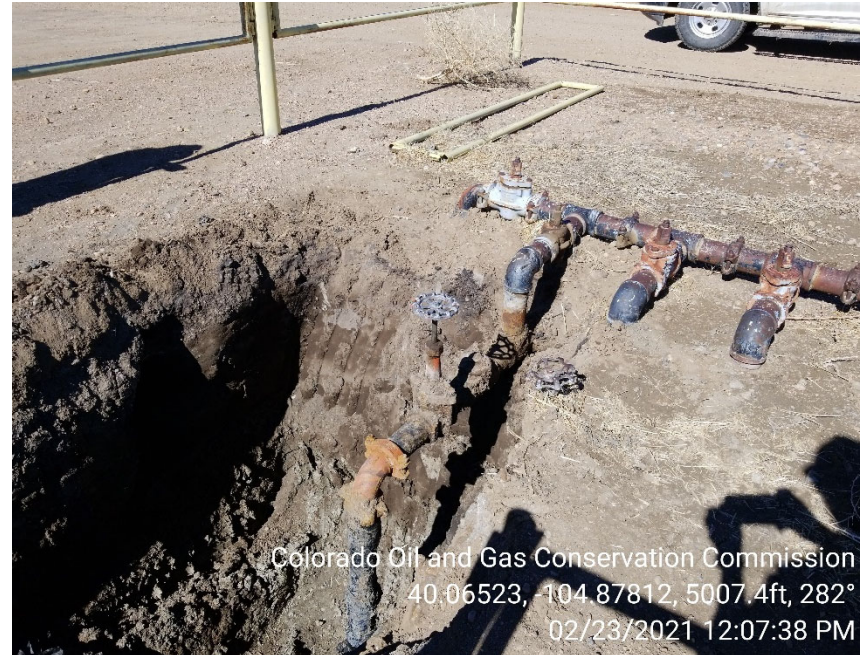
**Photo 2 – Spill excavation with exposed flowline.  
Impacts still visible insitu.**

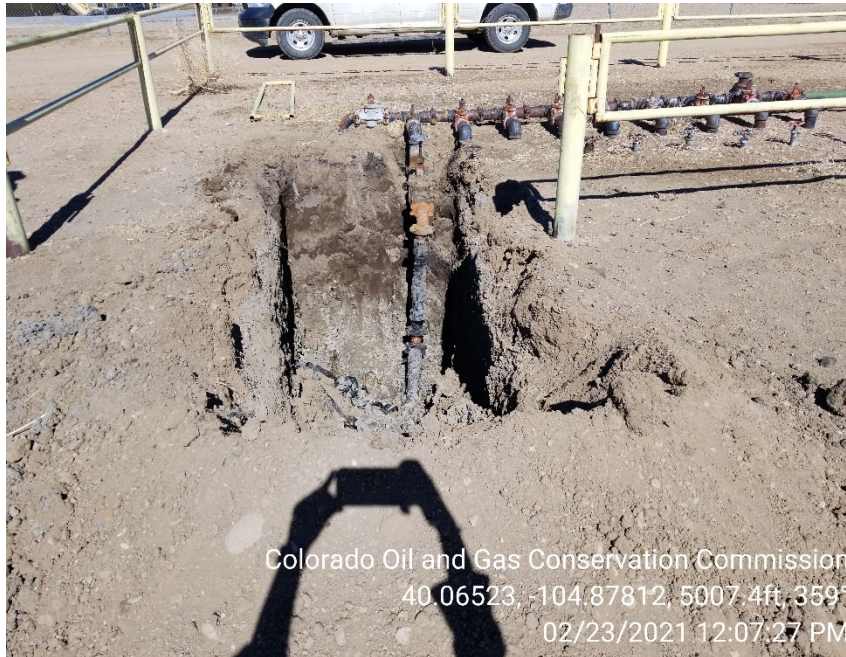
**Photo 3 – Spill excavation with exposed flowline.  
Impacts still visible insitu.**

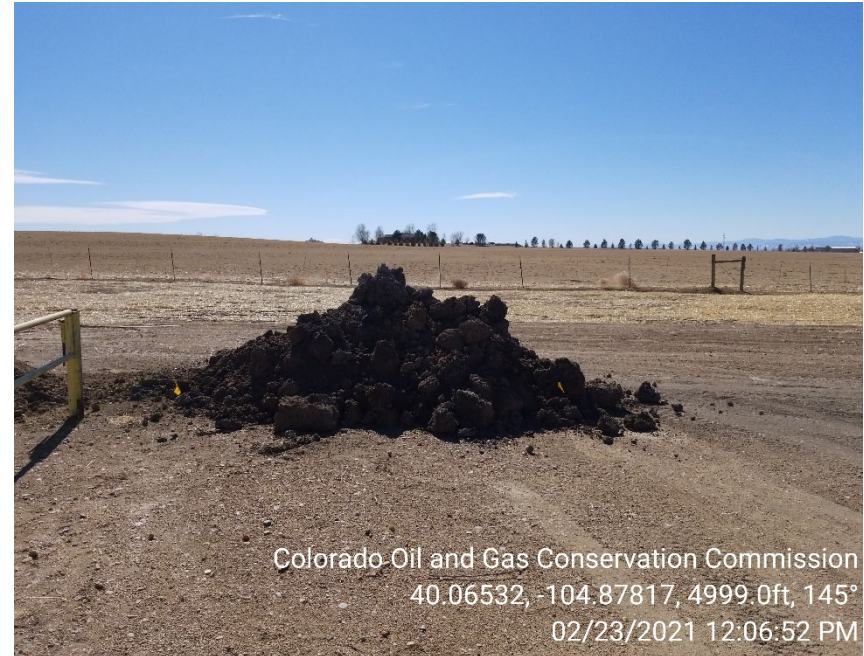
**Photo 4 – Soils pile on Location.**
