## Inspection Photos

Location Name: CAERUS PICEANCE LLC ENCANA-67S95W /21NWNW

Location ID: 334732

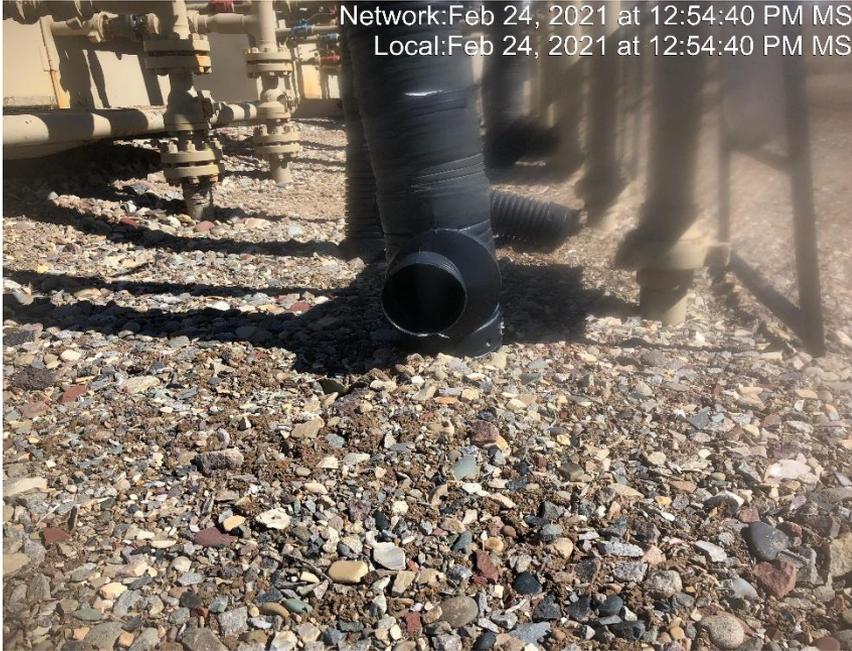
Photo #2960 Flow line heating insulation open ended and not capped.

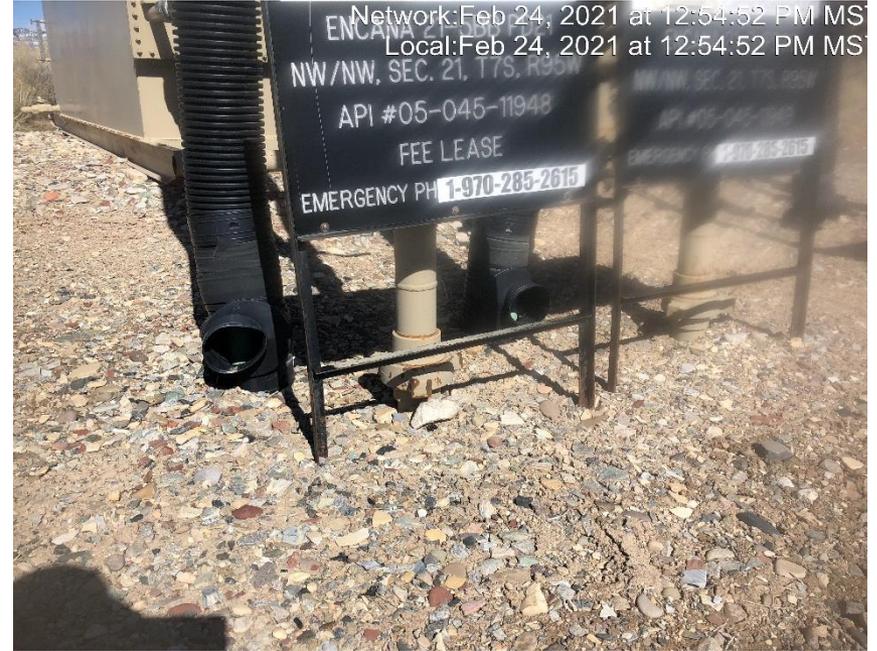
Photo #2961 Flow line heating insulation open ended and not capped.

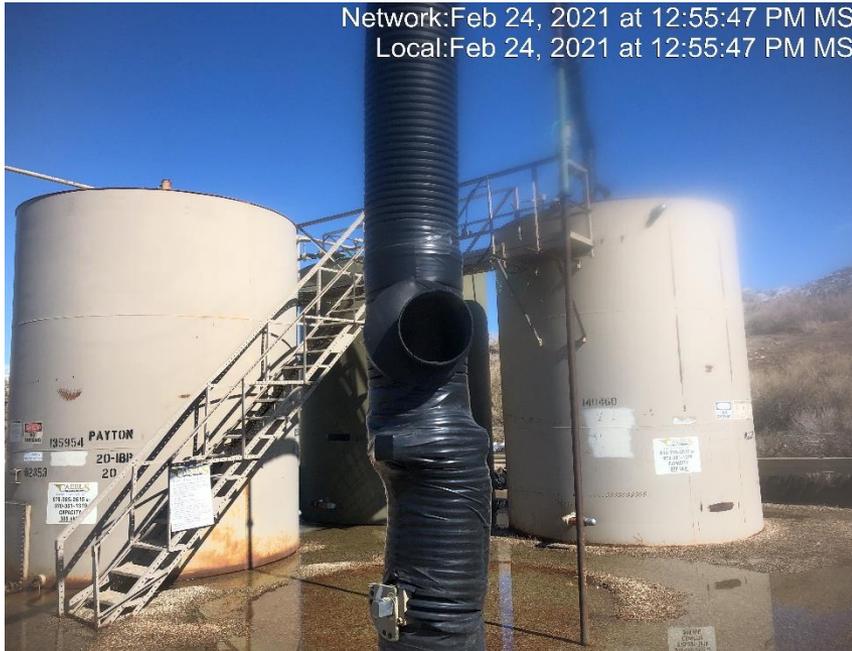
**Photo #2962 Flow line heating insulation open ended and not capped.**

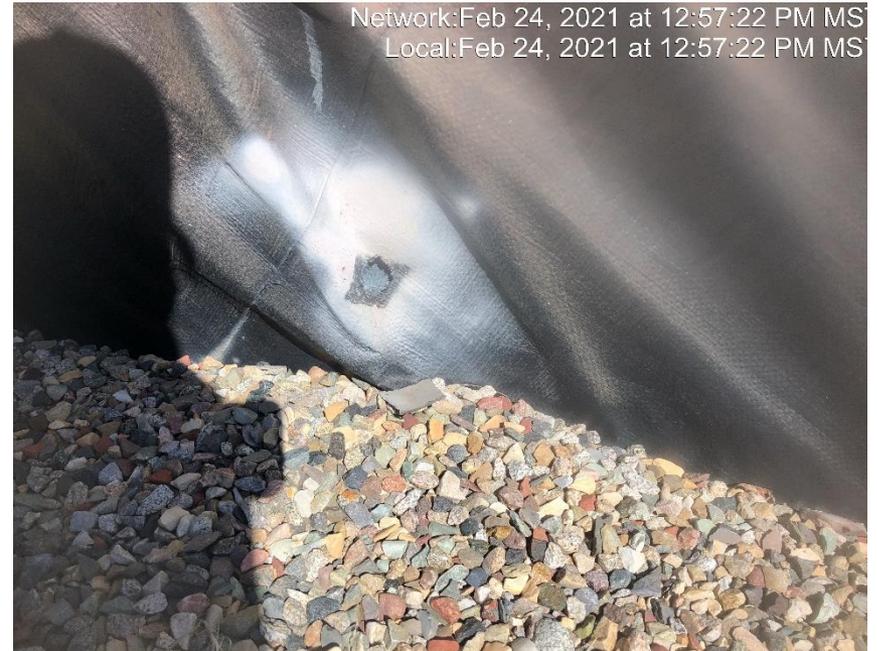
**Photo #2963 Multiple holes in tank containment liner**

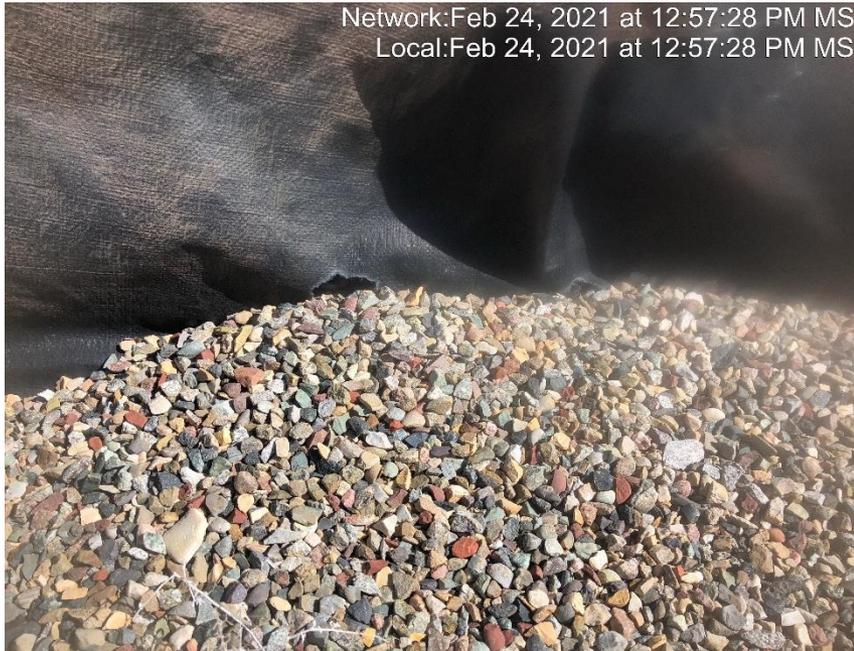
**Photo #2964 Multiple holes in tank containment liner**
