Inspection Photos

Location Name: CAERUS PICEANCE LLC Federal /21-9C (PJ-21)

Location ID: 427395

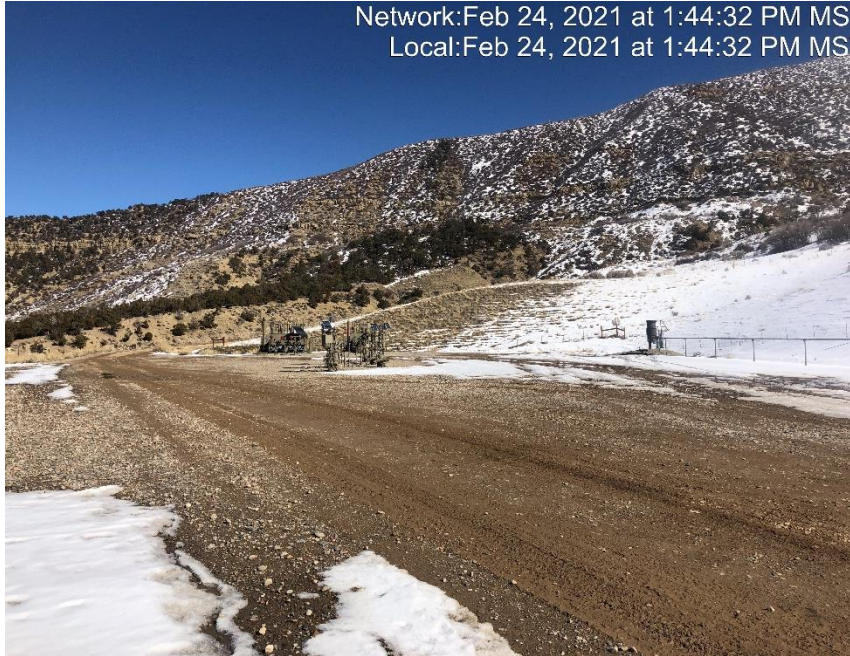
Photo #2966 from entrance to location.

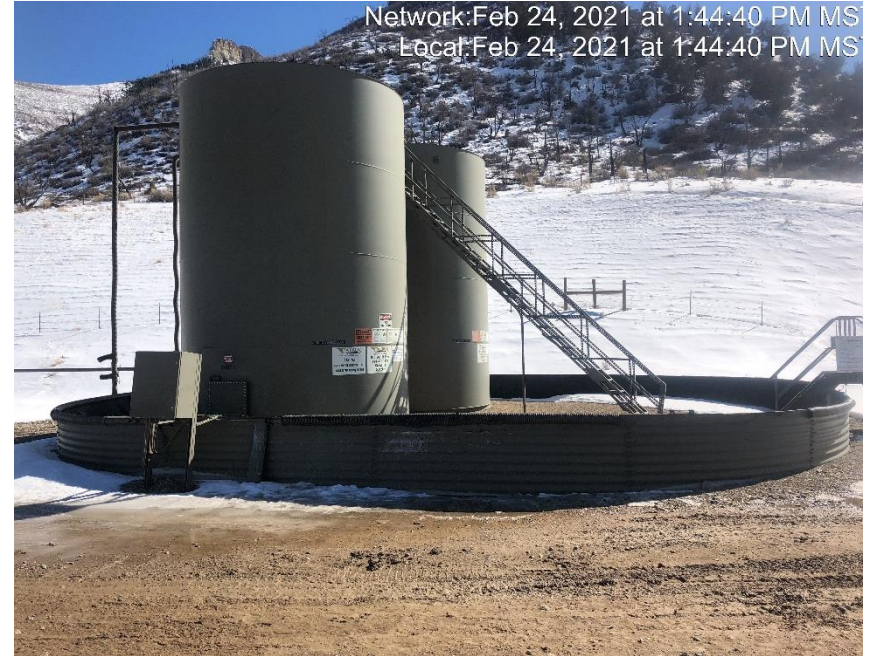
Photo #2967 from entrance to location

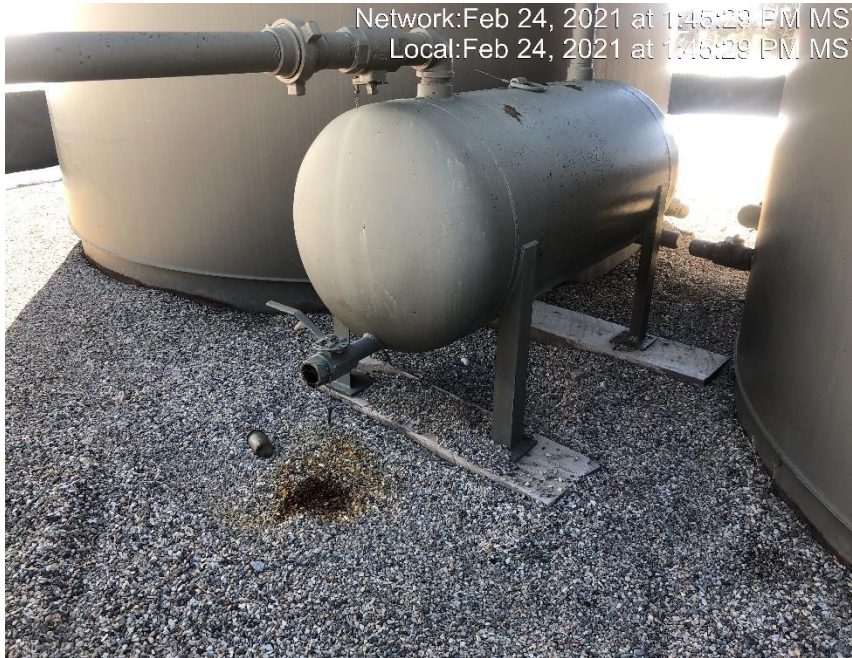
Photo #2968 Stained soils under ECD fluid knock out drain valve.
