Inspection Photos
Location Name: GUILDNER #1
Location ID: 317889
Remediation Project No. 16185

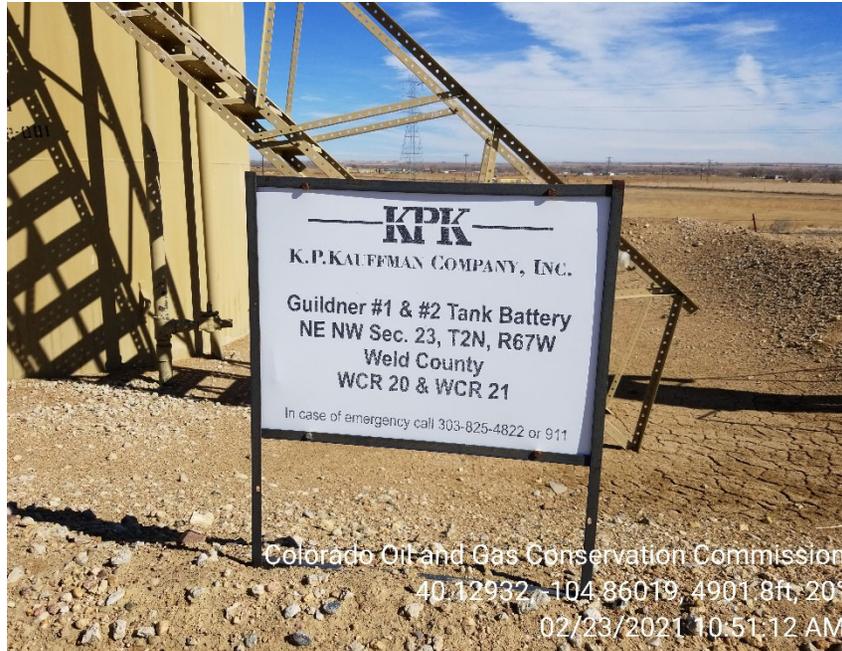
Photo 1 – Location sign

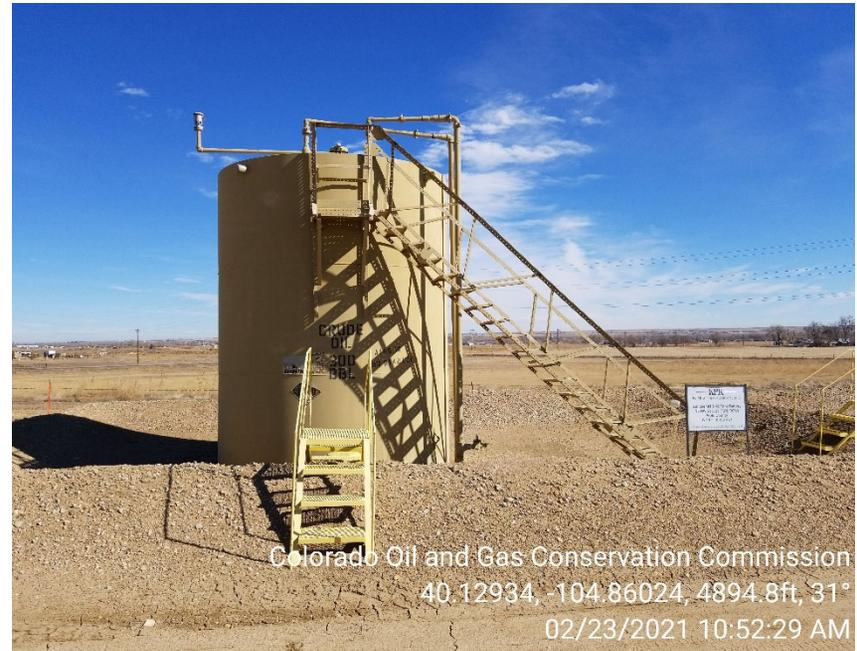
Photo 2 – Location photo

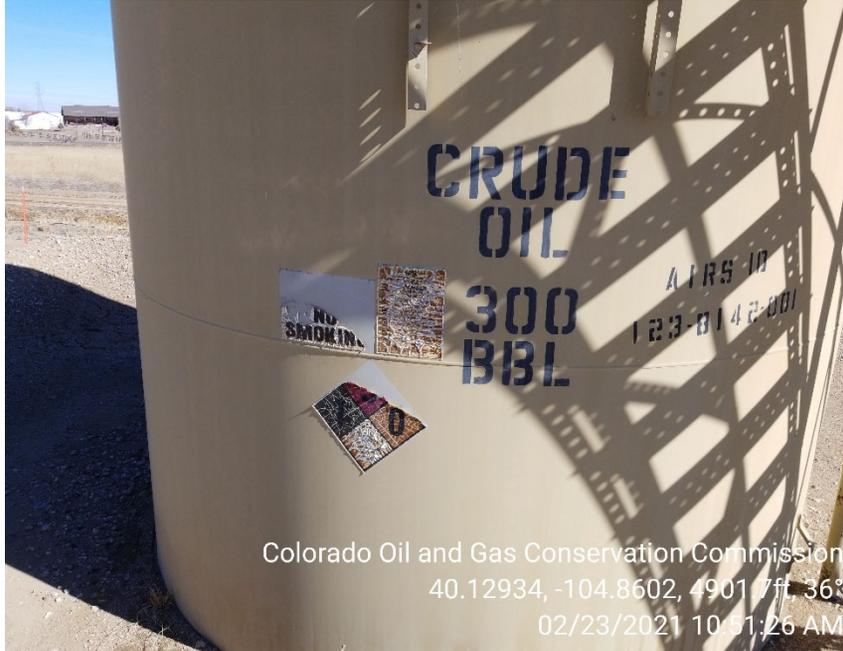
Photo 3 – NFPA label peeling from crude oil tank and no longer legible.

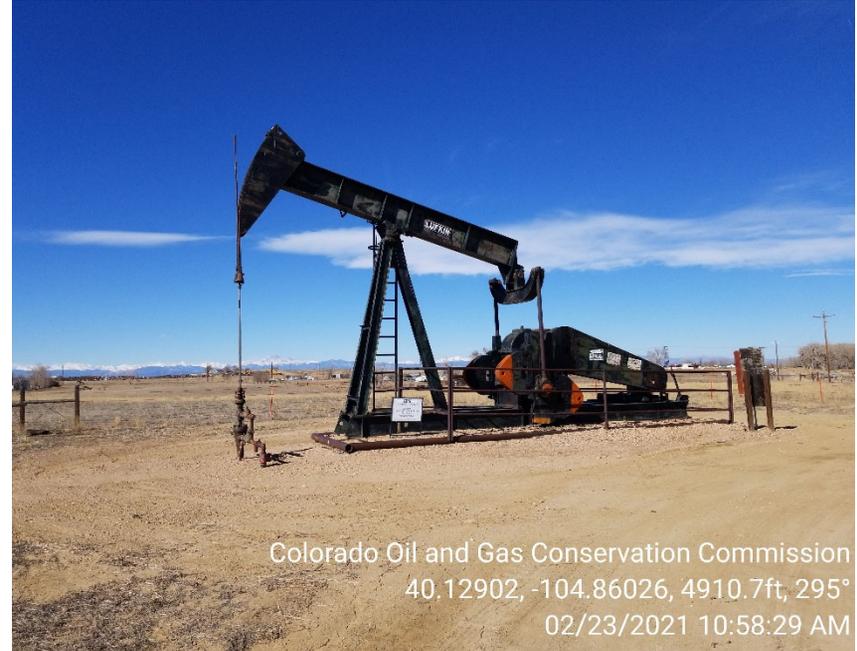
Photo 4 – Location photo

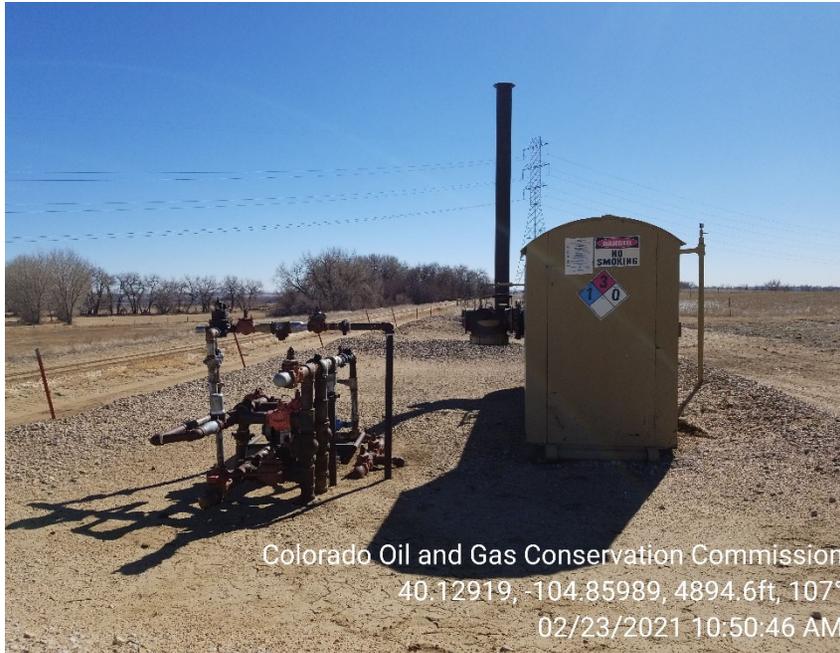
Photo 5 – Location photo

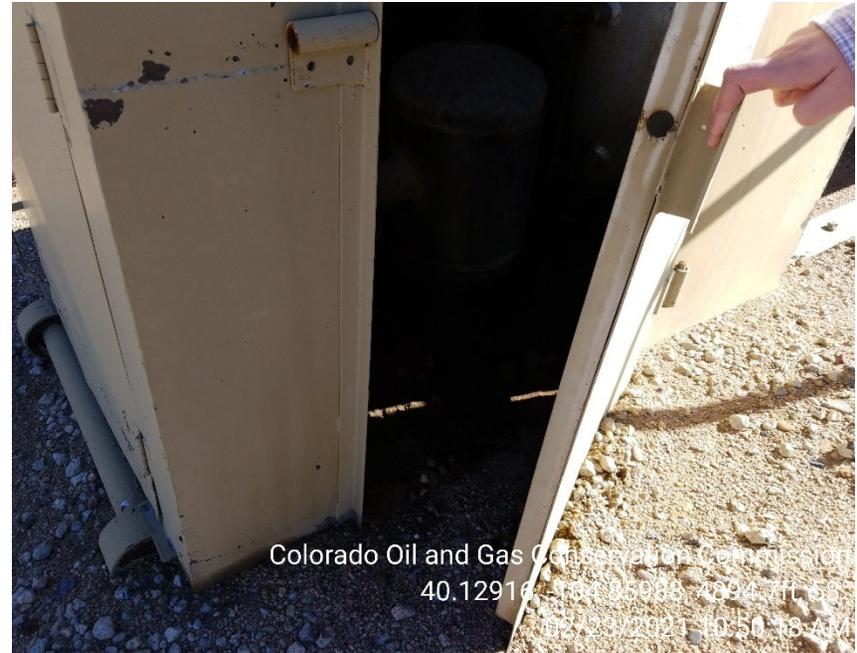
Photo 6 – Stained soil observed at separator

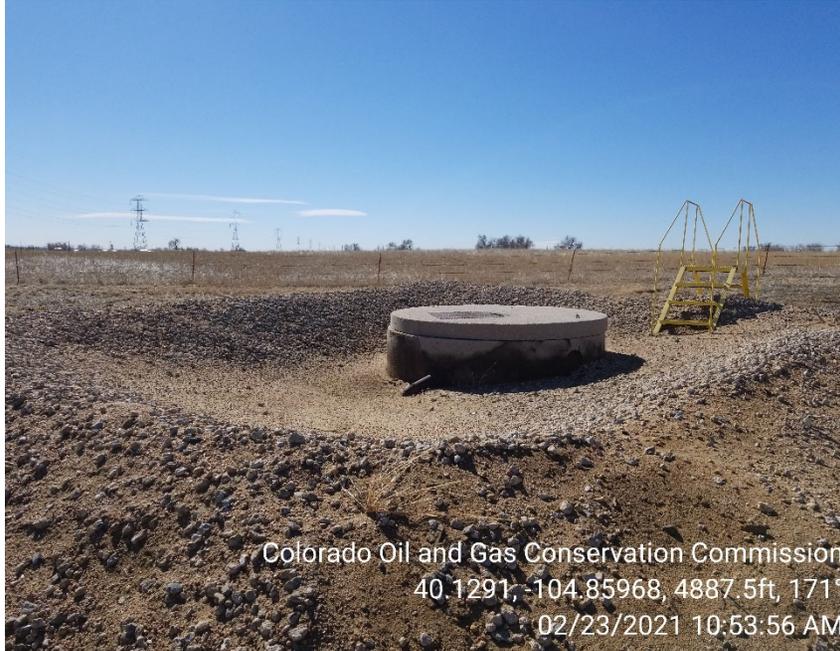
Photo 7 – Produced water vault. Weeds observed in Insp. Doc#697601087 have been removed.

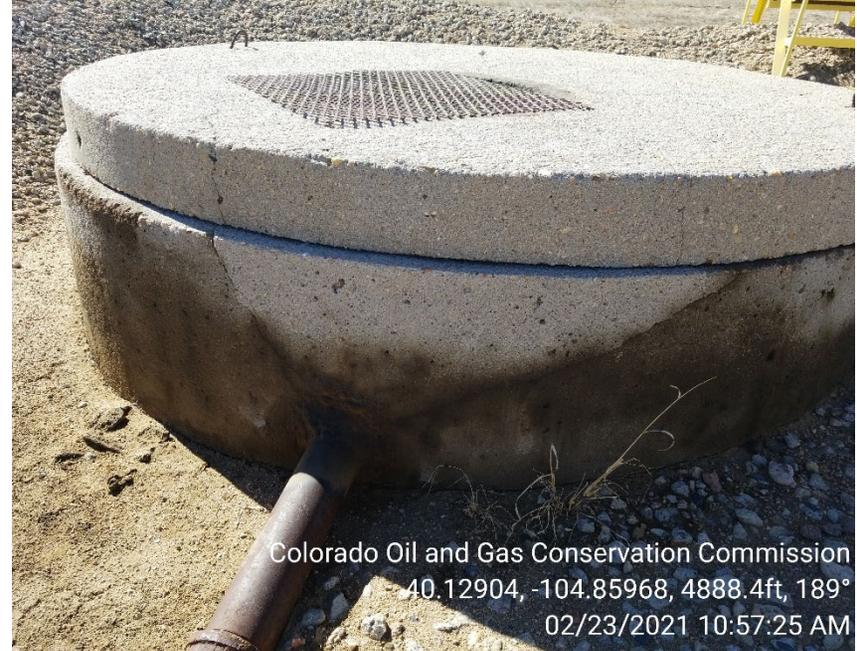
Photo 8 – Cracks/staining visible on produced water vault.

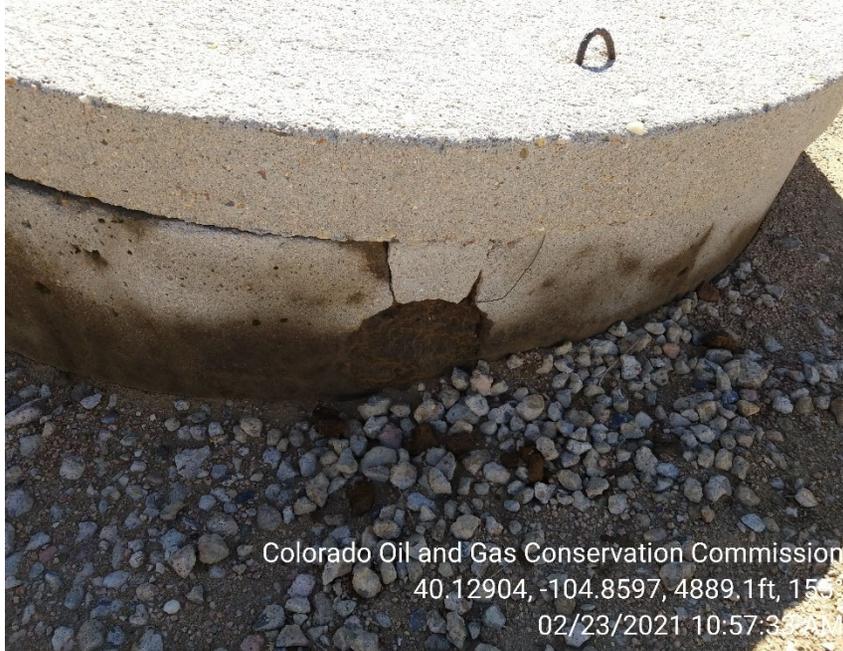
Photo 9 – Cracks/staining visible on produced water vault.

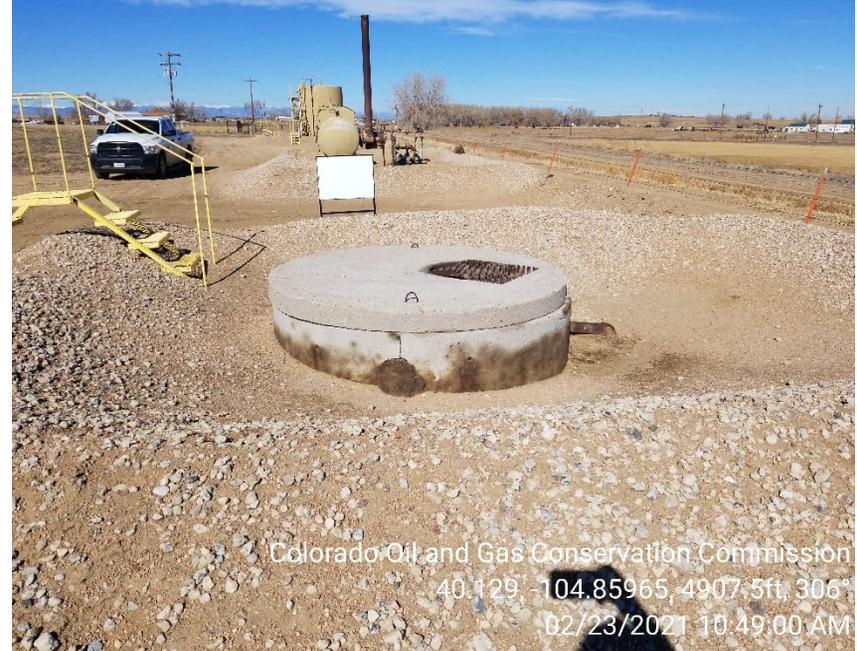
Photo 10 – Cracks/staining visible on produced water vault.

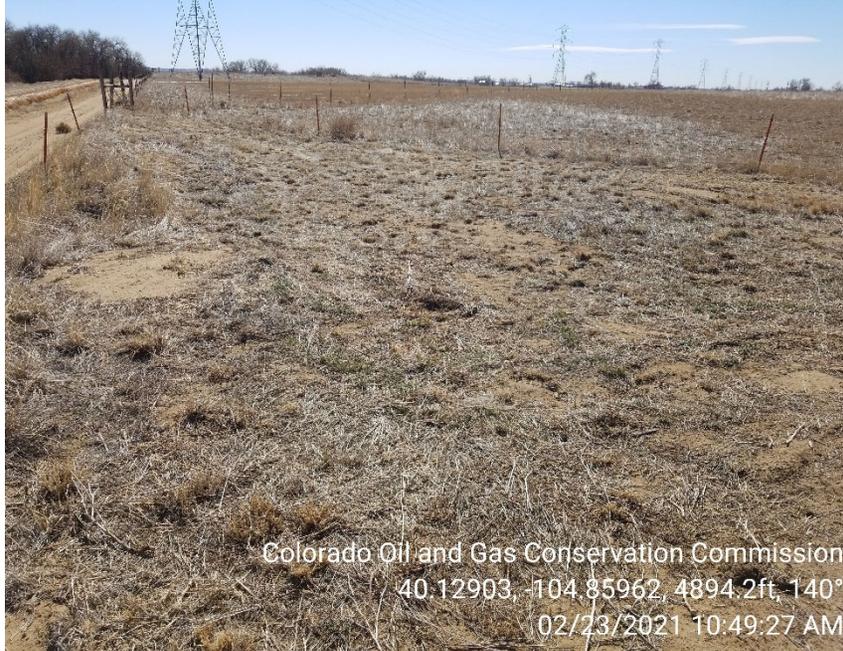
Photo 11 – Former pit area. No evidence of work preformed for Remediation Project No. 16185.
