**Inspection Photos**  
**Location Name: John Weigandt Consolidation**  
**Spill ID 465402**

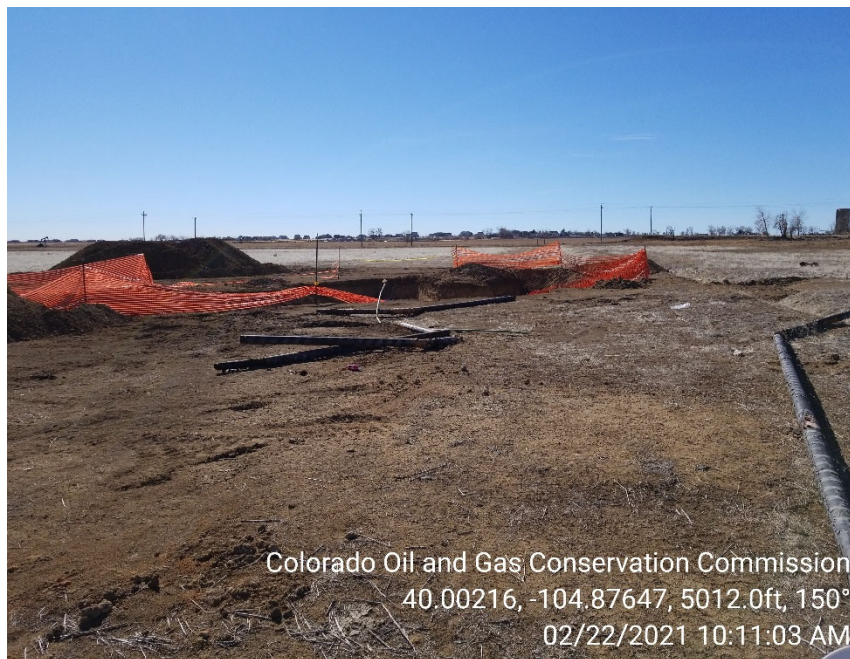
**Photo 1 – Spill area. Pipe and additional debris on left on location**

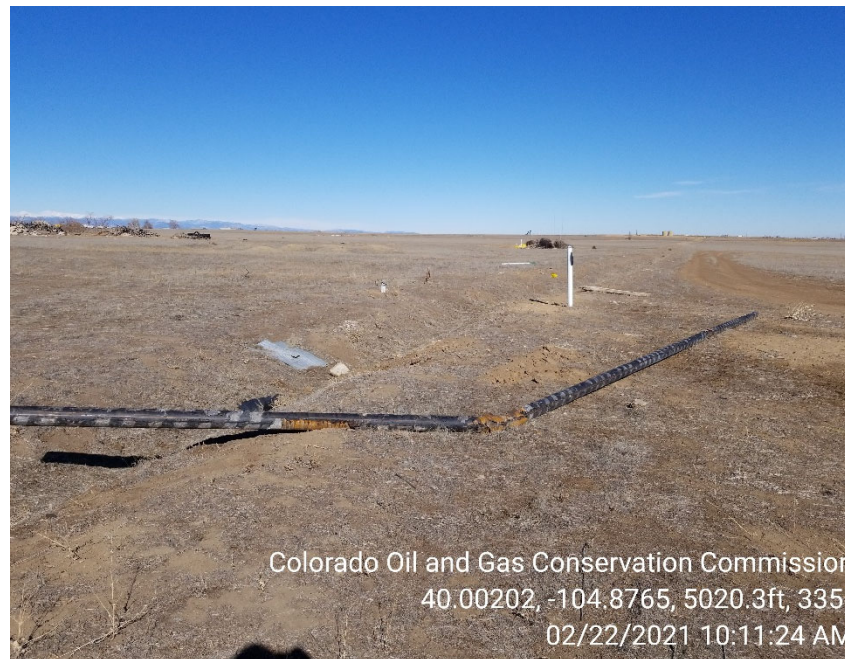
**Photo 2 – Pipe and additional debris on left on location**

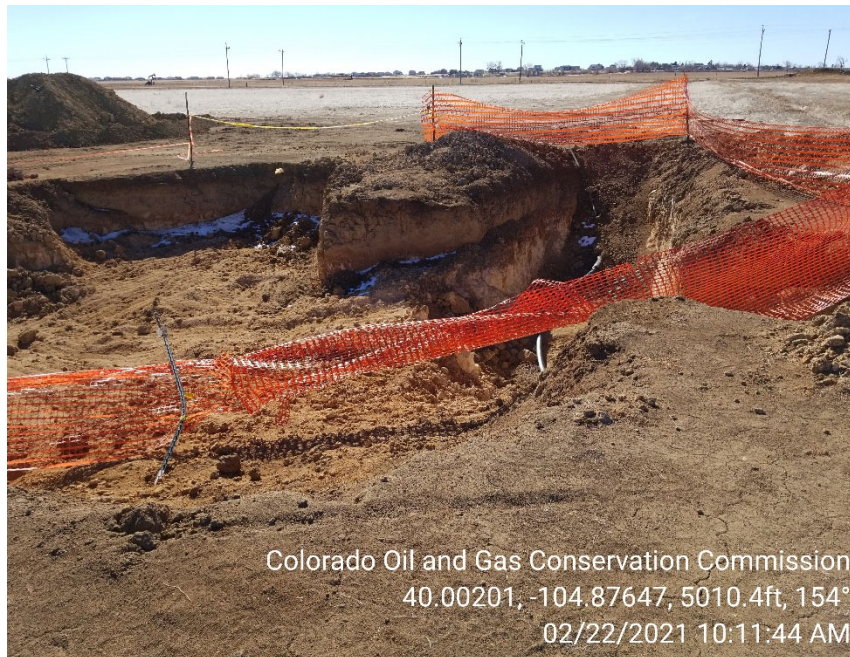
**Photo 3 – Fence down around open excavation**

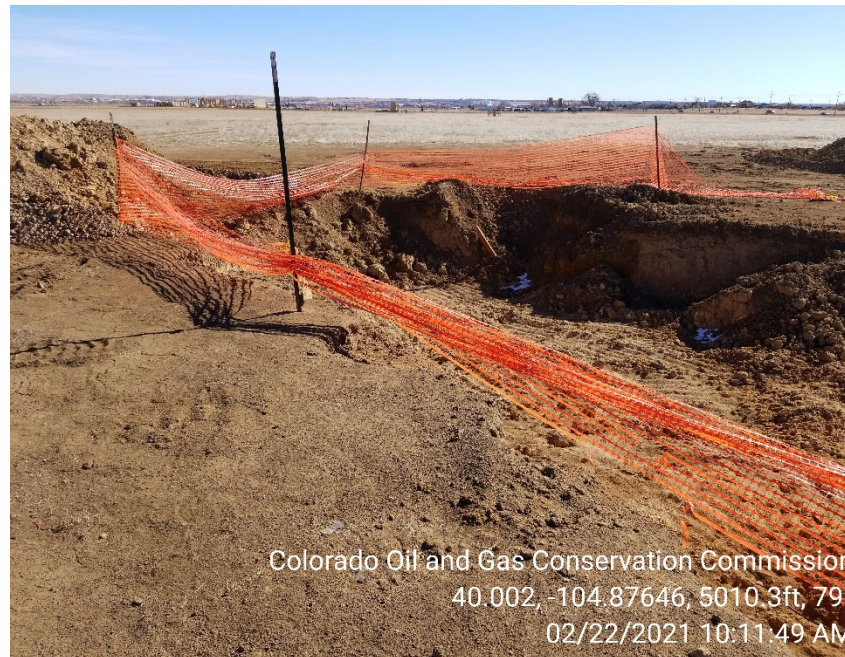
**Photo 4 – Fence down around open excavation**

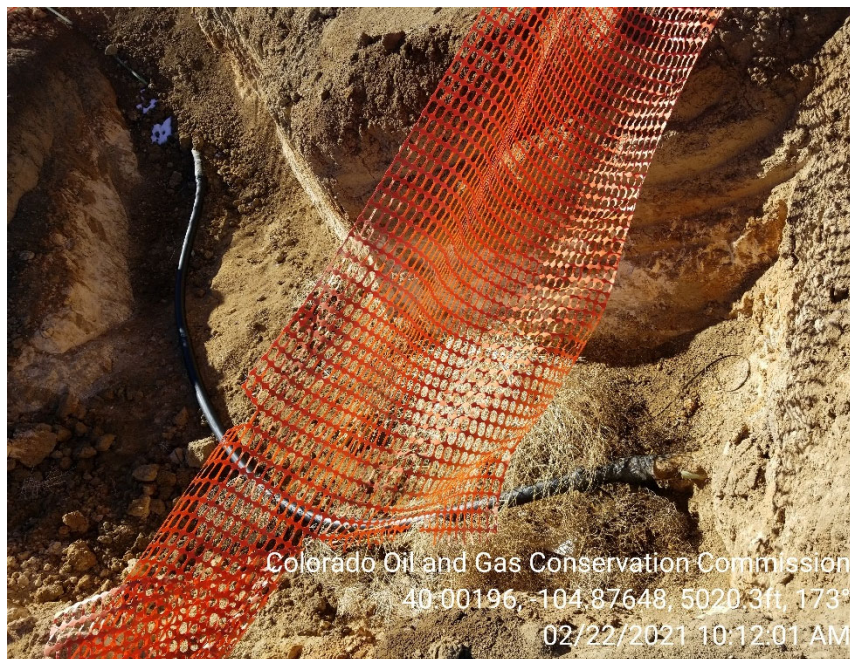
**Photo 5 – Repaired flowline in open excavation**

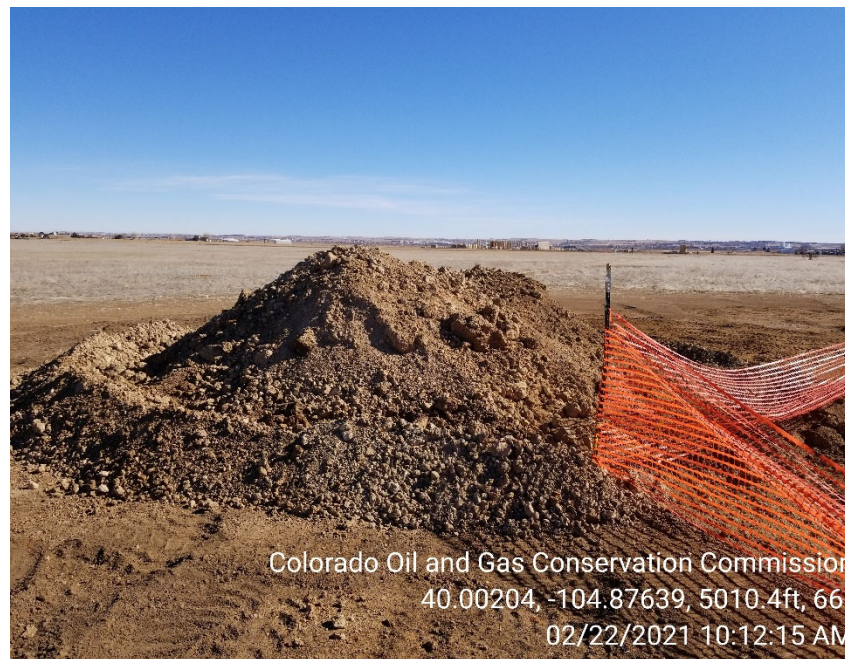
**Photo 6 – Soils stored on location**

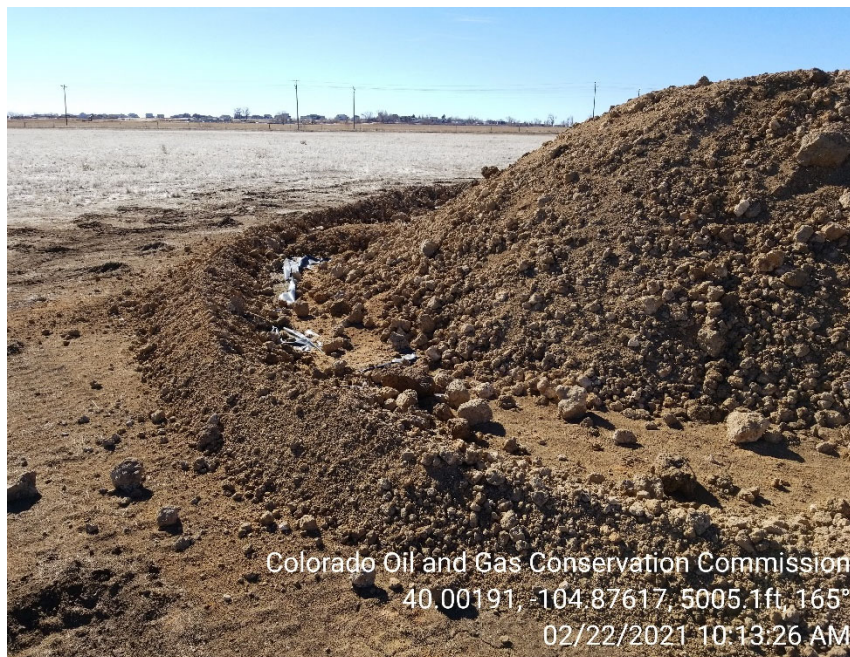
**Photo 7 – Soils stored on location**

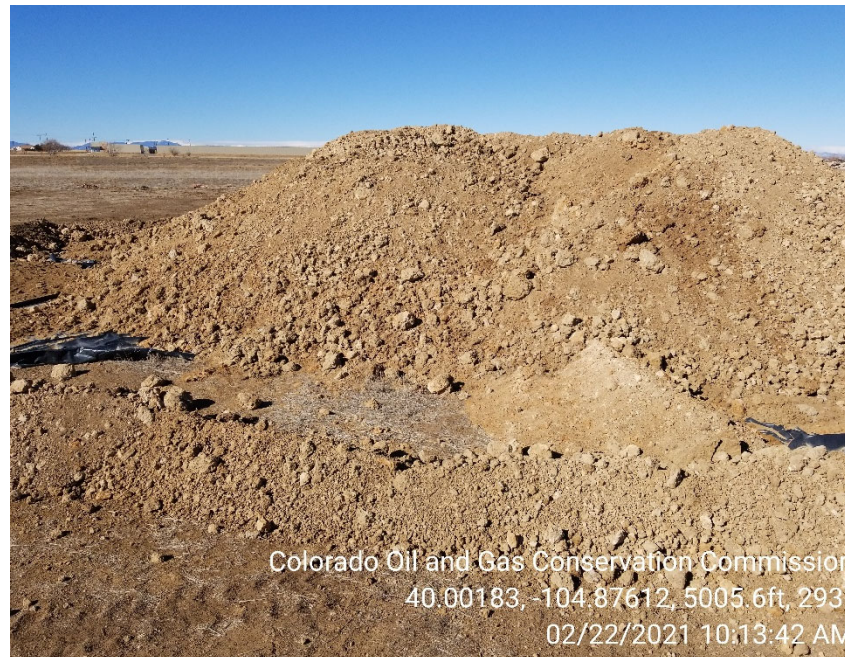
**Photo 8 – Soils stored on location**

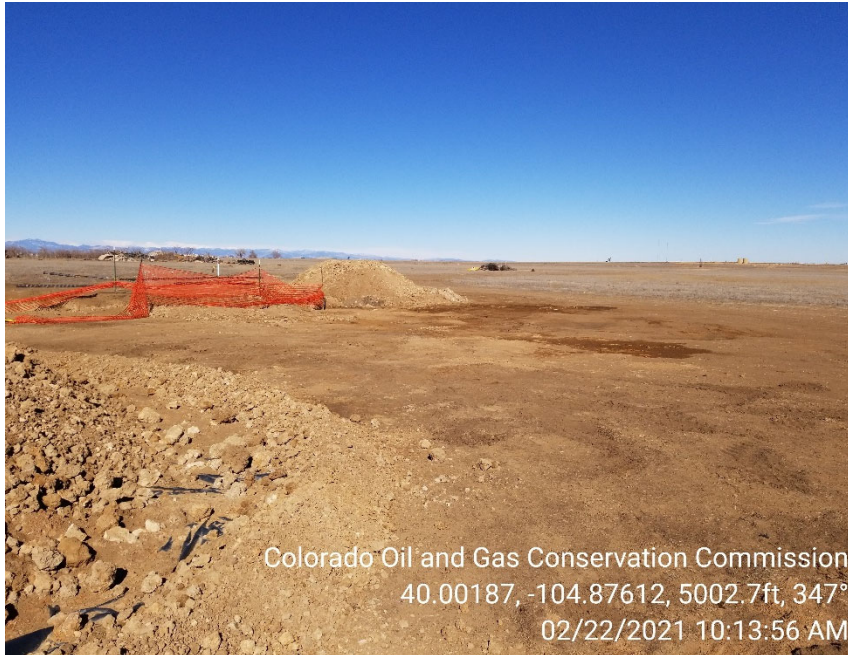
**Photo 9 – Stained soil visible on location outside of excavation area**

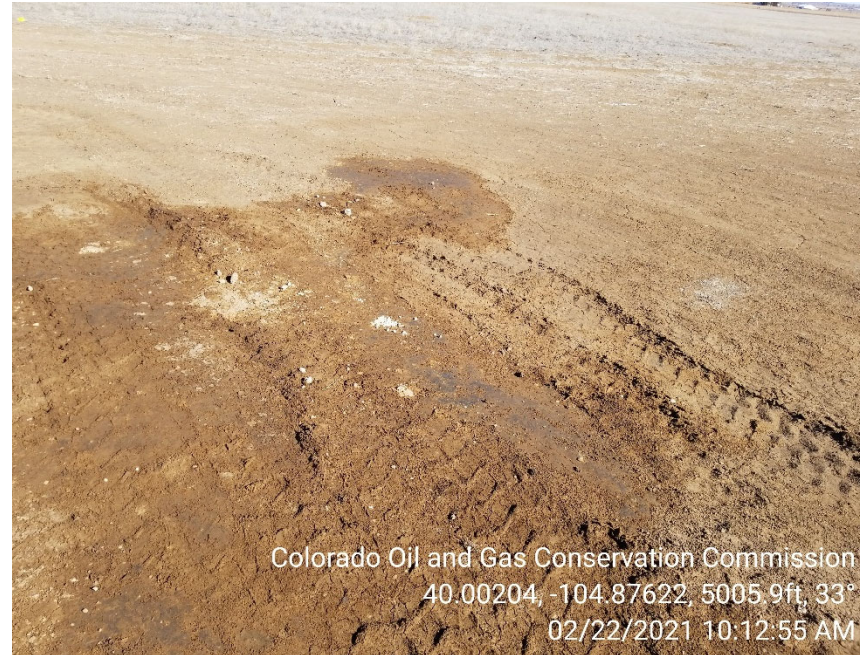
**Photo 10 – Stained soil visible on location outside of excavation area**
