**CAERUS PICEANCE LLC
CHEVRON-66S96W 4SWNW
Location # 335577**

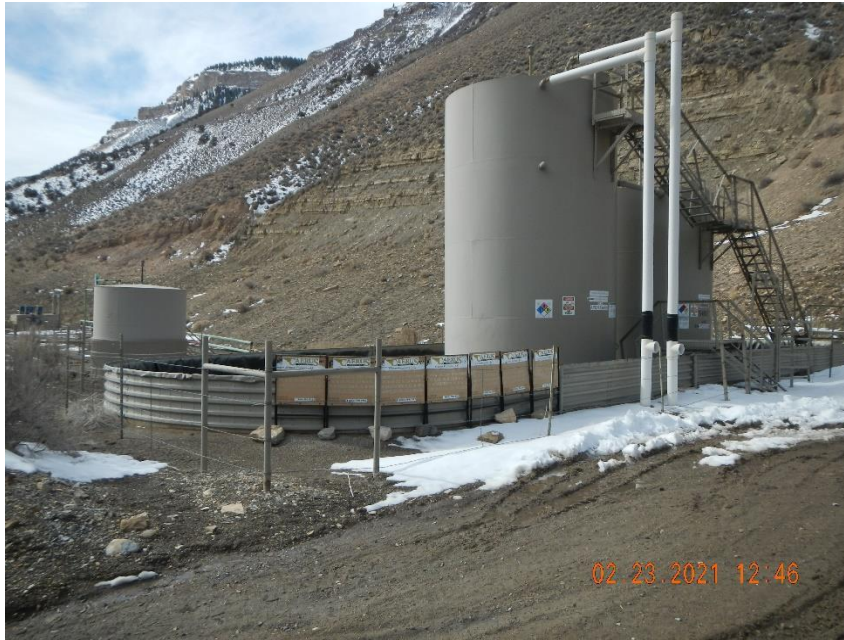
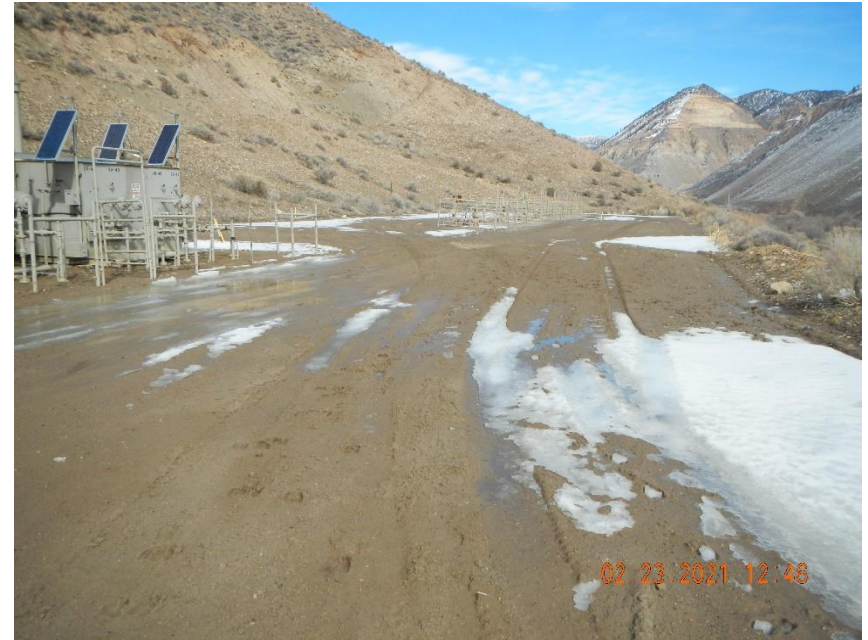
**Location shows signs of lack of stabilization BMP's
in some areas (rutting is present).**

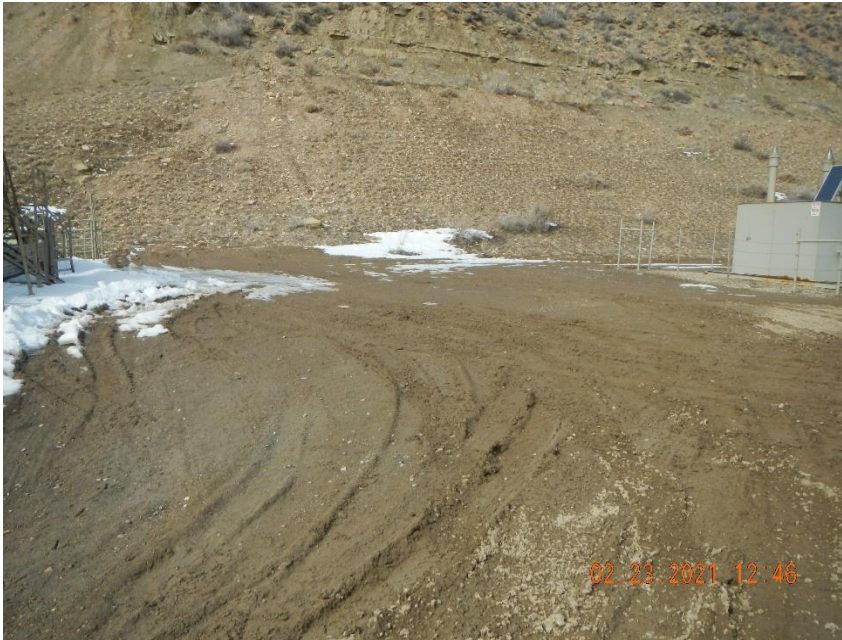
**Location shows signs of lack of stabilization BMP's
in some areas (rutting is present).**

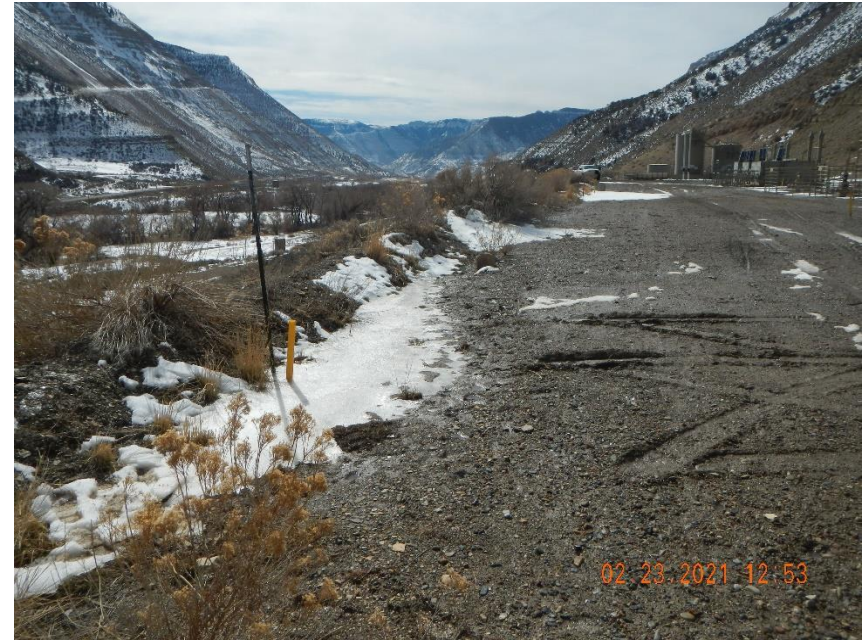
**Location shows signs of lack of stabilization BMP's
in some areas (rutting is present).**

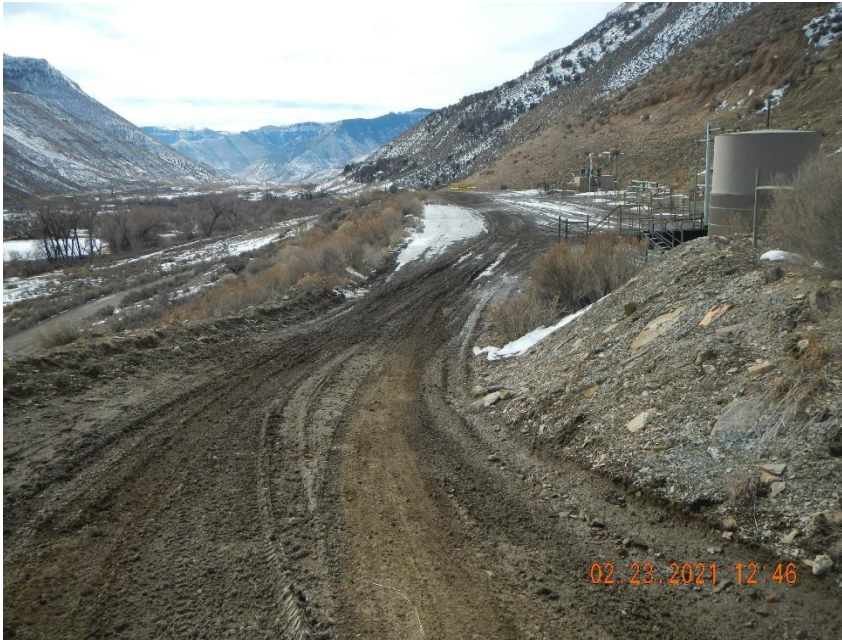
**Access road shows signs of lack of stabilization
BMP's in some areas (rutting is present).**

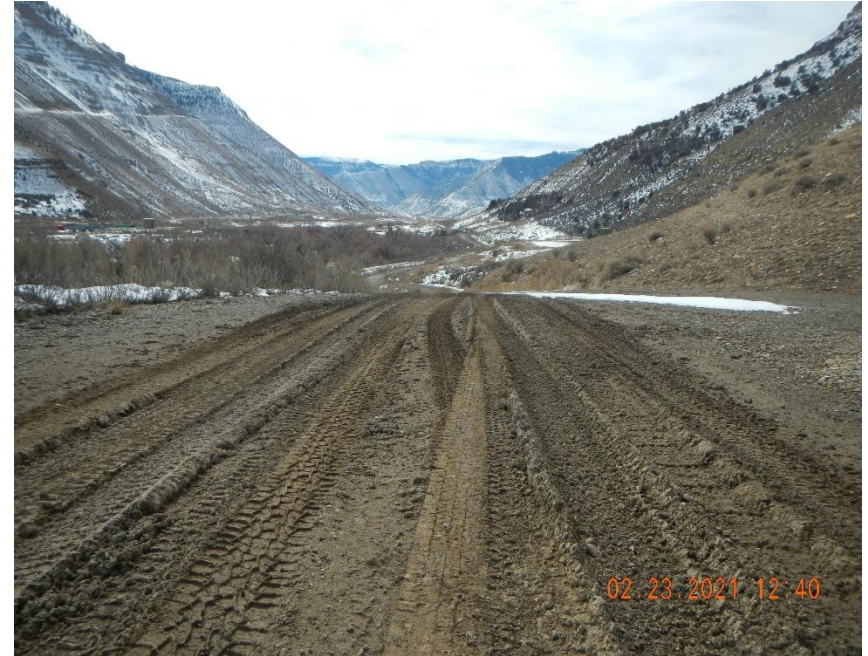
**Access road shows signs of lack of stabilization
BMP's in some areas (rutting is present).**

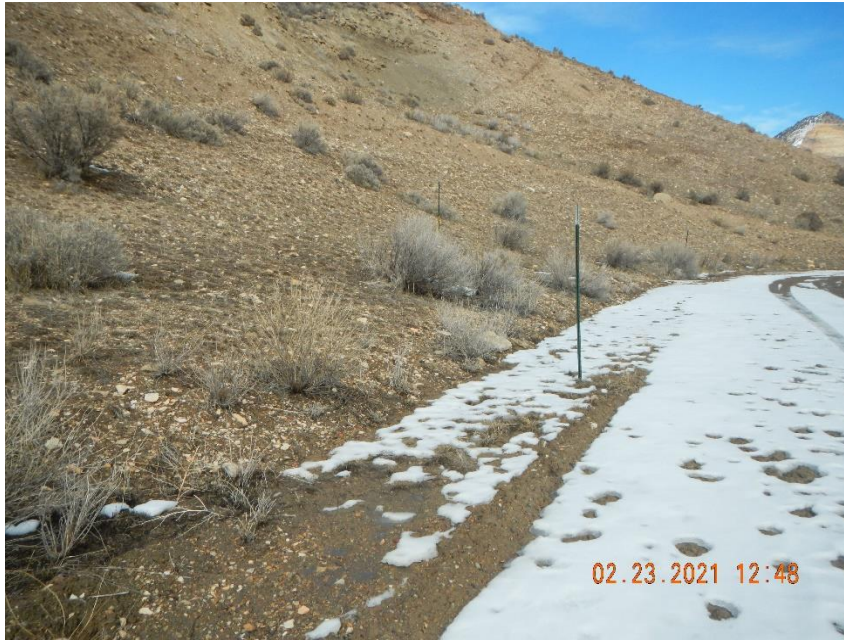
Sediment build up in perimeter ditch.

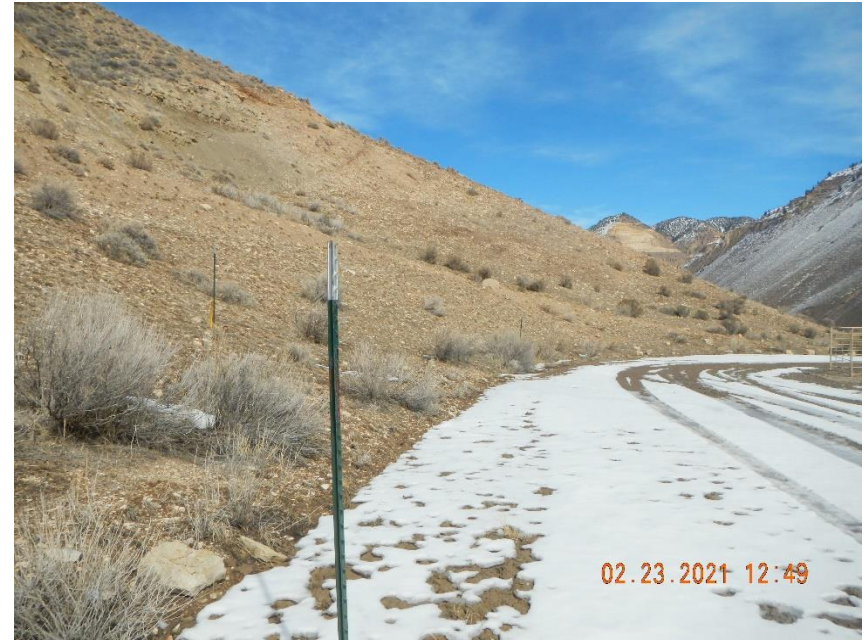
Sediment build up in perimeter ditch.

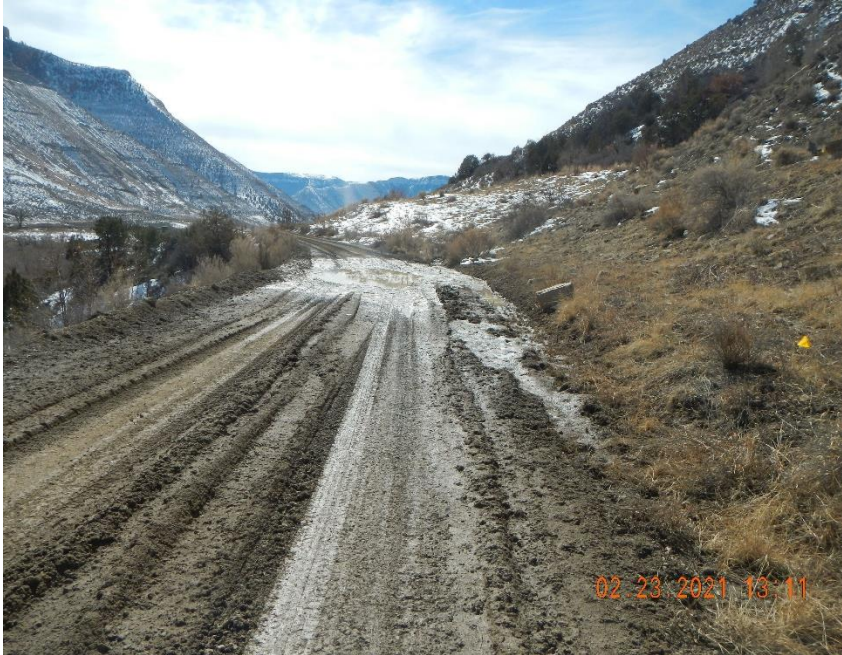
**N39.55096 W108.12064 Rut damage in ditch.
Water not draining off road into culvert or ditch.**

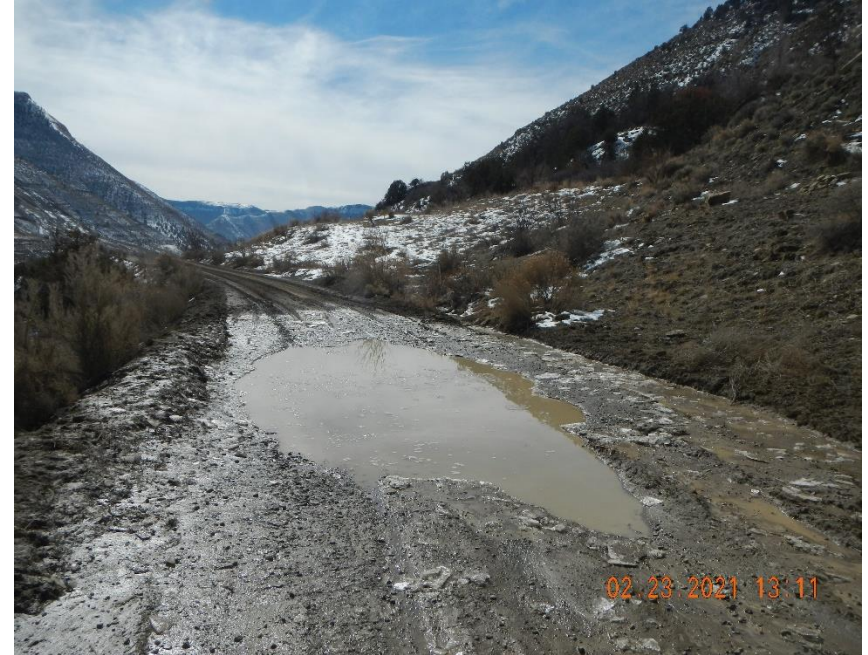
**Access road shows signs of lack of stabilization
BMP's in some areas (rutting is present).**

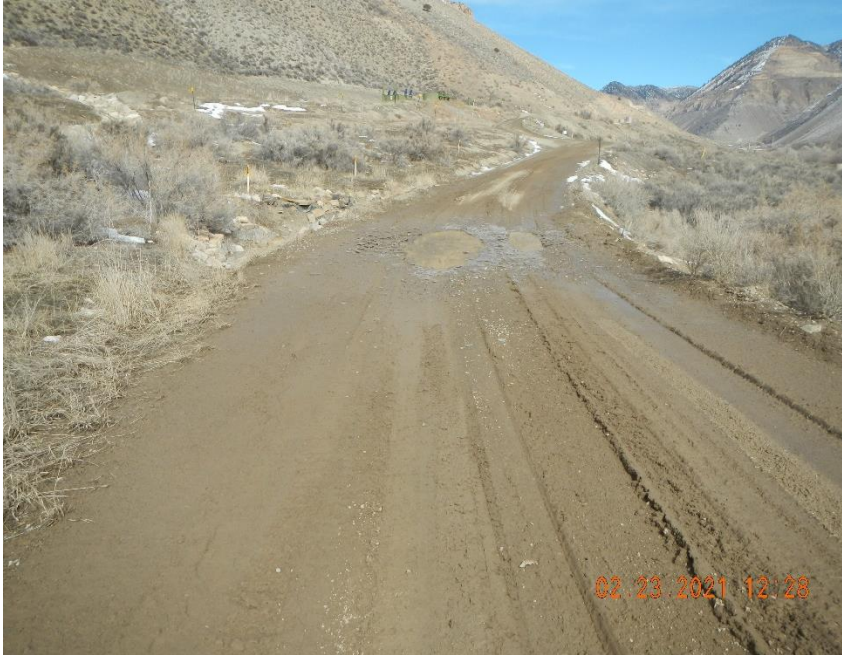
**Access road shows signs of lack of stabilization
BMP's in some areas (rutting is present).**

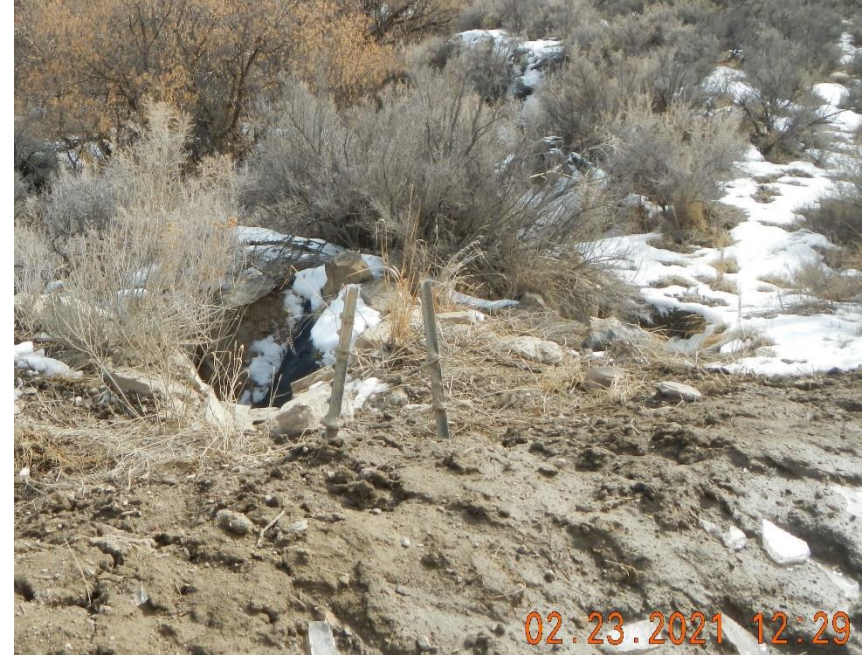
**N39.55348 W-108.11985 Erosion damage
from culvert outlet.**

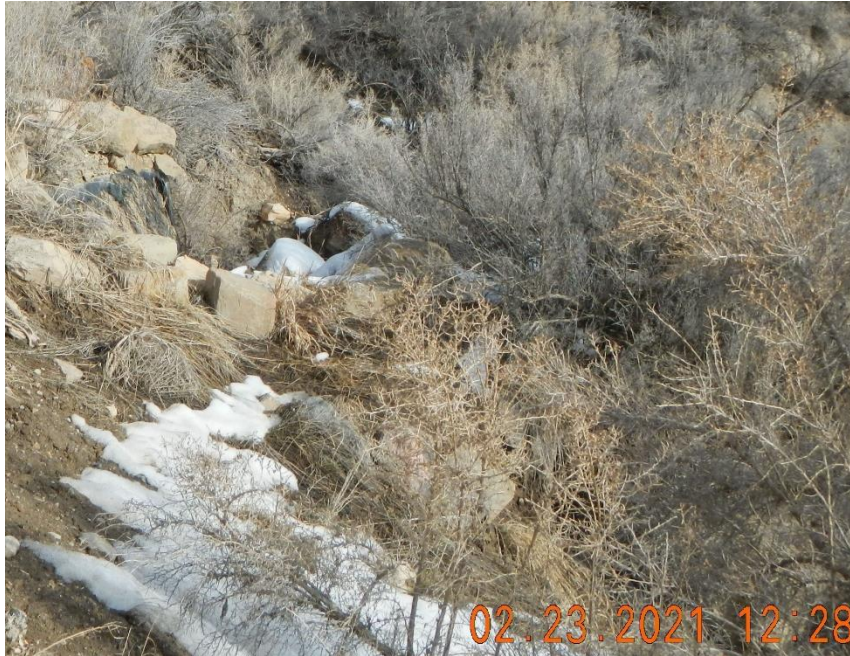
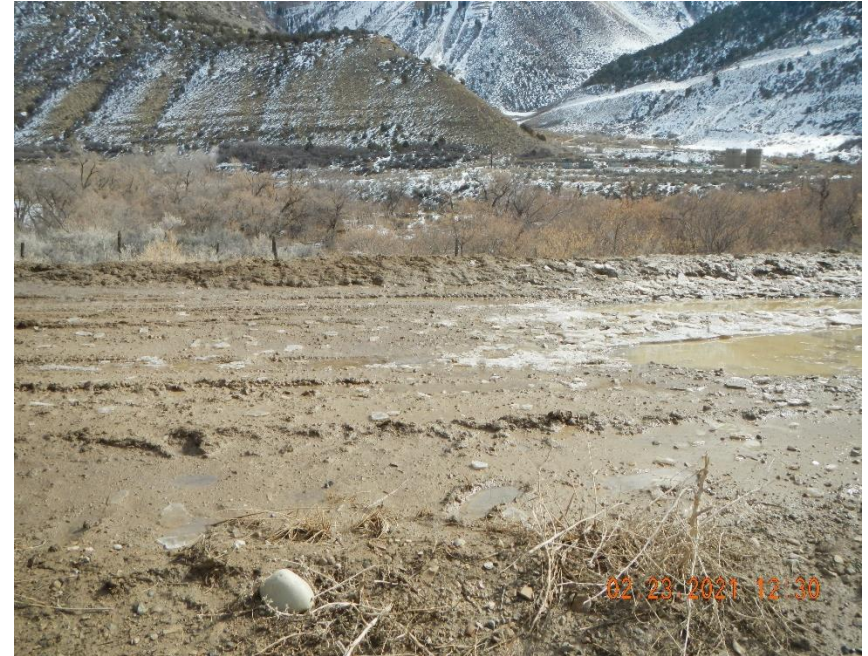
**N39.55348 W-108.11985 Erosion damage
from culvert outlet.**
