Inspection Photos
Operator: Hilcorp Energy
API: 067-08055
Date: 2/24/2021

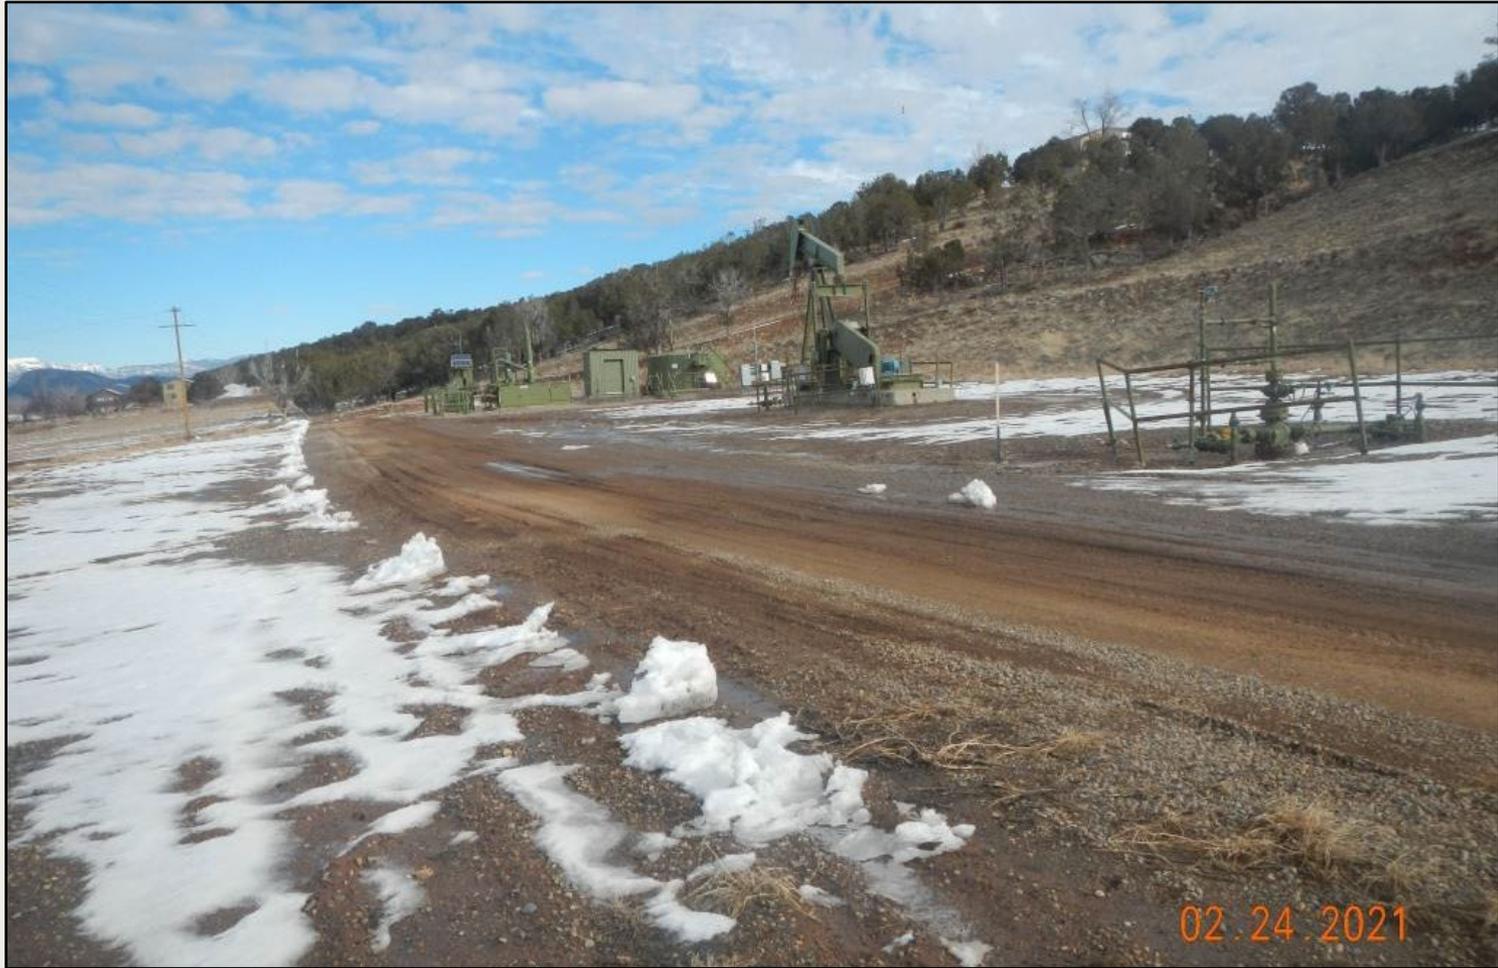
Photo 1. View of the eastern project area from the southwestern corner facing center.

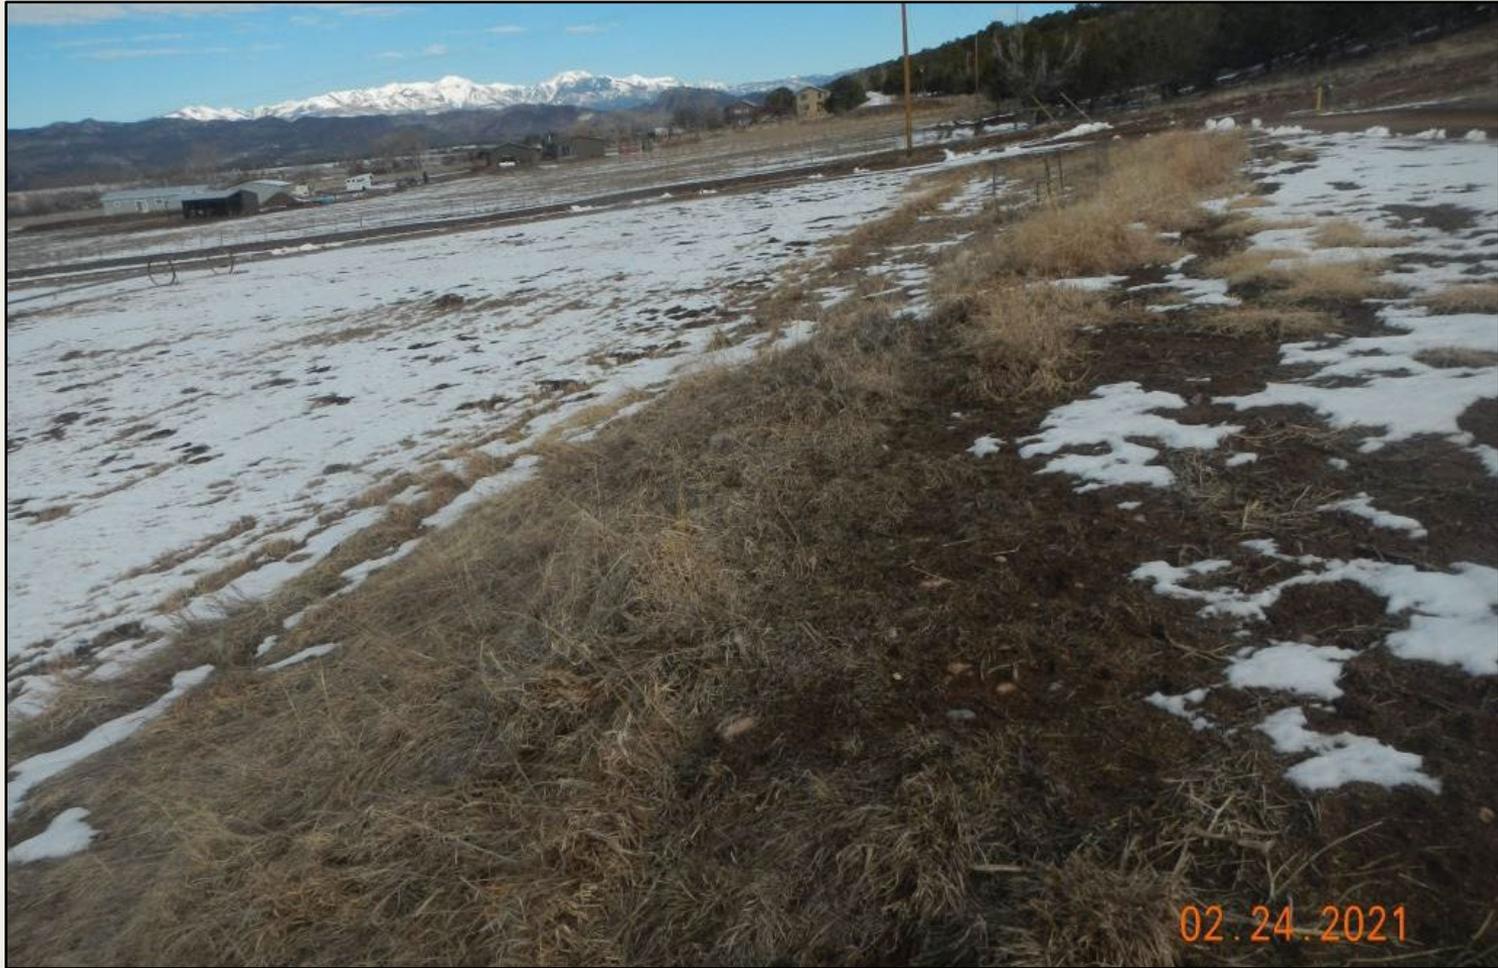
Photo 2. View of the western project area facing northward. Vegetation appears to be progressing in with smooth brome. Snow covered areas need to be assessed during the active growing season.

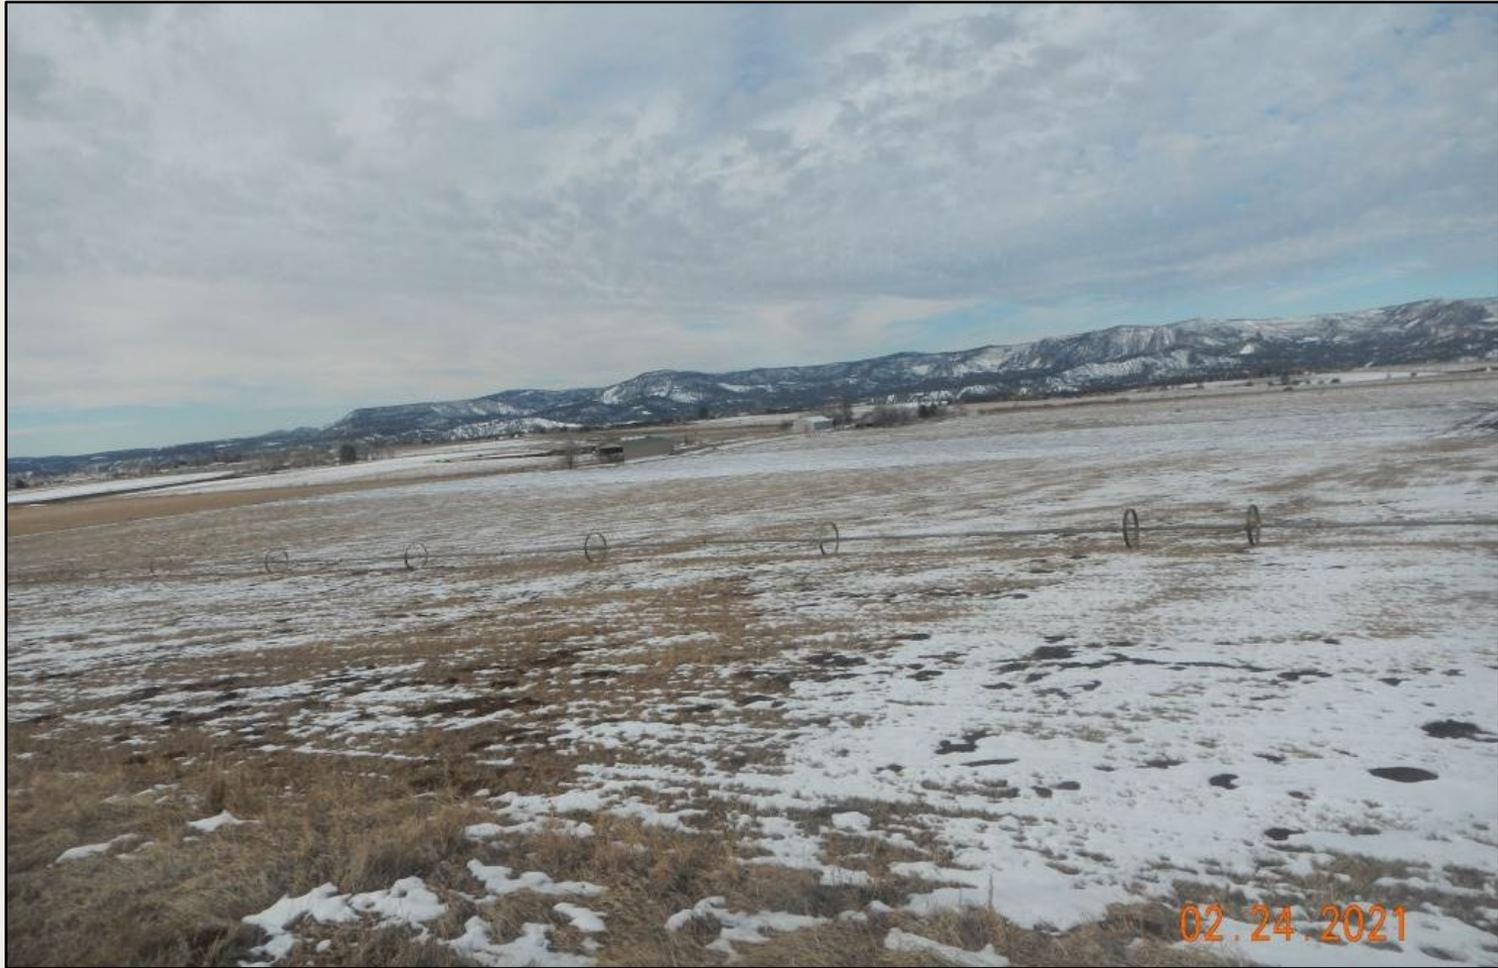
Photo 3. View of the reference area comprised of perennial irrigated grasses such as smooth brome, partially snow covered at this time.
