Inspection Photos

Operator: Hilcorp Energy
API: 067-08075
Date: 2/24/2021

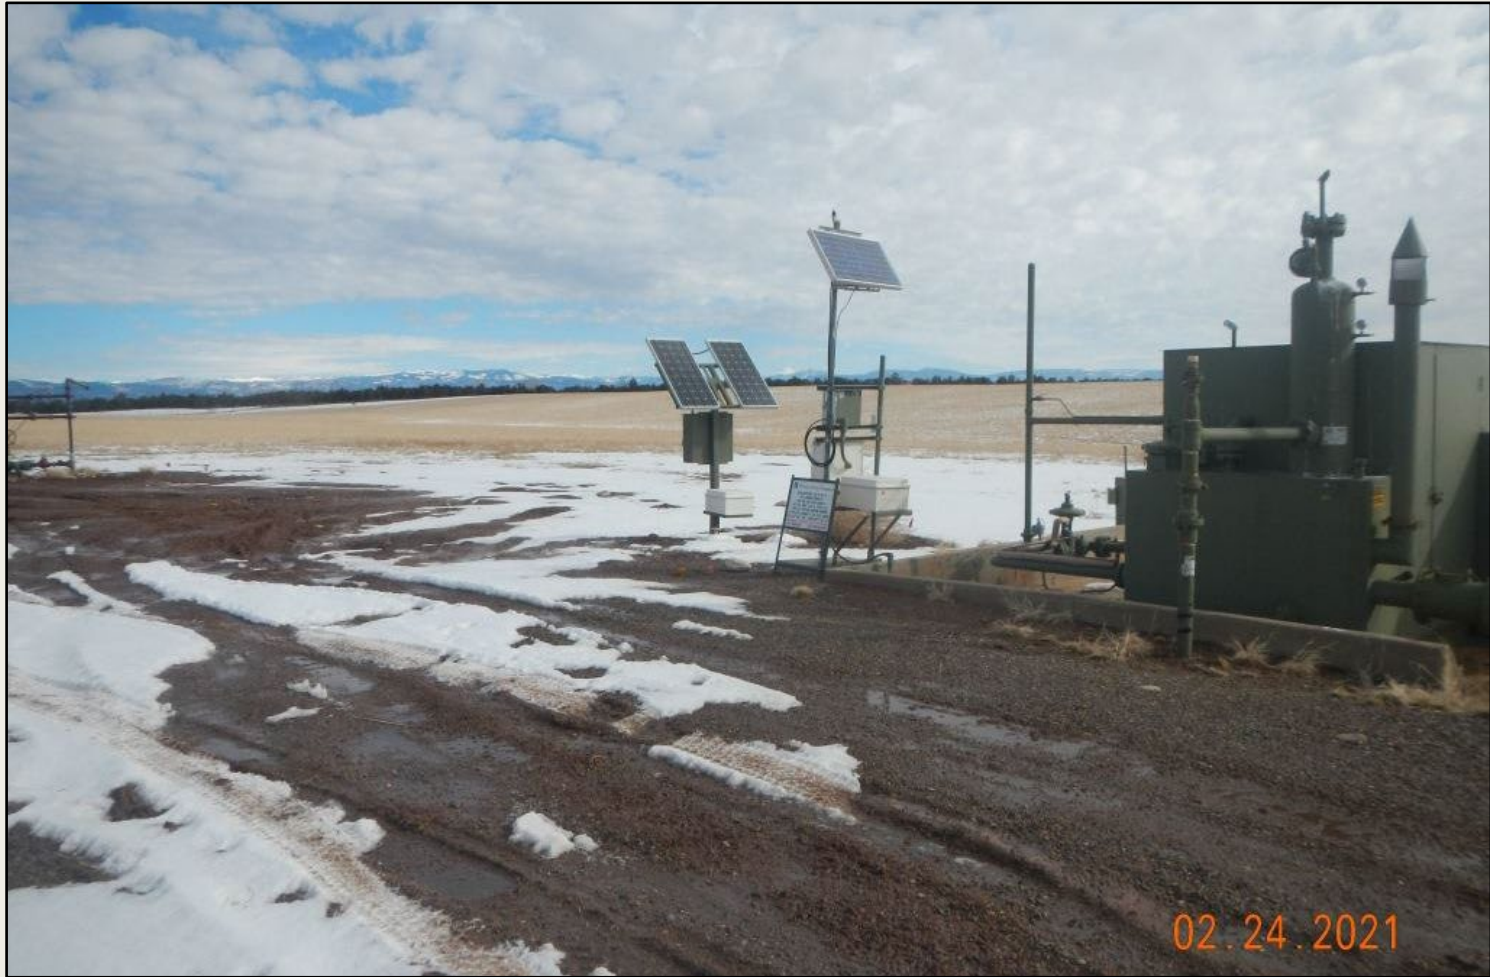
Photo 1. View of the eastern project area from the southwestern corner facing center.

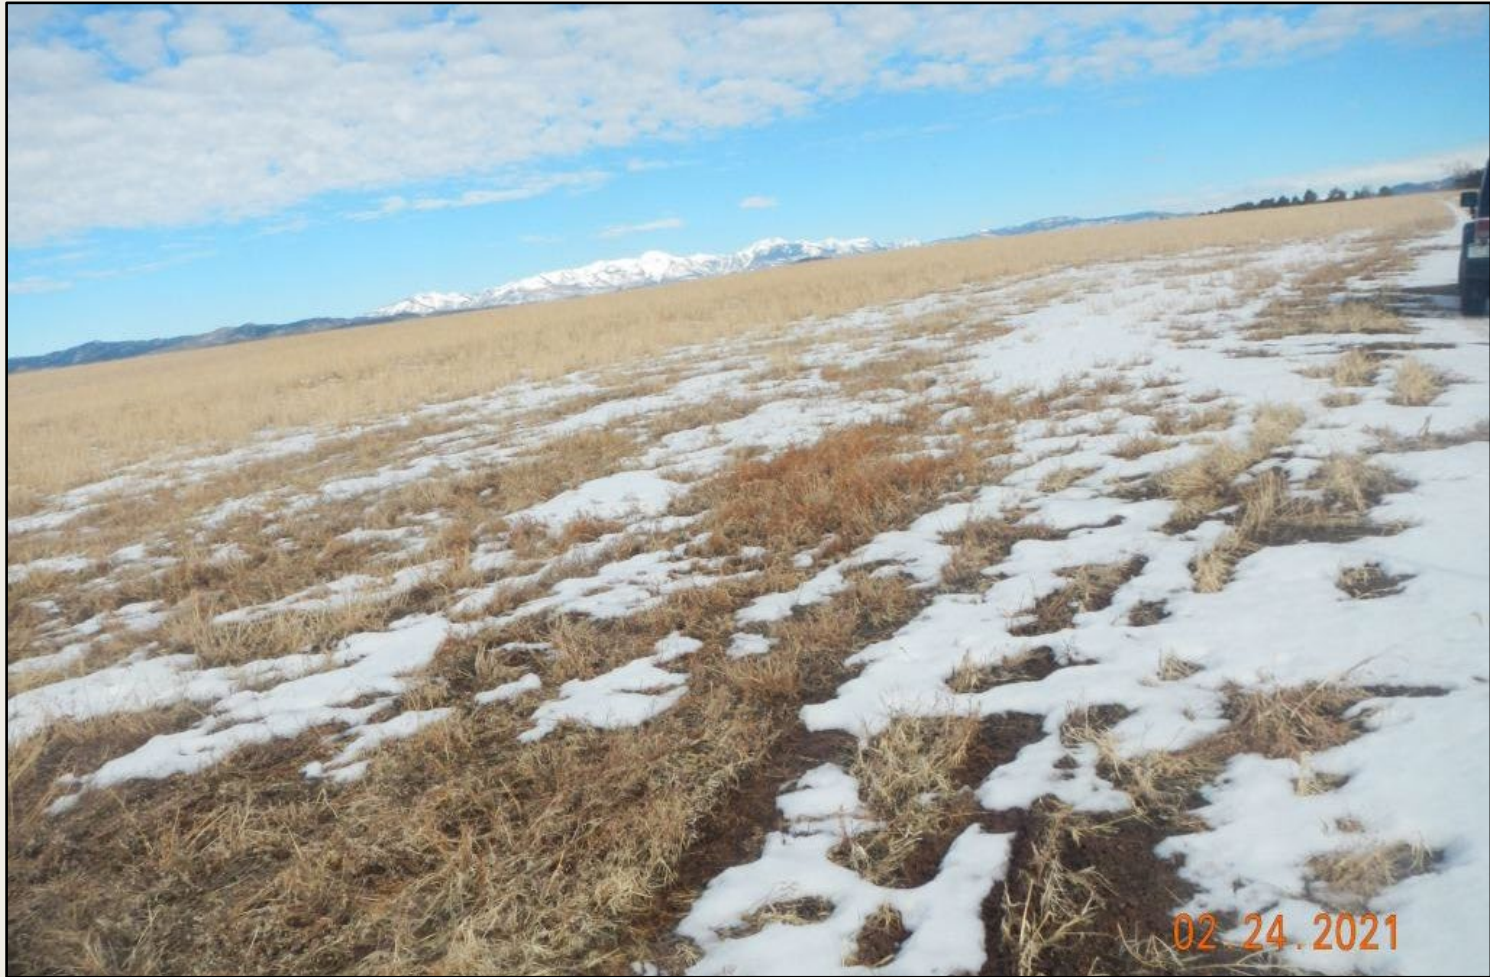
Photo 2. View of the western project area facing northward. Vegetation appears to be progressing in with smooth brome. Snow covered areas need to be assessed during the active growing season.

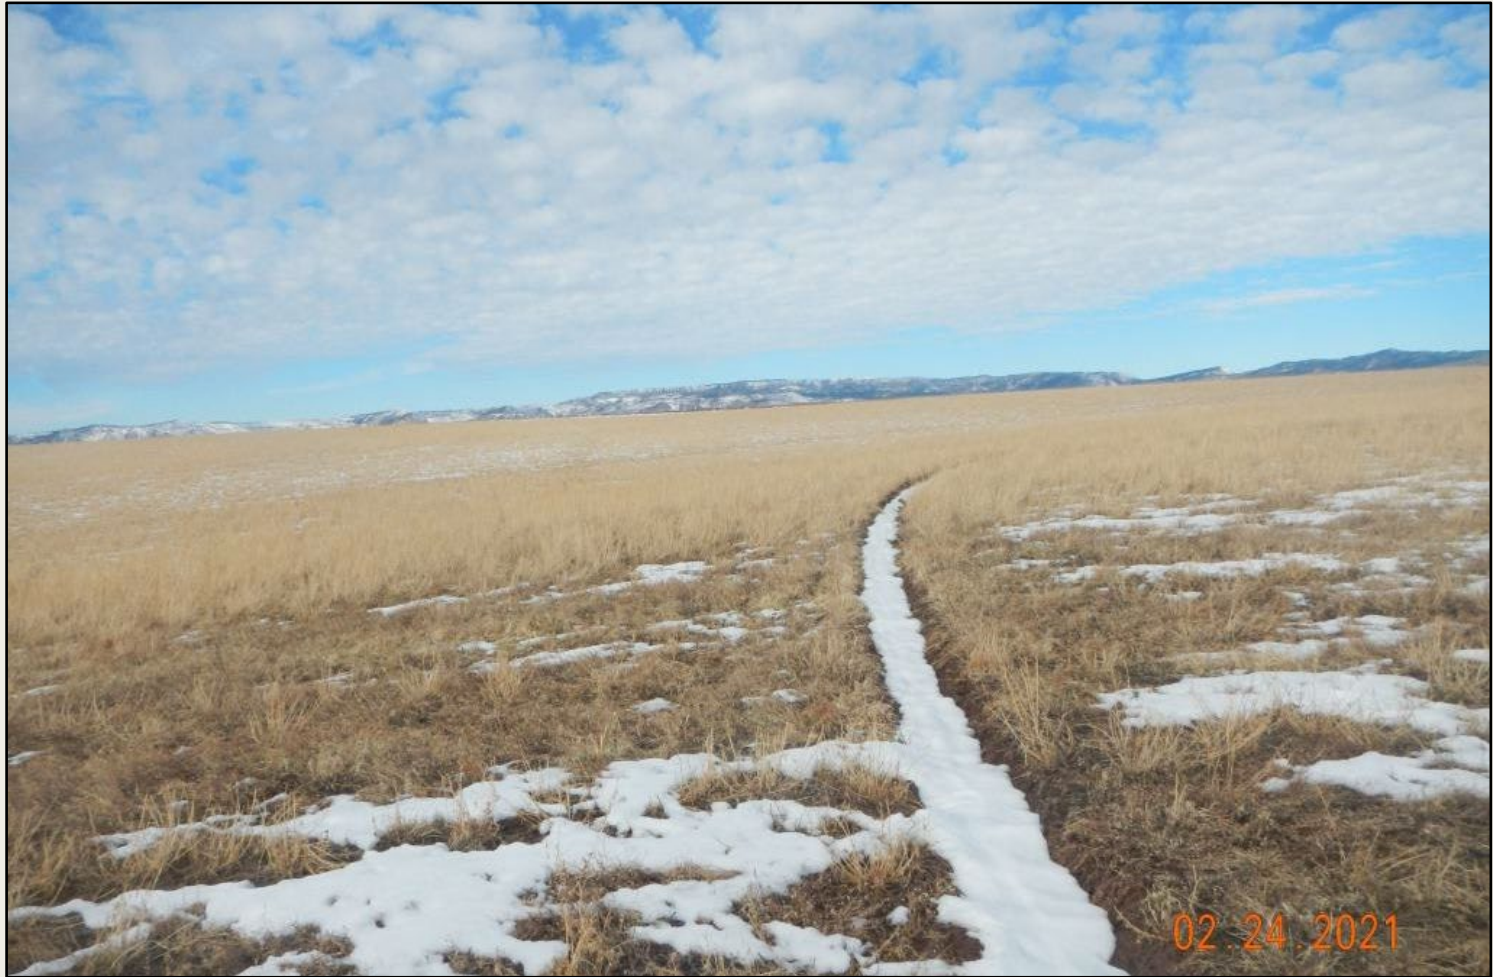
Photo 3. View of the reference area comprised of perennial irrigated grasses such as smooth brome, partially snow covered at this time.

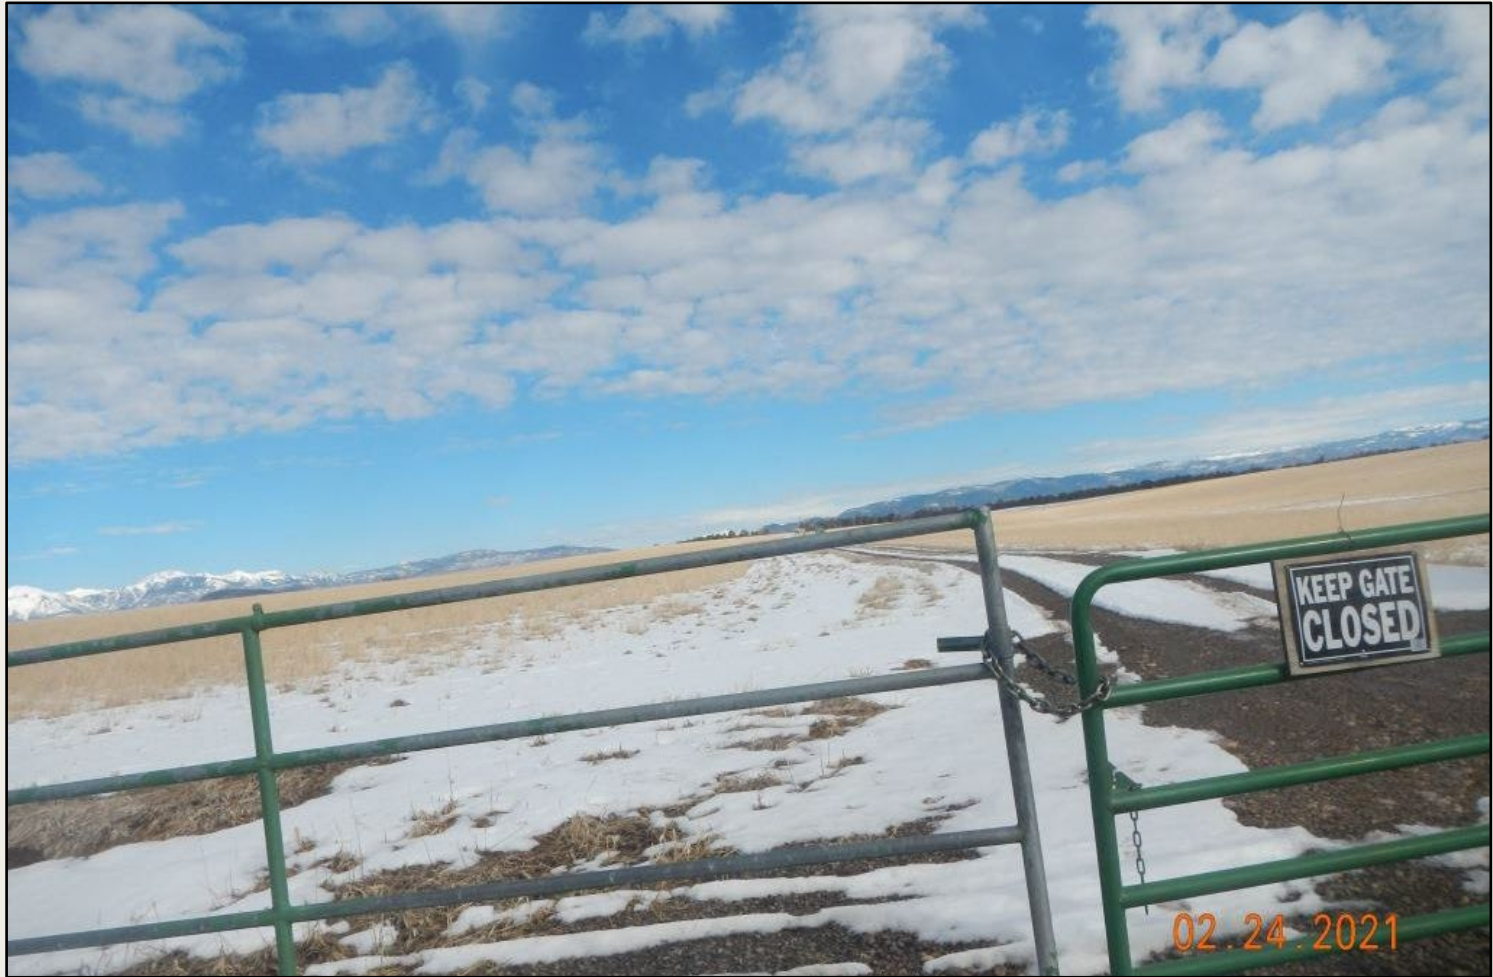
Photo 4. View of closed gate after leaving location.
