Inspection Photos
Operator: Hilcorp Energy
API: 067-09459
Date: 2/24/2021

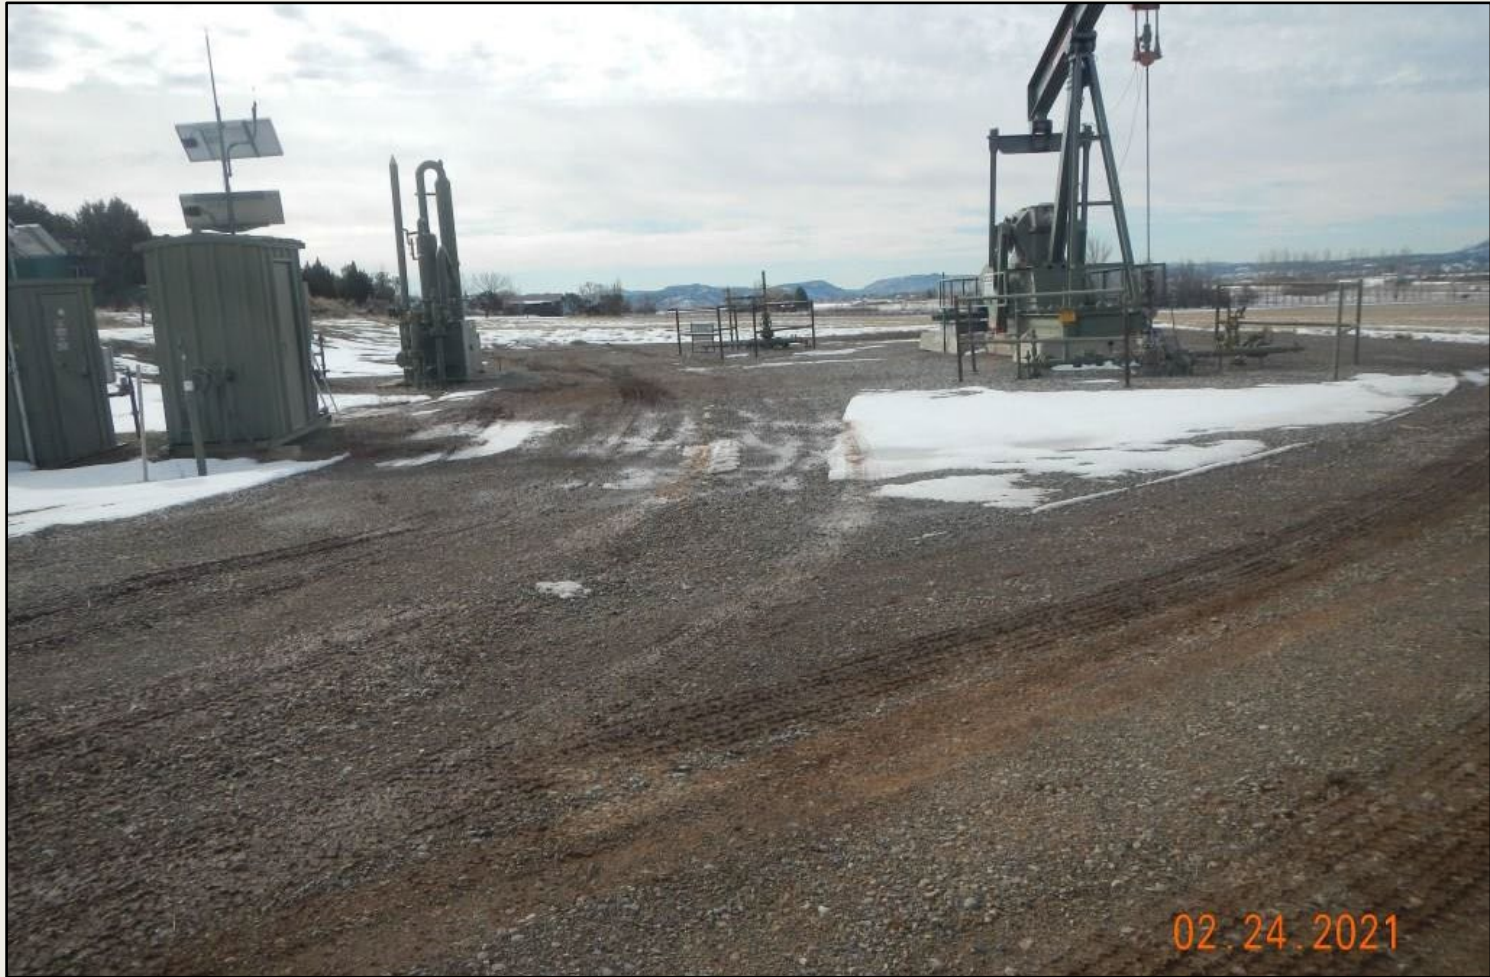
Photo 1. View of the well pad entrance facing center.

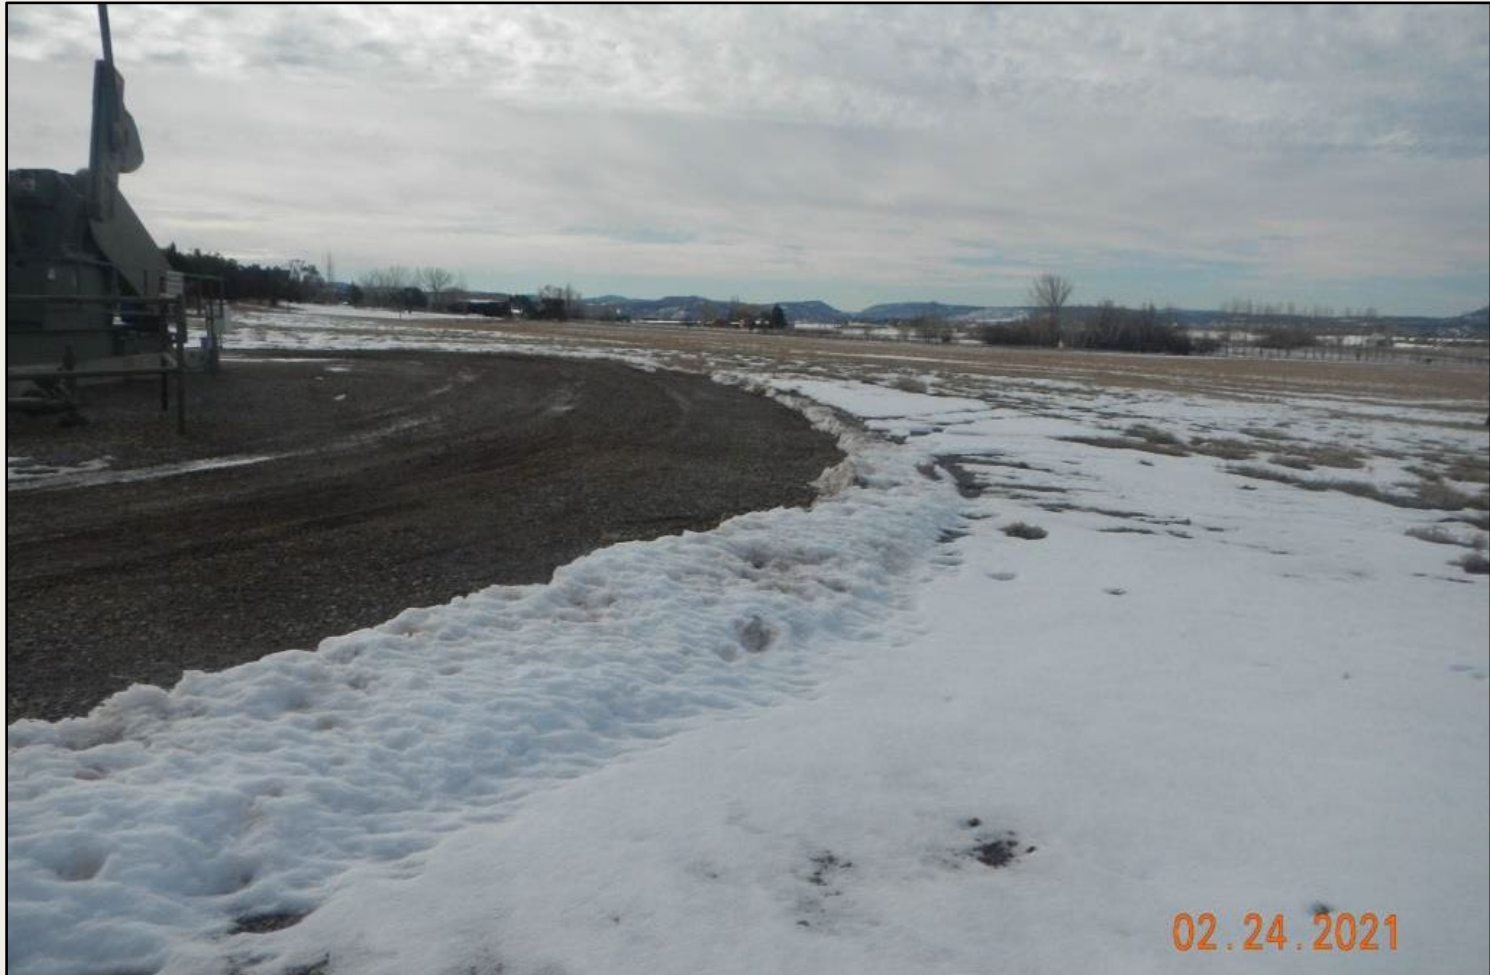
Photo 2. View of the western project area facing southward. Snow covered areas need to be assessed during the active growing season.

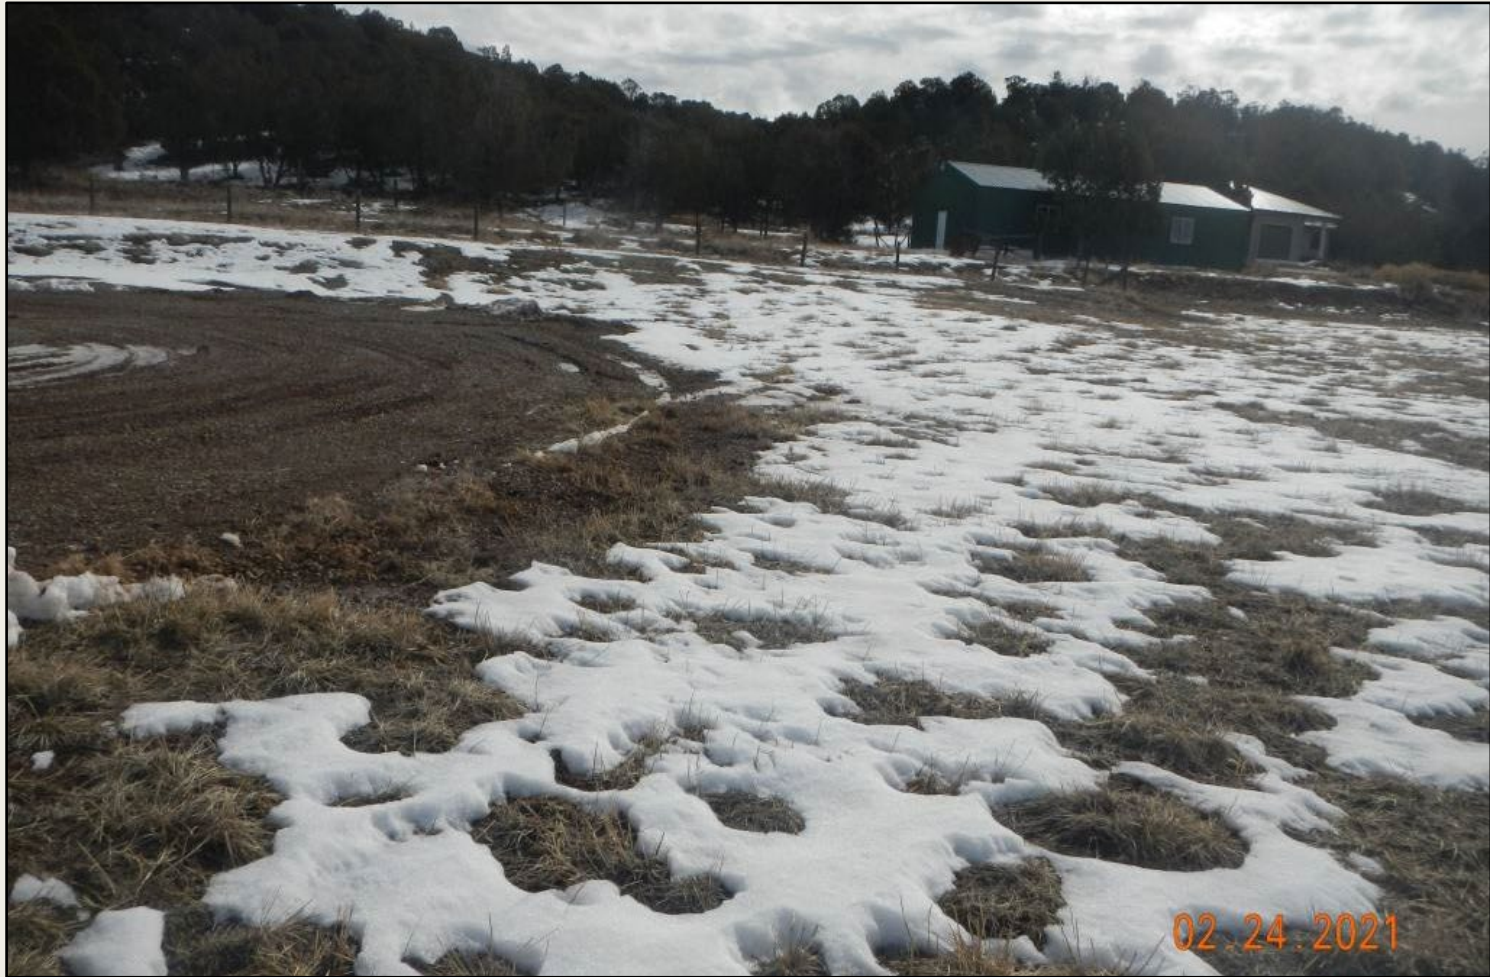
Photo 3. View of the southern project area from the southwestern corner facing eastward.

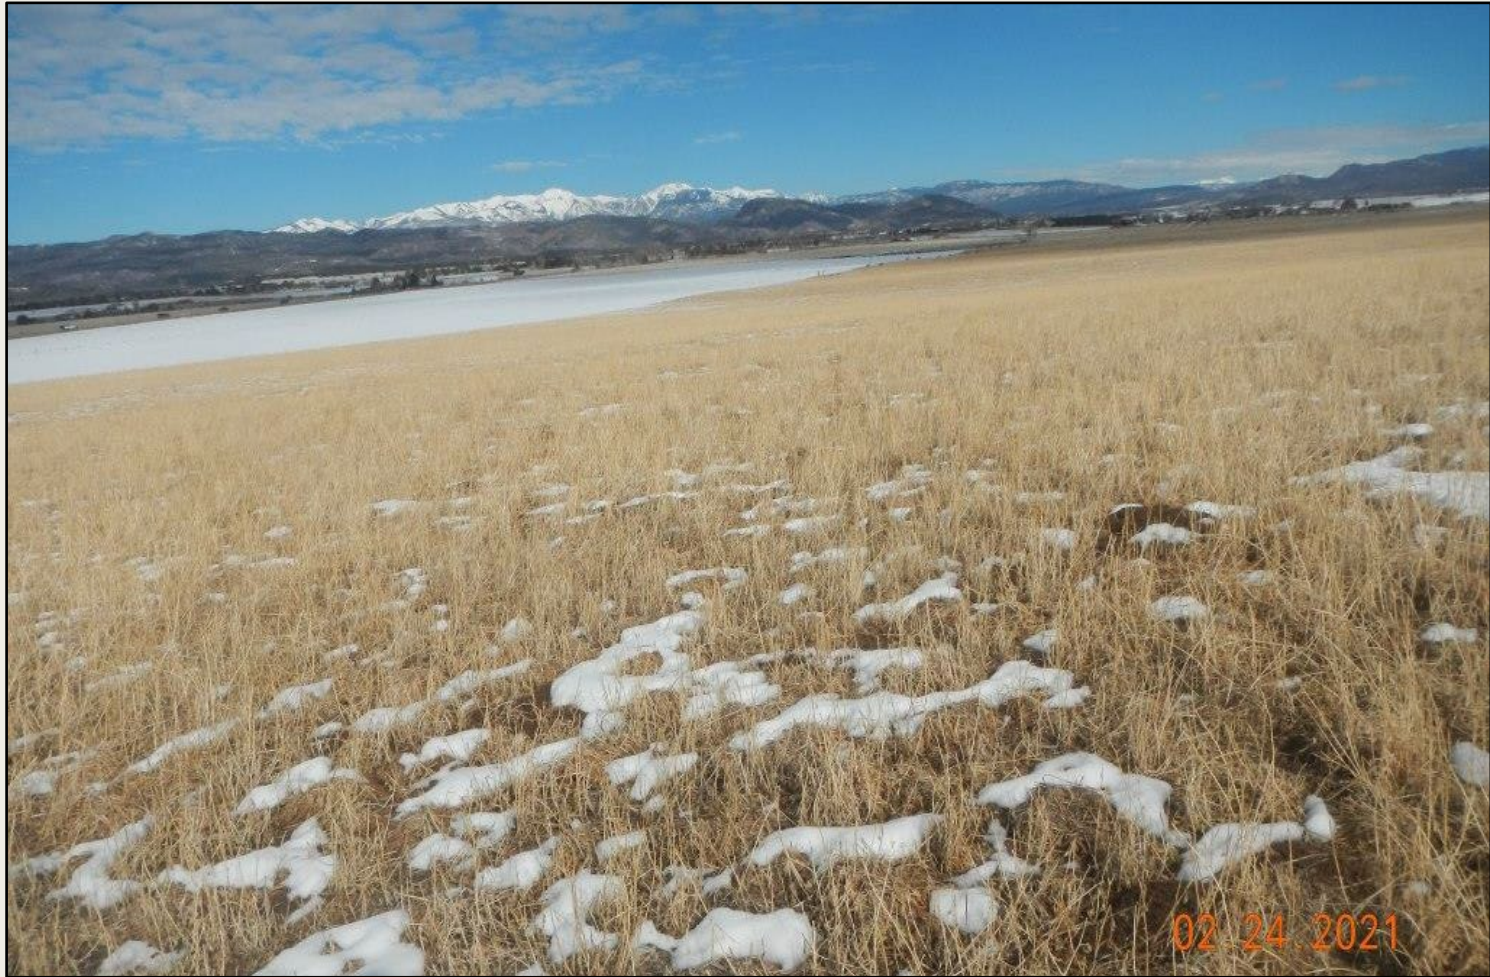
Photo 4. View of the reference area comprised of perennial irrigated grasses such as smooth brome, partially snow covered at this time.
