Inspection Photos

API: 011-06164

Operator: STRACHAN EXPLORATION INC

Inspection Date: 2/23/2021

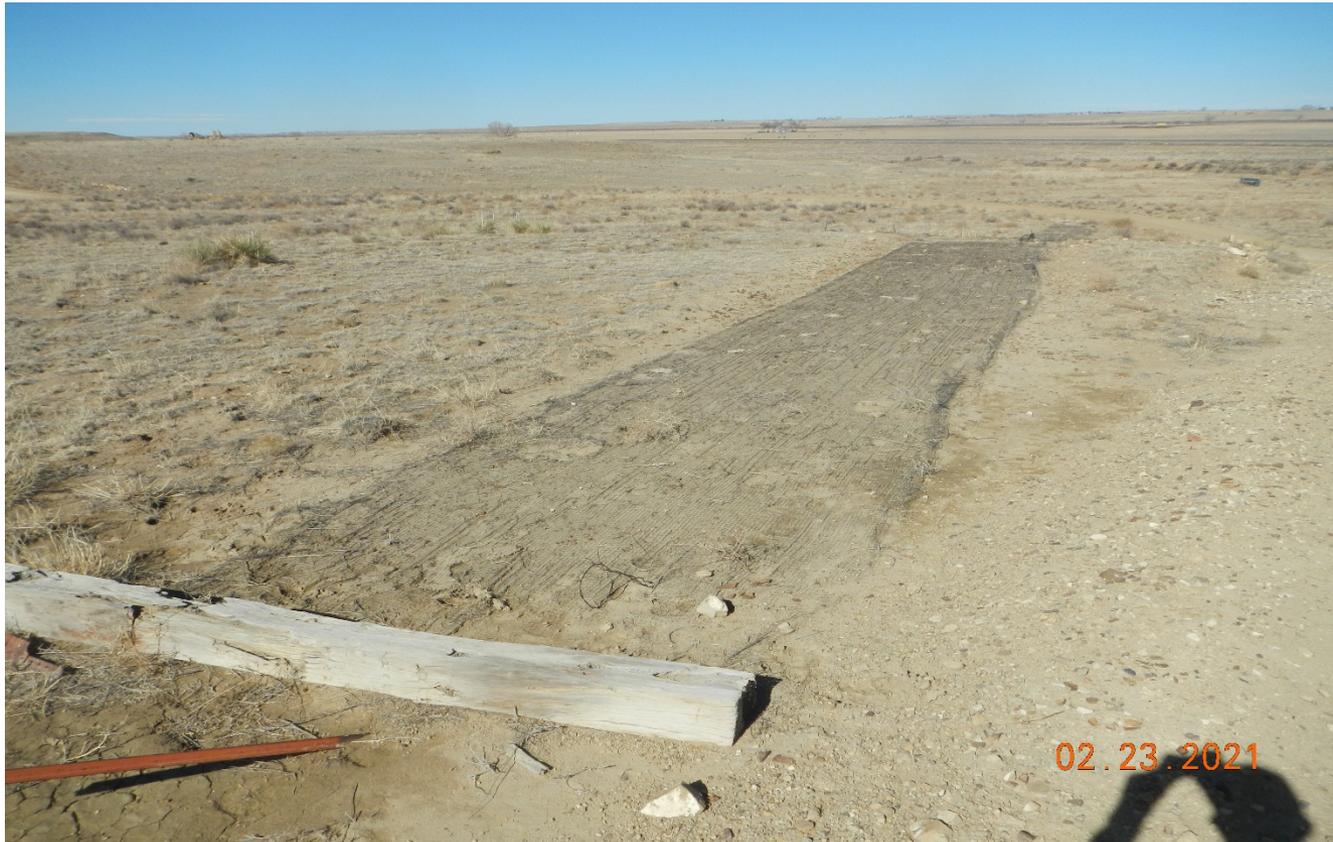
Photo 1. Facing toward the disturbance adjacent to the main road which had been previously cited. This area was repaired however vegetation has not established and the BMP's are degraded.

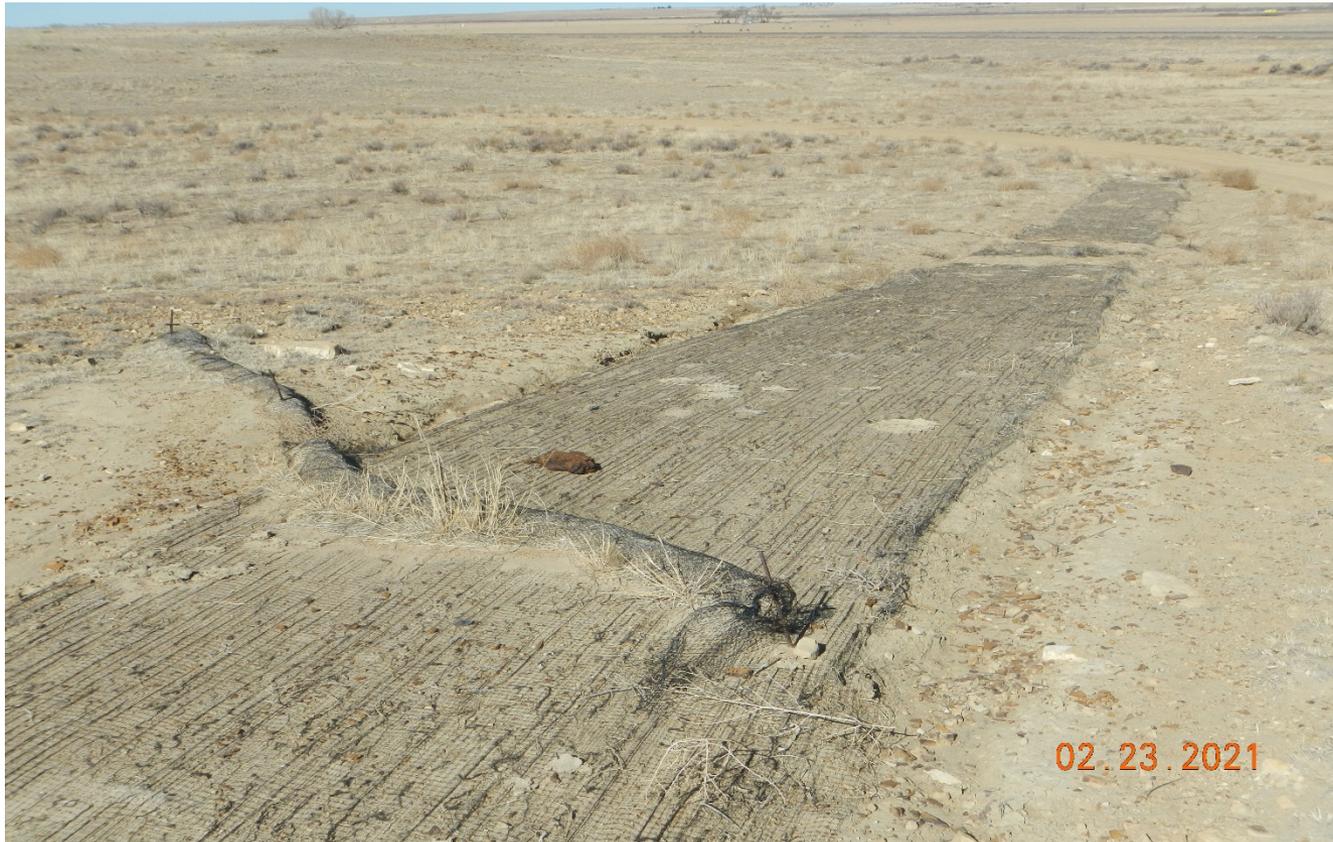
Photo 2. The wattles and straw blanket are degraded.

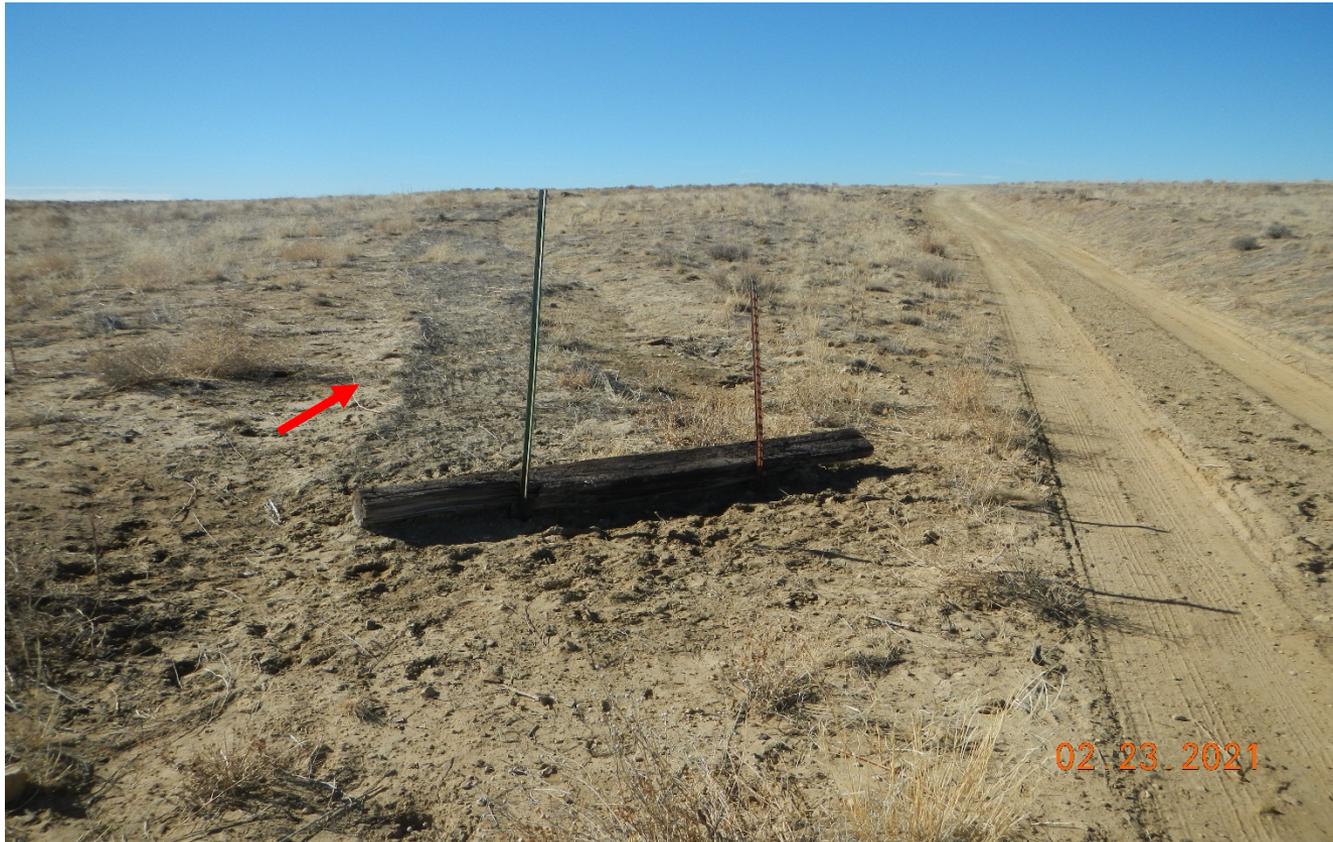
Photo 3. Facing toward the disturbance adjacent to the main road which had been previously cited. This area was repaired however vegetation has not established and the BMP's are degraded.

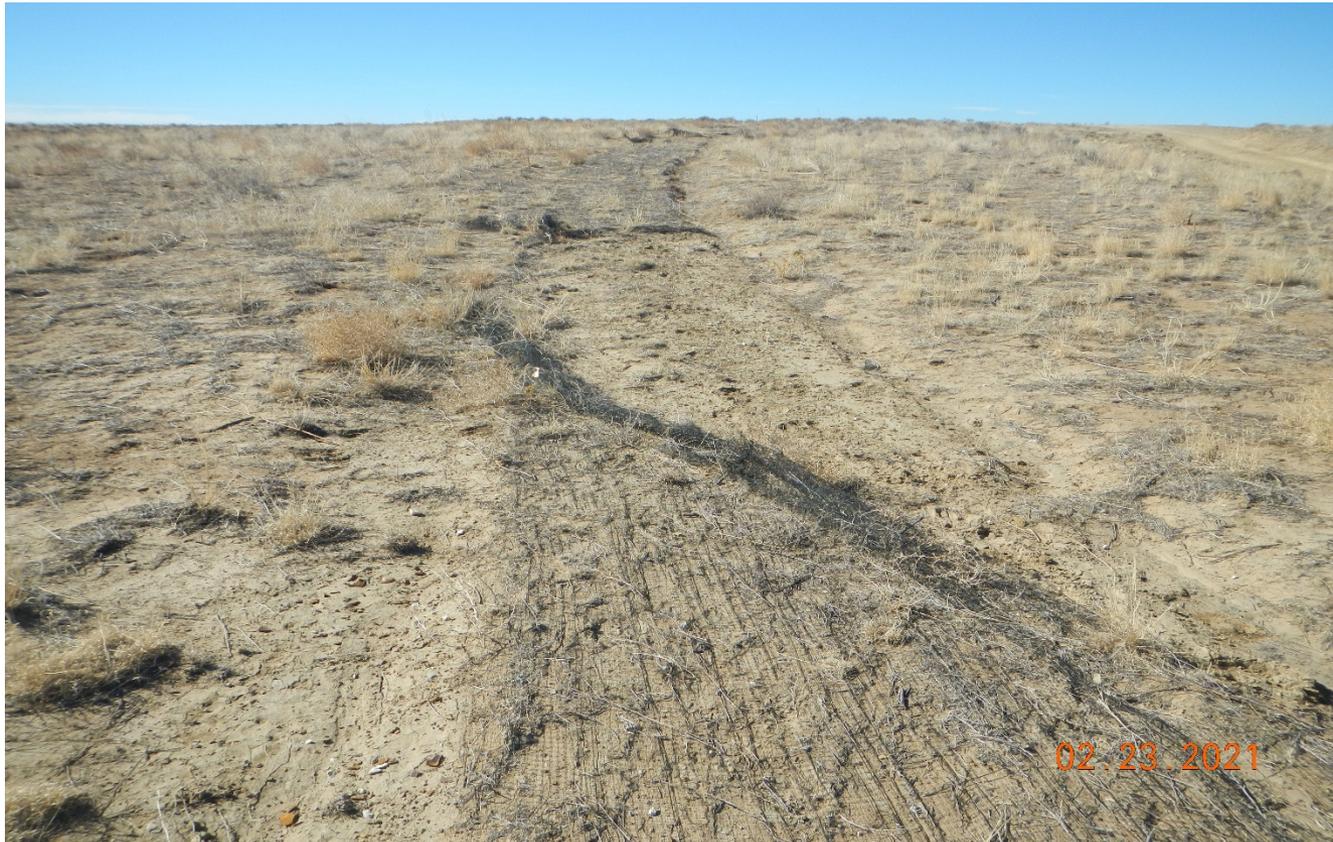
Photo 4. The netting from the straw blanket needs to be removed in areas with out pulling up vegetation. Bare areas need to be reseeded.

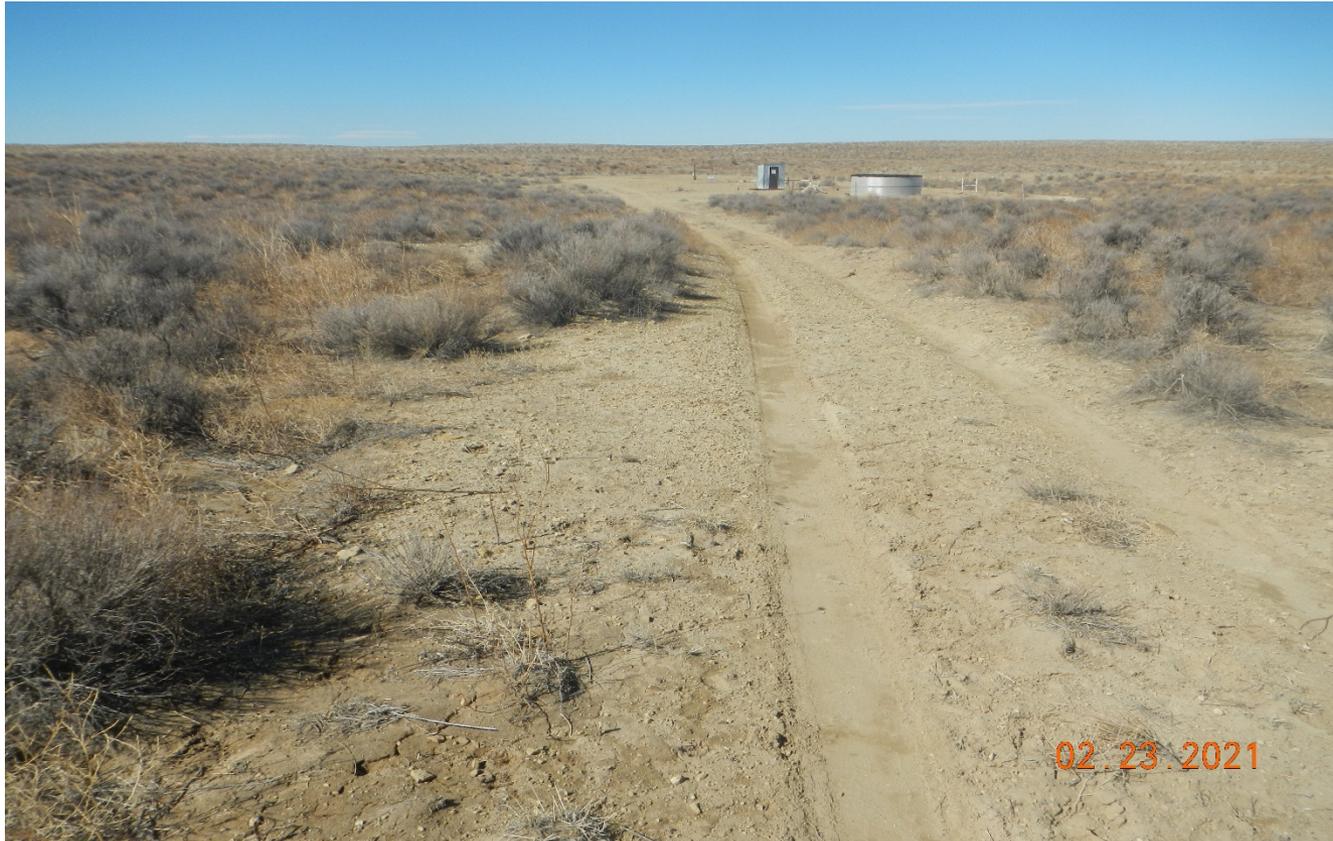
Photo 5. Facing northwest toward along the access road toward the location.

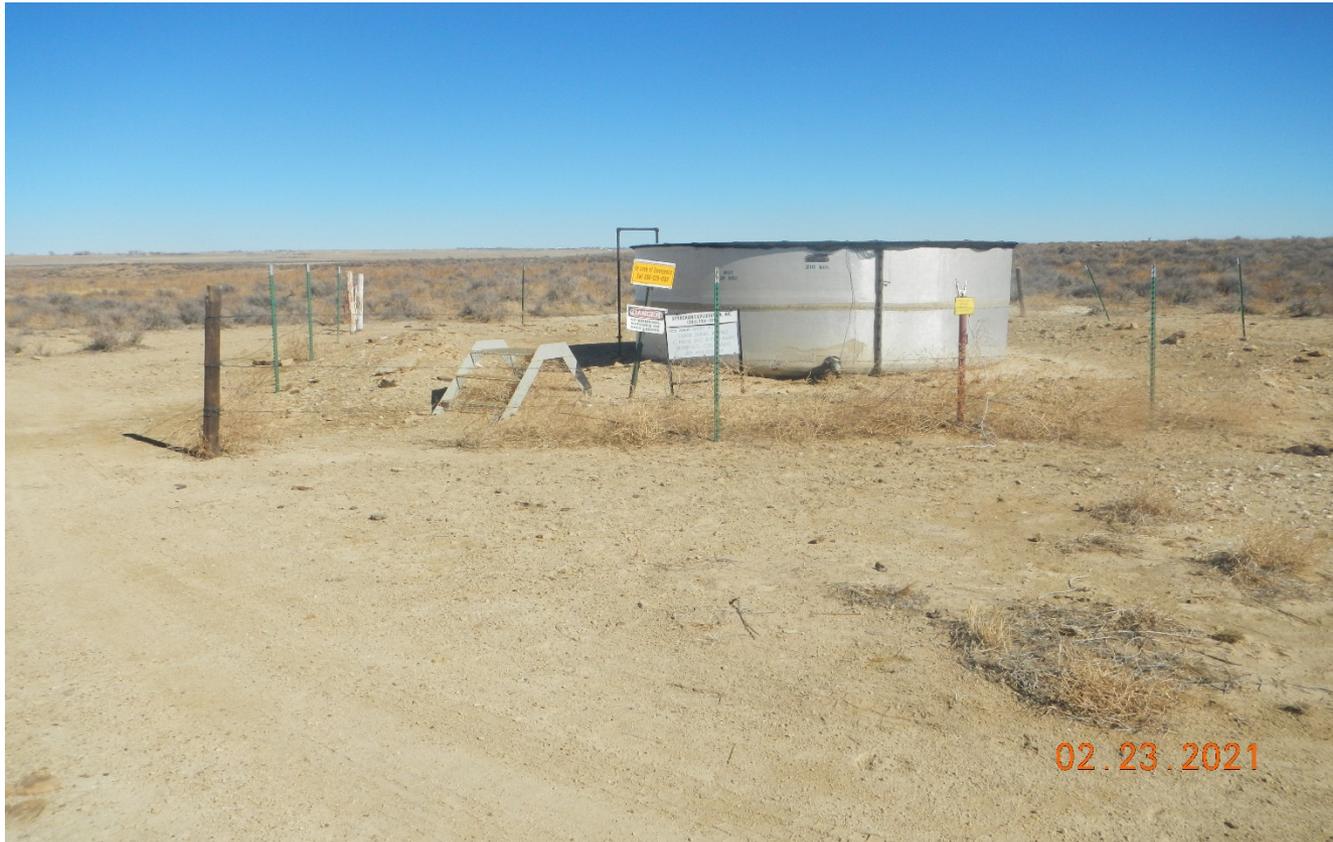
Photo 6. Facing toward the tank battery.

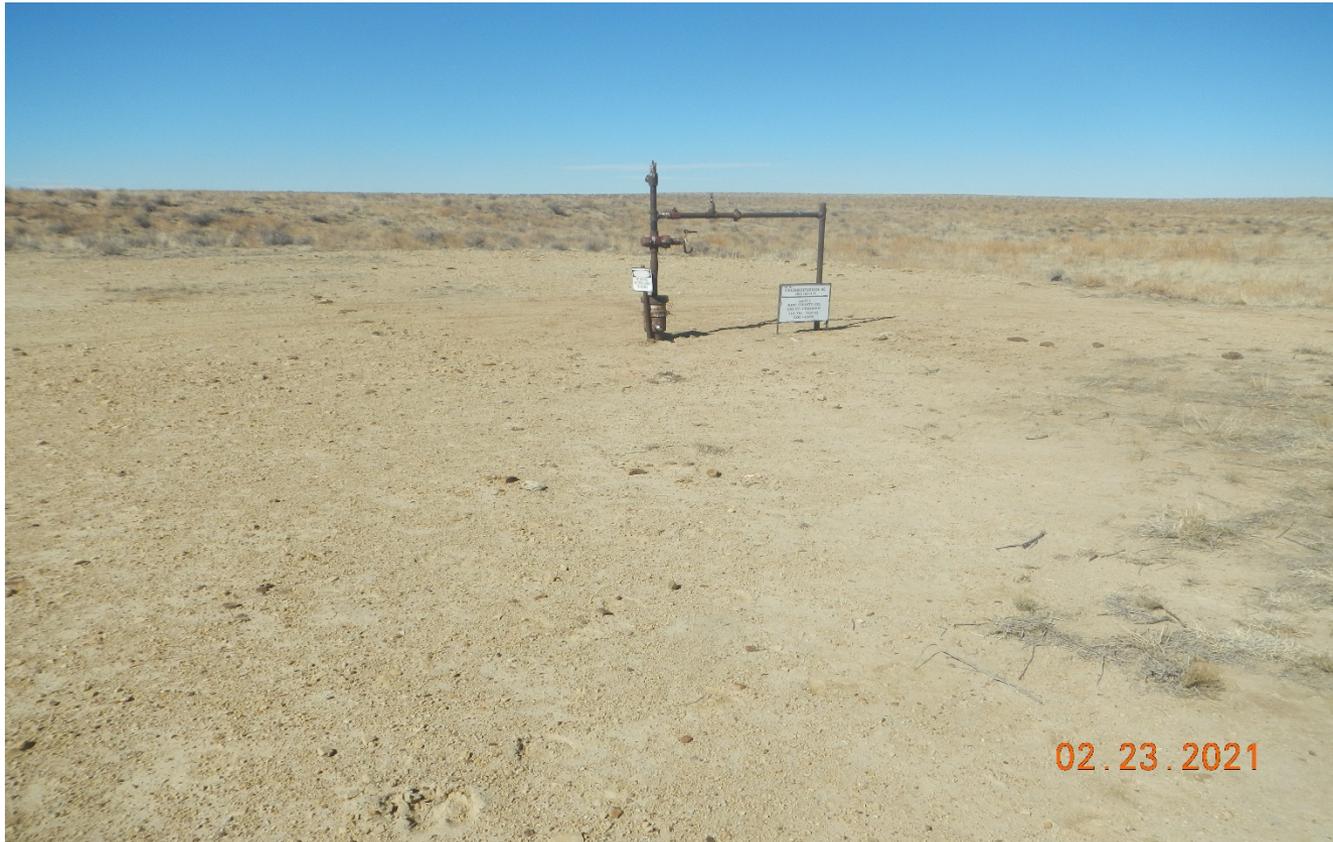
Photo 7. Facing toward the wellhead. Sign is posted.
