Inspection Photos

API: 011-06019

Operator: OXY USA INC

Inspection Date: 2/23/2021

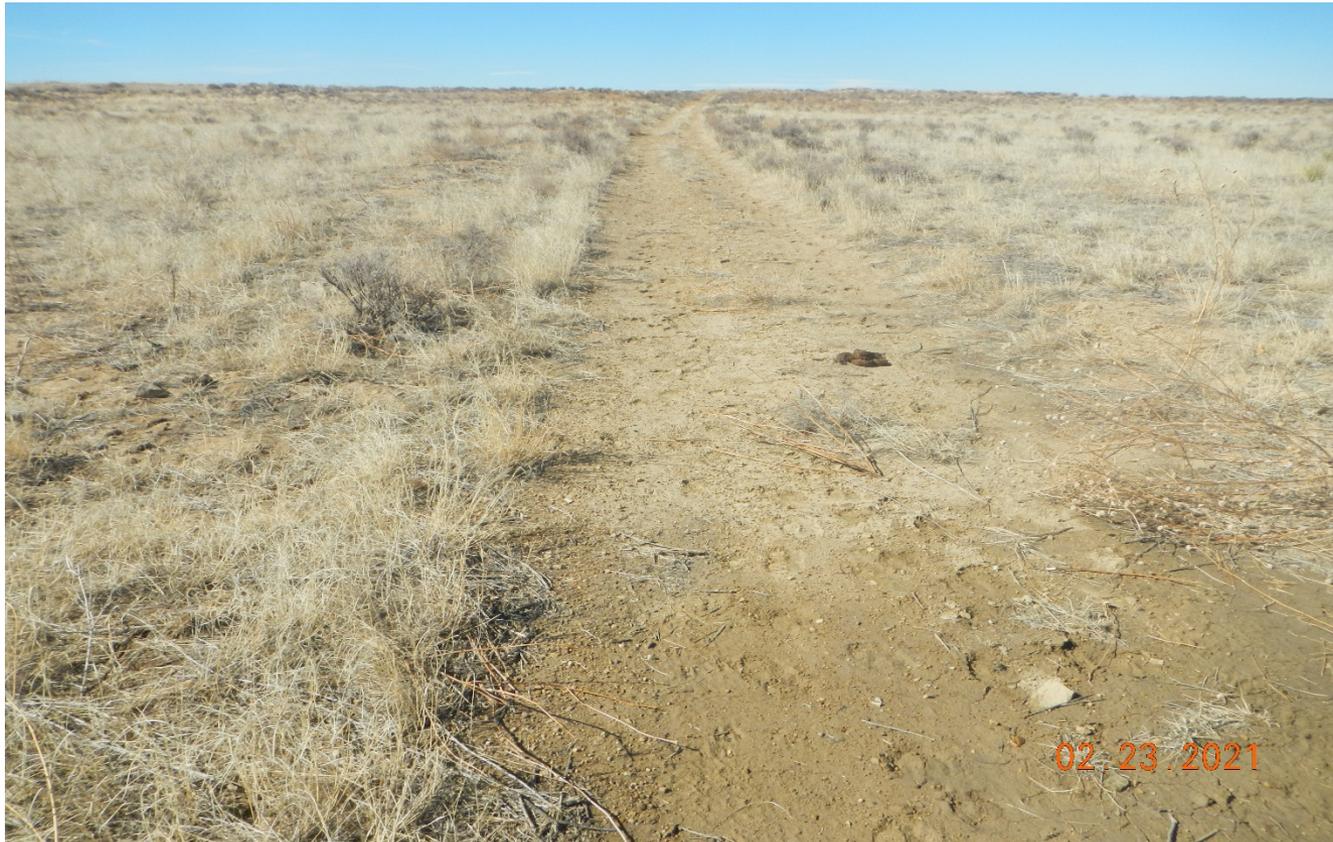
Photo 1. Facing west toward the access road which has not been reclaimed.

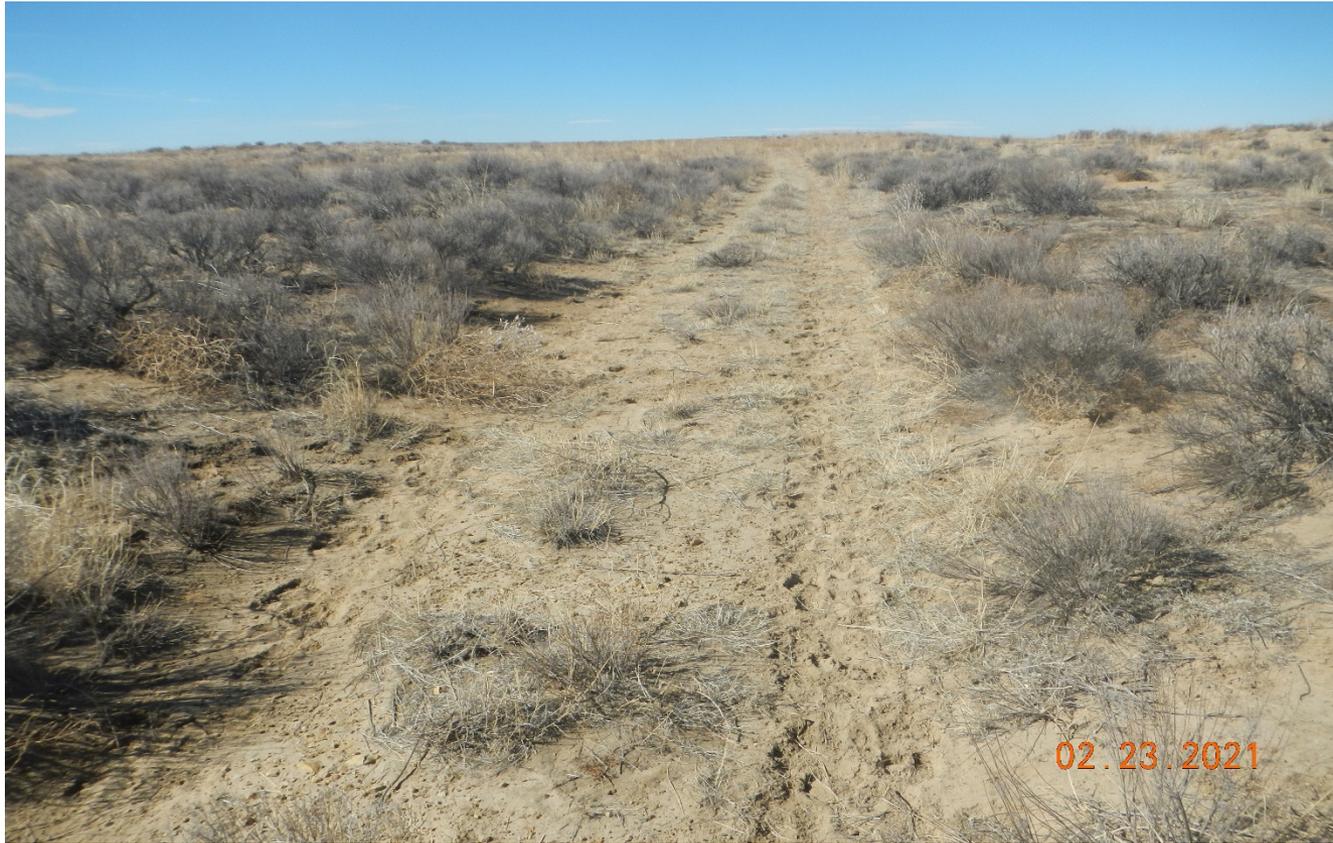
Photo 2. Facing west along the access road. The access road needs to be reclaimed.

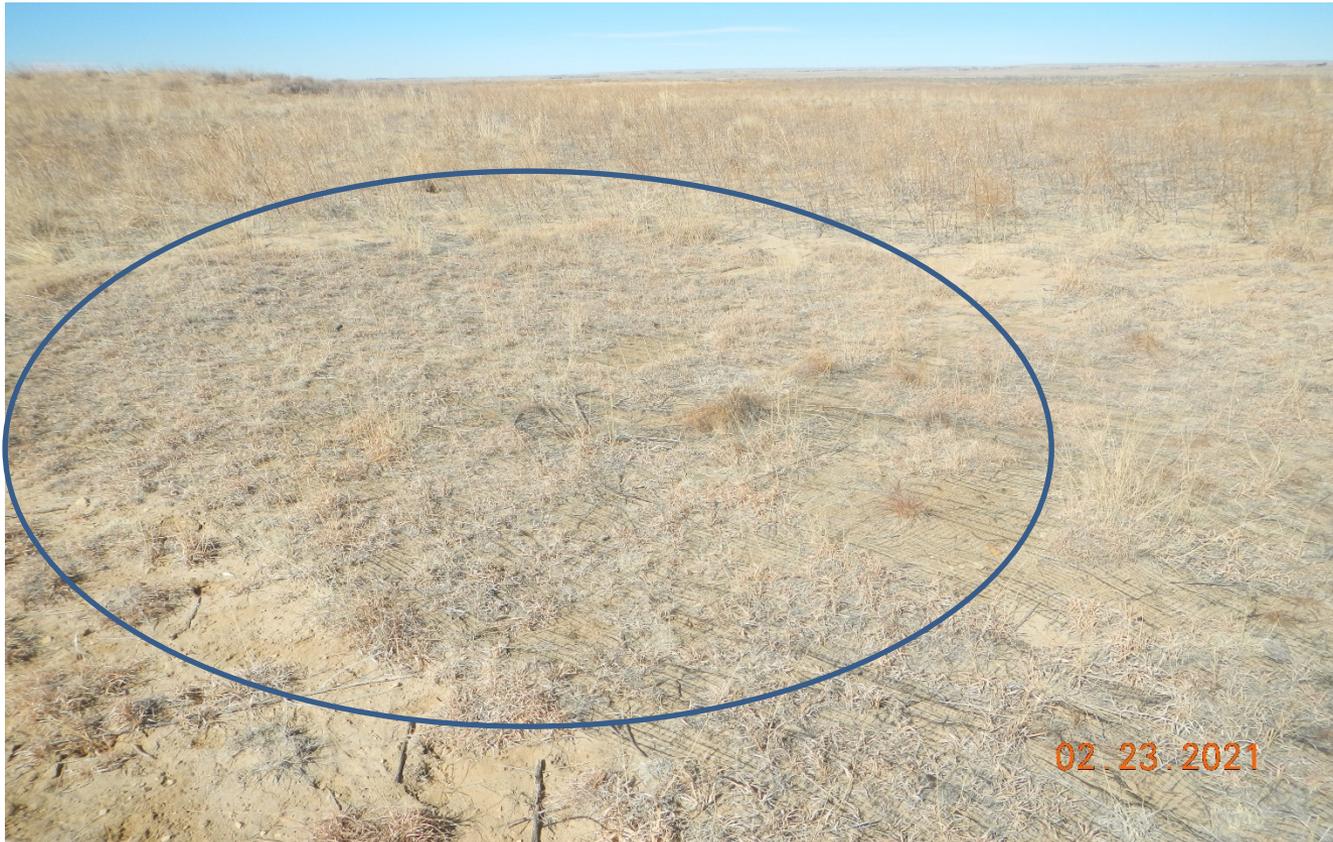
Photo 3. Facing northwest toward the location. The area circled is where straw blanket was installed. Vegetation grew really well compared to other areas without strawblanket.

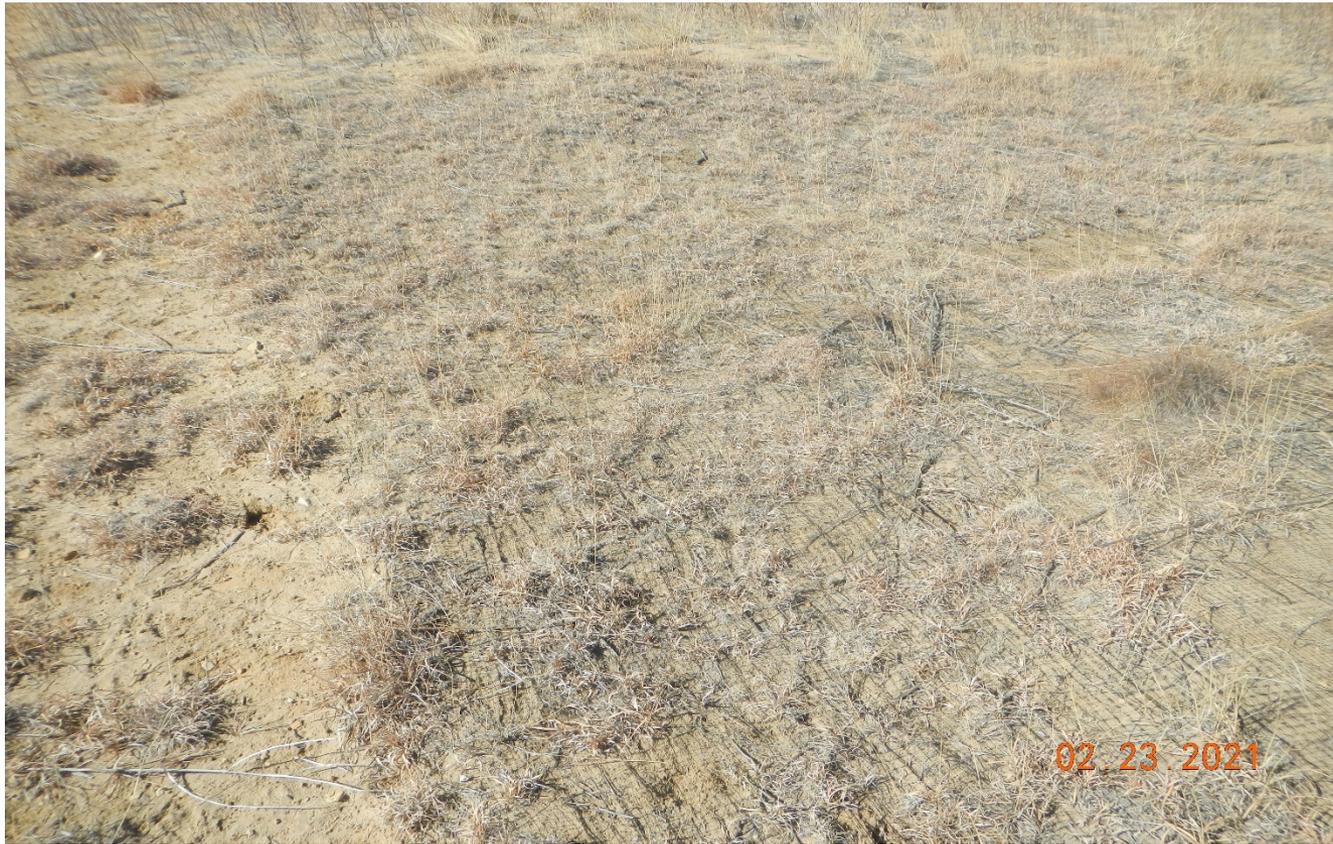
Photo 4. View of groundcover where blanket was installed.

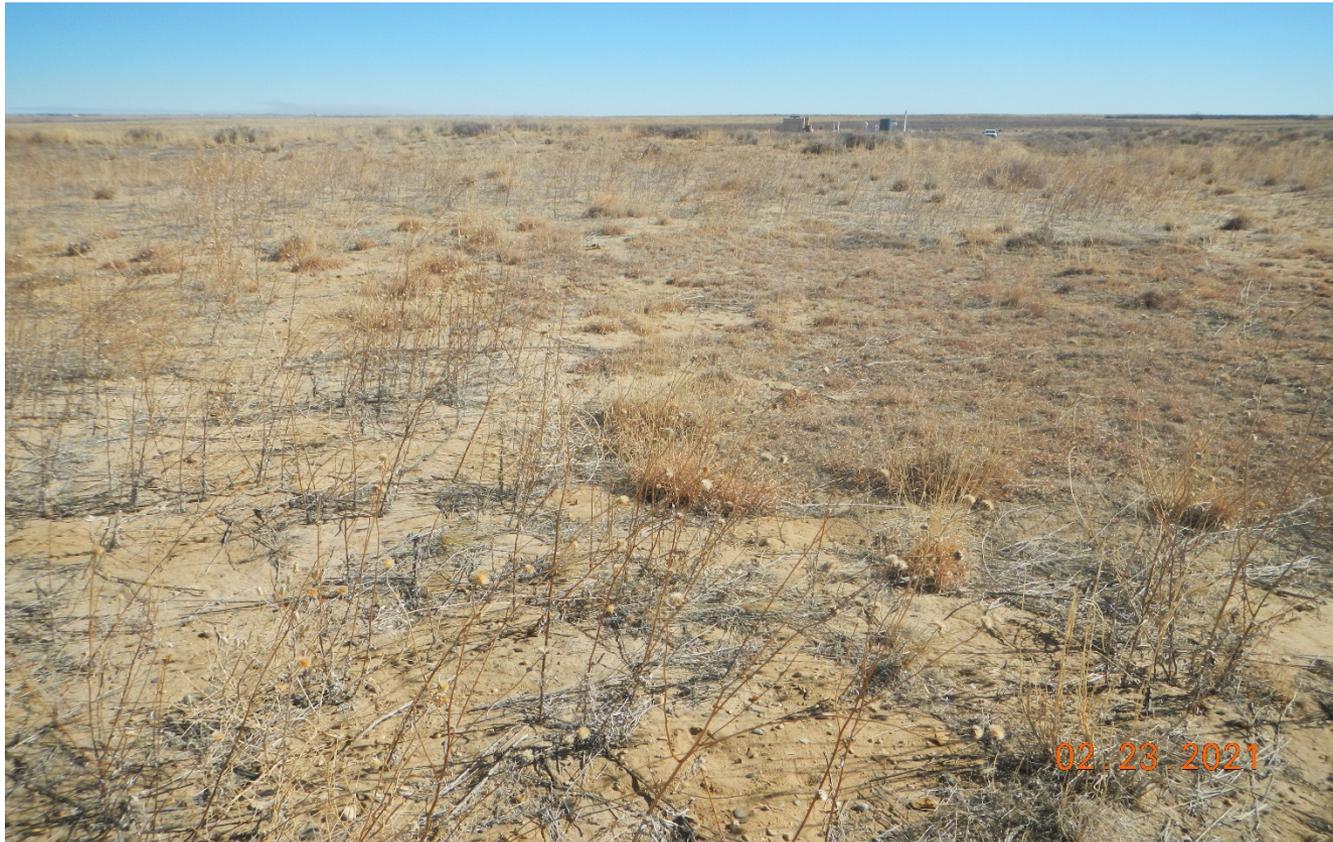
Photo 5. Facing east at the location.

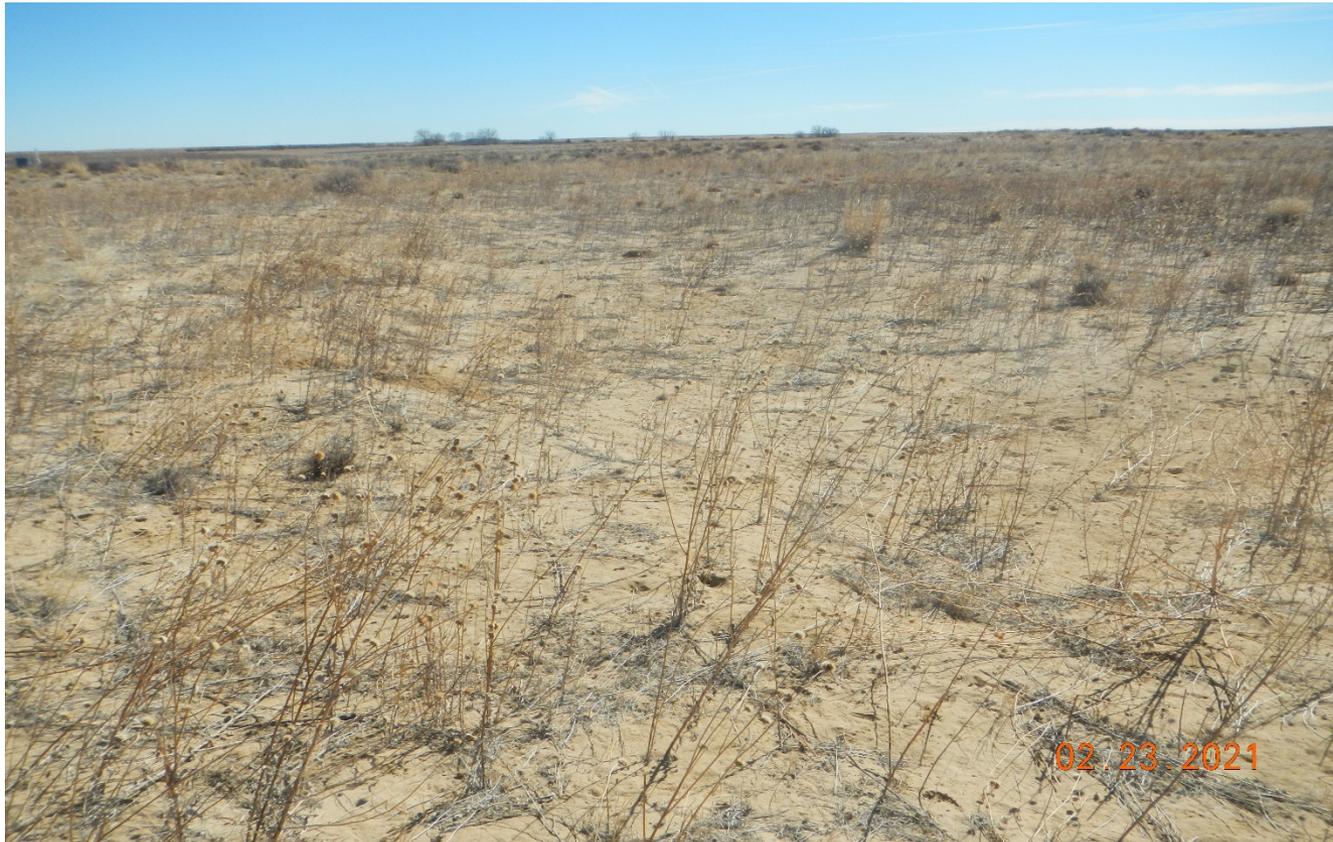
Photo 6. Facing southeast at the location.

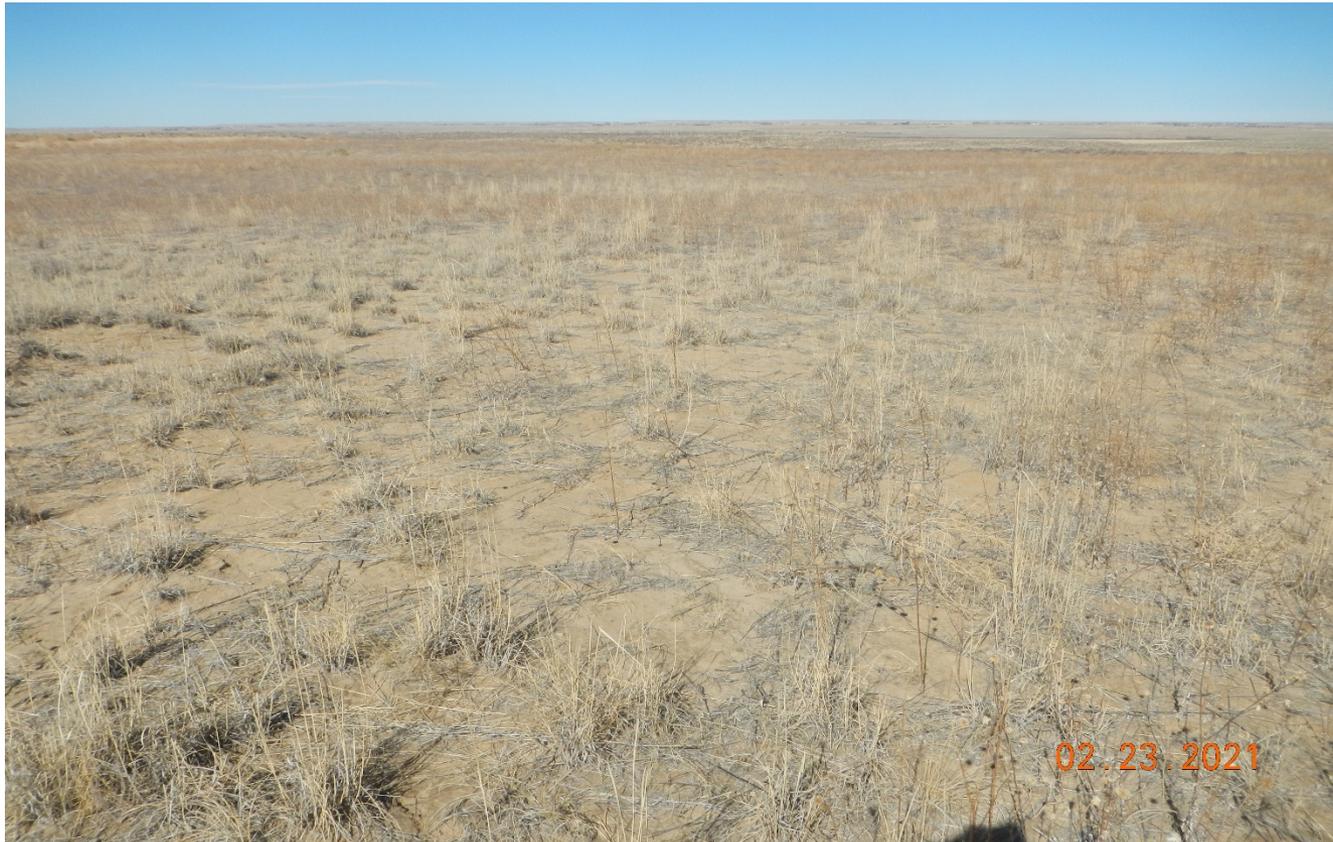
Photo 7. Facing north toward the surrounding undisturbed area.
