Inspection Photos

API: 011-06024

Operator: OXY USA INC

Inspection Date: 2/23/2021

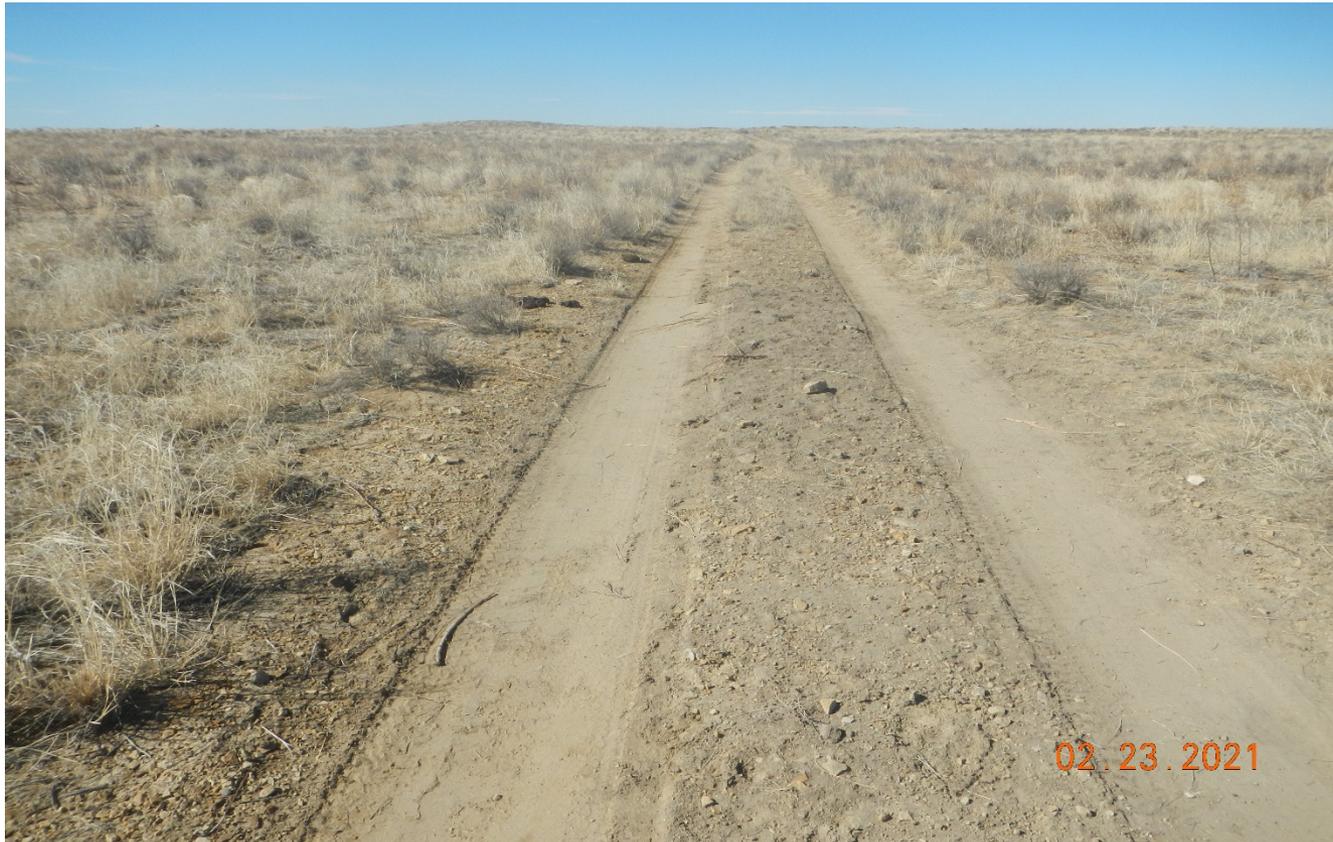
Photo 1. Facing west toward the access road which has not been reclaimed. It appears topsoil has been spread along the road and at areas of the location.

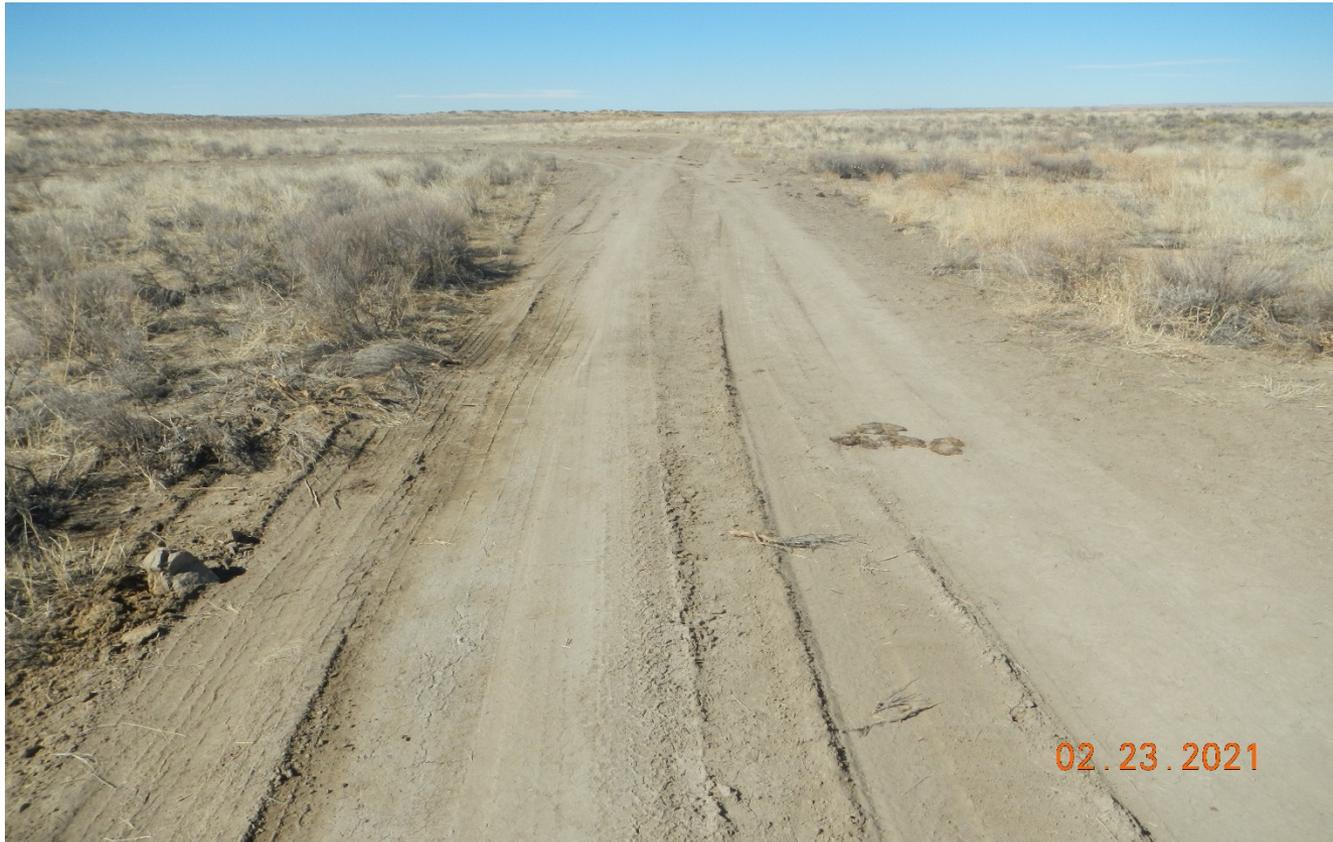
Photo 2. Facing west toward the access road near the location. It appears topsoil has been spread along the road and at areas of the location.

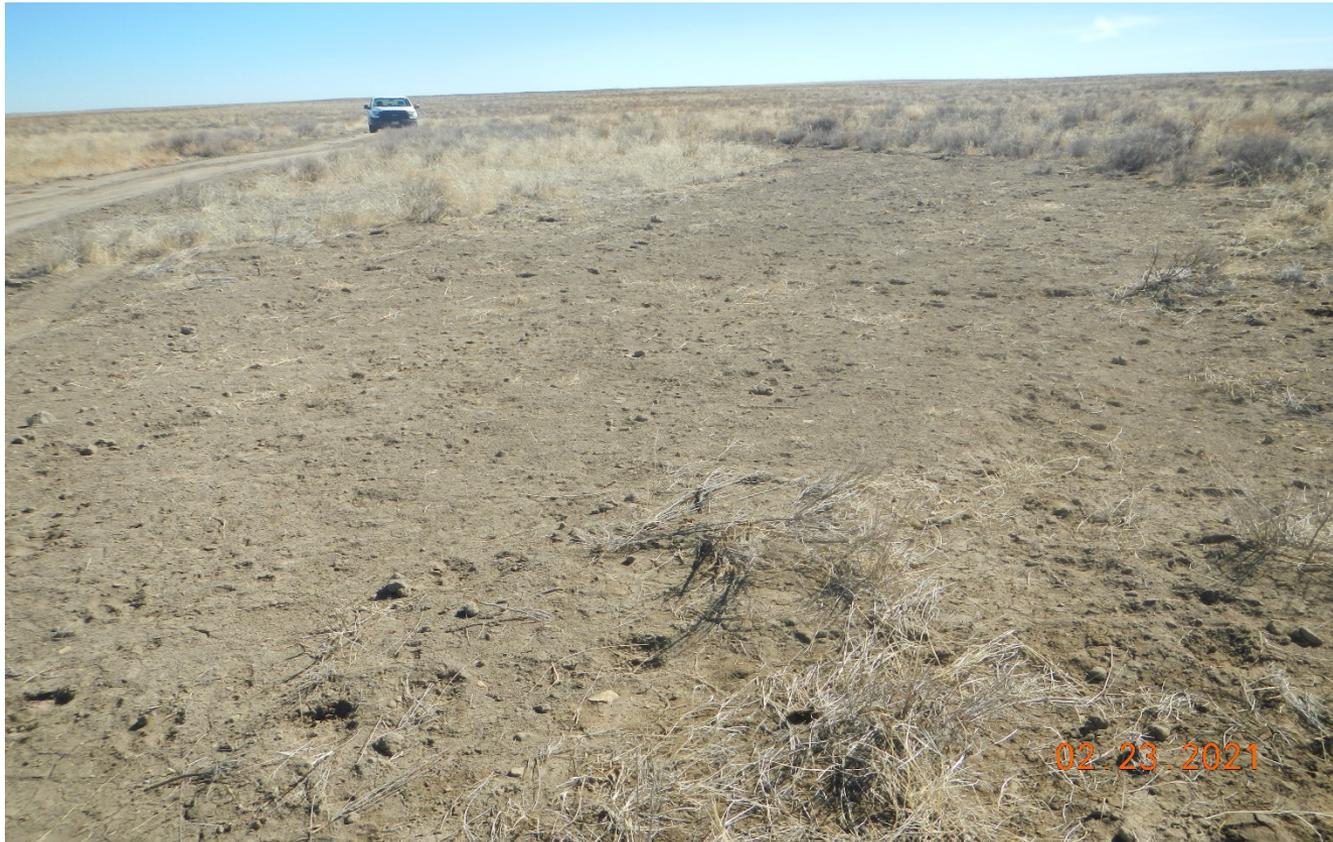
Photo 3. Facing east at the location where topsoil has been spread out.

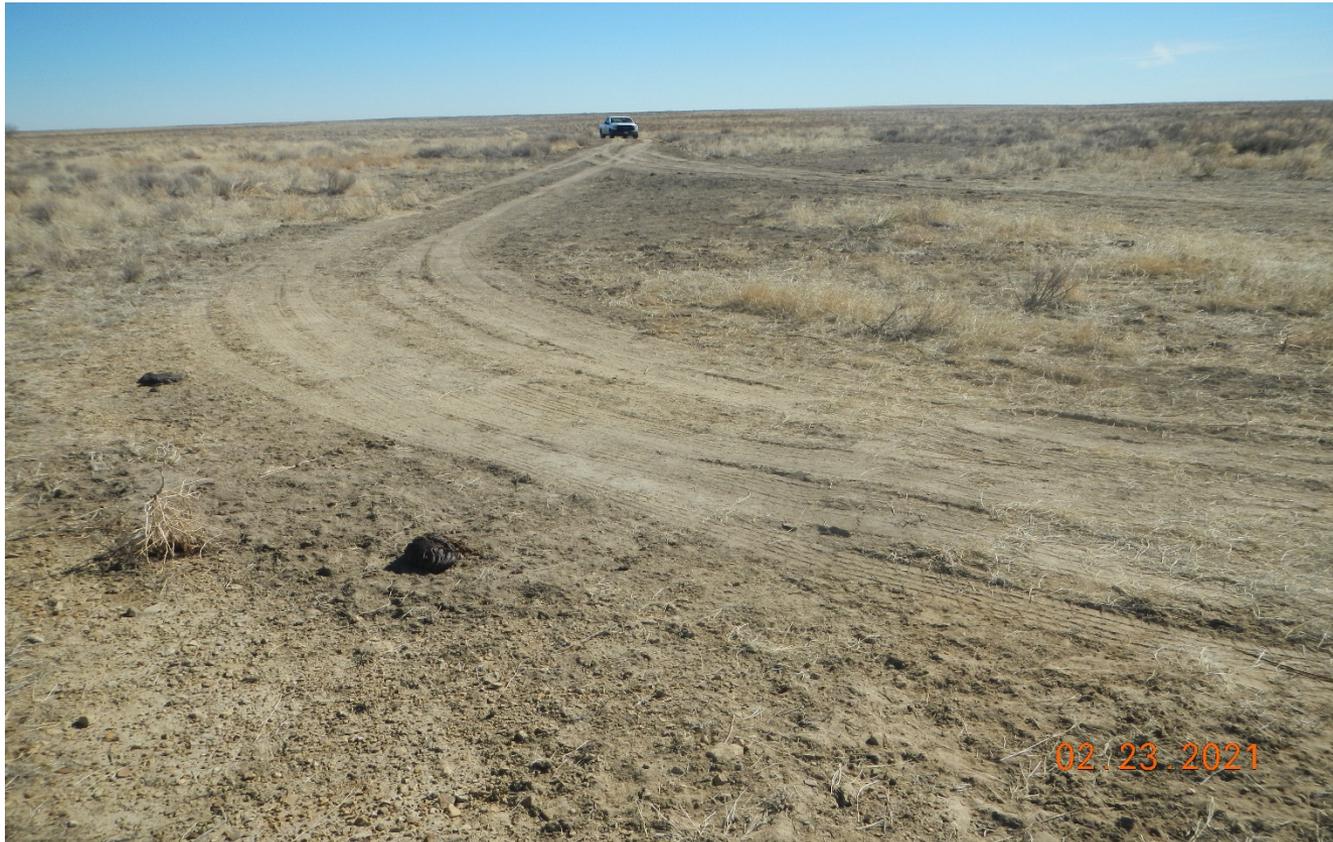
Photo 4. Facing east at the location. Trucks have hauled in topsoil to the location.

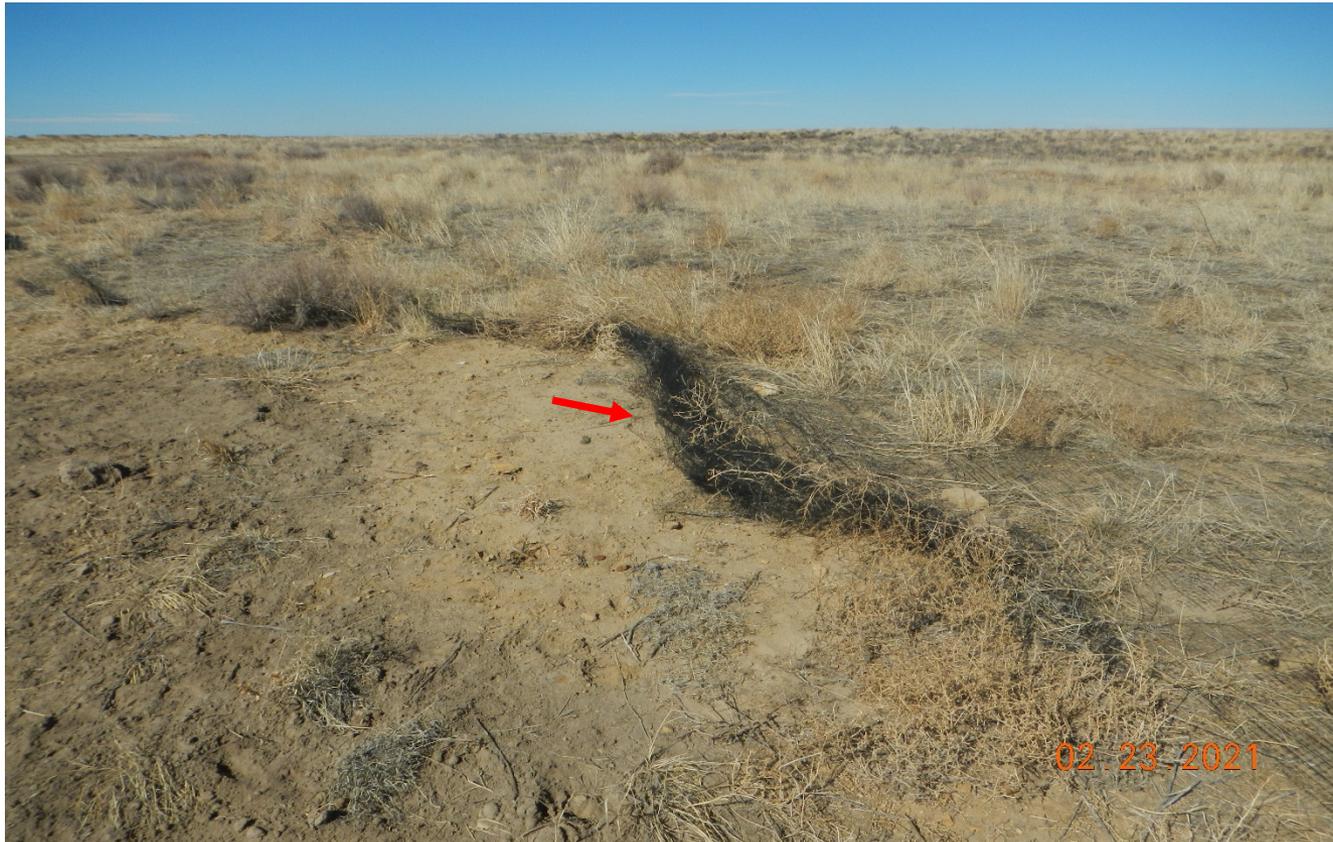
Photo 5. Facing northwest at the location where reclamation was previously performed. The plastic netting from the blanket is bunched up in areas and should be cut and removed without pulling up the vegetation.

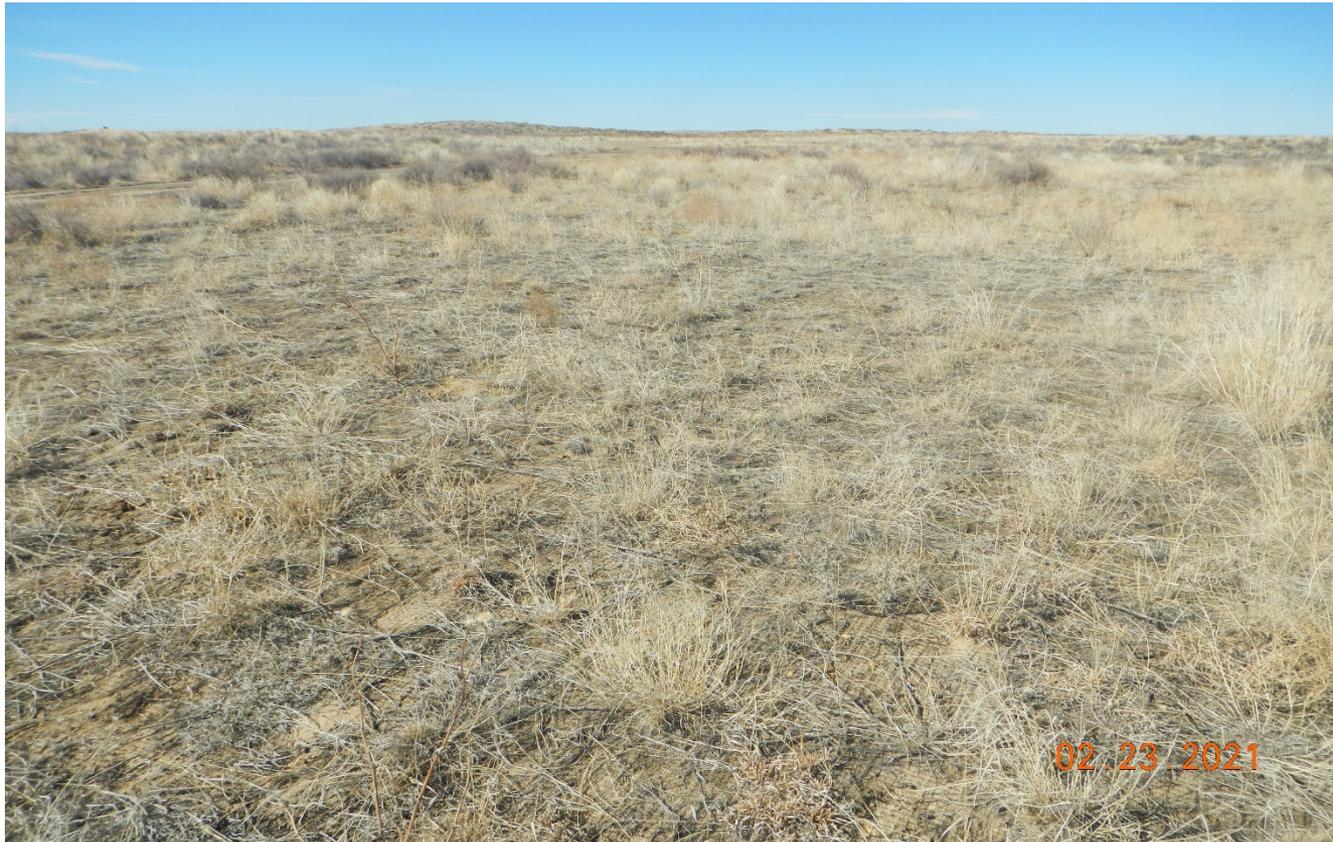
Photo 6. Facing southwest at the location. Vegetation has grown in very well where straw blanket was installed in this area.
