Inspection Photos

API: 011-06036

Operator: OXY USA INC

Inspection Date: 2/23/2021

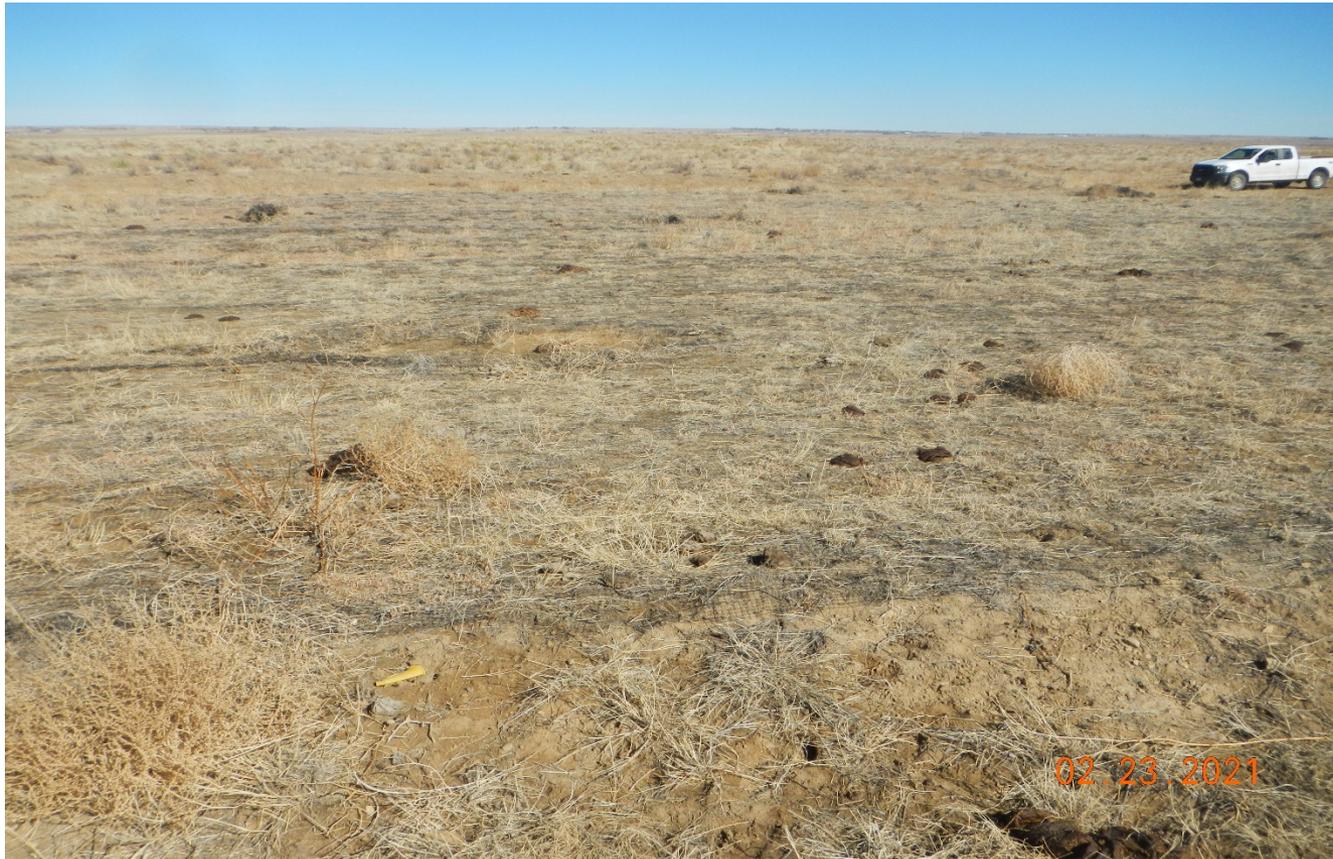
Photo 1. Facing northeast toward the location. Straw blanket was installed on most of the location. Vegetation has grown in very well where straw blanket was installed in this area.

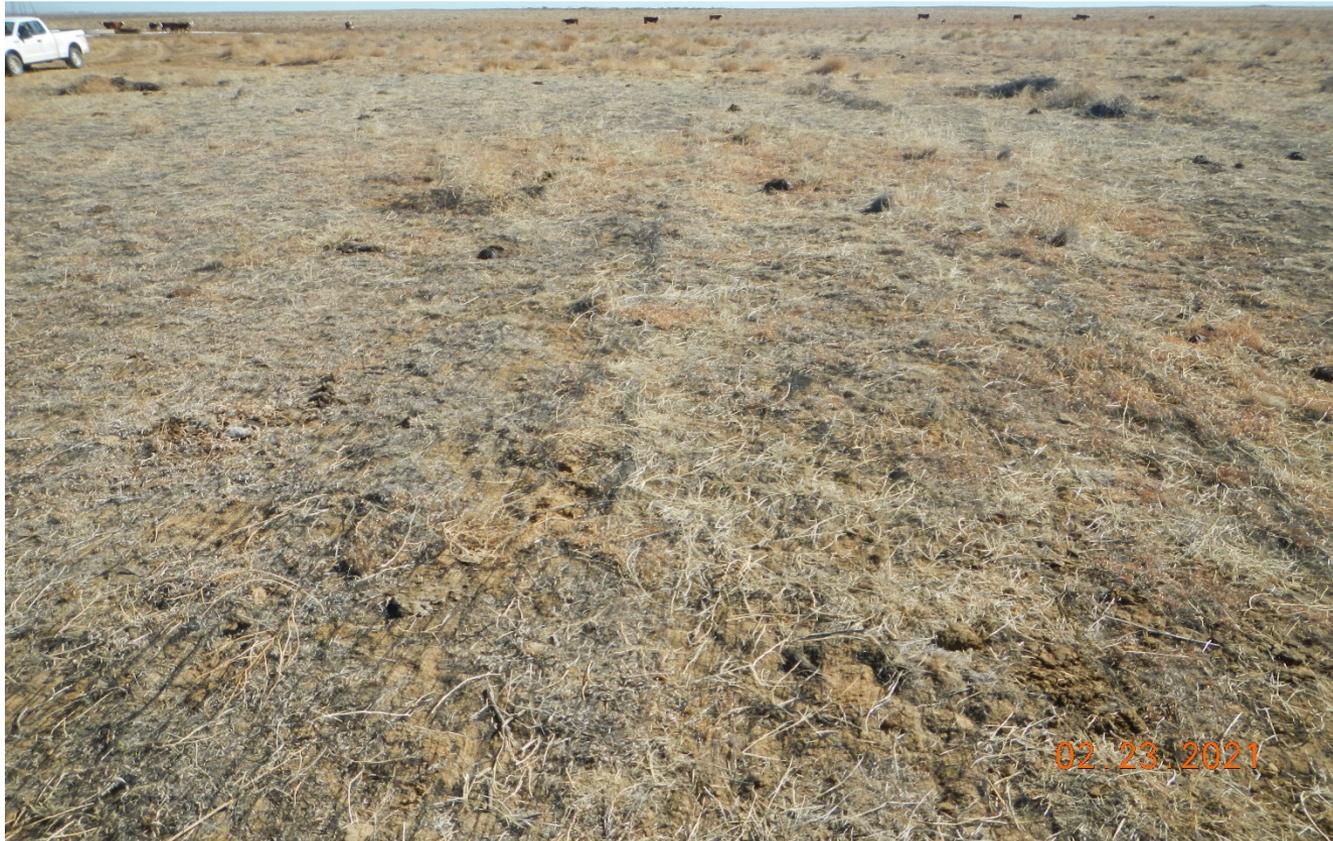
Photo 2. View of vegetation cover where straw blanket was installed.

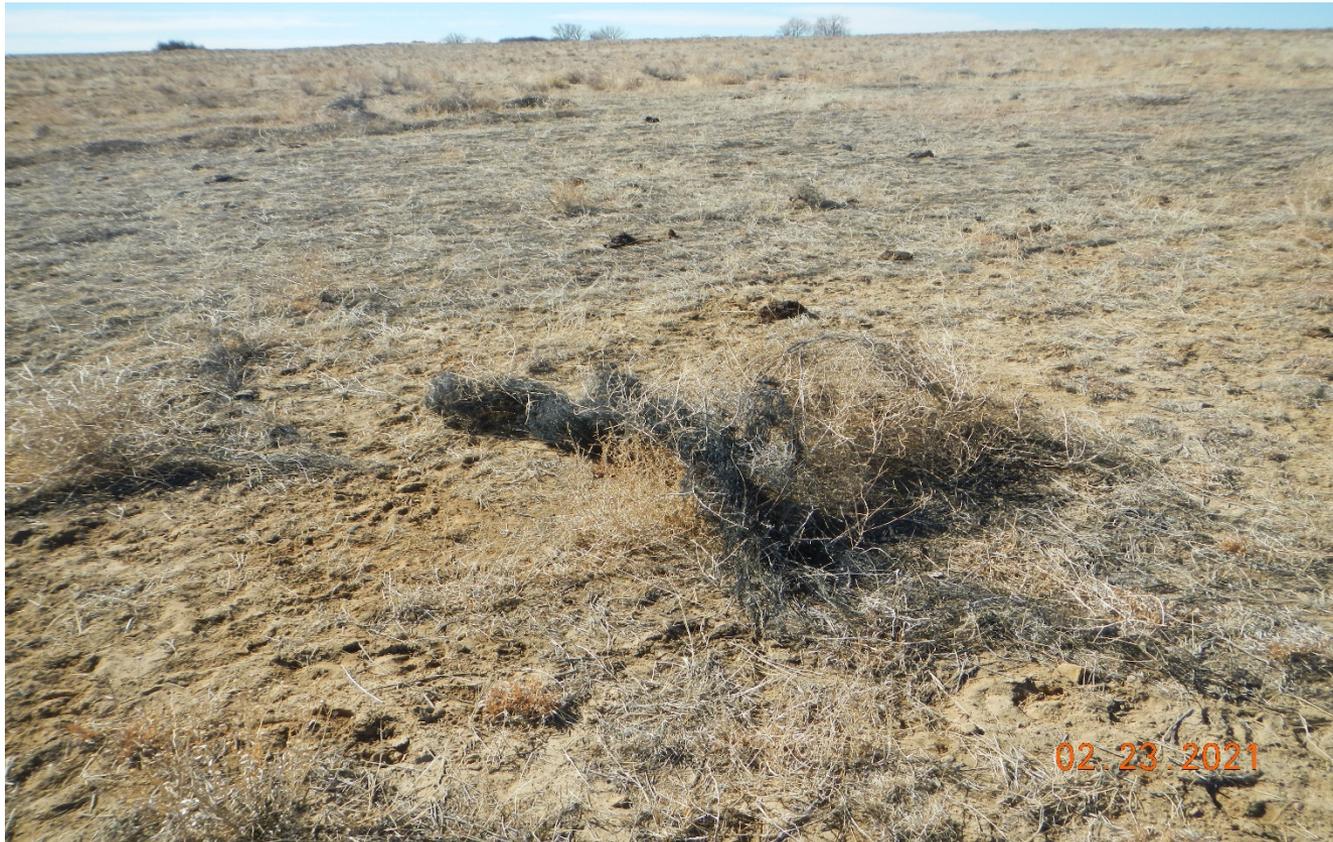
Photo 4. The plastic netting from the blanket is bunched up in areas and should be cut and removed without pulling up the vegetation.
