# Inspection Photos

API: 099-06868

Operator: LAMAR OIL & GAS EXPLORATION

Inspection Date: 2/23/2021

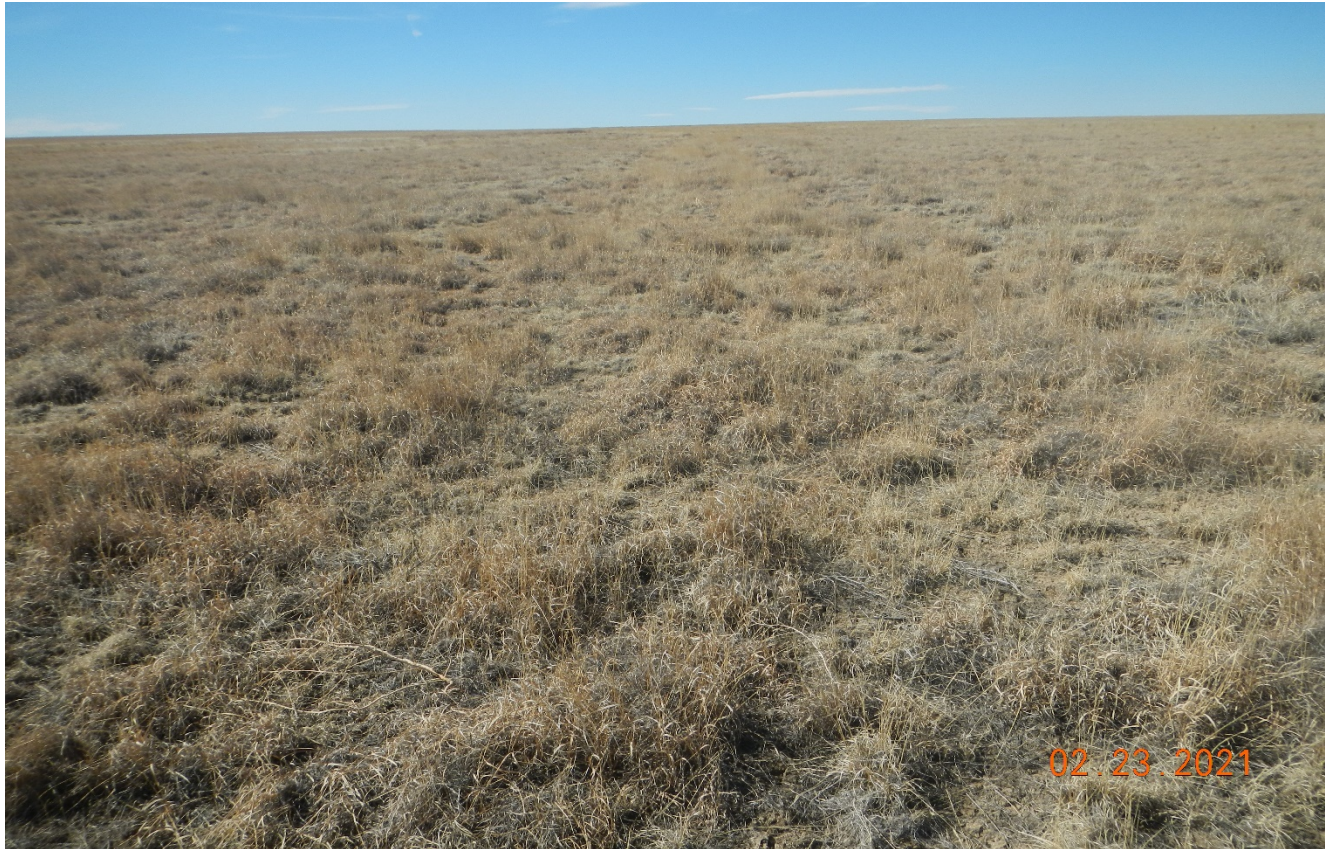
**Photo 1.** Facing west toward the reclaimed access road. Vegetation has uniformly re-established.

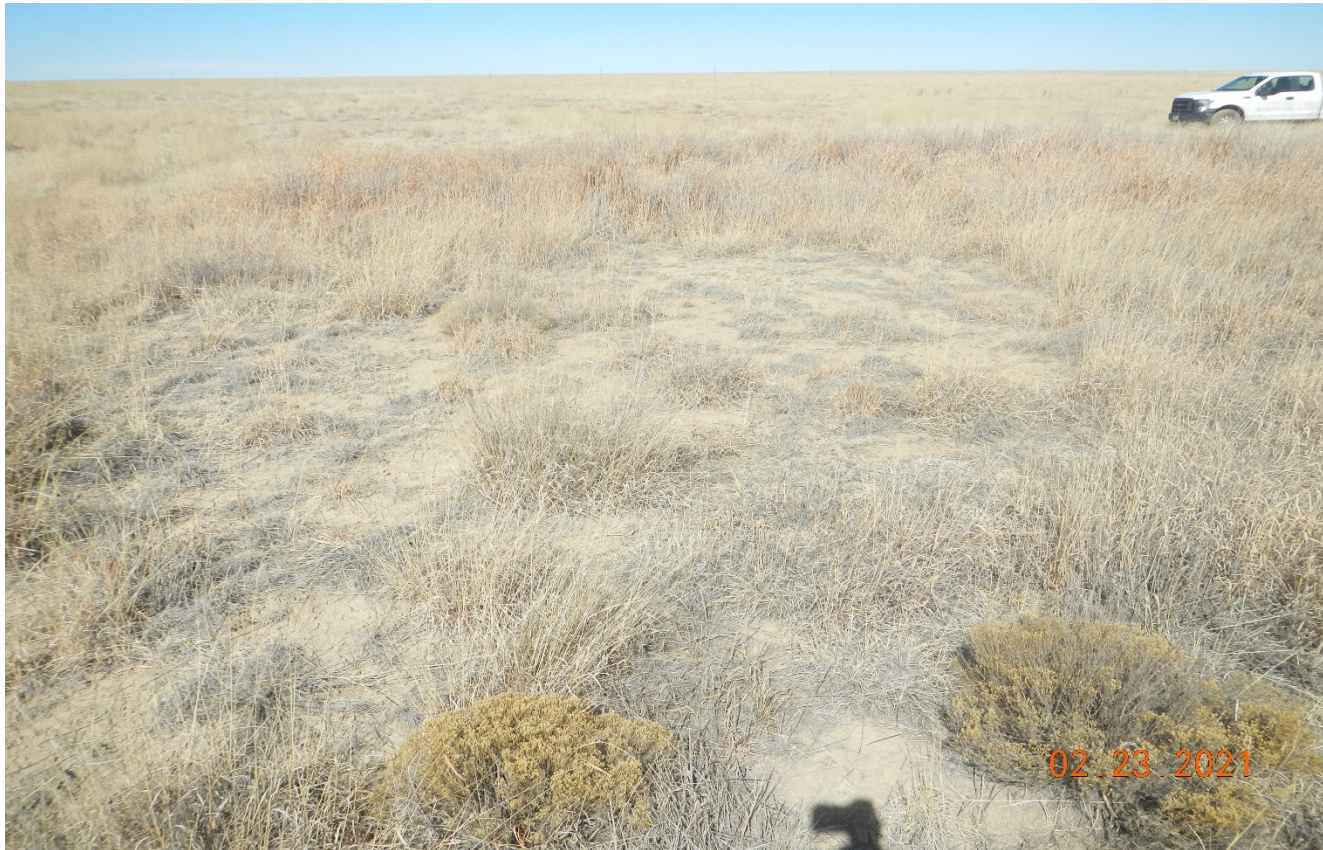
**Photo 2.** Facing north at the center of the location.

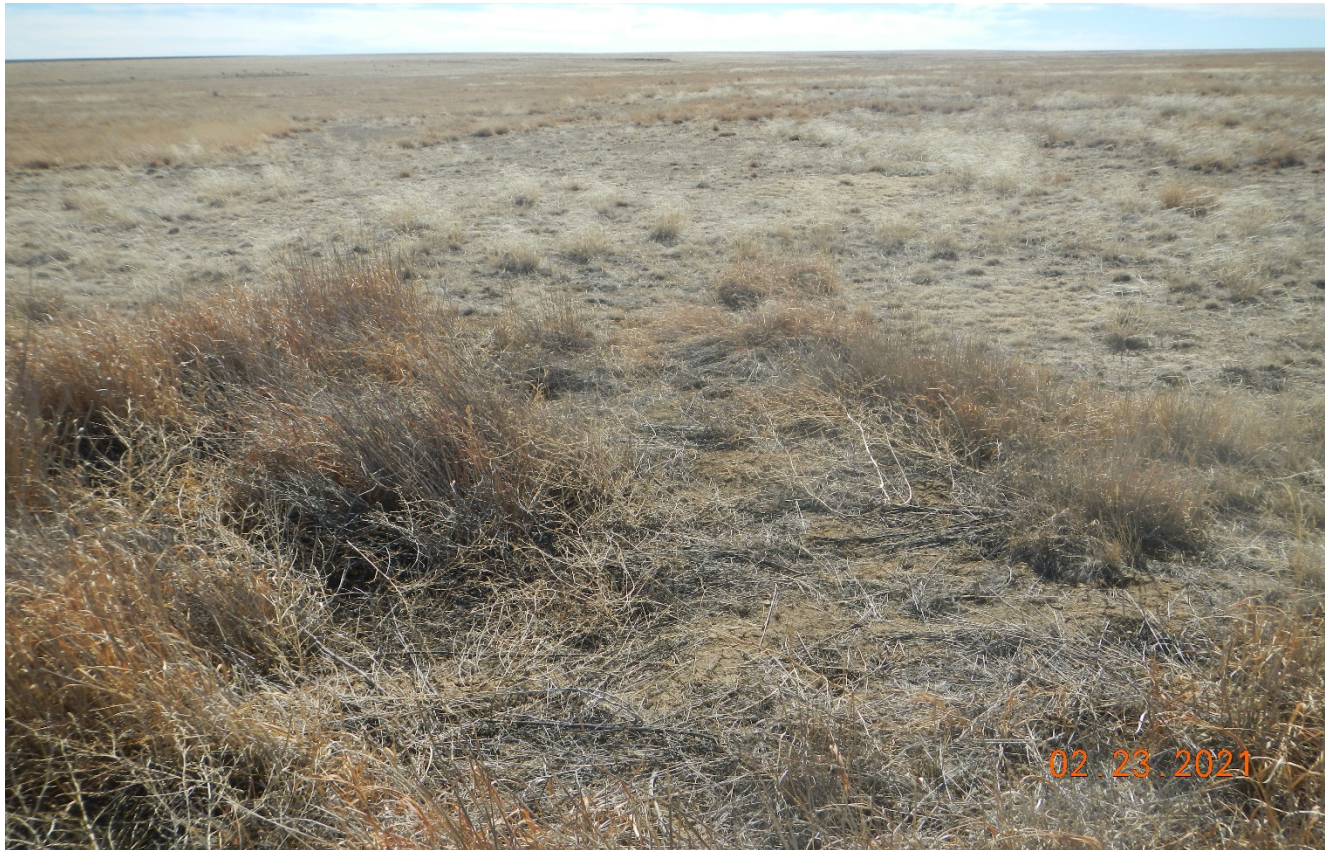
**Photo 3.** Facing south at the center of the location.

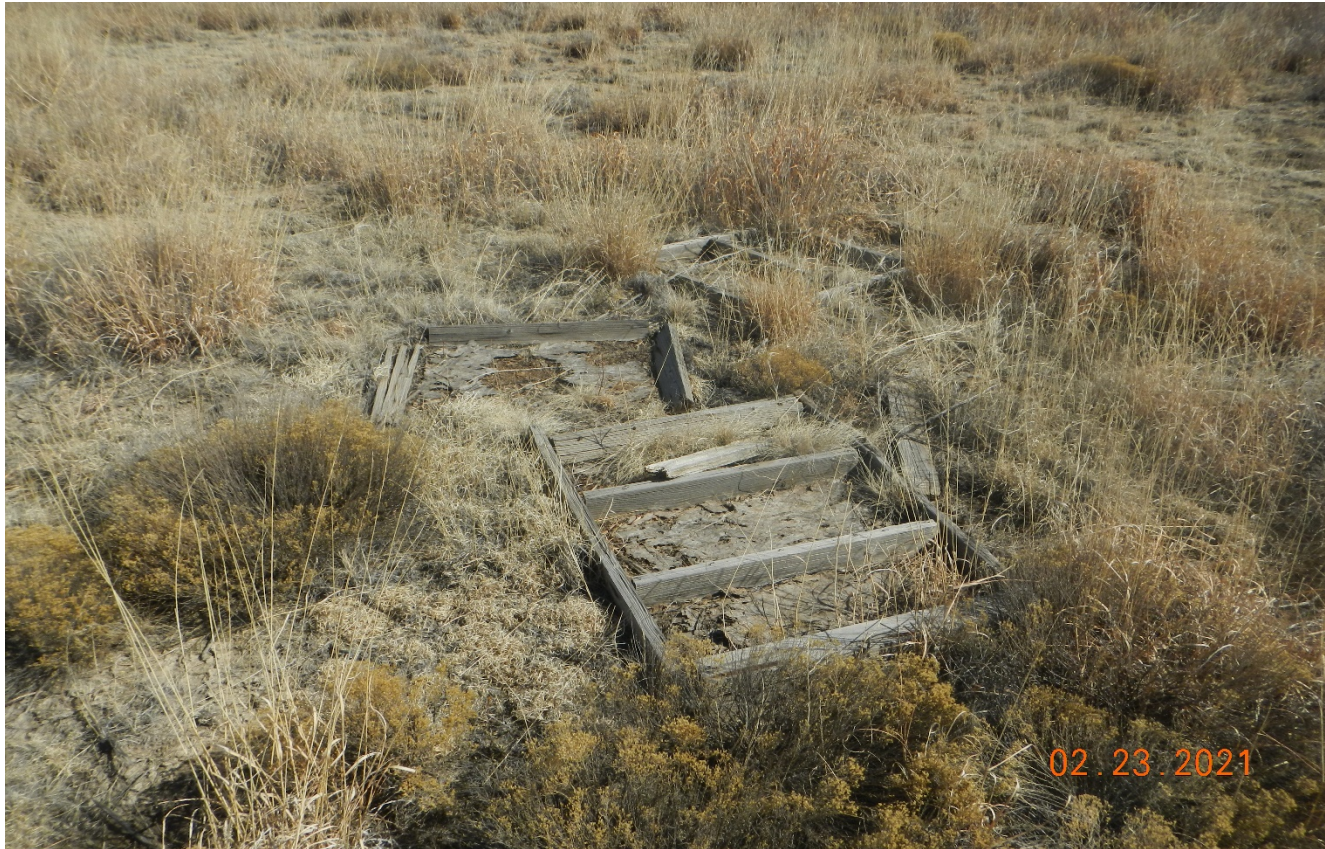
**Photo 4.** Plywood debris has not been removed.

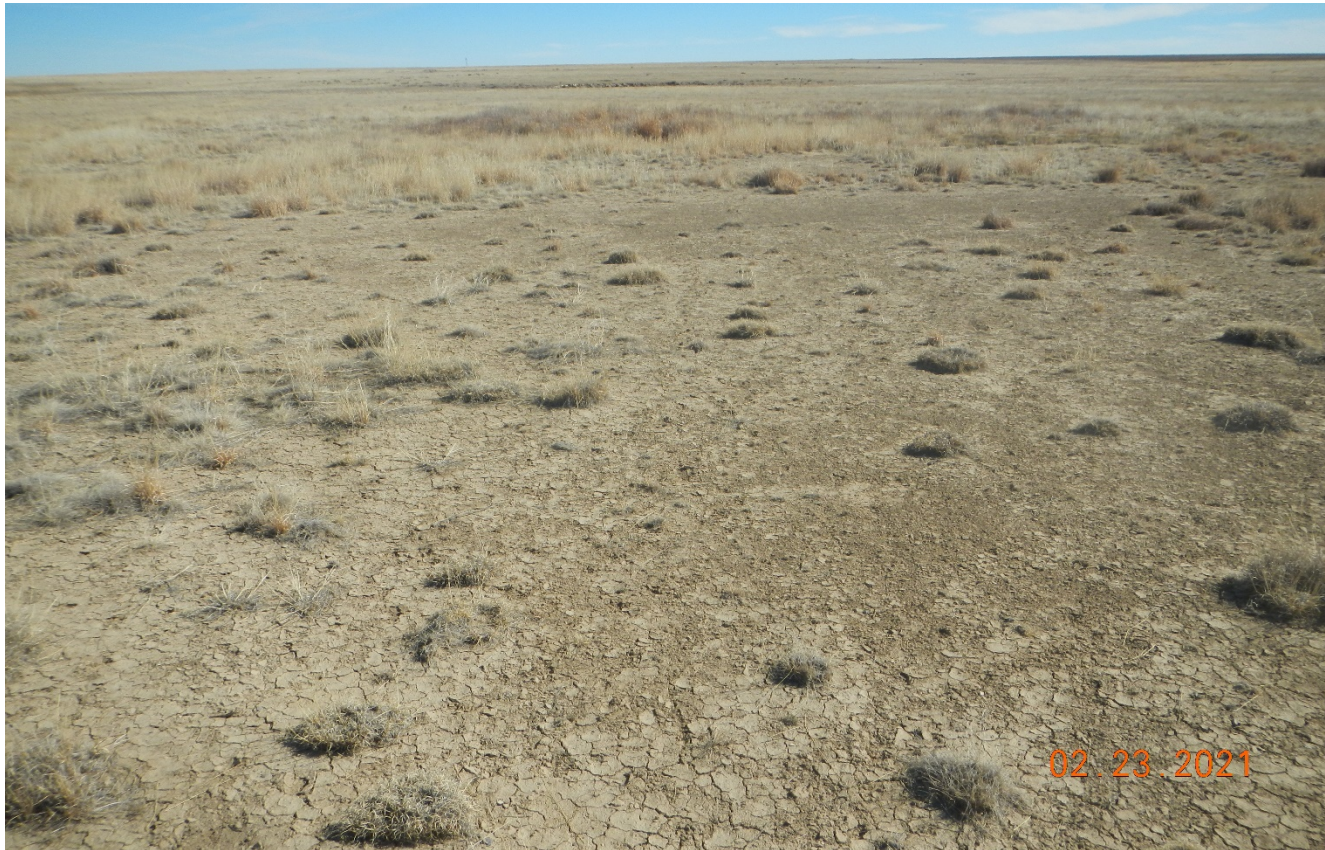
**Photo 5.** Facing east at the north side of the location. This area has not established vegetation.

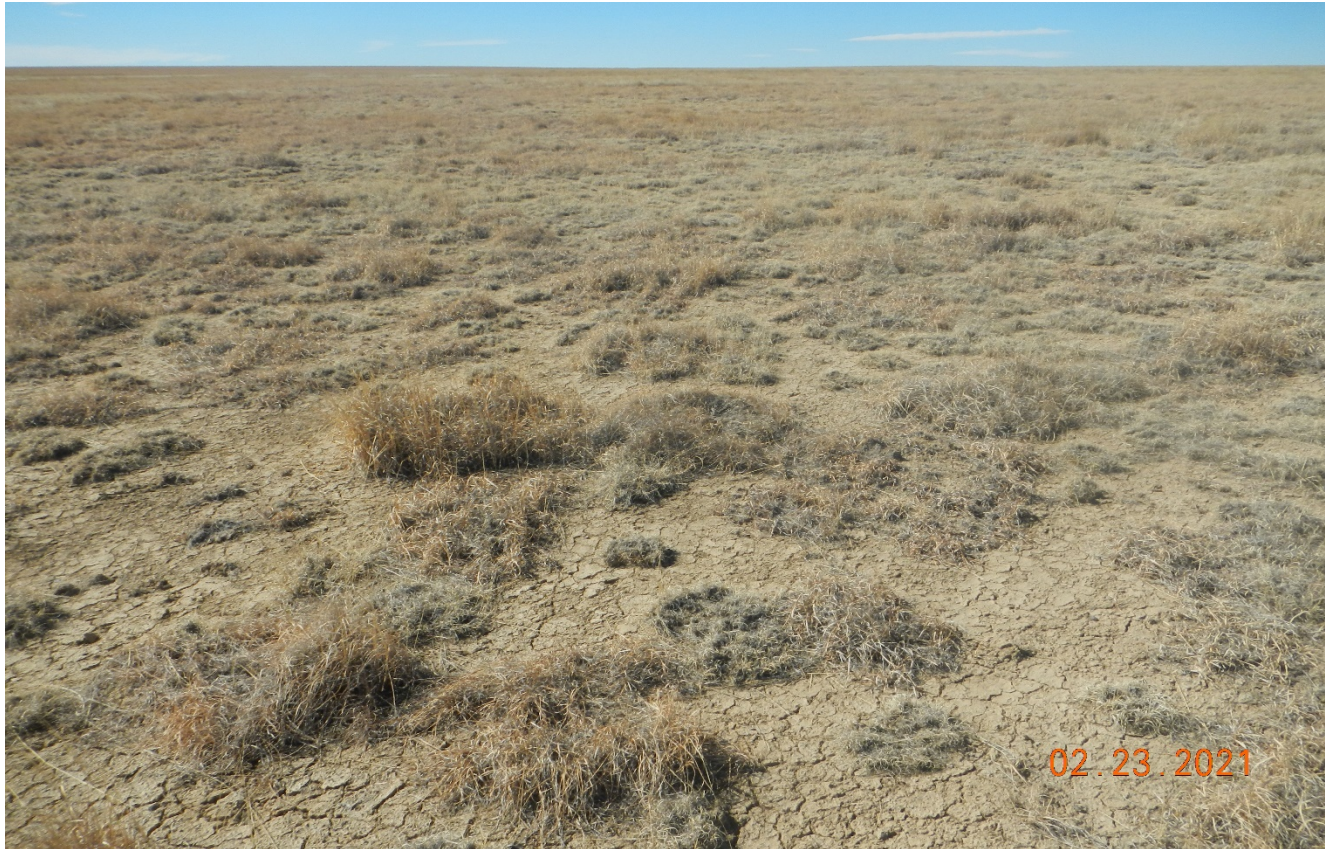
**Photo 6.** Facing west toward the surrounding undisturbed area.
