Inspection Photos

API: 099-06285

Operator: LAMAR OIL & GAS EXPLORATION

Inspection Date: 2/23/2021

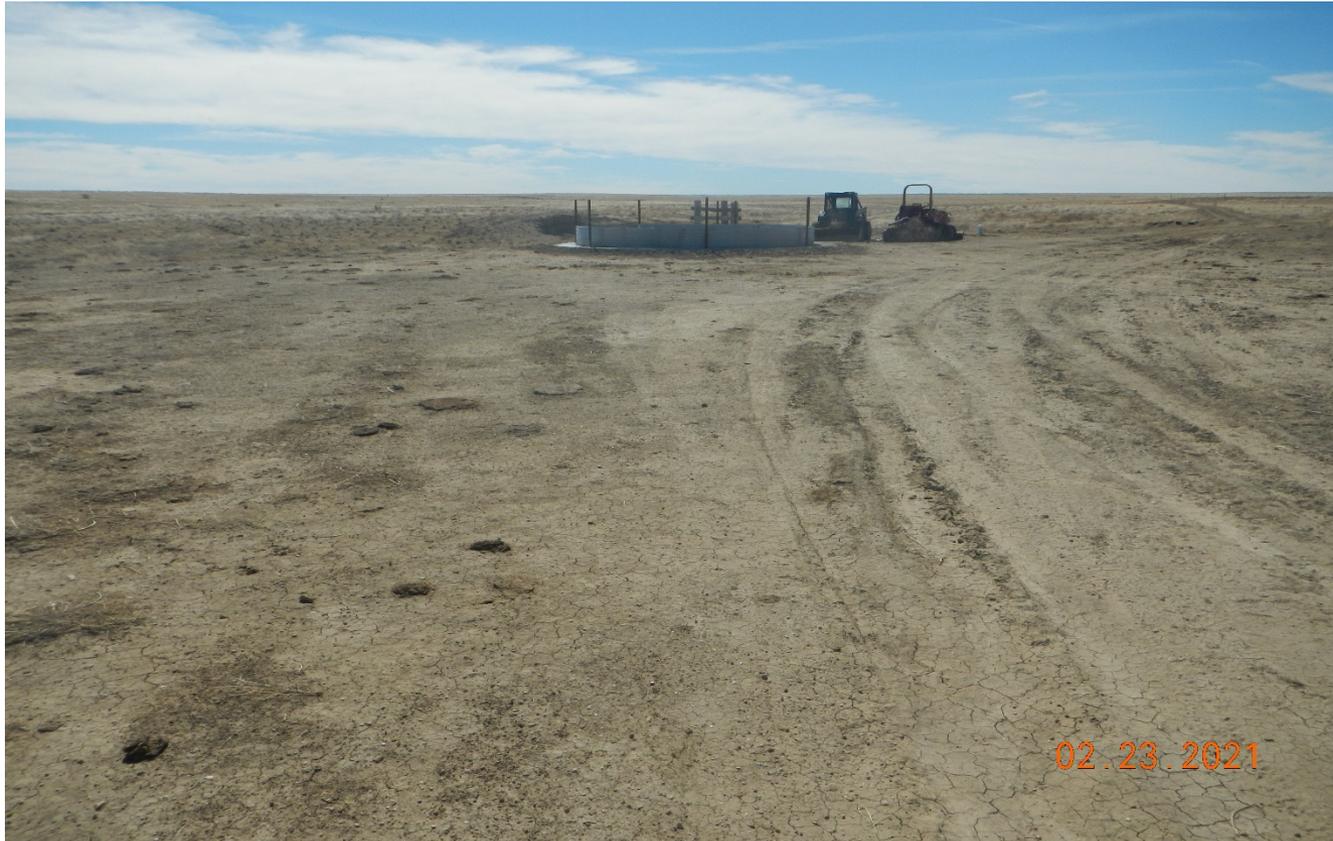
Photo 1. Facing south toward the location. A water tank has been installed at the south side of the location. There appears to be no attempt to perform reclamation.

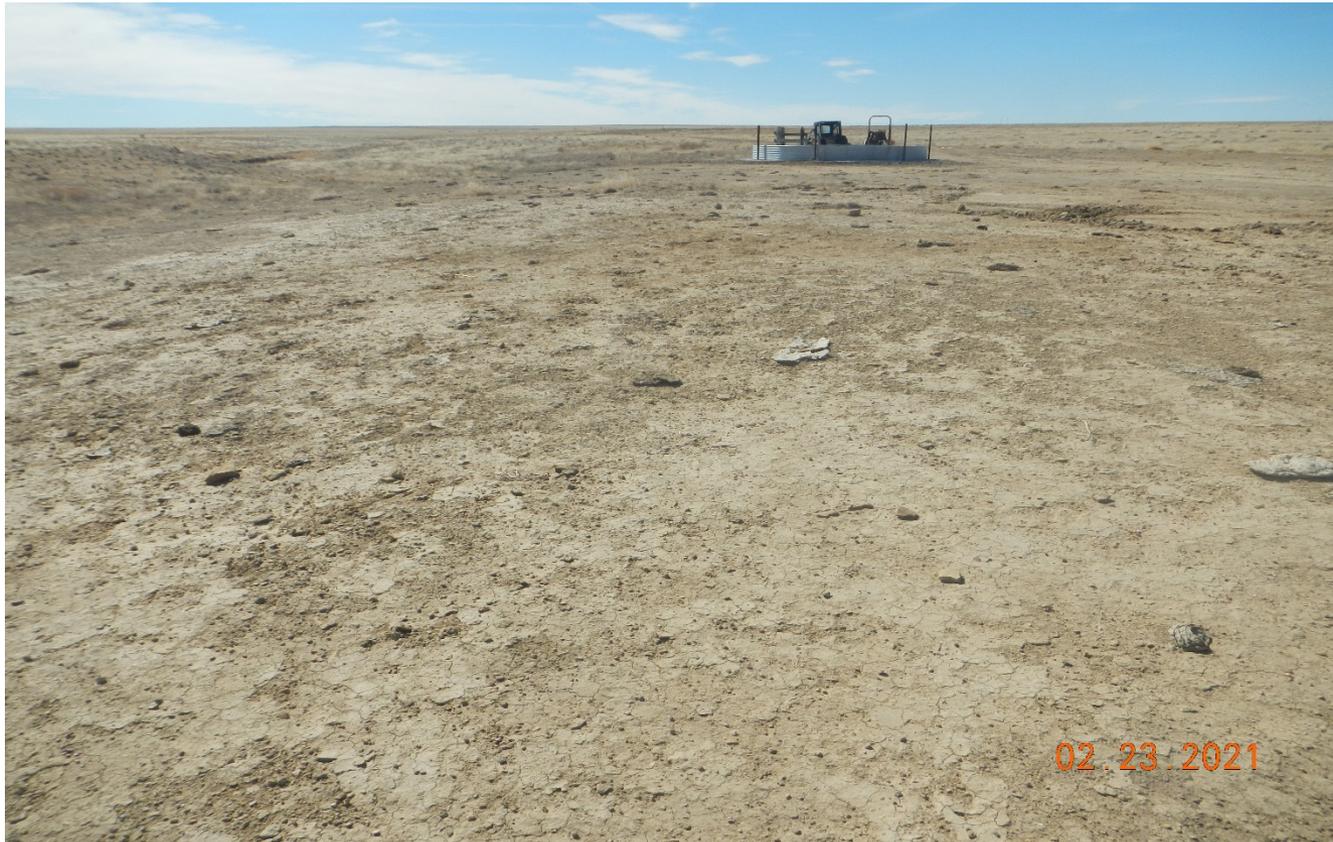
Photo 2. Facing south at east side of the location. This is where the tank battery was location. This area has not been recontoured and reclaimed.

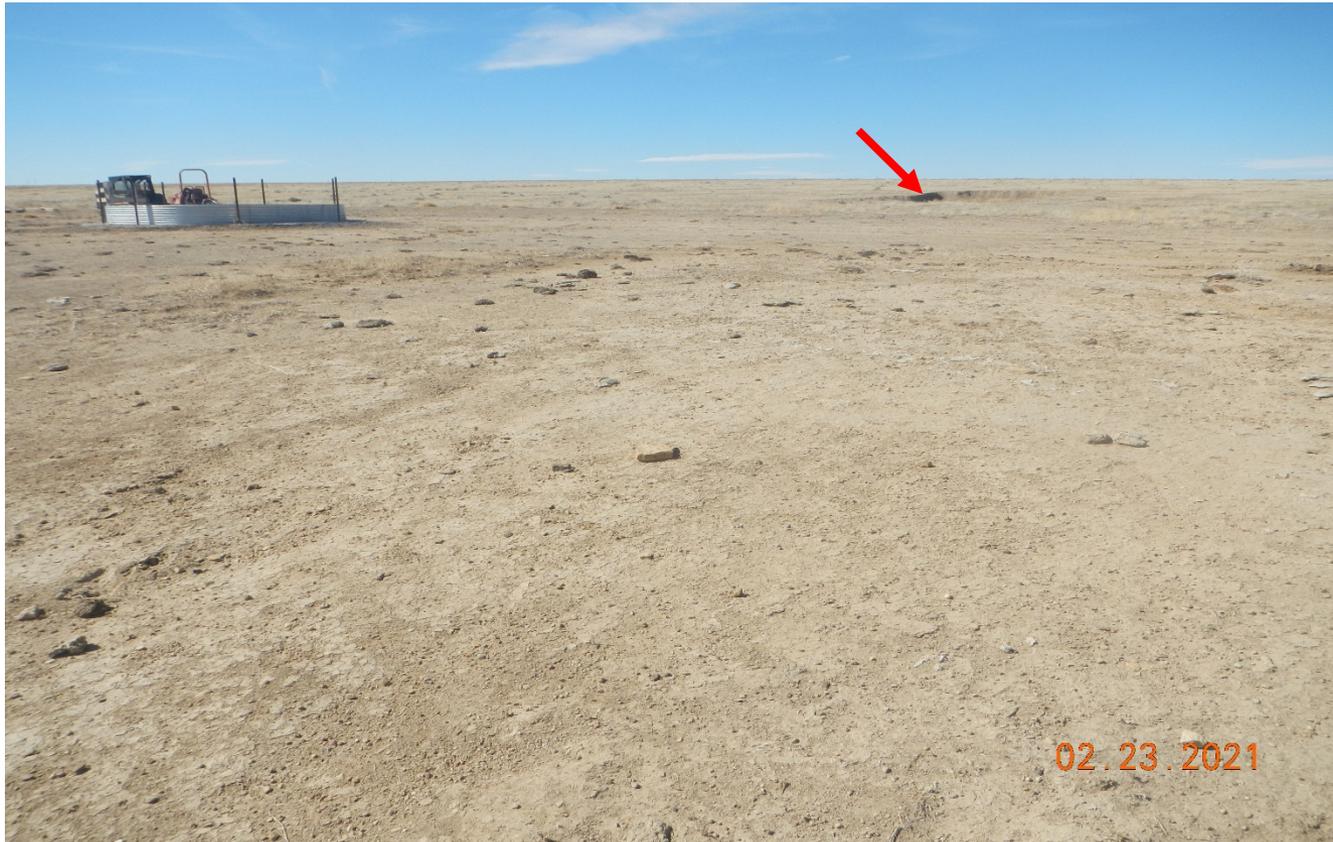
Photo 3. Facing west at the location. There is an excavated area shown at red arrow. Material will need to be recontoured to this area.

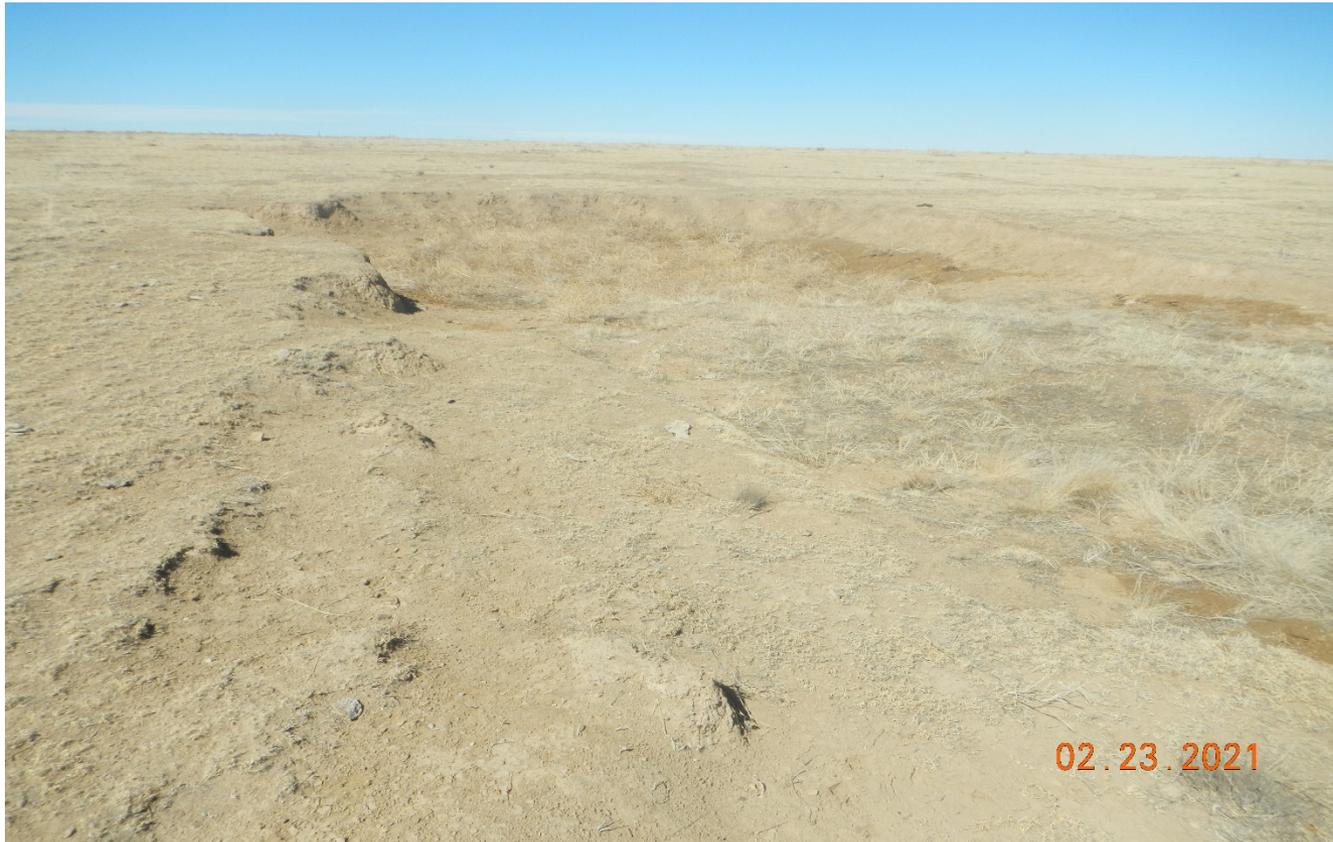
Photo 4. Facing toward the excavated area at the west side of the location.

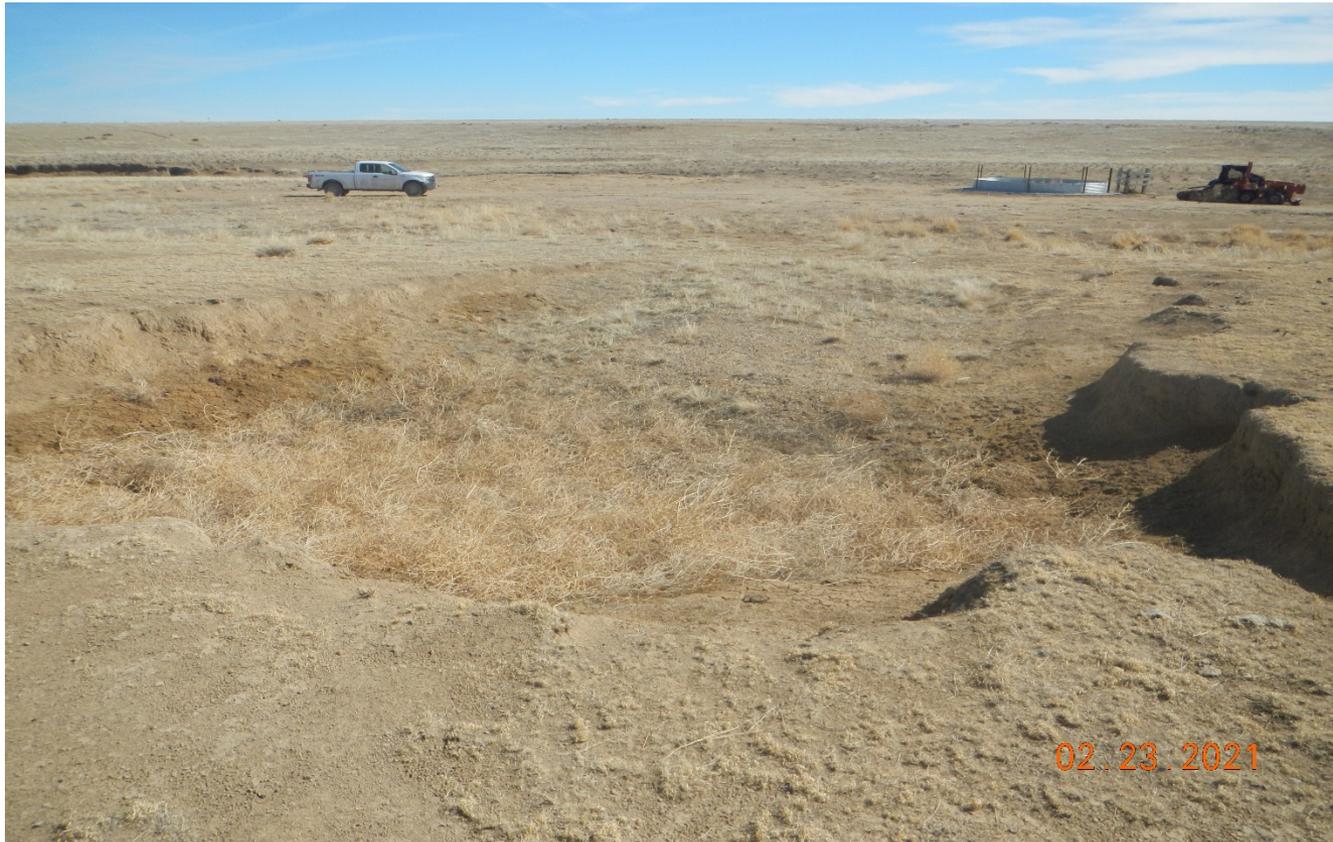
Photo 5. Facing east at the excavated area which needs to be recontoured and reclaimed.

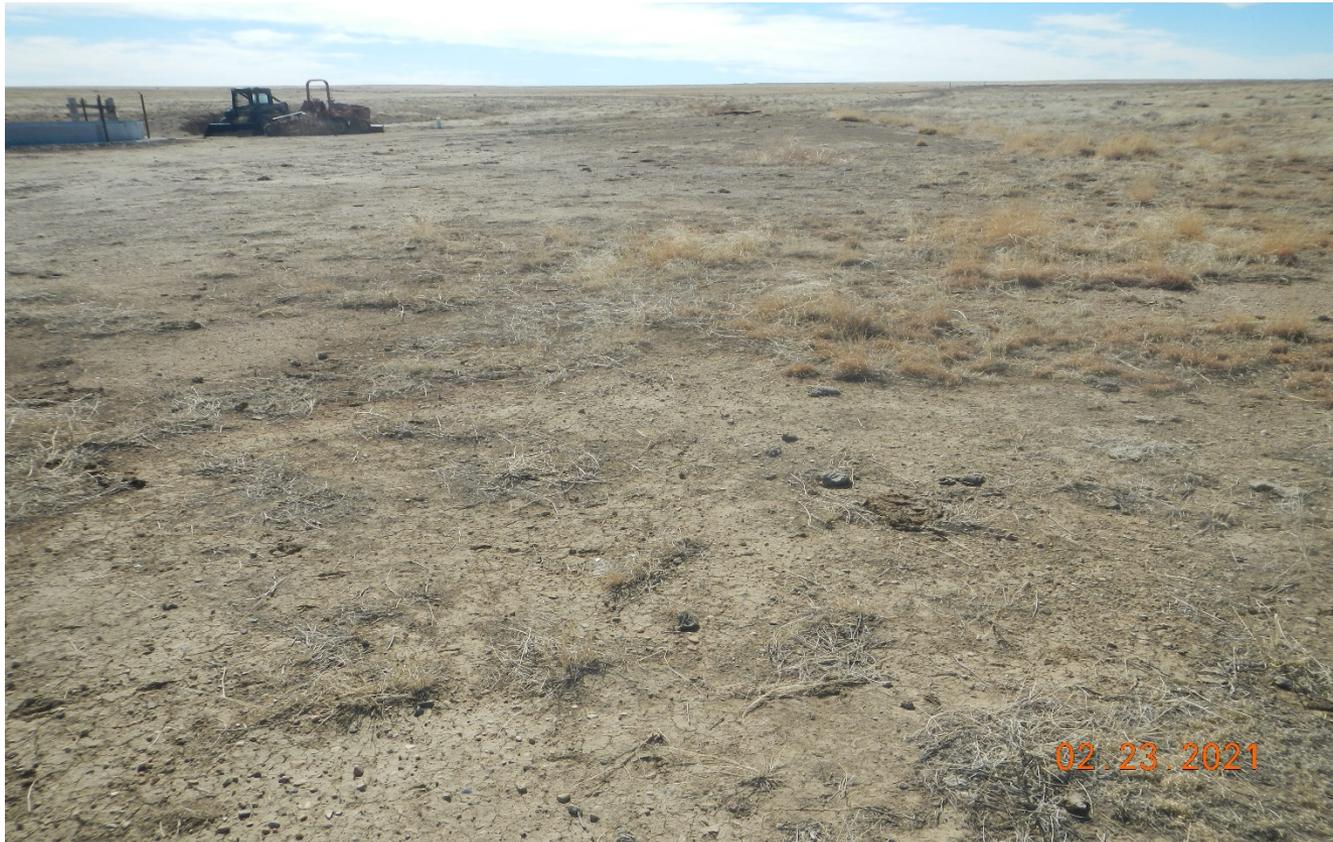
Photo 6. Areas of the location have not been reclaimed and vegetation has not established.

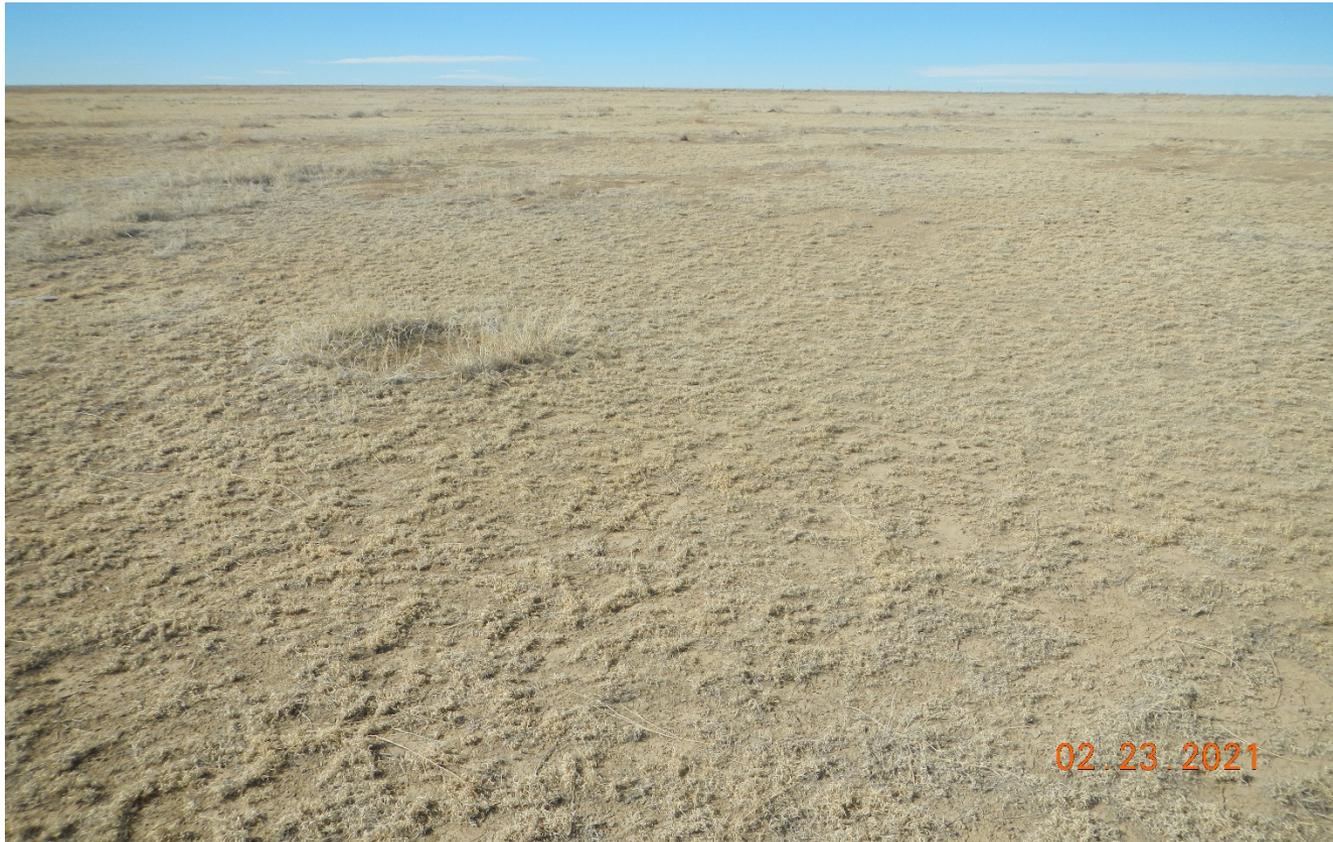
Photo 7. Facing west toward the surrounding undisturbed reference area.
