Inspection Photos

API: 099-06138

Operator: OXY USA INC

Inspection Date: 2/23/2021

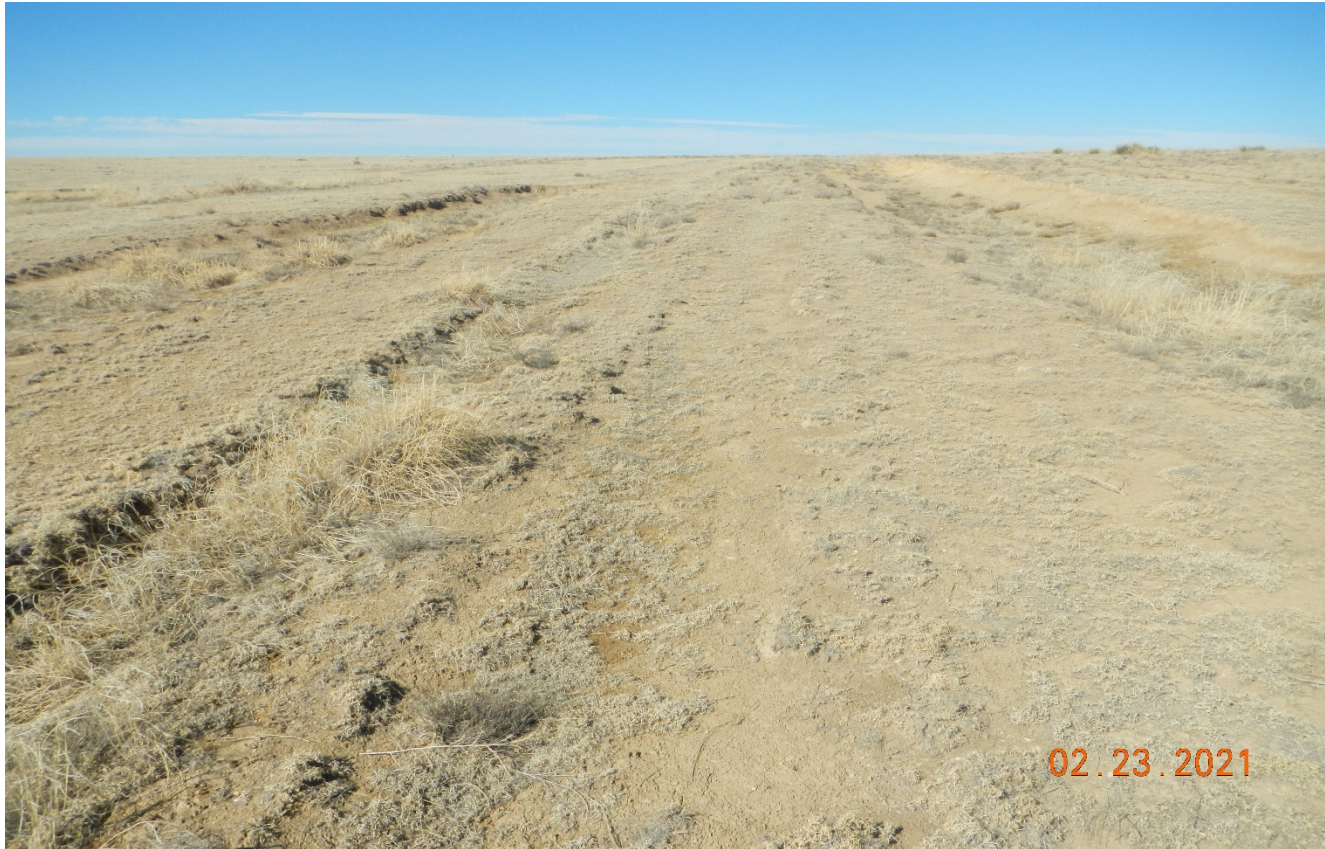
Photo 1. Facing north along the former access road at Lat/Long:37.87672,-102.72188. This area of the road has eroded and needs to be repaired and reclaimed.

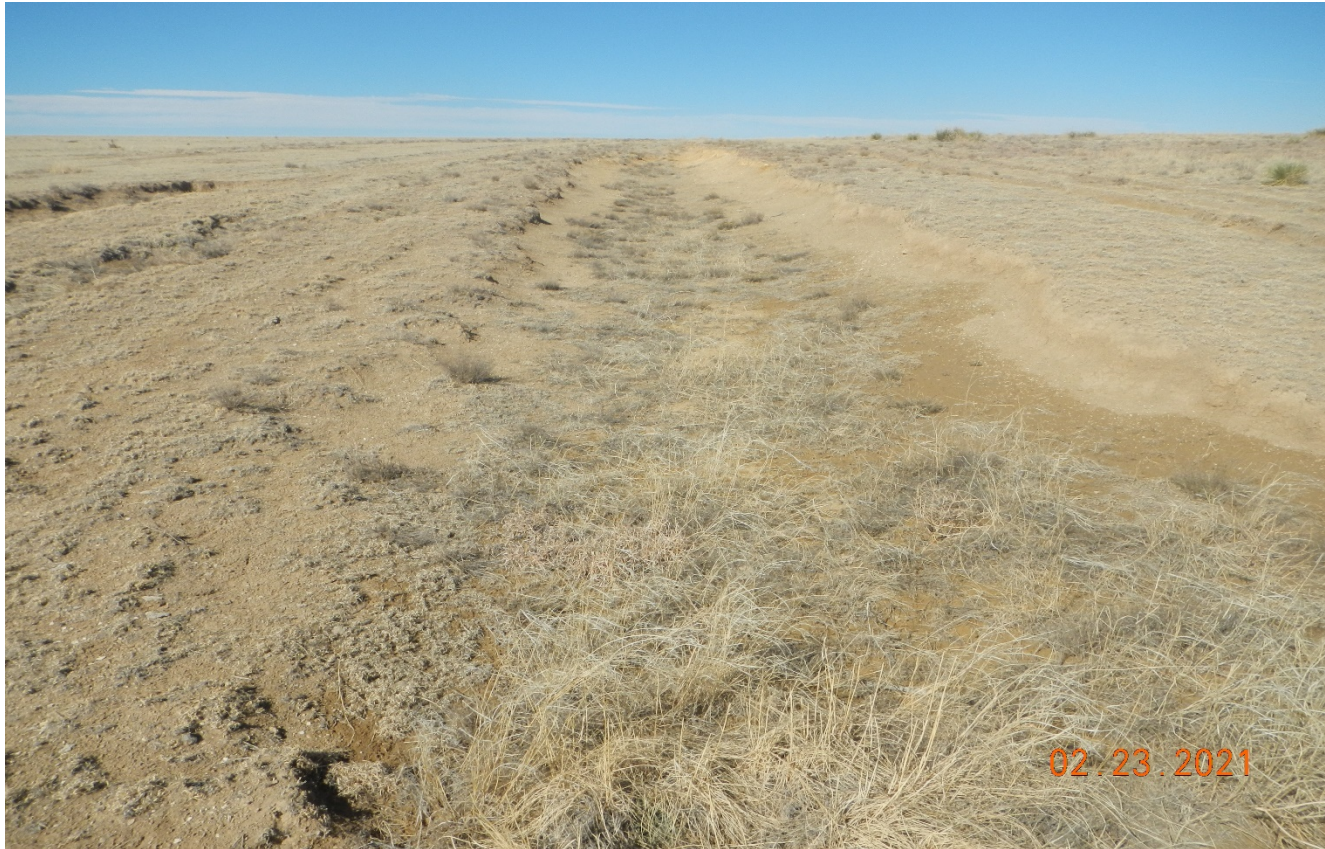
Photo 2. Facing north along the former access road at Lat/Long:37.87672,-102.72188. This area of the road has eroded and needs to be repaired and reclaimed.

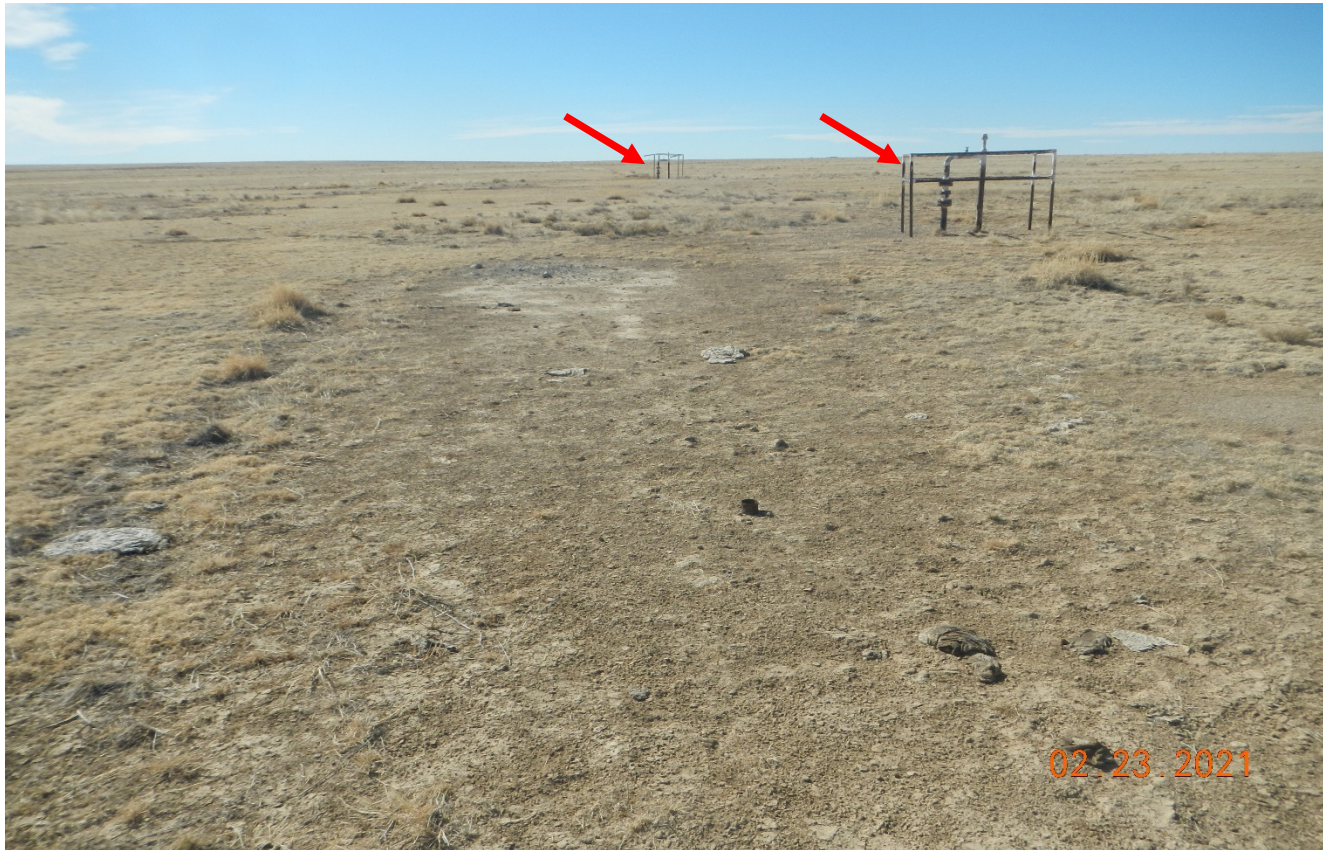
Photo 3. Facing west toward the location. There are two pipe risers that remain at the location shown at red arrows. Vegetation has not re-established near the risers.

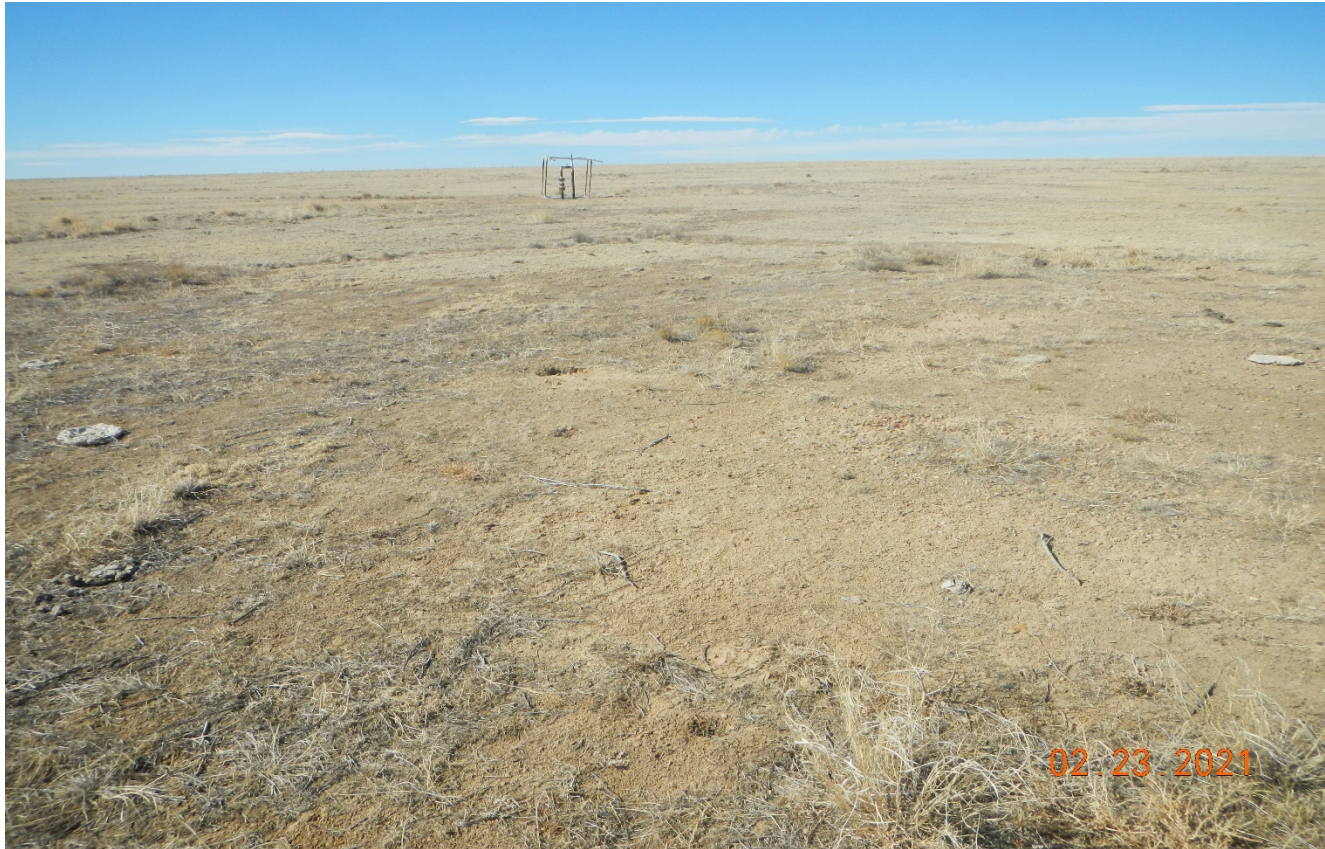
Photo 4. Facing northwest at the location. Vegetation has not re-established in this area. Soil may be compacted in this area.

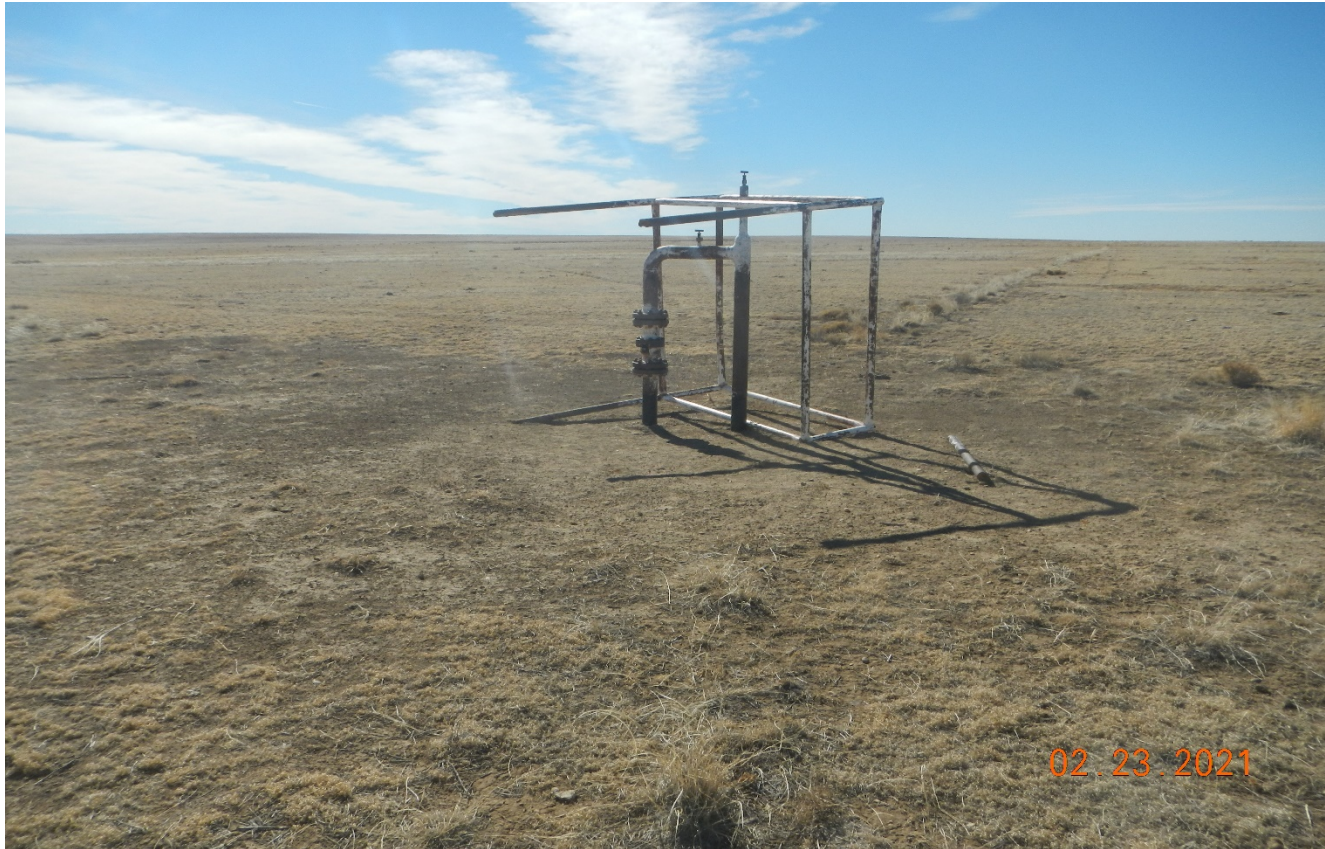
Photo 5. Facing toward the pipe riser at the west side of the location. All equipment/risers need to be removed.

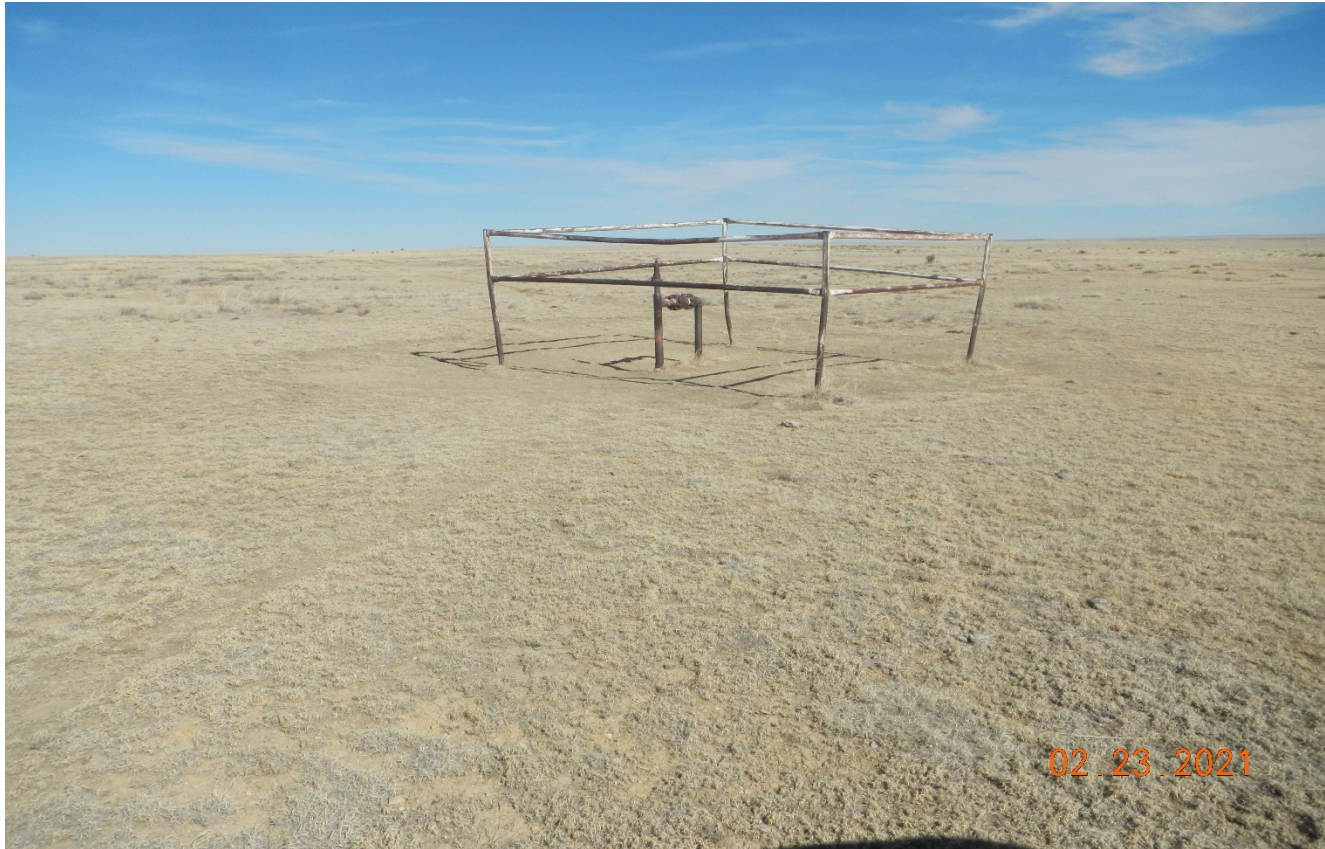
Photo 6. Another pipe riser associated with the well site was found at Lat/Long:37.87789,-102.71800. All equipment/risers need to be removed.
