Inspection Photos

Location Name: LARAMIE ENERGY LLC Hawkins Ranch /10-4 Pad

Location ID: 334520

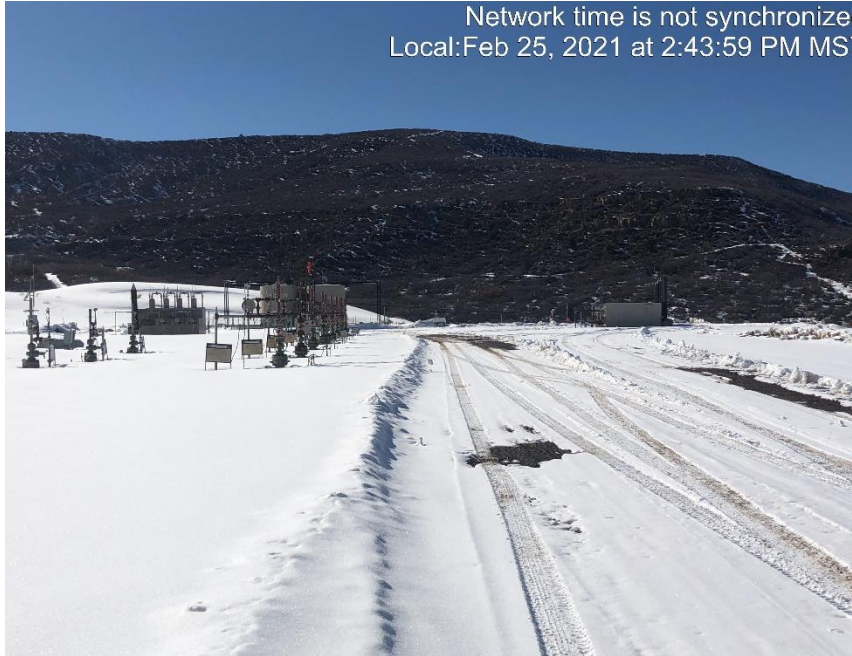
Photo #2992 from entrance to location.

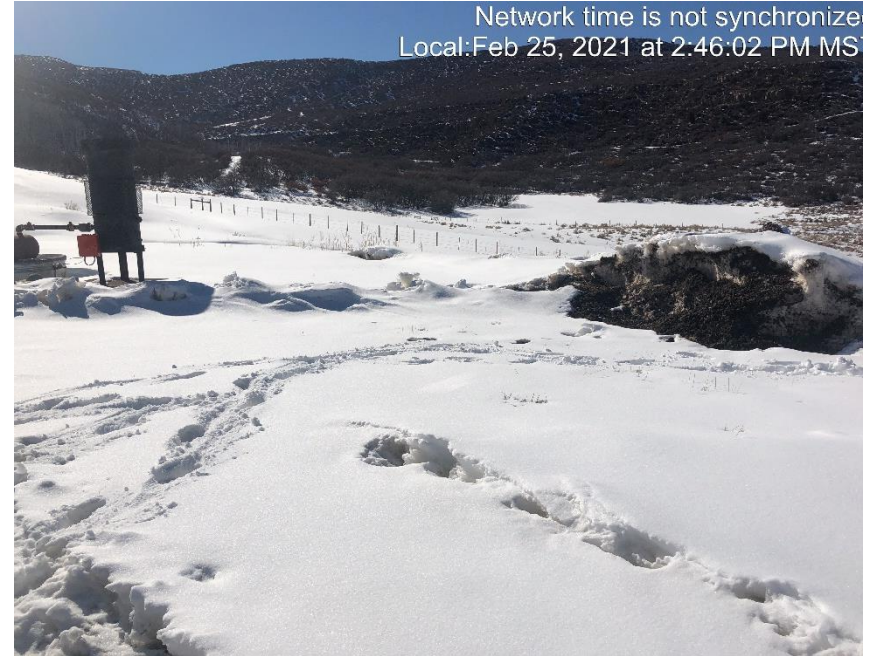
Photo #2995 Sediment has been transported off of location due to snow plowing.

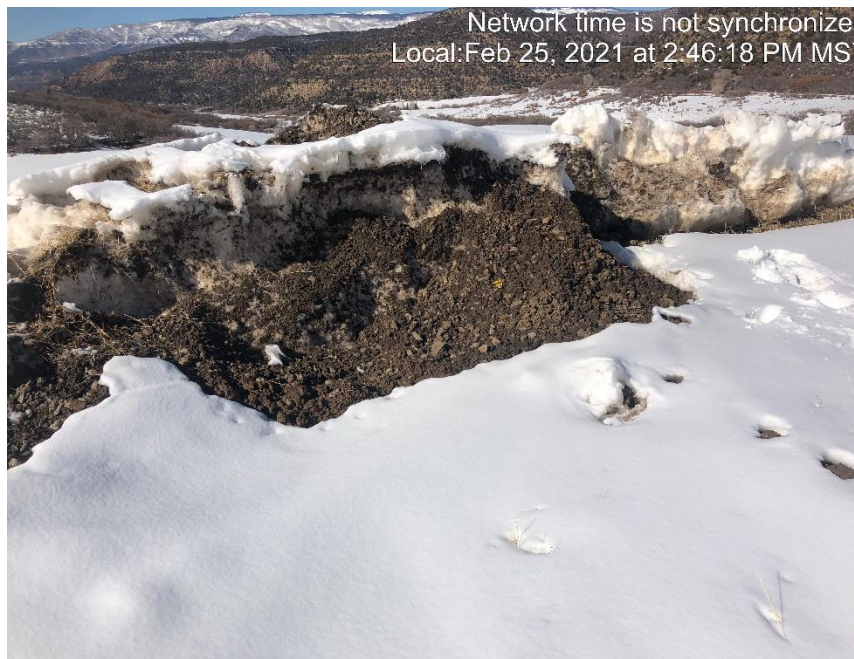
Photo #2996 Sediment has been transported off of location due to snow plowing.

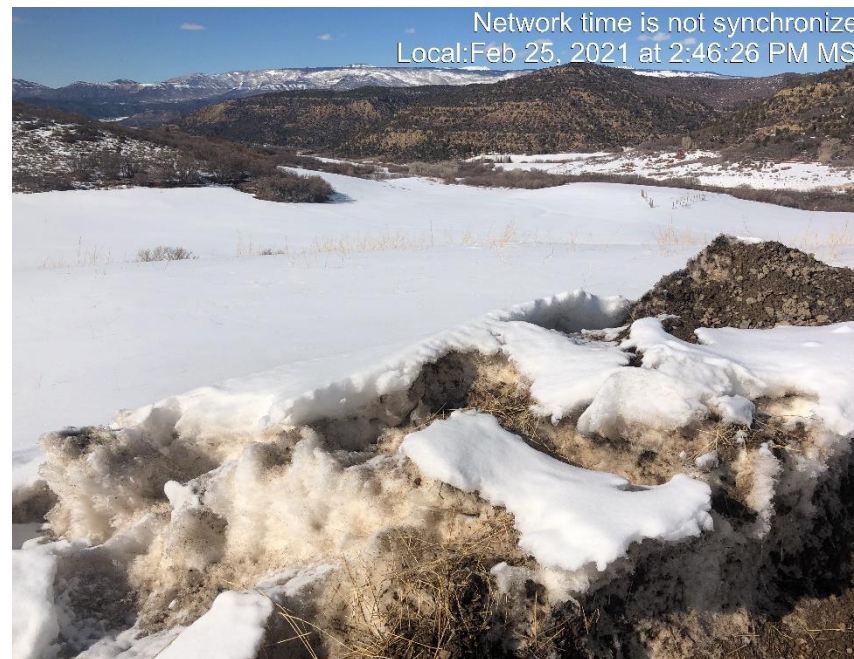
Photo #2997 No BMP's located between the edge of fill slope and Sediment pile.

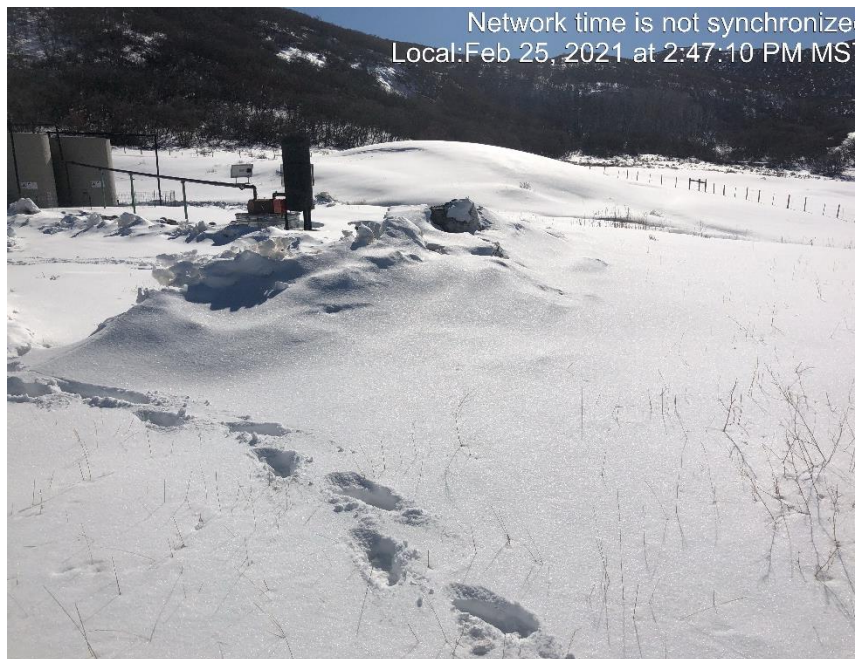
Photo #2998 No BMP's to control Sediment run off of location.

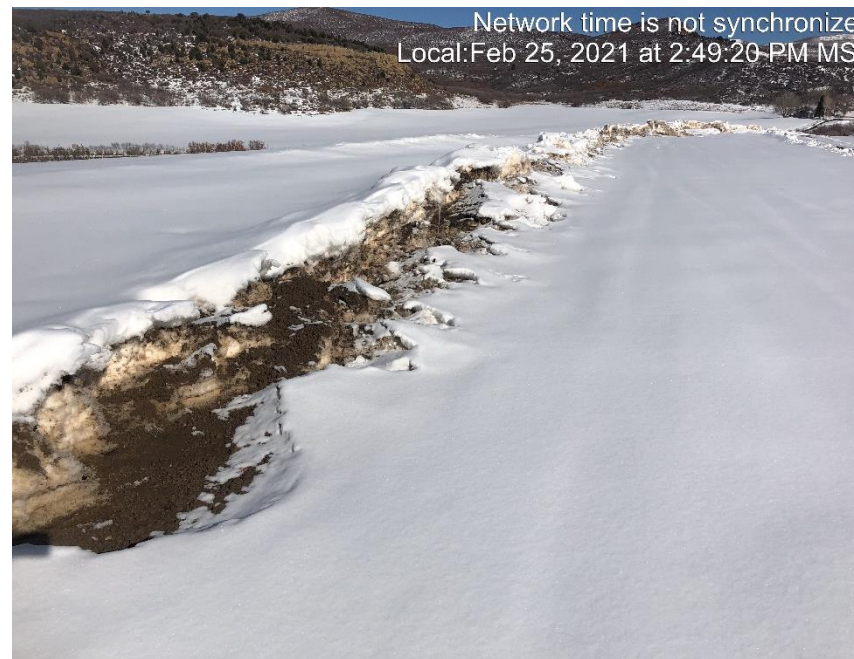
Photo #2999 Sediment has been transported off of location due to snow plowing.
