## Inspection Photos

Location Name: CAERUS PICEANCE LLC TIPPING-67S96W /34NWNW

Location ID: 334094

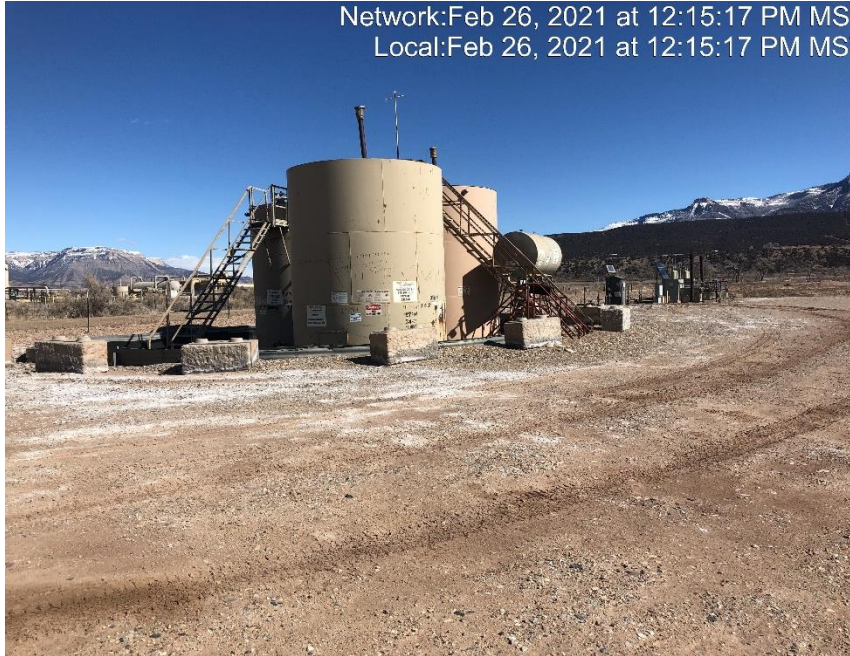
Photo #3008 from entrance to location.

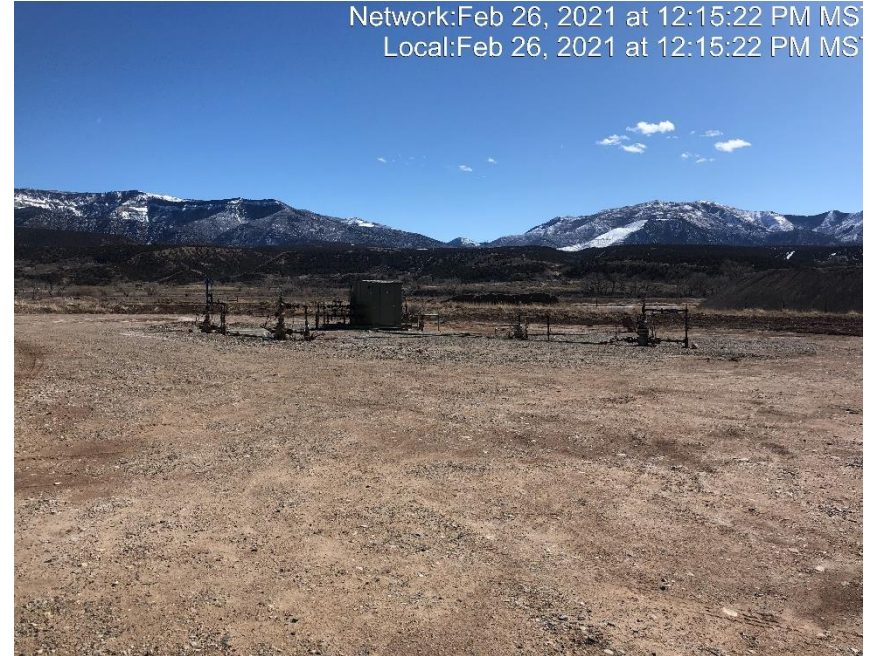
Photo #3009 from entrance to location

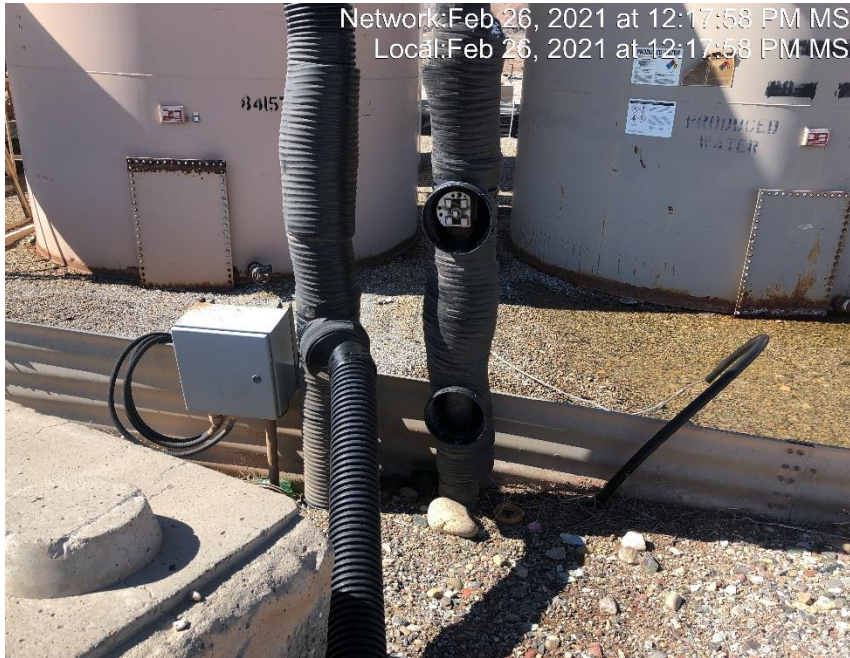
**Photo #3010 Multiple places with flow line heating insulation open ended and not capped.**

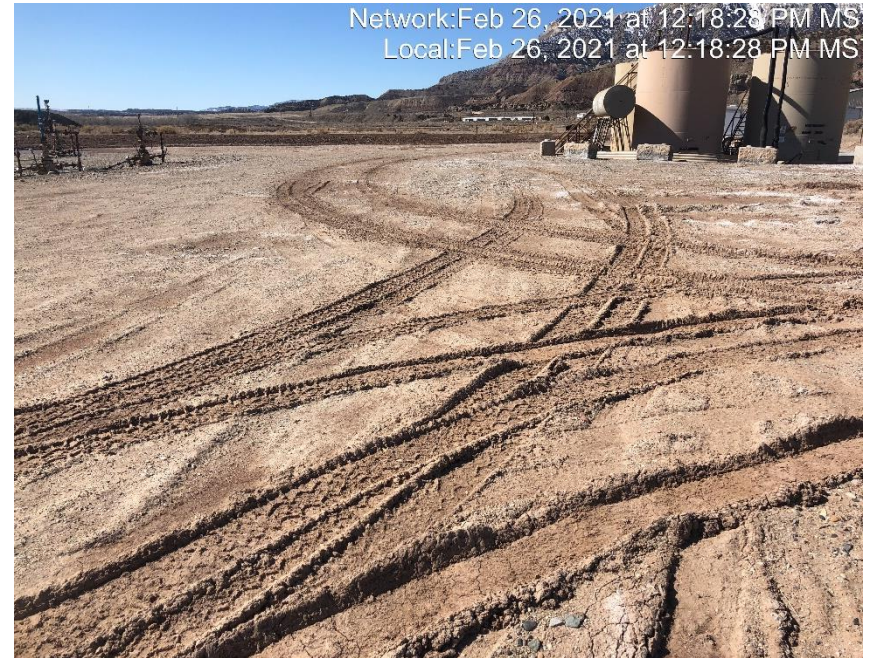
**Photo #3011 Rutting present on location due to lack of stabilization.**

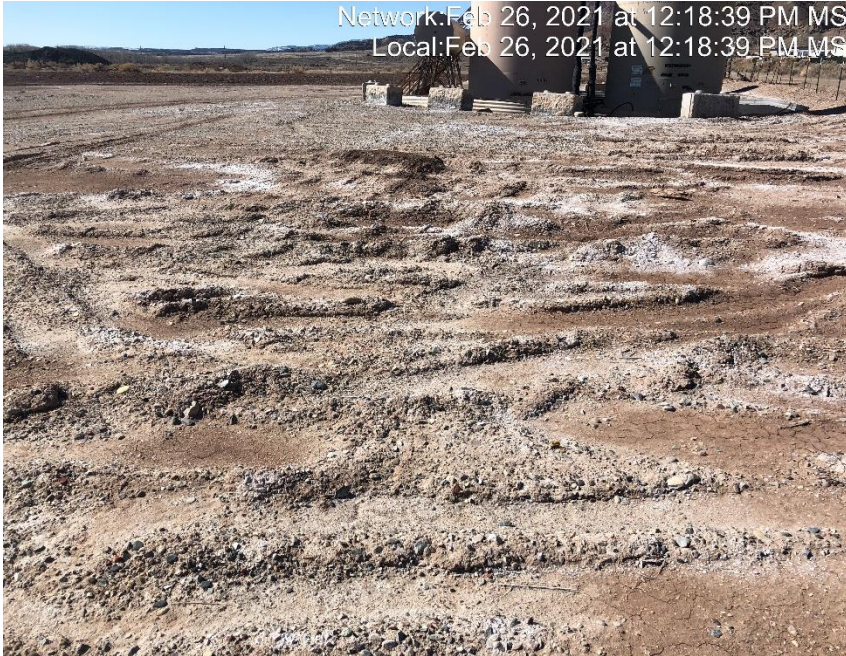
**Photo #3012** Rutting present on location due to lack of stabilization.

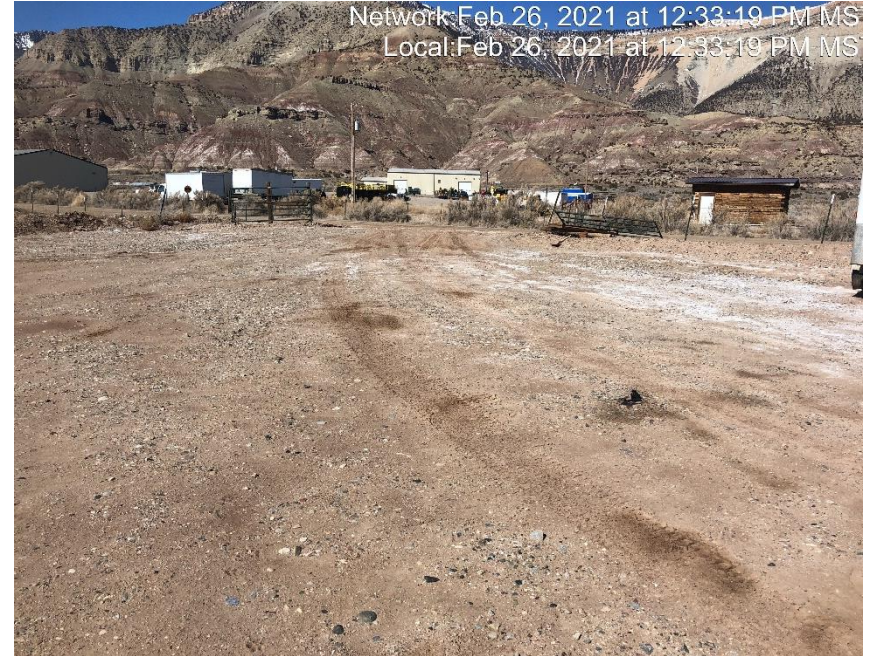
**Photo #3013** No form of tracking control at entrance to location.
