**TEP ROCKY MOUNTAIN LLC  
FEDERAL-66S96W 34SWNE  
Location # 335164**

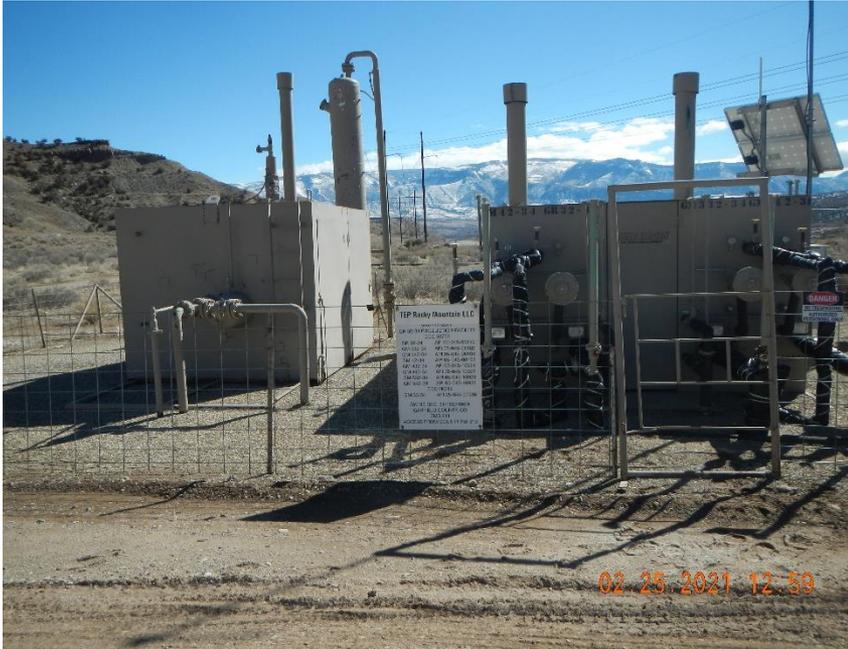
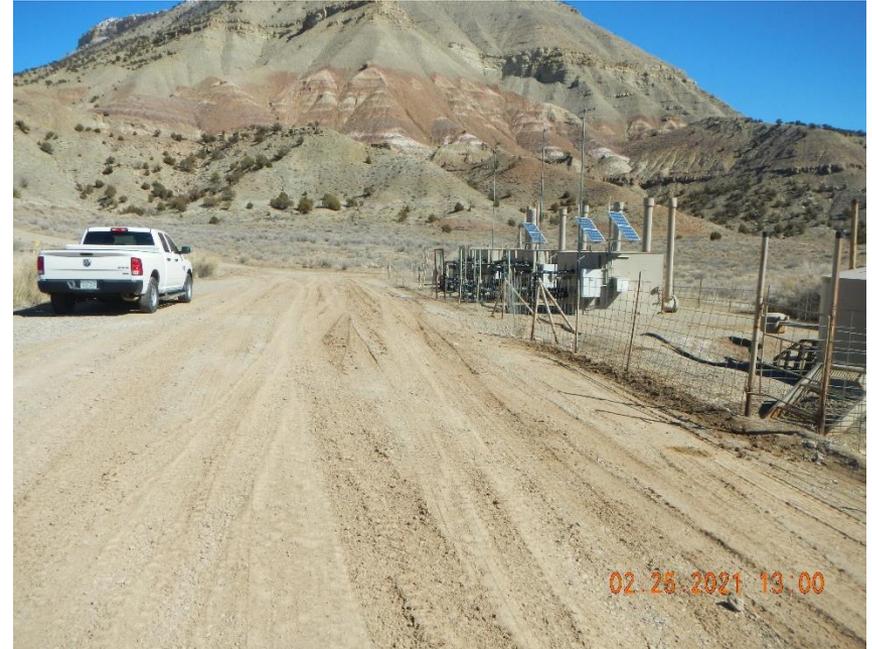
**Access road shows signs of lack of stabilization  
BMP's in some areas (rutting is present).**

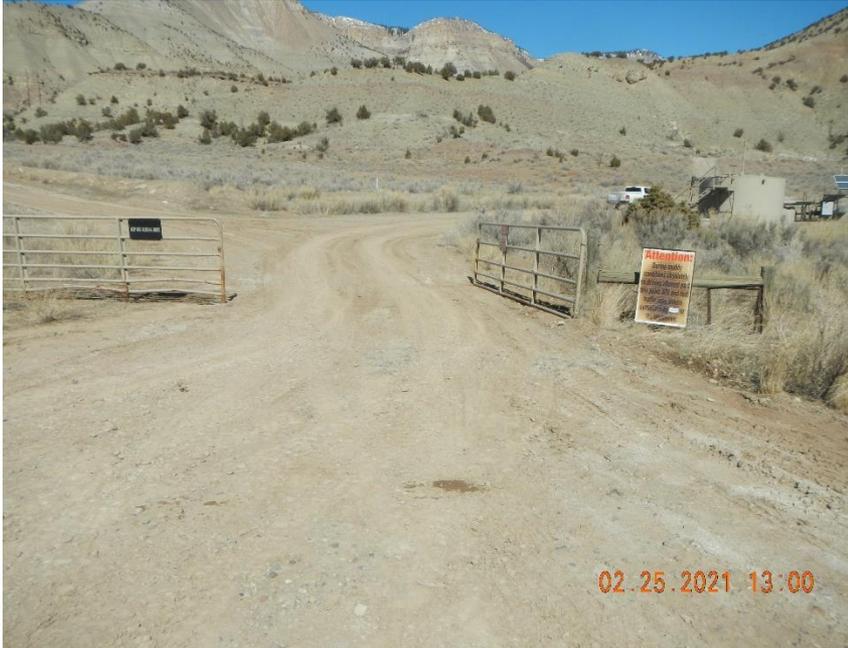
**No evidence of tracking control BMP's**

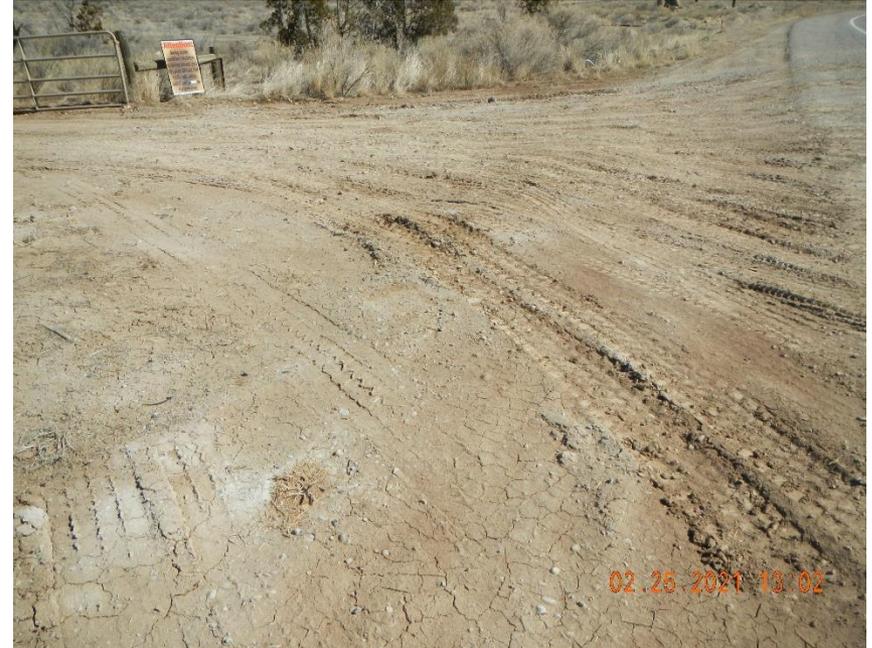
**No evidence of tracking control BMP's**

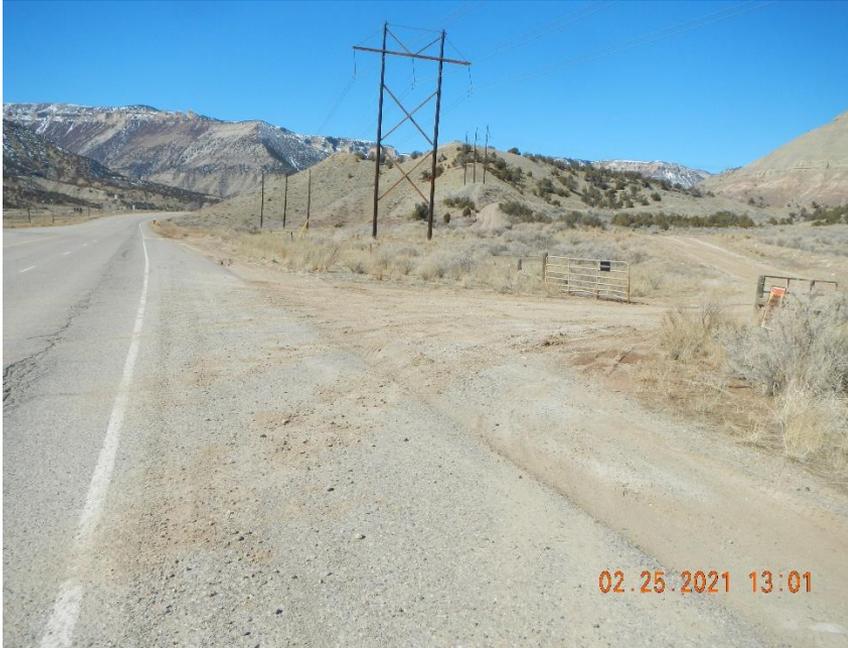
**No evidence of tracking control BMP's**

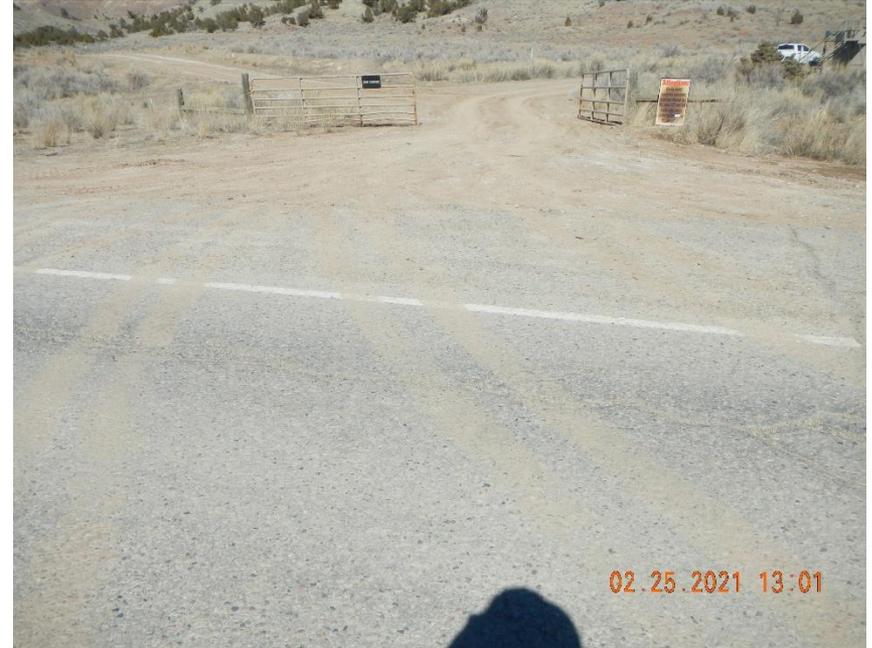
**No evidence of tracking control BMP's**

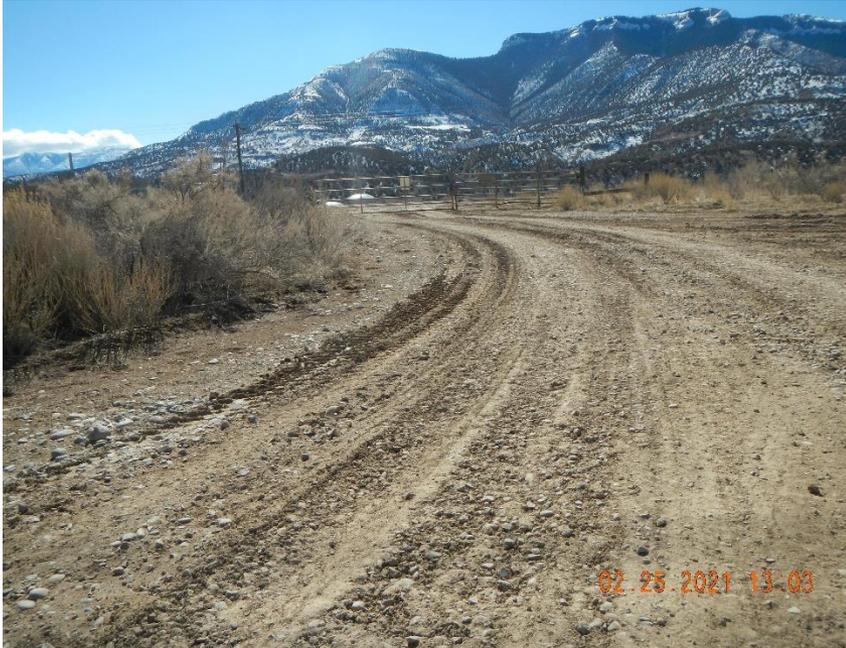
**Access road shows signs of lack of stabilization  
BMP's in some areas (rutting is present).**

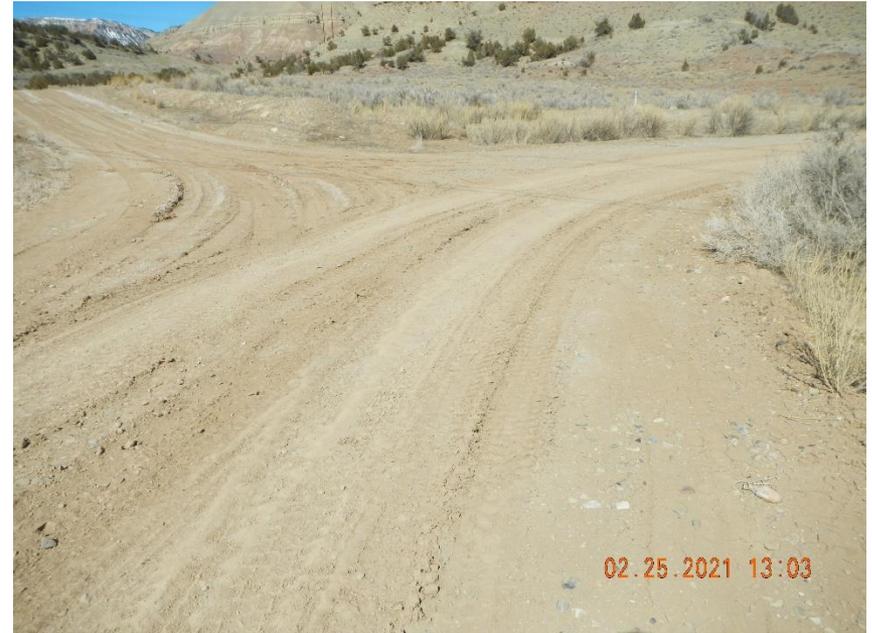
**Access road shows signs of lack of stabilization  
BMP's in some areas (rutting is present).**

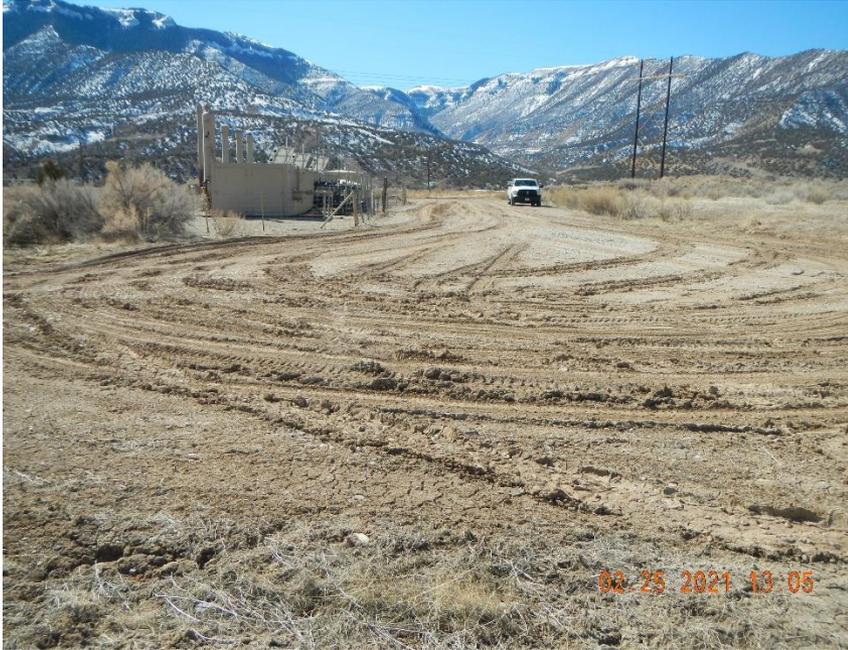
**Access road shows signs of lack of stabilization  
BMP's in some areas (rutting is present).**

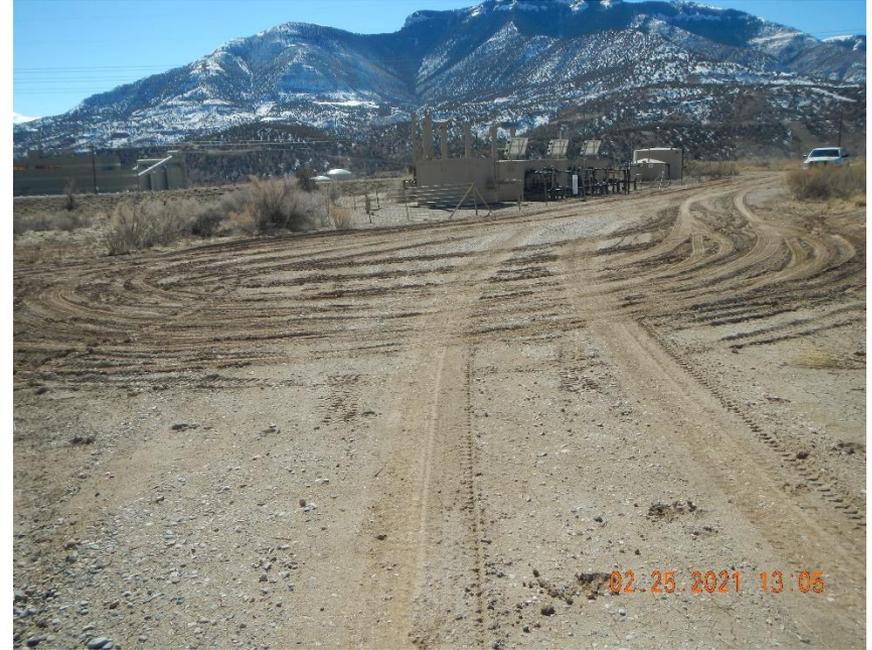
**Access road shows signs of lack of stabilization  
BMP's in some areas (rutting is present).**

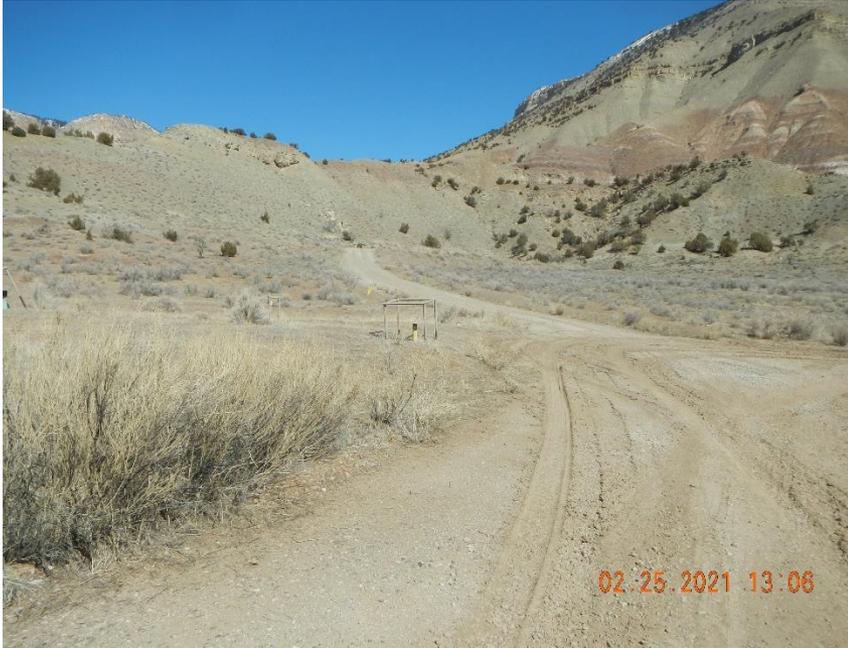
**Road ditch needs maintained.**

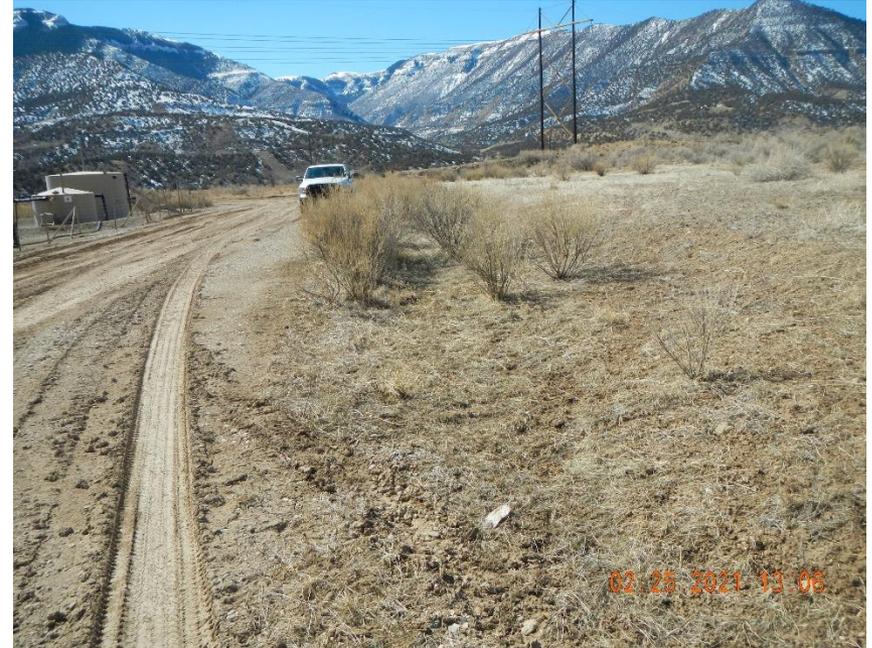
**Road ditch needs maintained.**

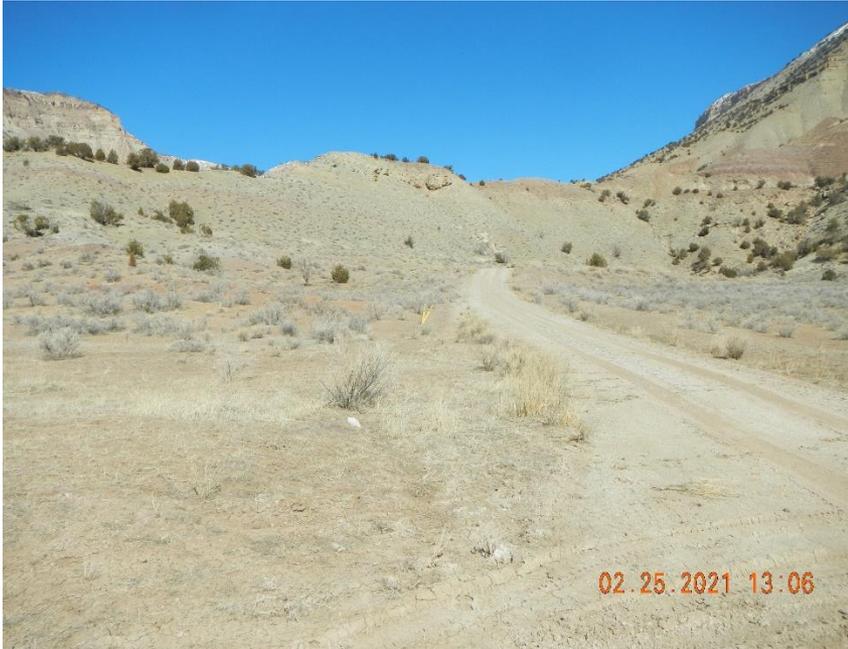
**Road ditch needs maintained.**

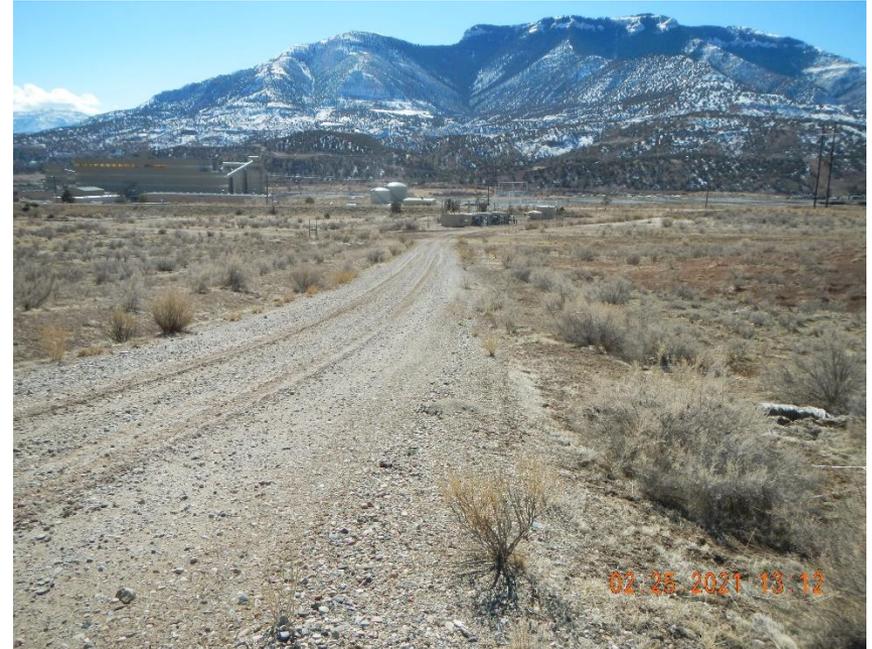
**Road ditch needs maintained.**

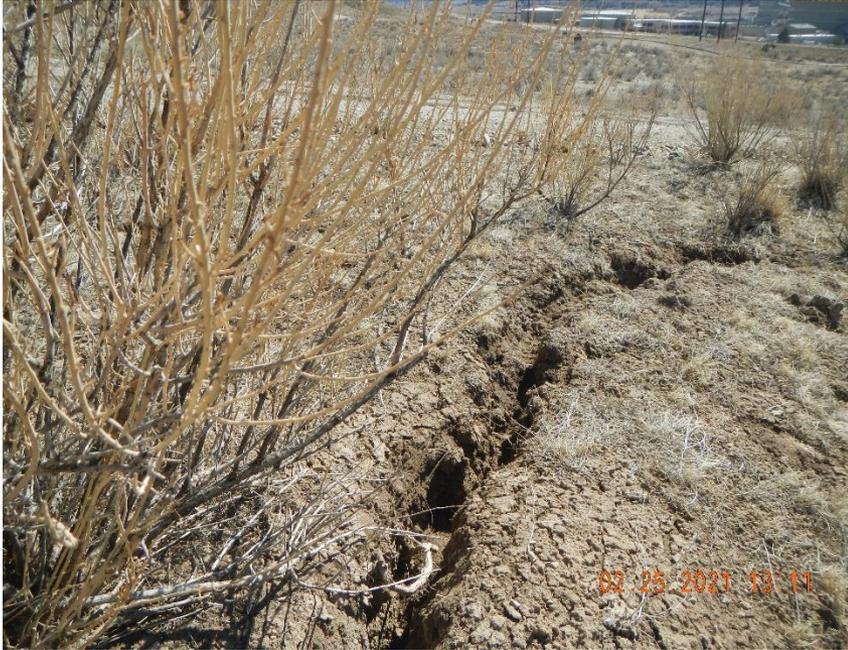
**Erosion subsidence crack along up hill road  
into location.**

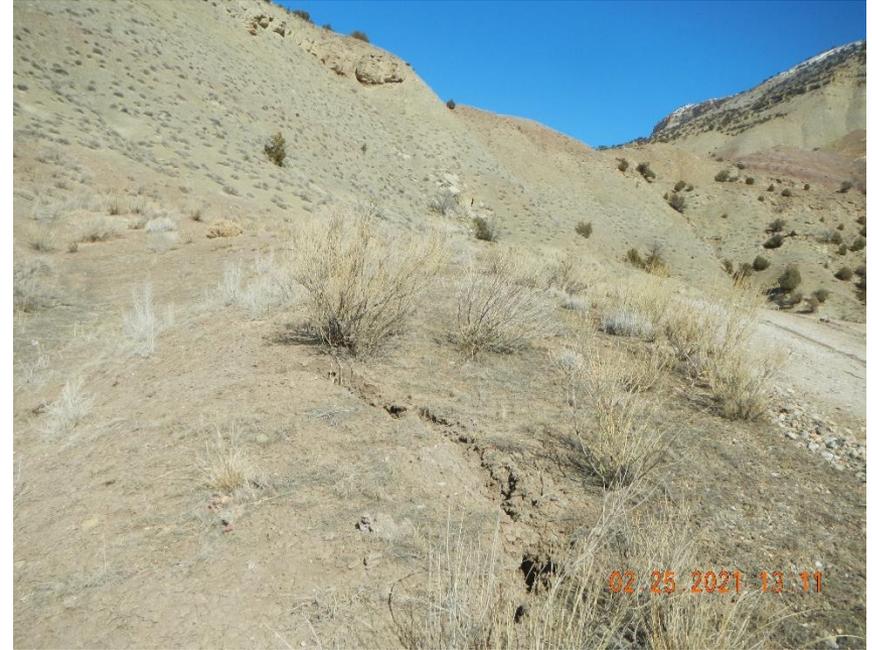
**Erosion subsidence crack along up hill road  
into location.**

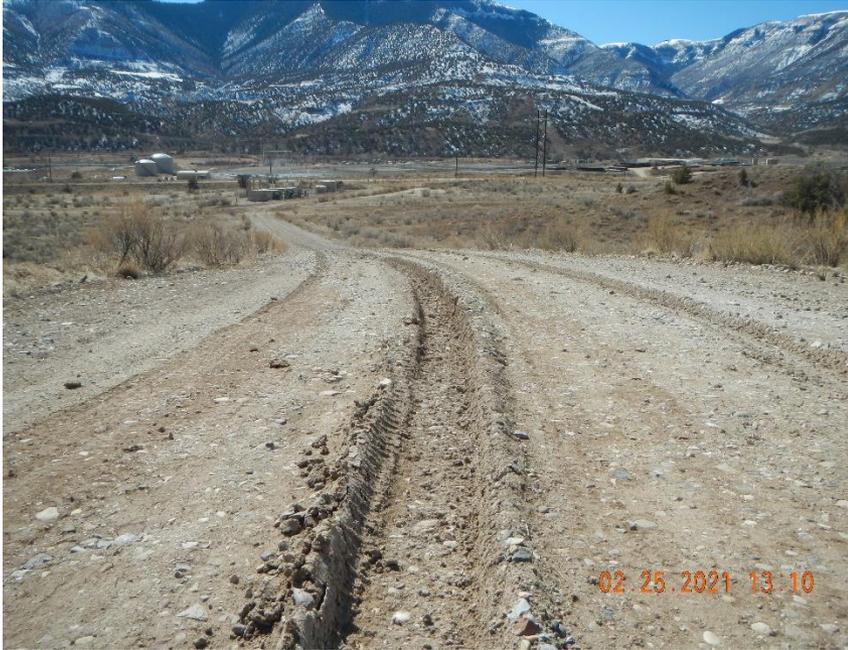
**Access road shows signs of lack of stabilization  
BMP's in some areas (rutting is present).**

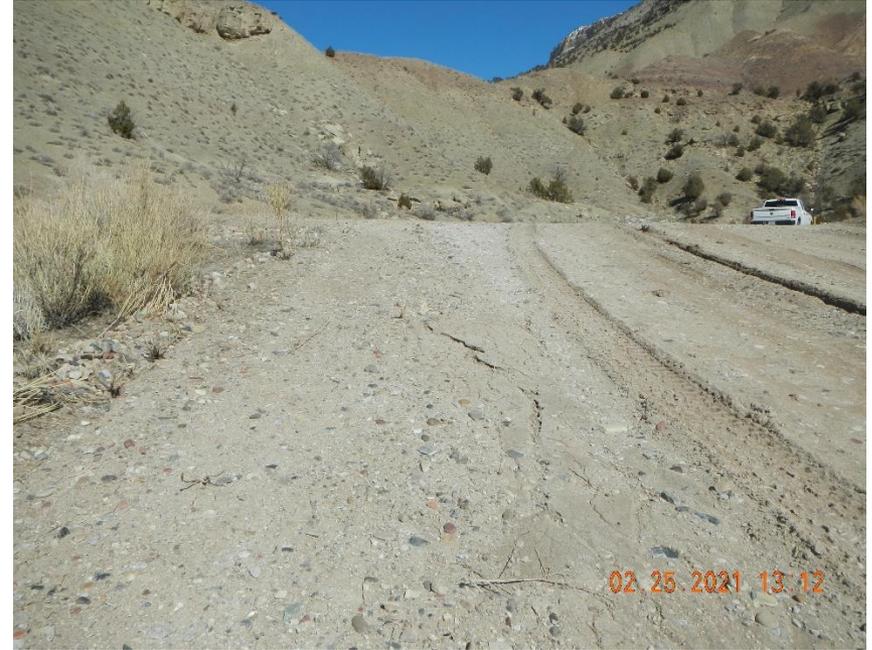
**Access road shows signs of lack of stabilization  
BMP's in some areas (rutting is present).**

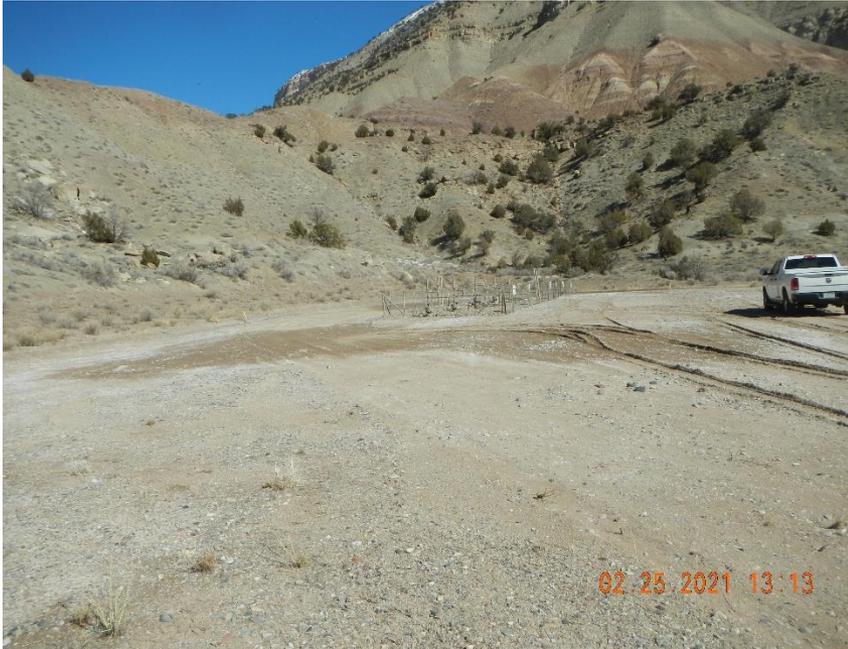
**Location shows signs of lack of stabilization  
BMP's in some areas (rutting is present).**

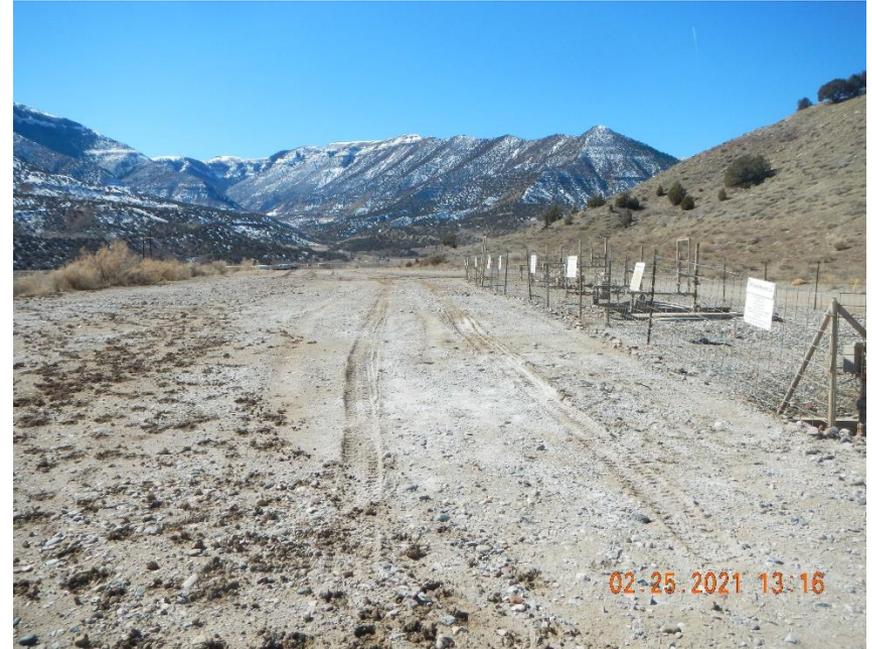
**Location shows signs of lack of stabilization  
BMP's in some areas (rutting is present).**
