**TEP ROCKY MOUNTAIN LLC
CHEVRON-66S96W 17NWNE
Location # 335654**

COLORADO
Oil & Gas Conservation
Commission
Department of Natural Resources

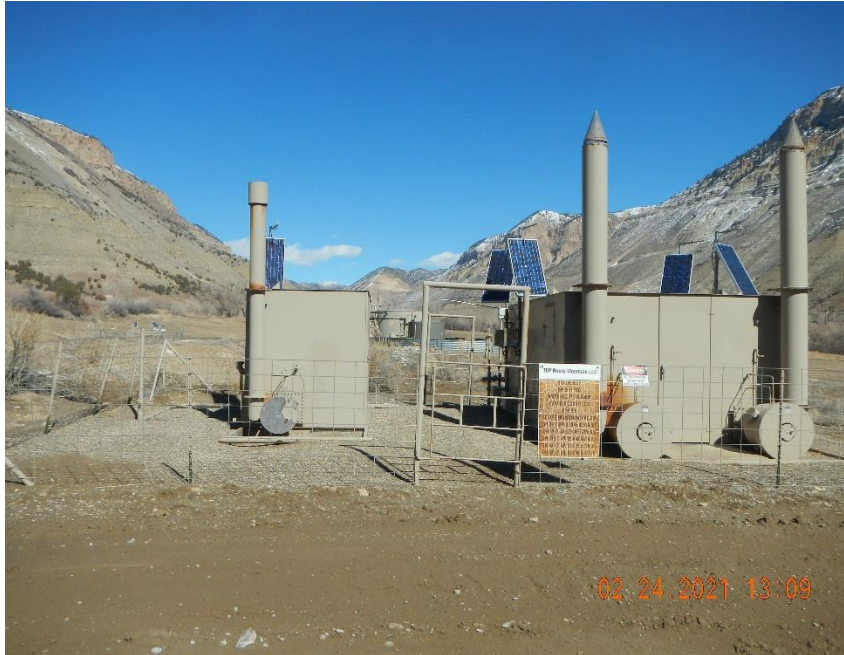
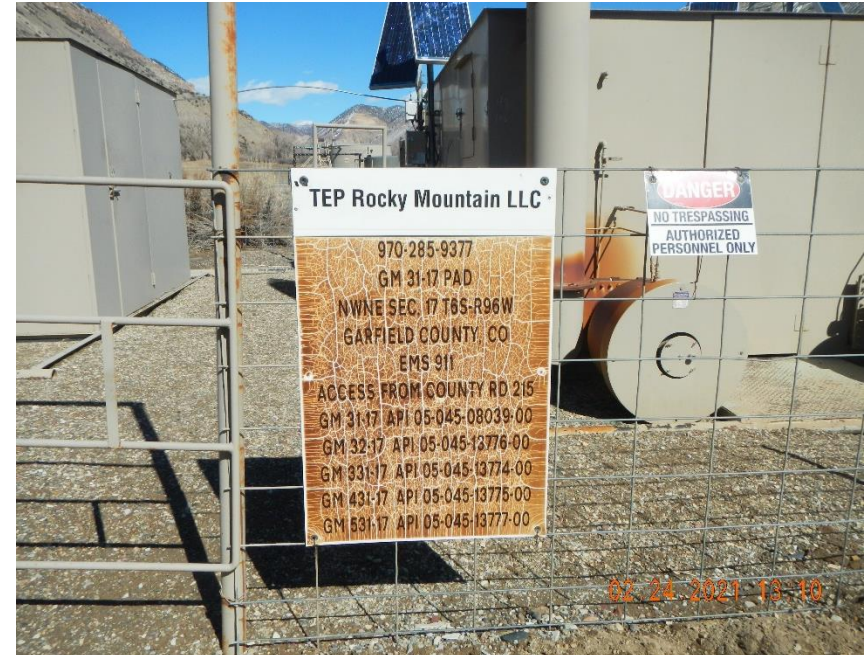
Sign is weathered.

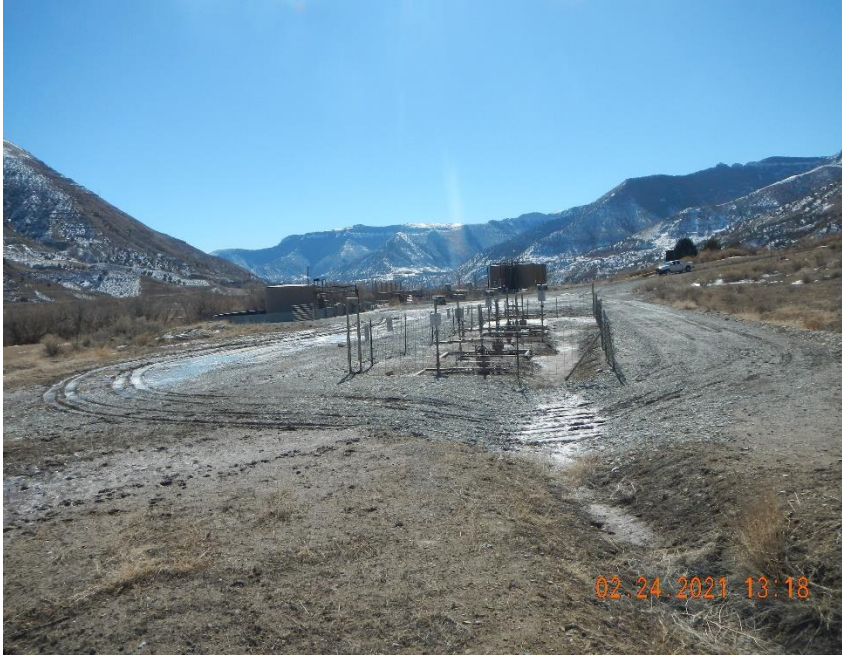
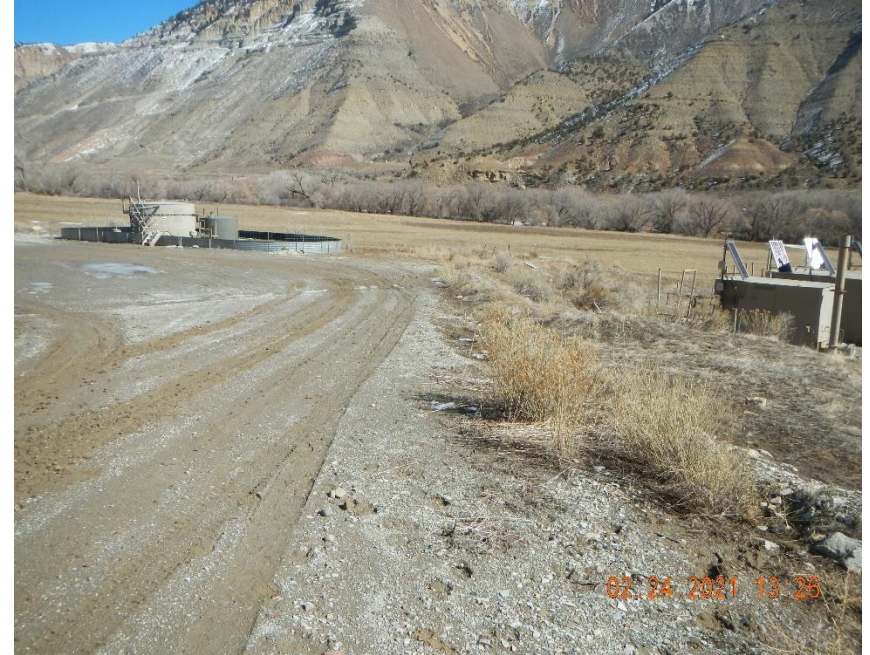
No battery sign at tank battery.

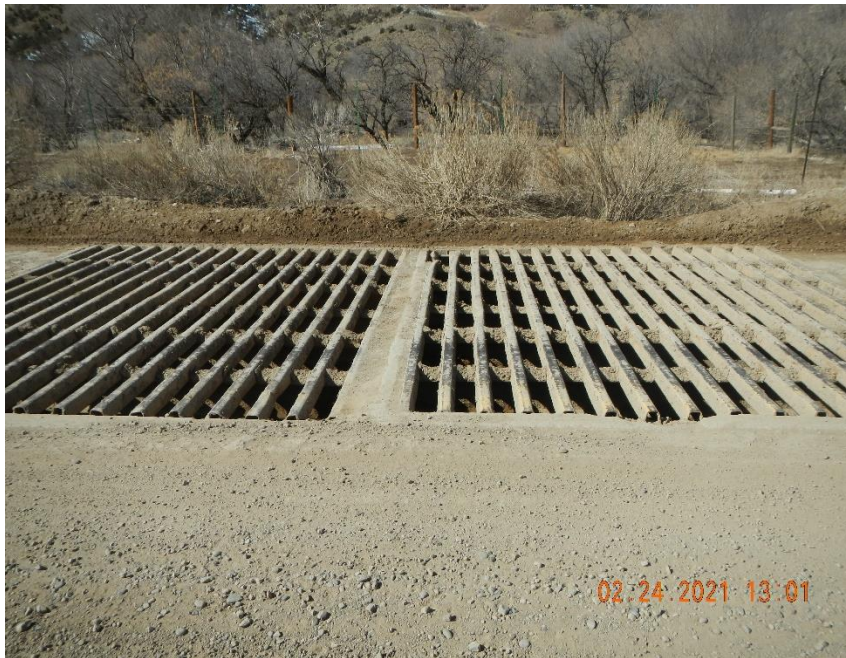
Cattle cleaned out on main road.

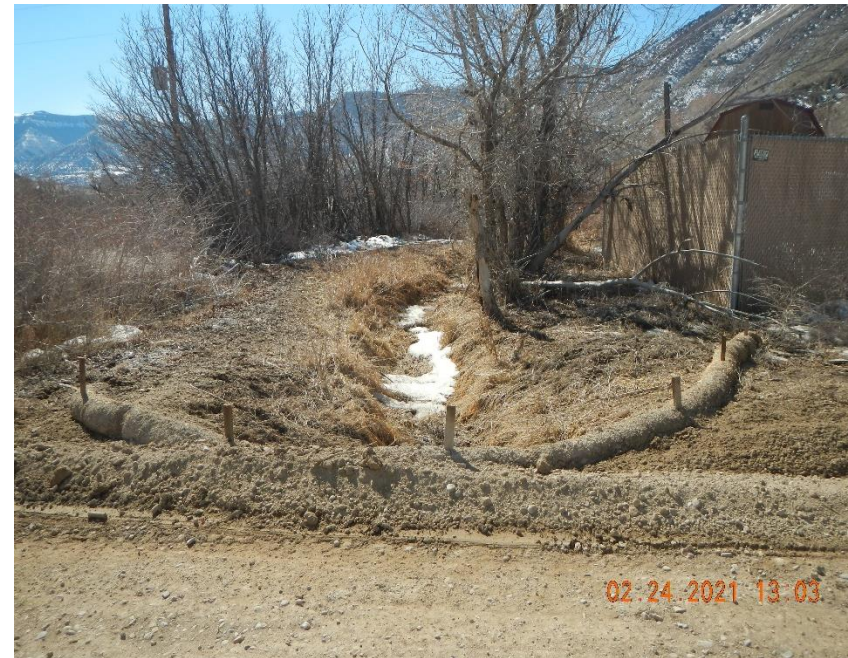
Wattle repaired or replaced.

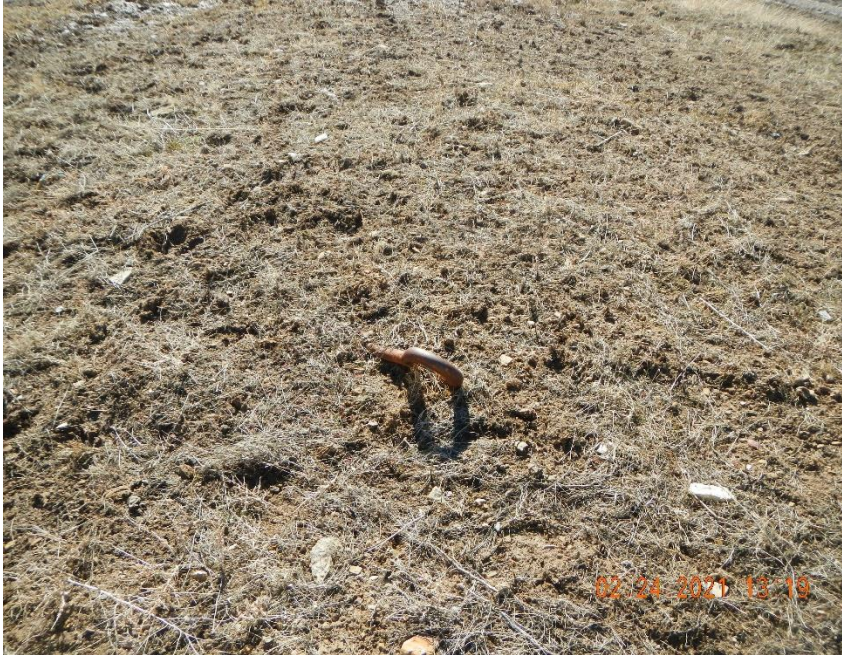
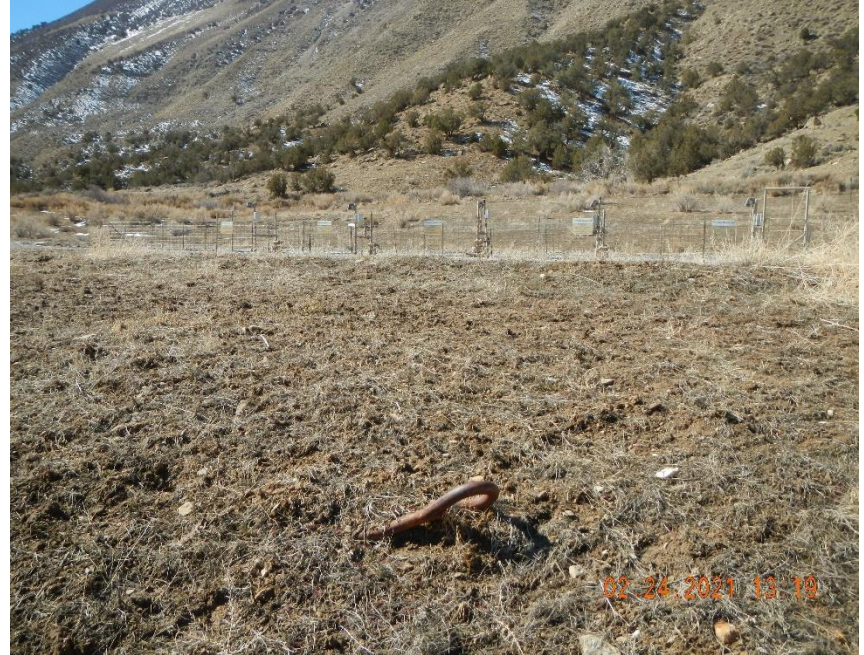
Unmarked deadman

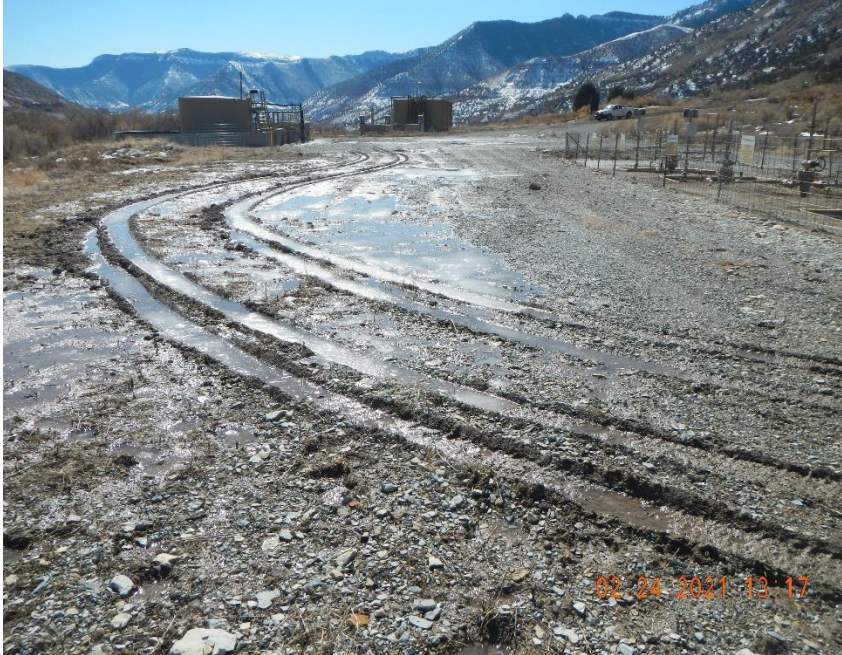
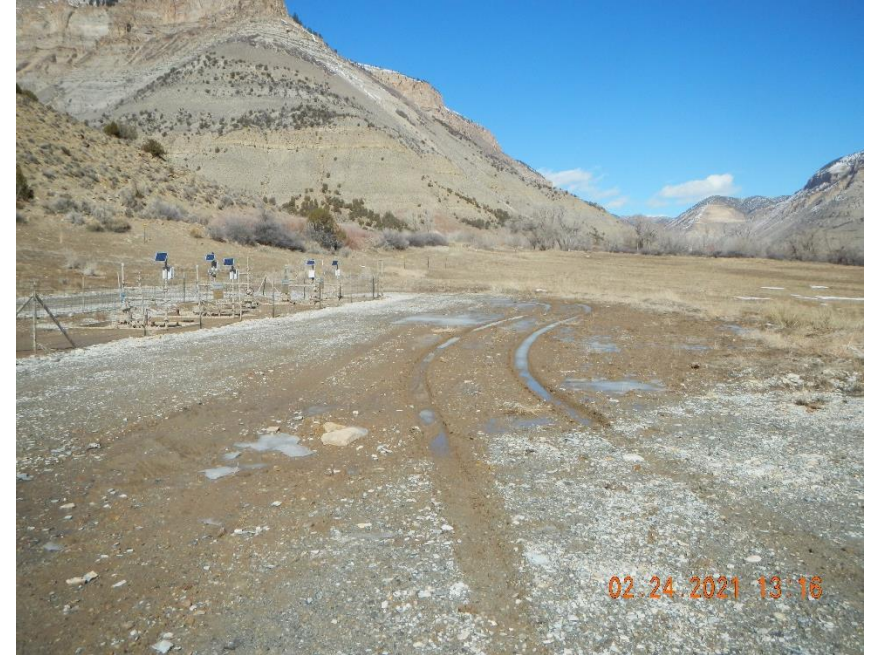
**Location shows signs of lack of stabilization
BMP's in some areas (rutting is present).**

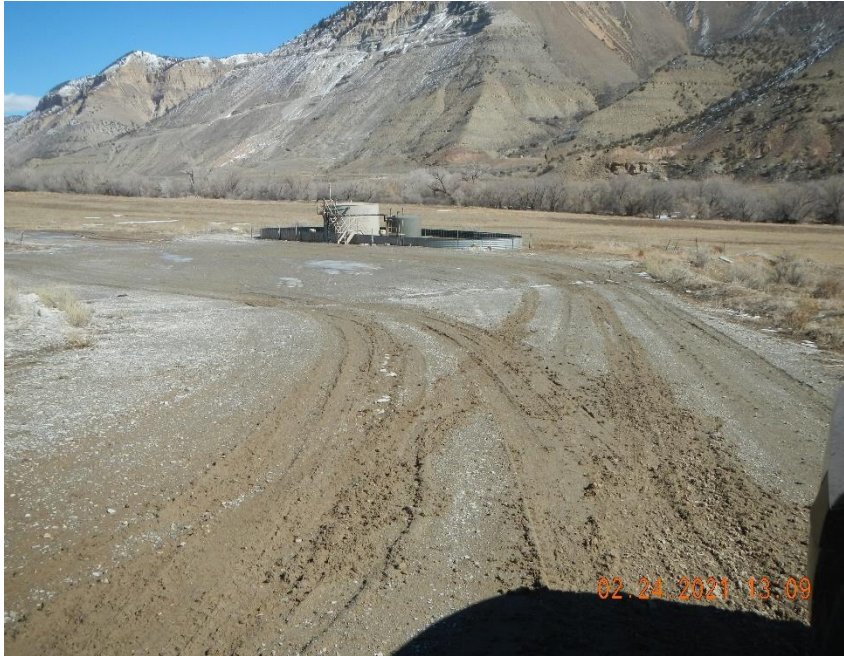
**Location shows signs of lack of stabilization
BMP's in some areas (rutting is present).**

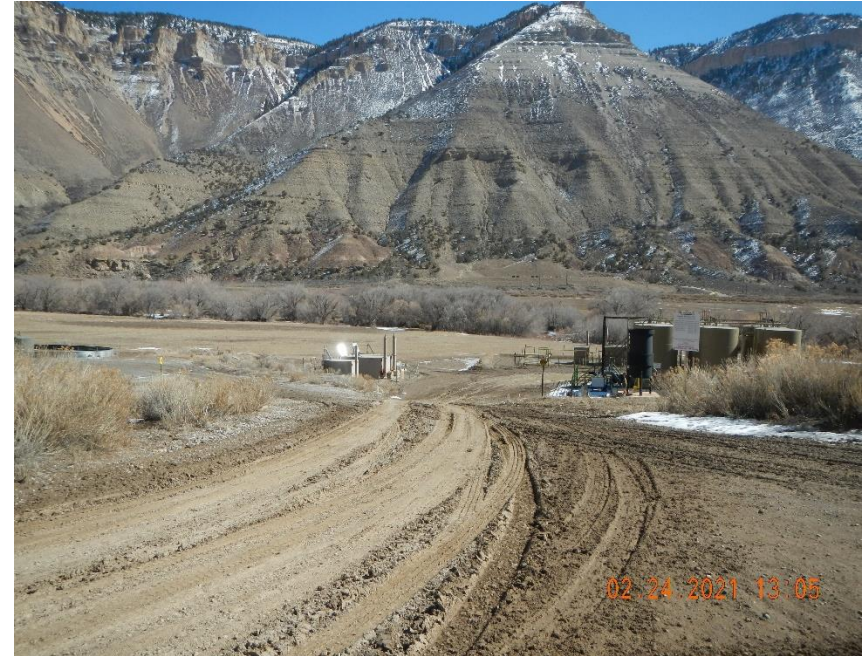
**Access road shows signs of lack of stabilization
BMP's in some areas (rutting is present).**

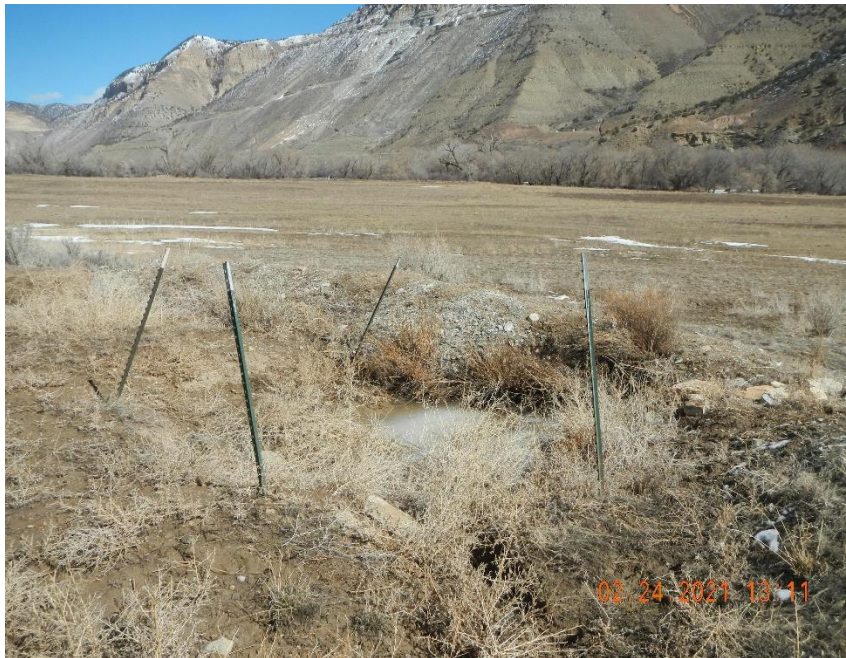
Check dam basin needs maintained.

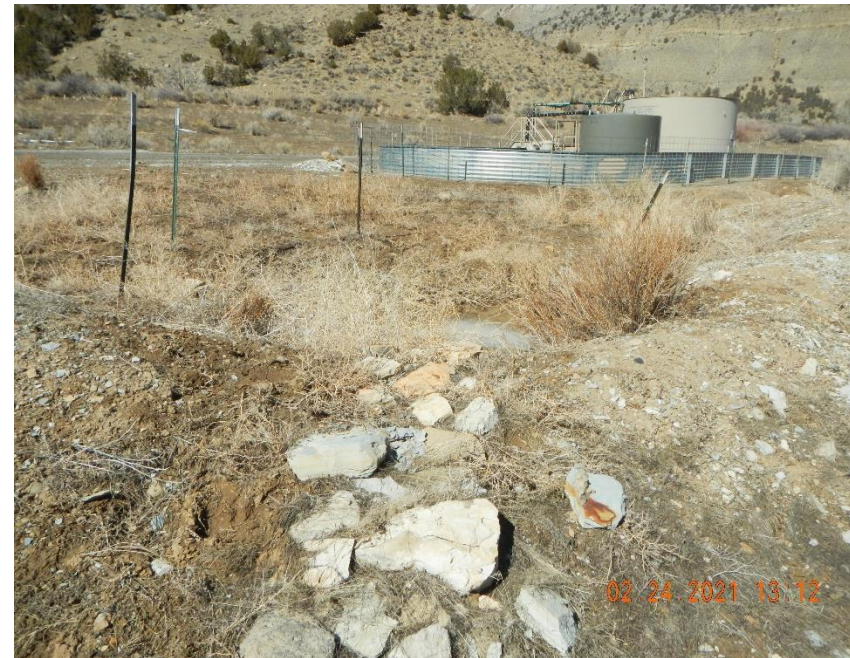
Riprap needs maintained.

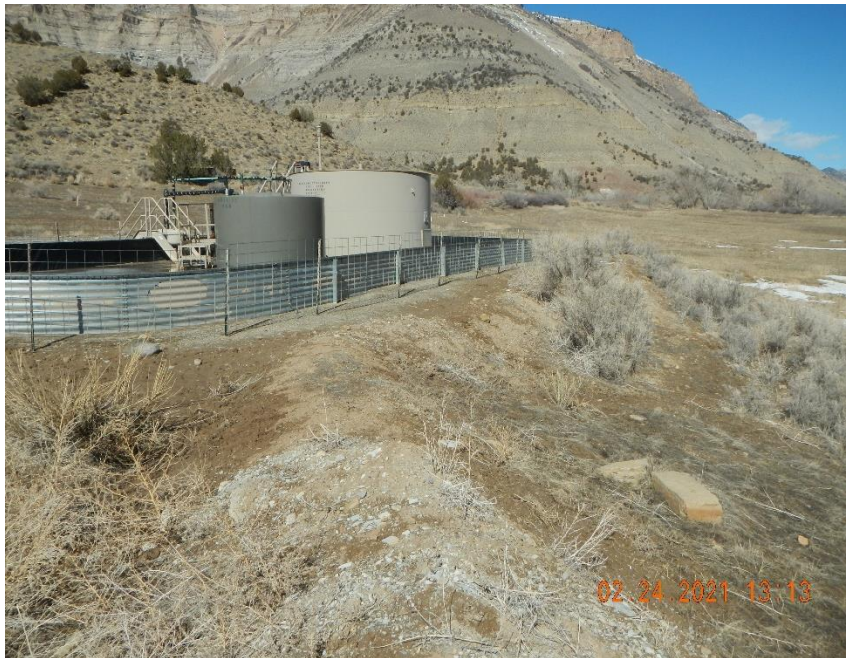
Perimeter berm behind tank battery is not consistent.

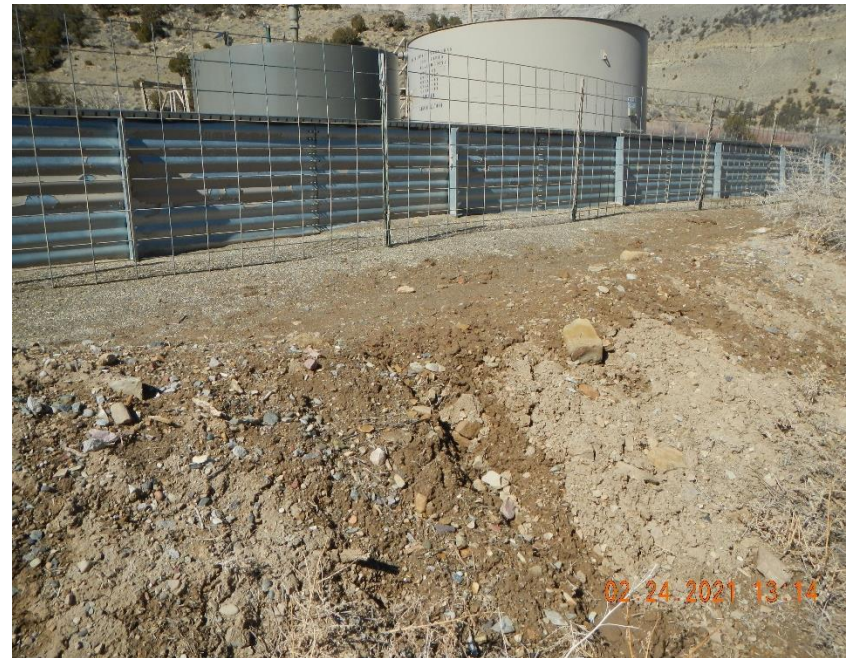
Washing over bank of location behind tank battery.

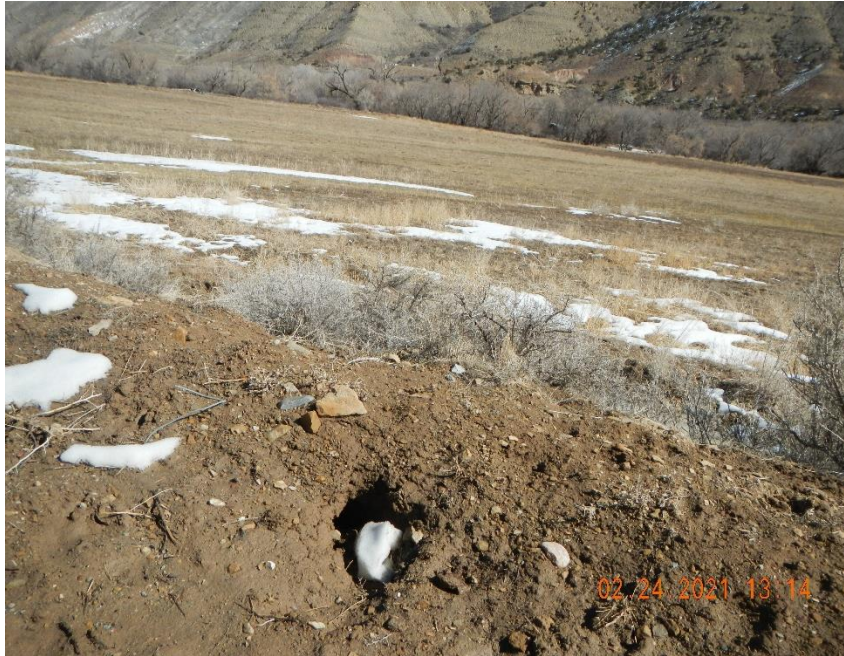
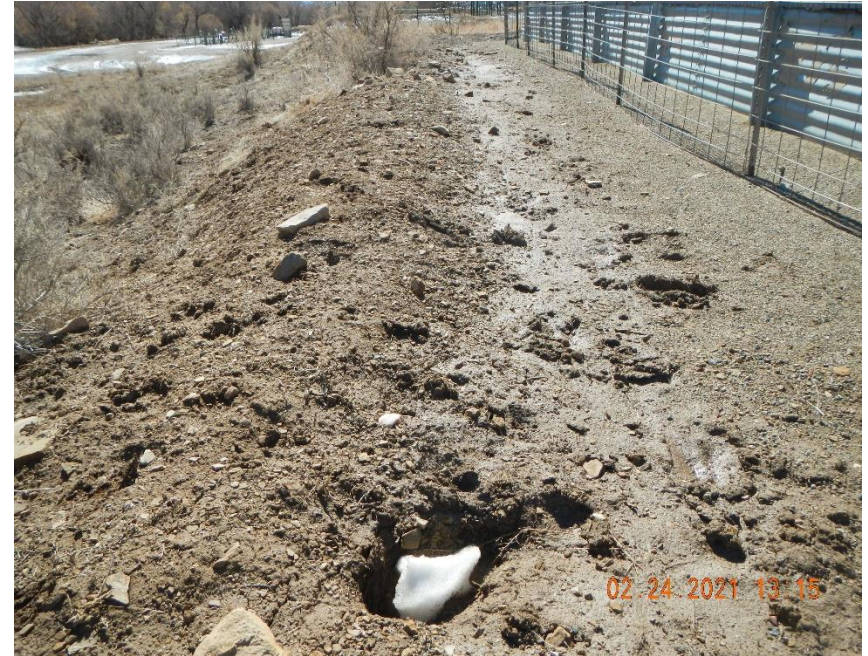
Channeling through perimeter berm.

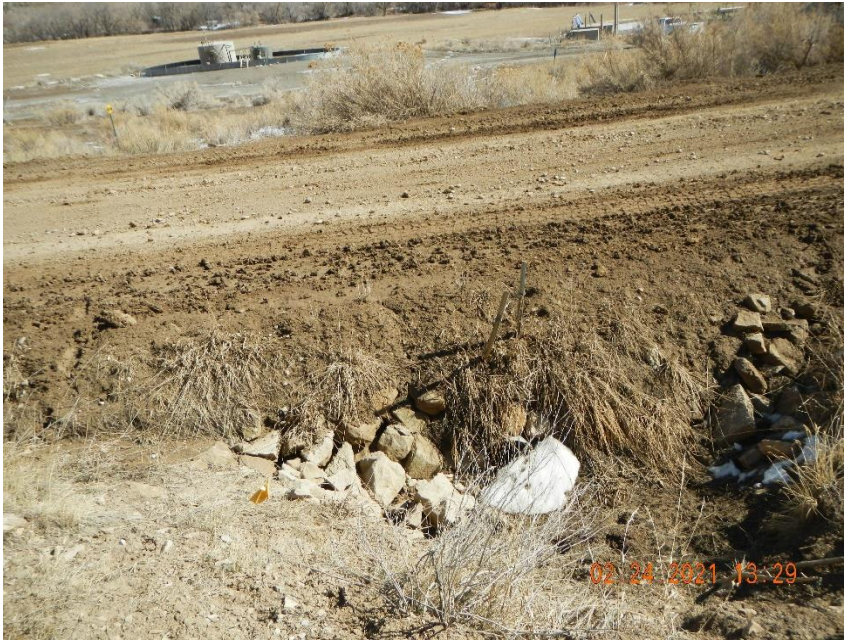
**Culvert before entrance needs maintained.
39.529205 108.131077**

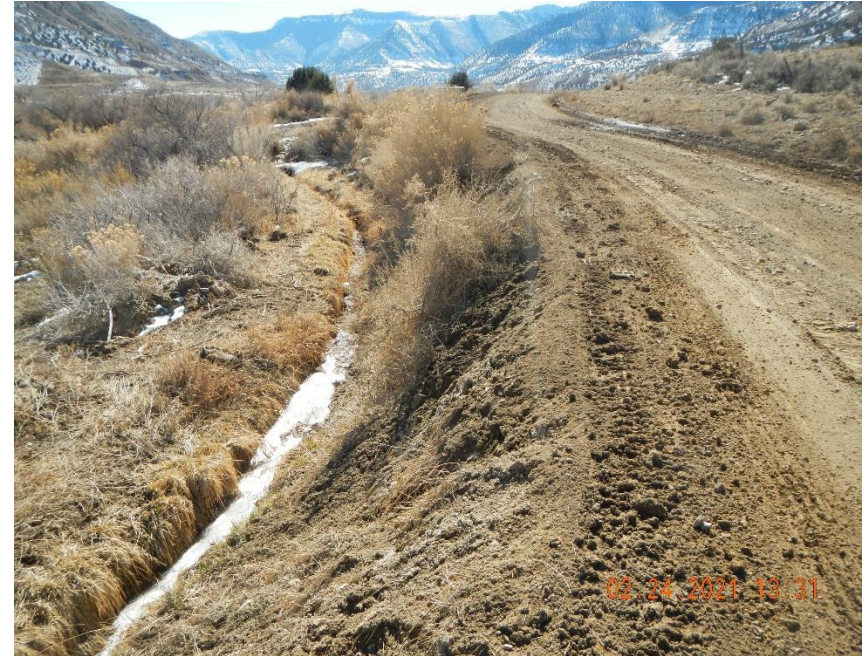
**Unable to see culvert outlet. Sediment
being bladed off shoulder of road.**

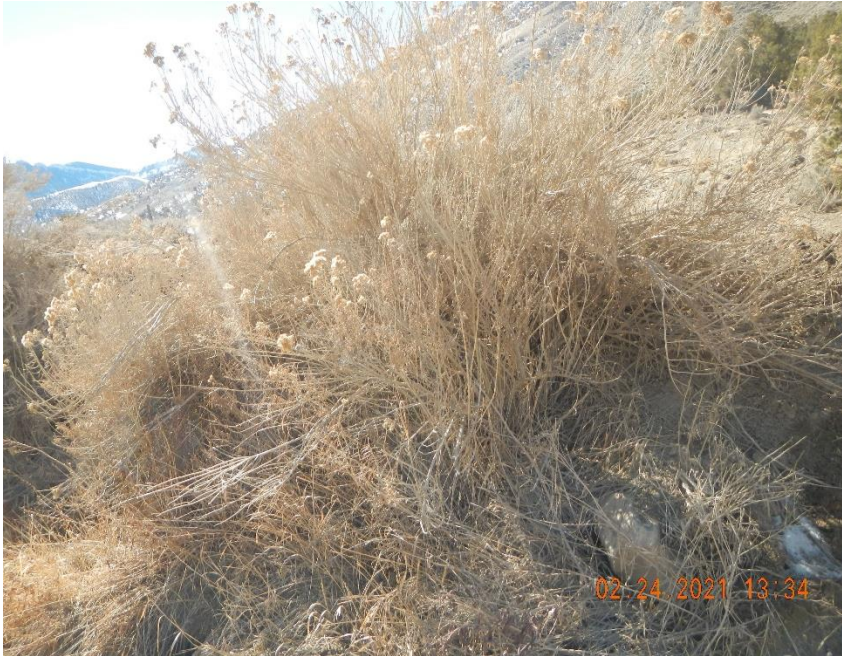
Unable to see culvert outlet.

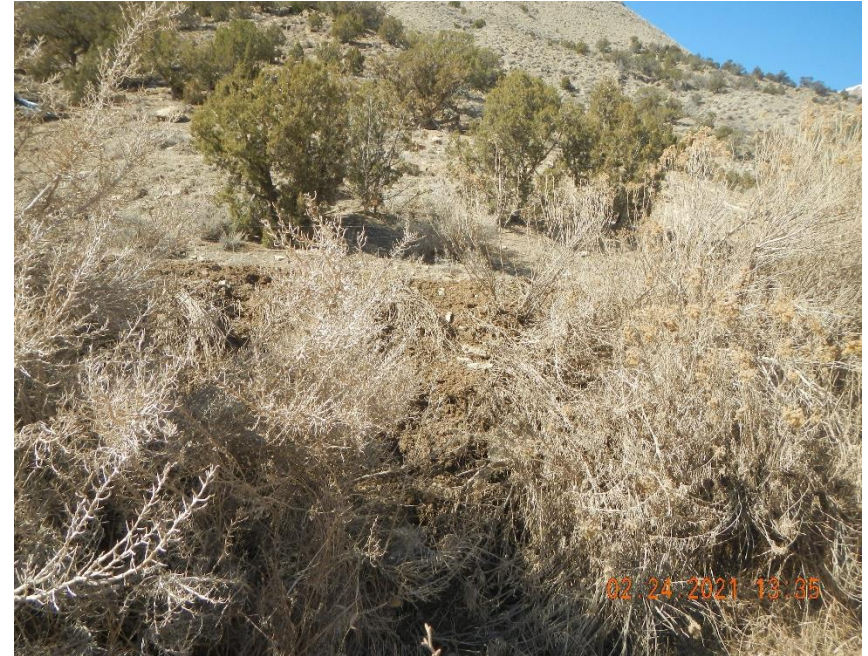
Sediment being bladed off shoulder of road.

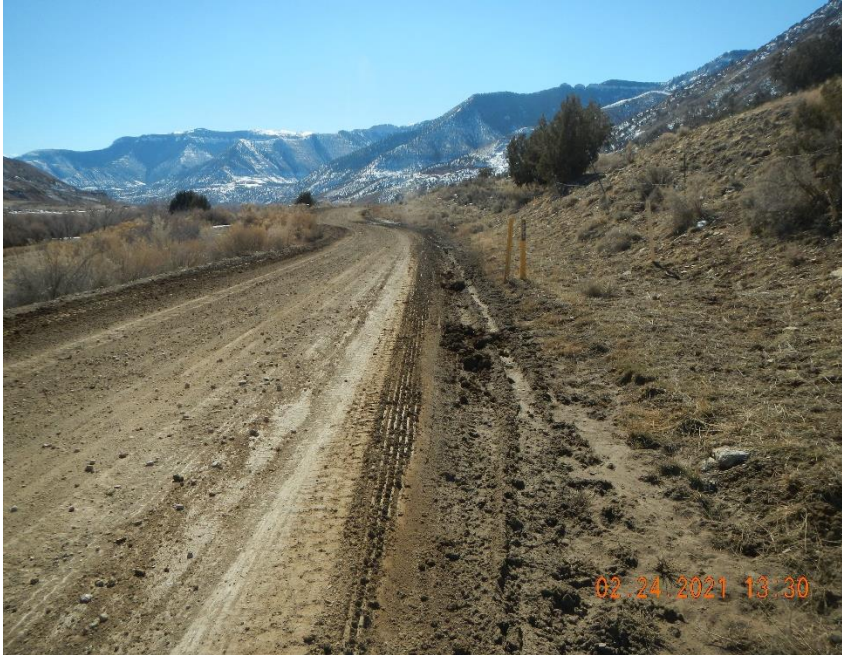
Road ditch needs maintained.

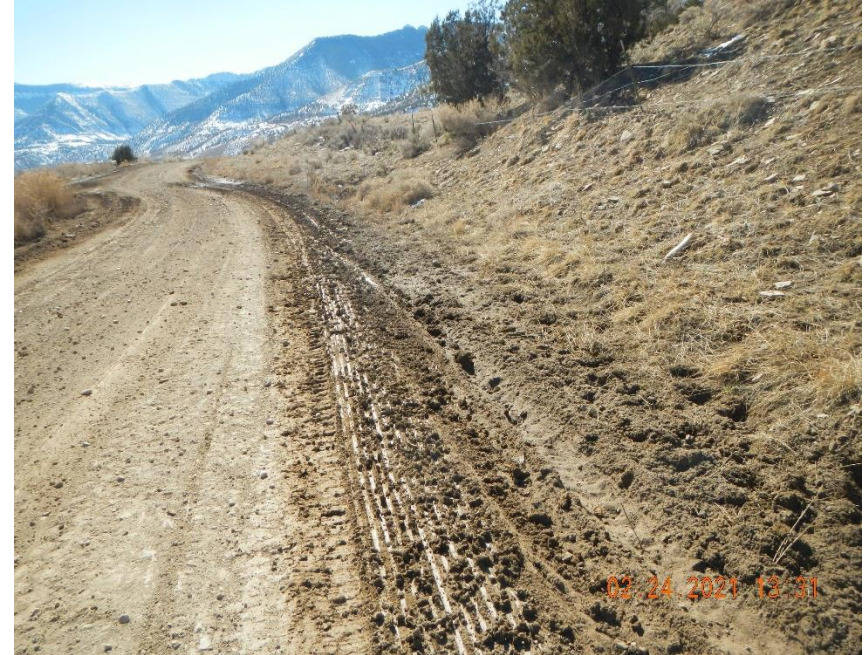
Road ditch needs maintained.
