CAERUS PICEANCE LLC

Parachute Creek /5A

Location # 335781

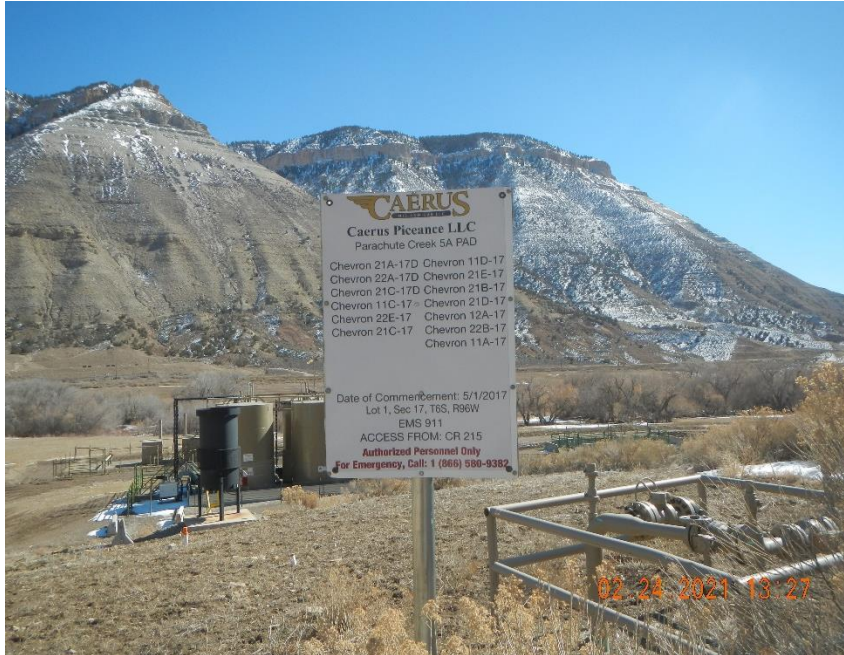
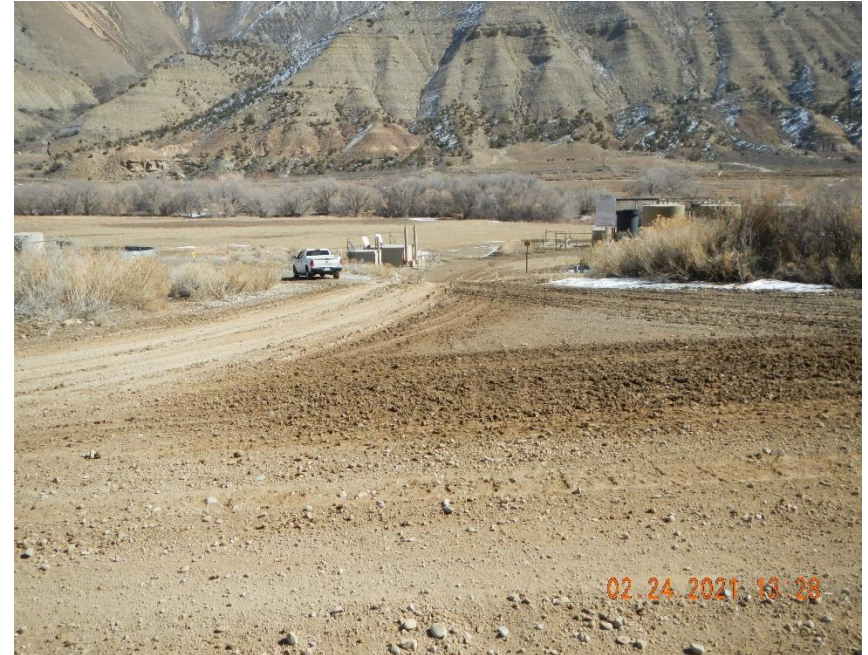
No evidence of tracking control BMP's

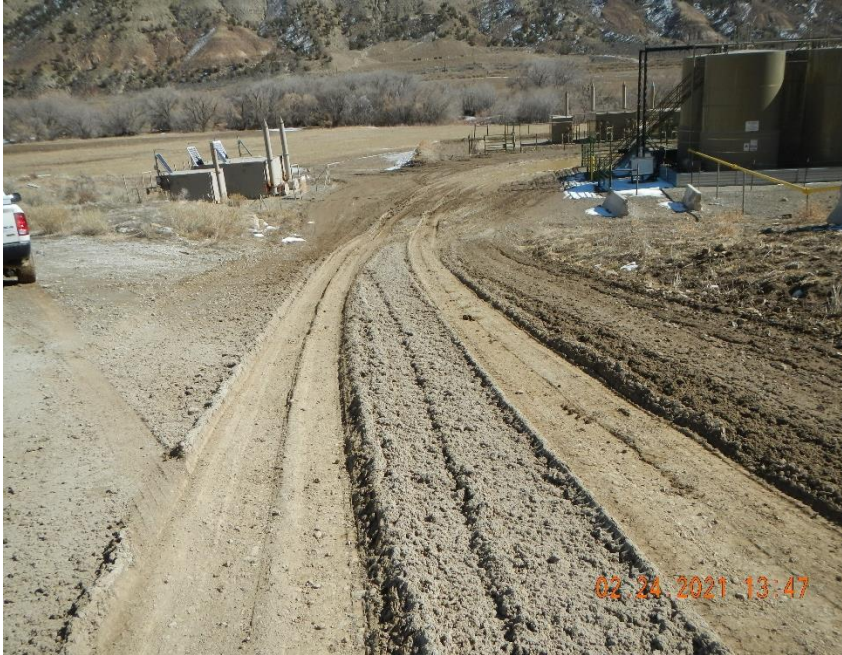
**Access road shows signs of lack of stabilization
BMP's in some areas (rutting is present).**

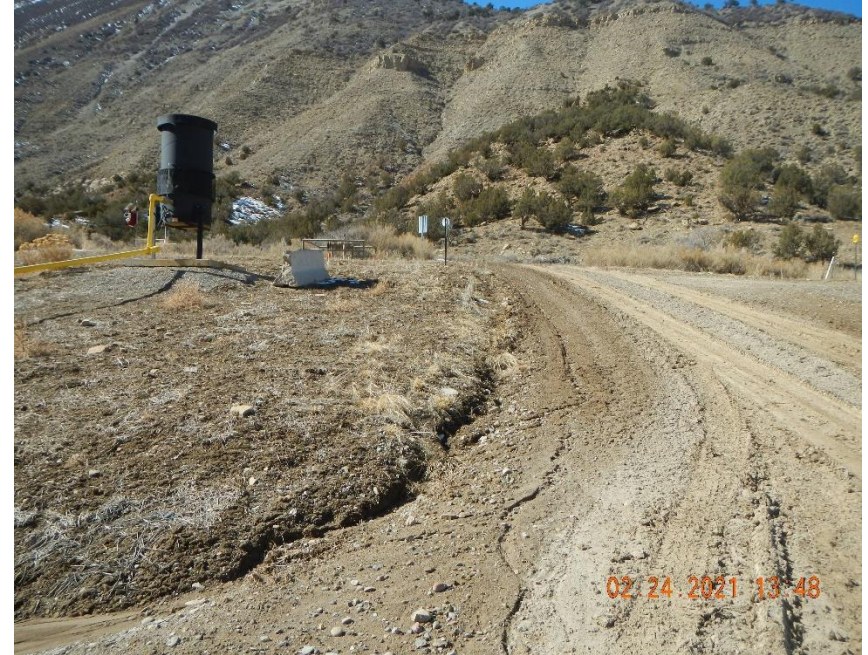
**Access road shows signs of lack of stabilization
BMP's in some areas (rutting is present).**

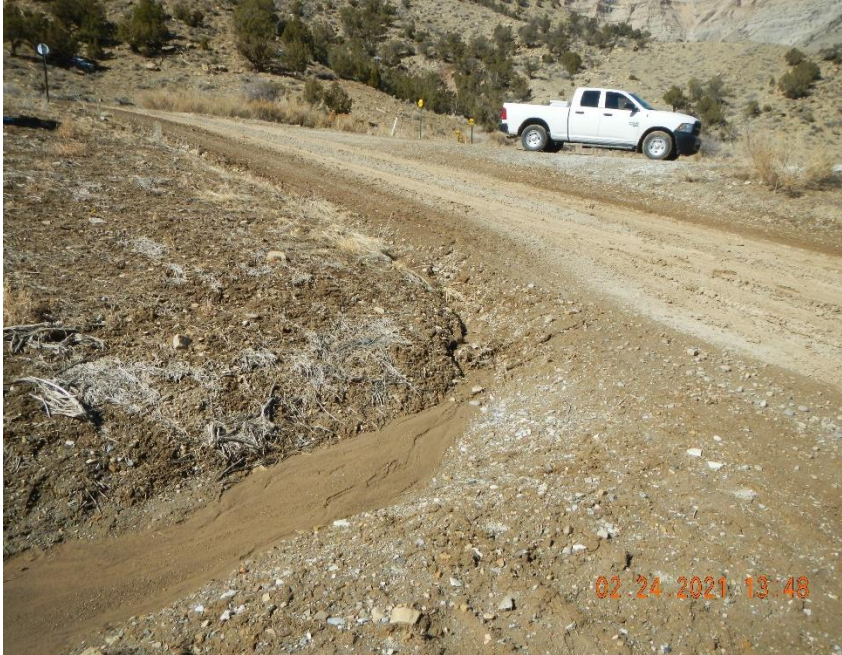
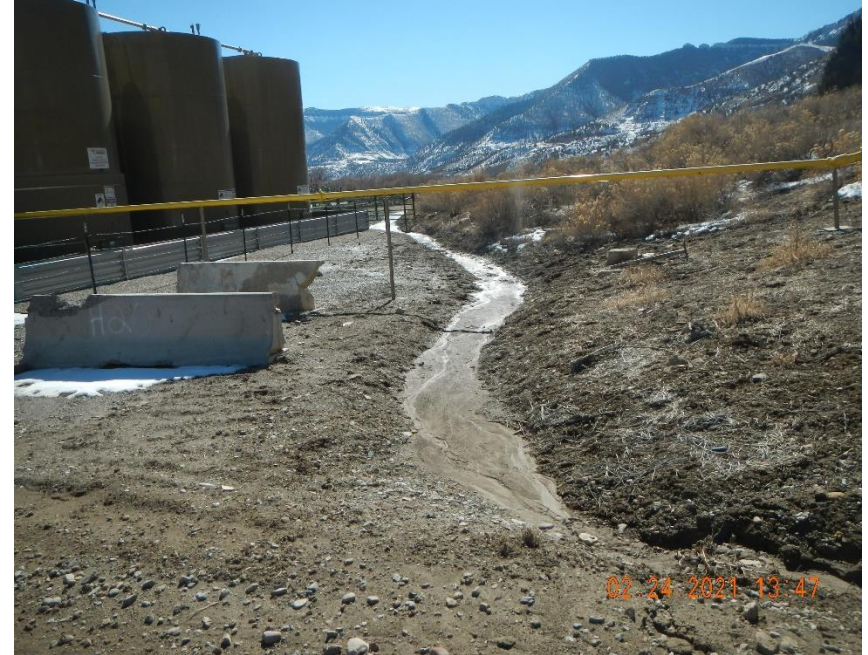
**Sediment build up in ditch from entrance
running behind location.**

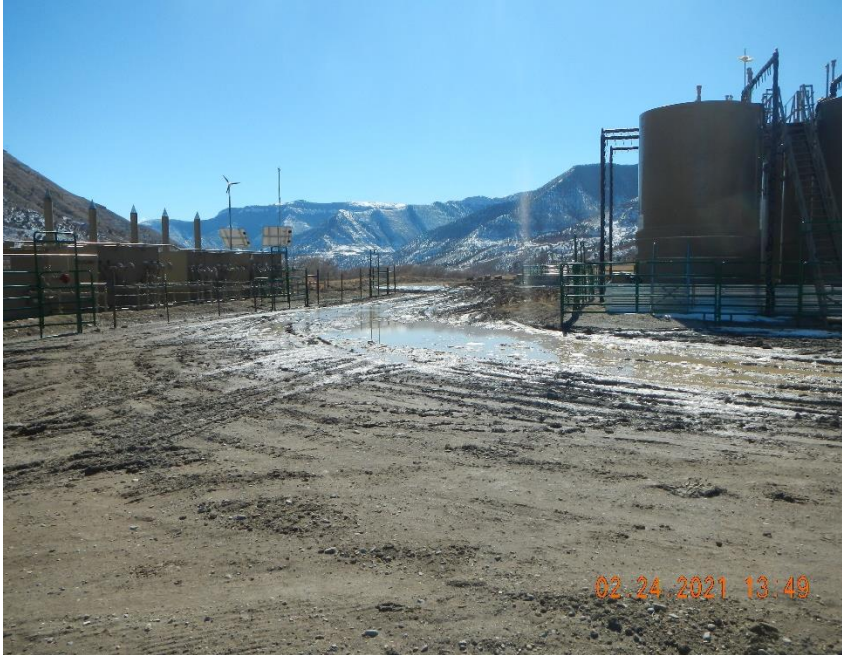
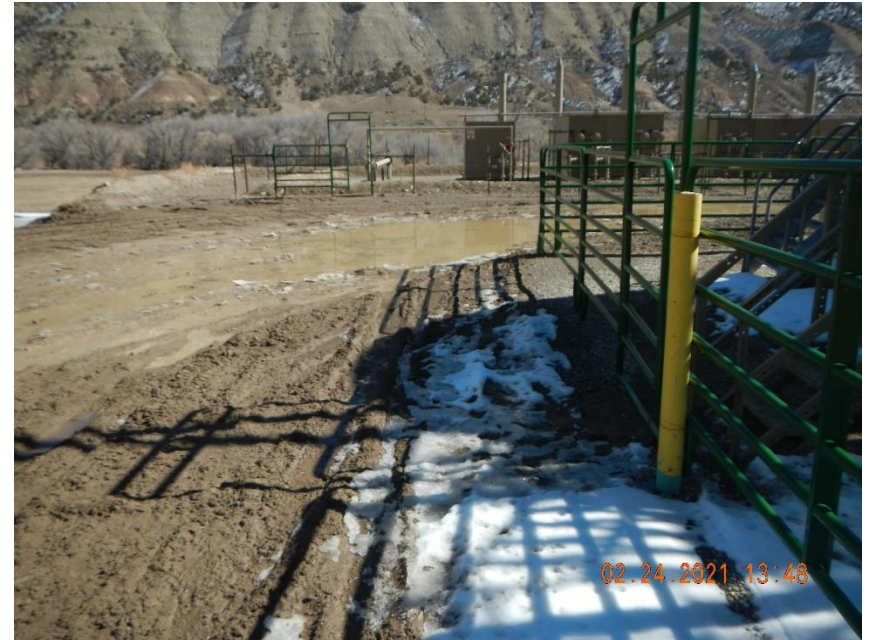
**Location shows signs of lack of stabilization
BMP's in some areas (rutting is present).**

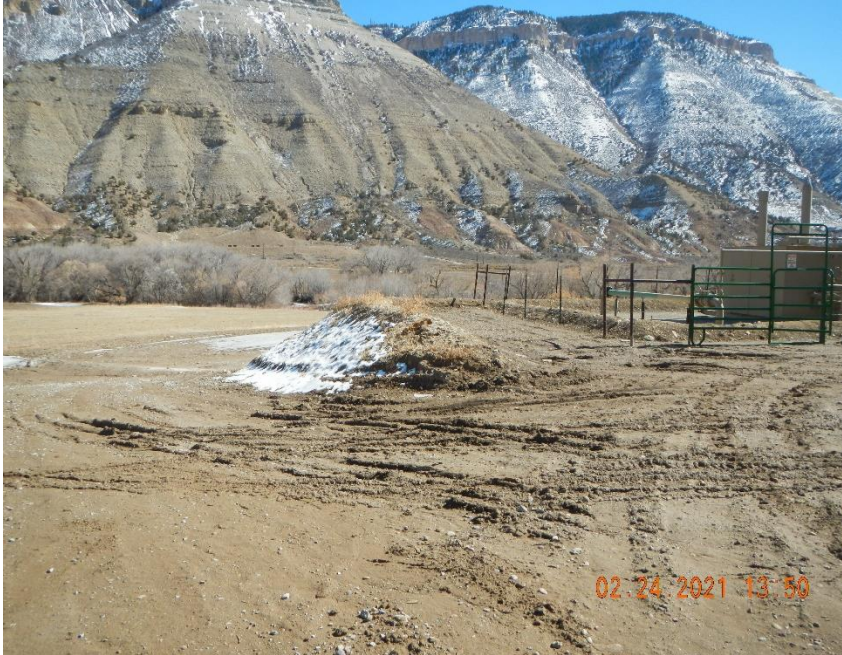
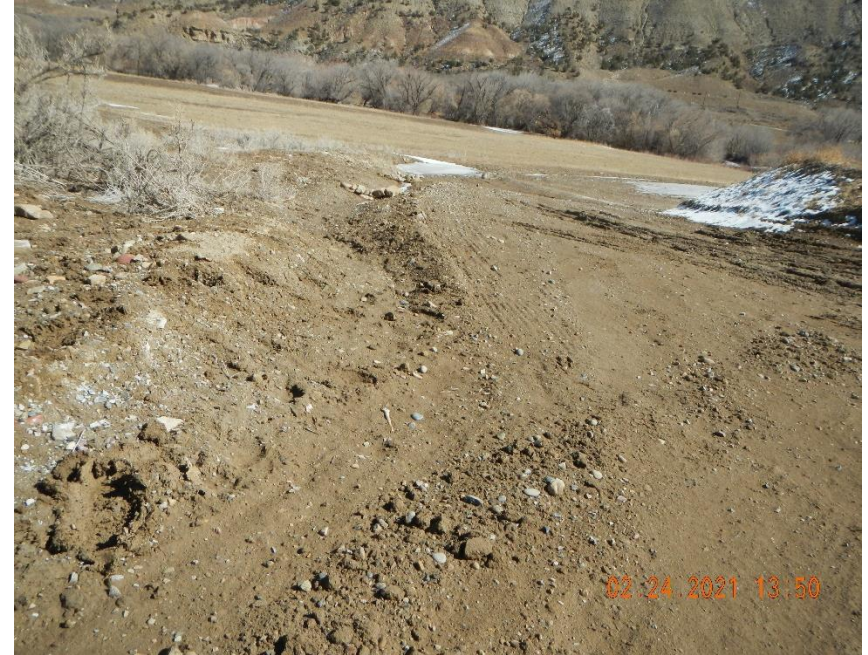
**Location shows signs of lack of stabilization
BMP's in some areas (rutting is present).**

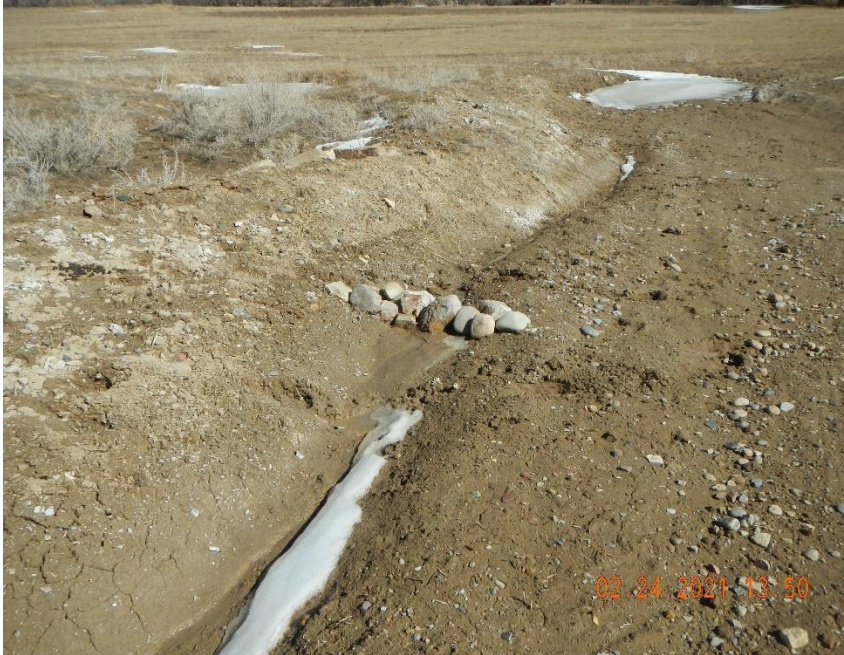
Ditch along road to lower well pad loosely compacted.

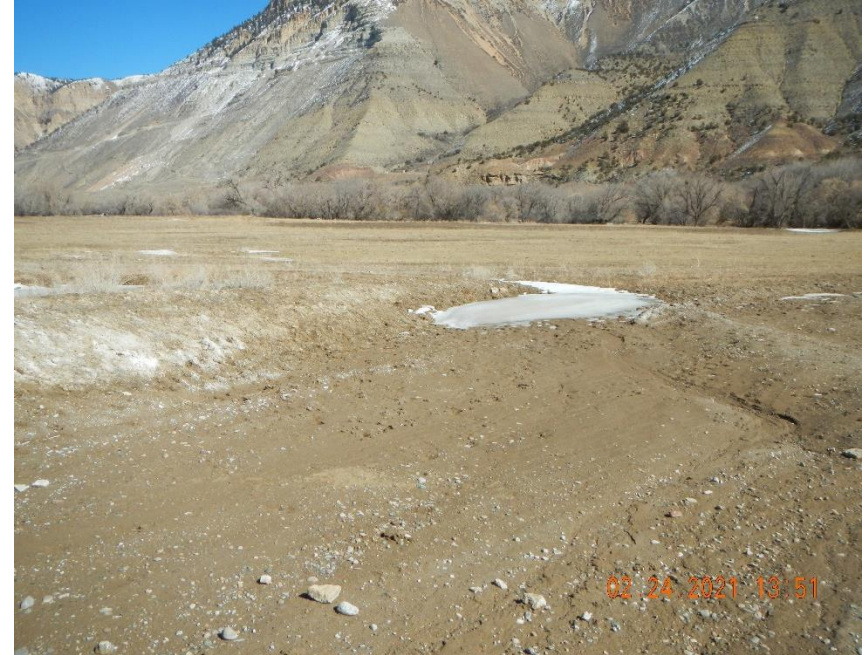
Sediment movement down road to lower pad.

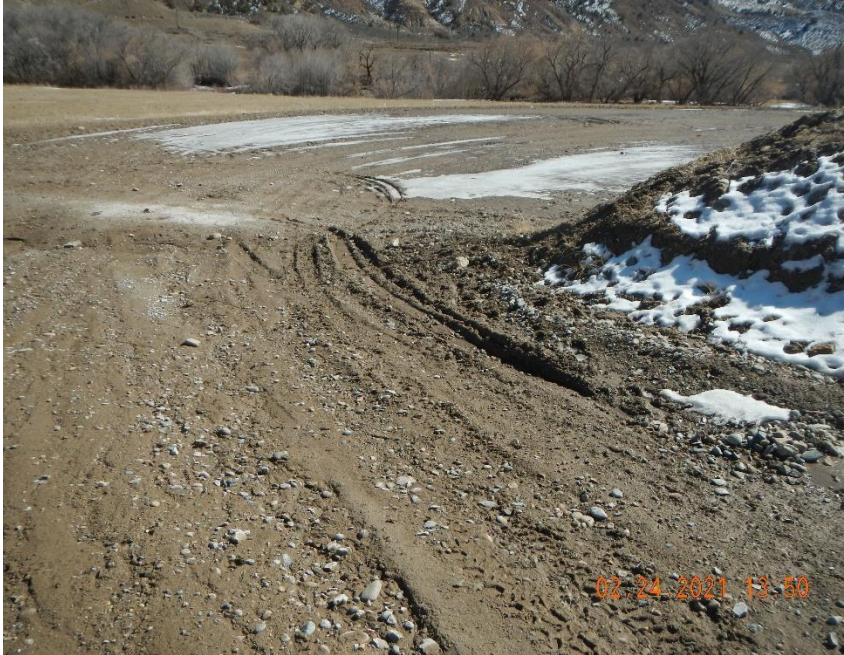
**Road and location shows signs of lack of stabilization
BMP's in some areas (rutting is present).**

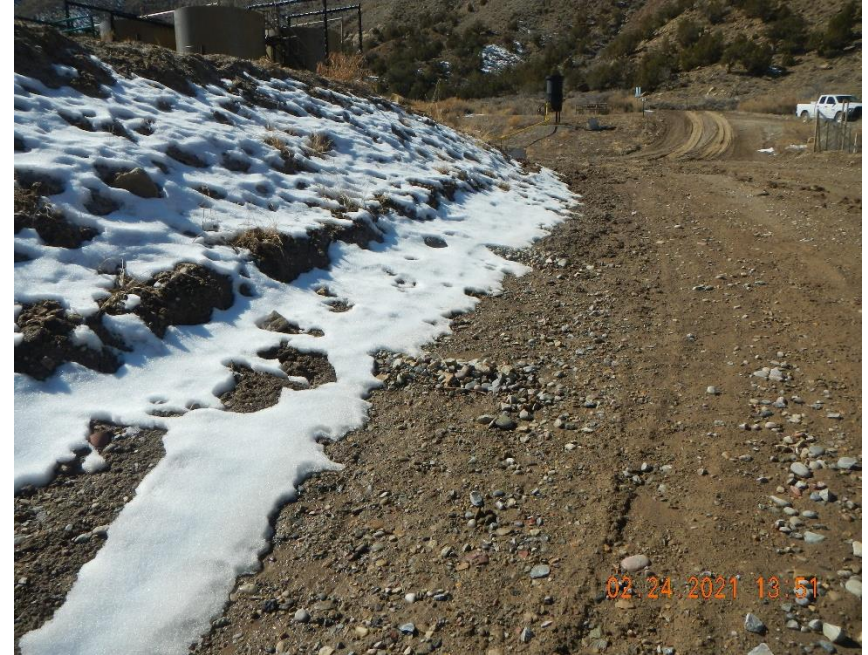
Ditch along road to lower well pad needs maintained.

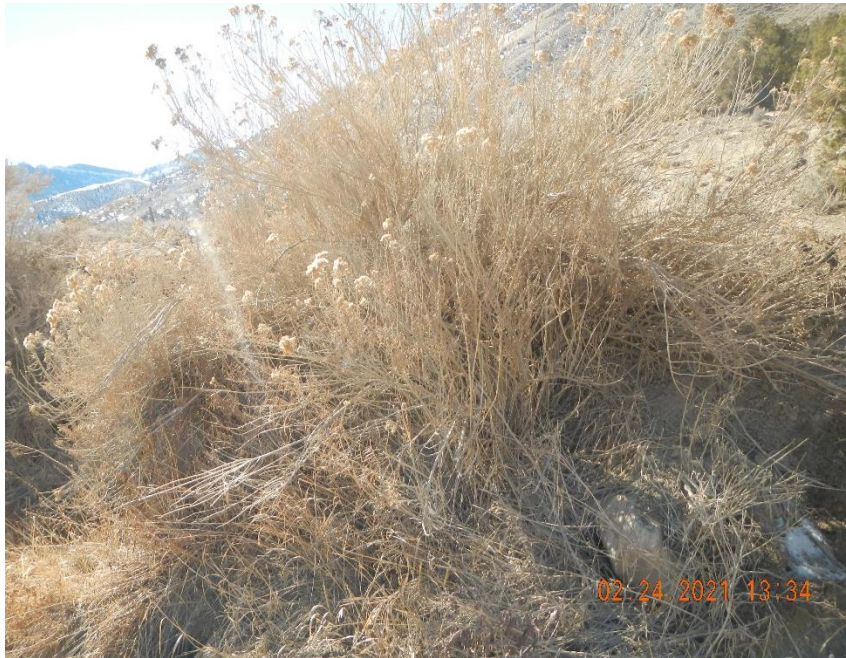
Unable to see culvert outlet.

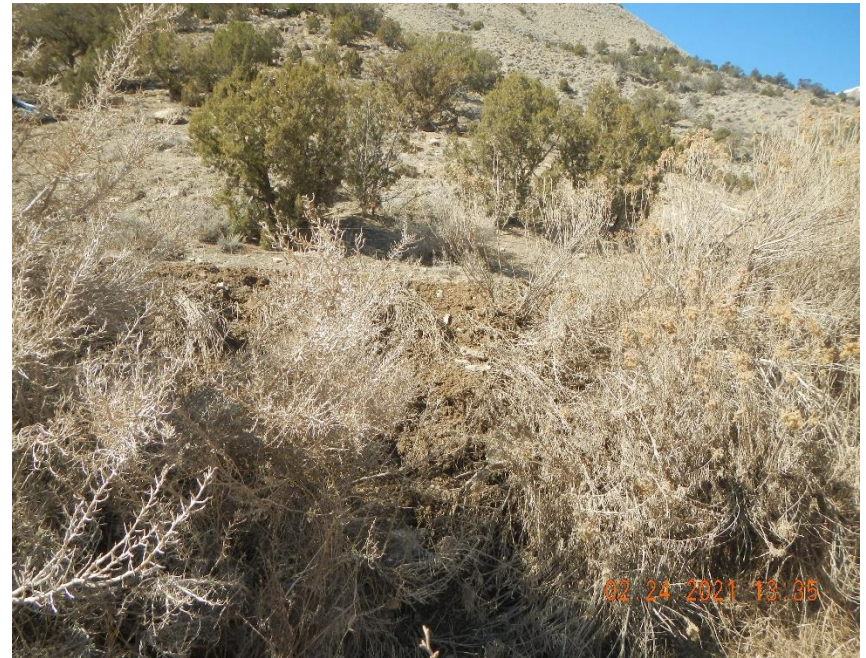
Sediment being bladed off shoulder of road.
