TEP ROCKY MOUNTAIN LLC
CHEVRON-66S96W 8NWSW
Location # 335619

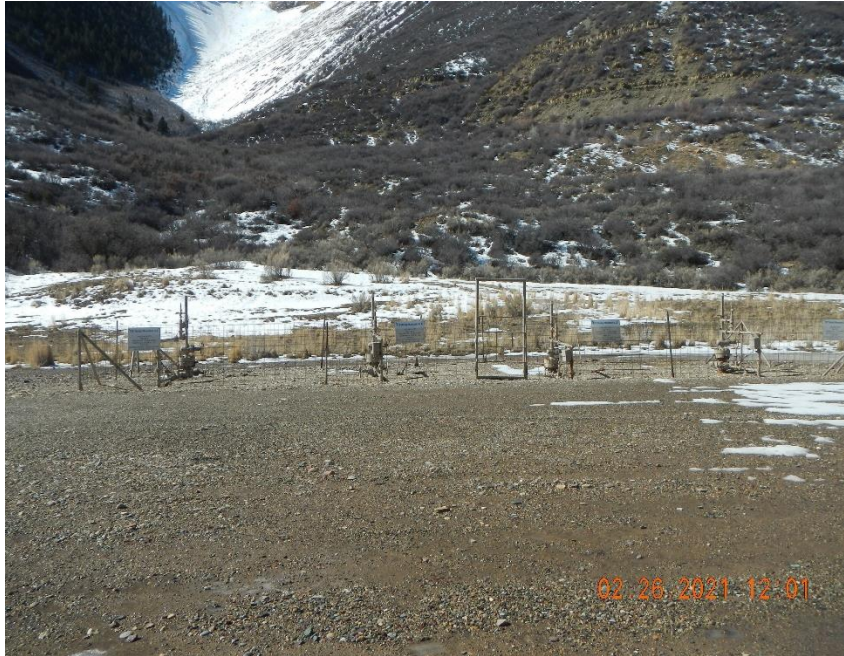
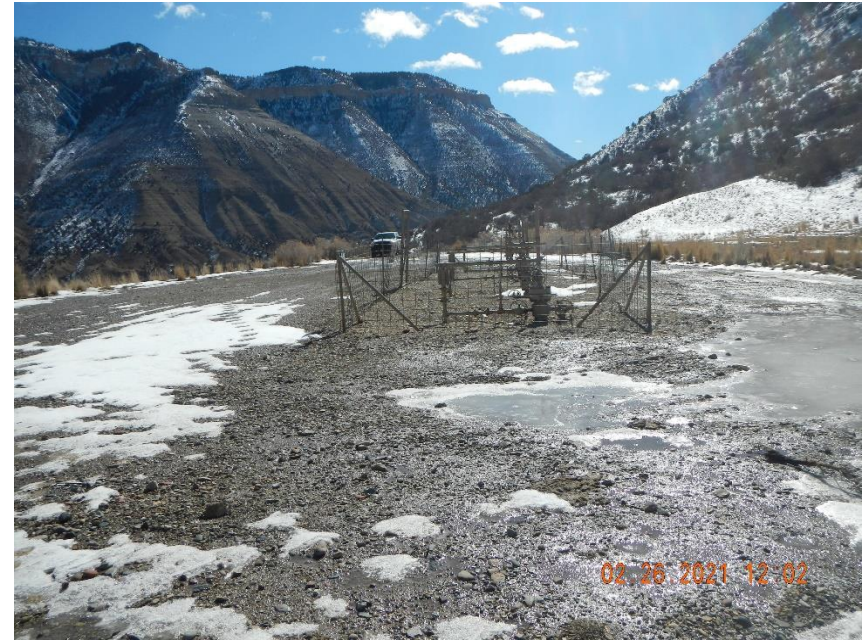
Location has impoundment of storm water.

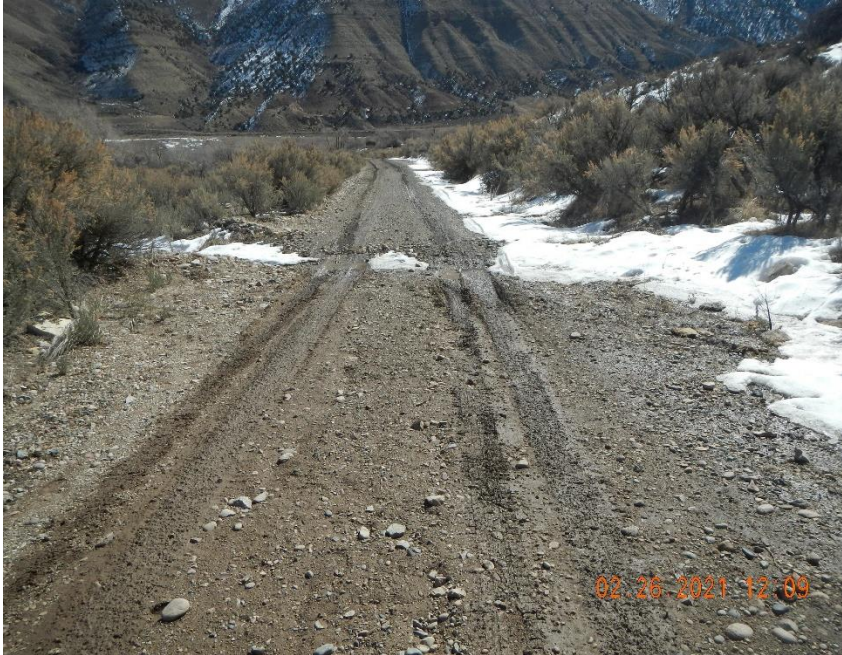
Drain crossing road. Access road shows signs of lack of stabilization BMP's in some areas (rutting is present).

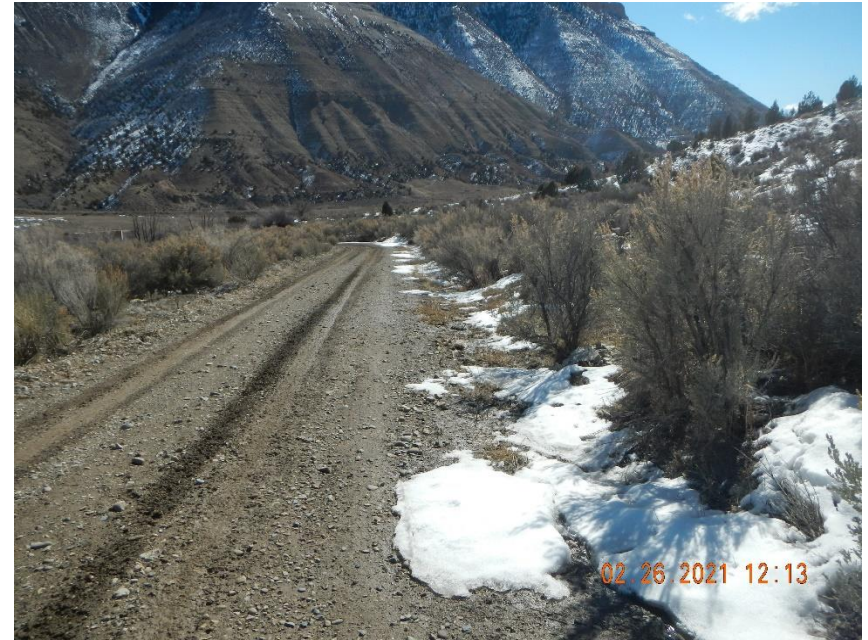
Ditch needs maintained.

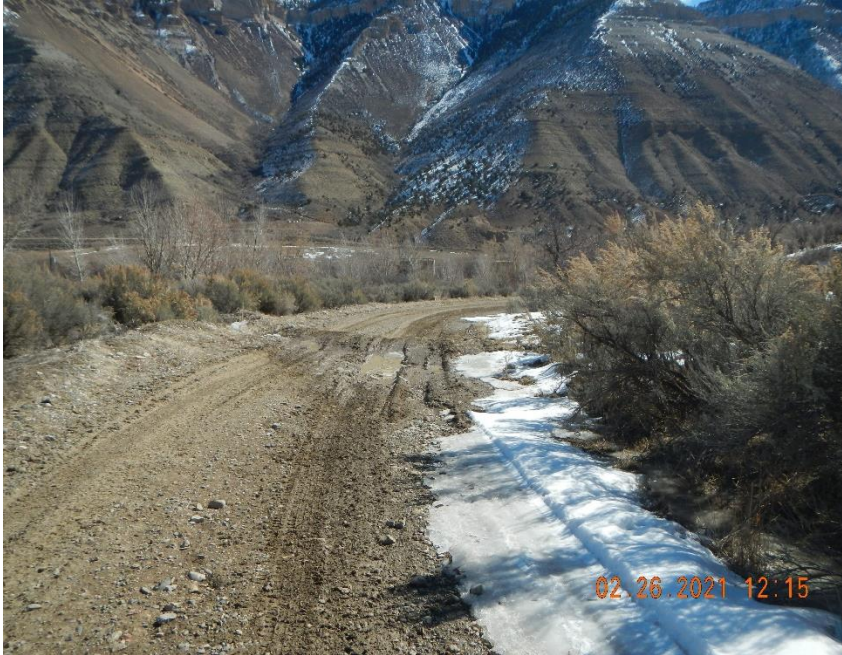
Drain crossing road. Access road shows signs of lack of stabilization BMP's in some areas (rutting is present).

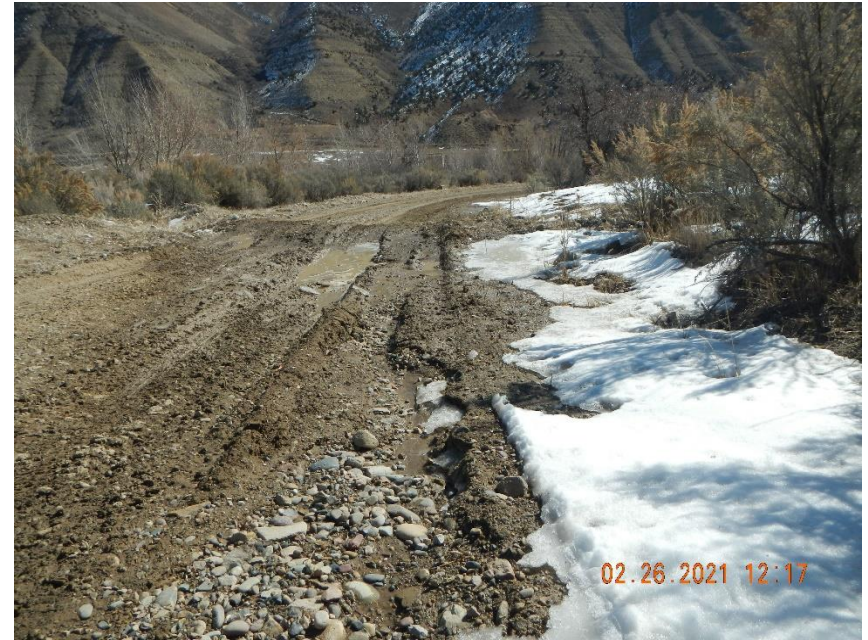
Ditch needs maintained.

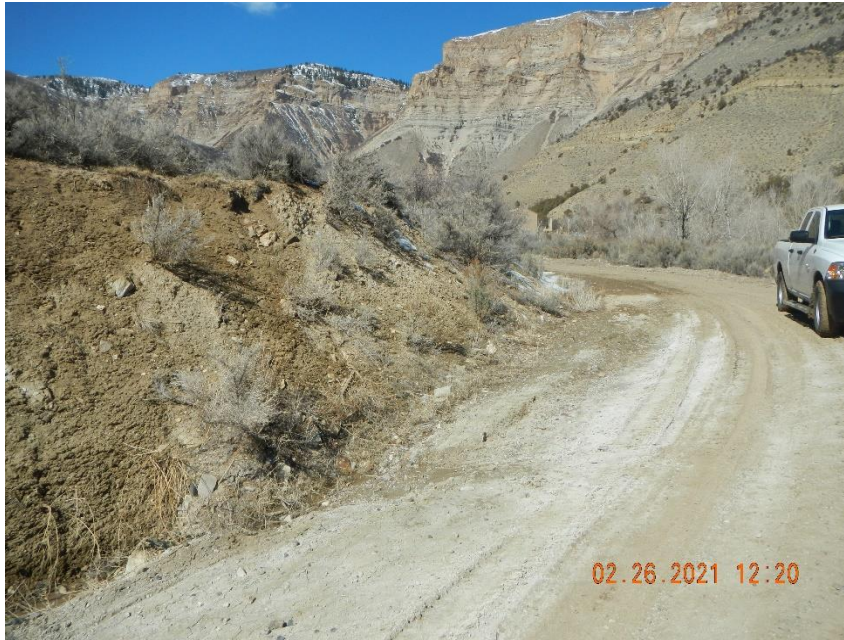
Ditch needs maintained.

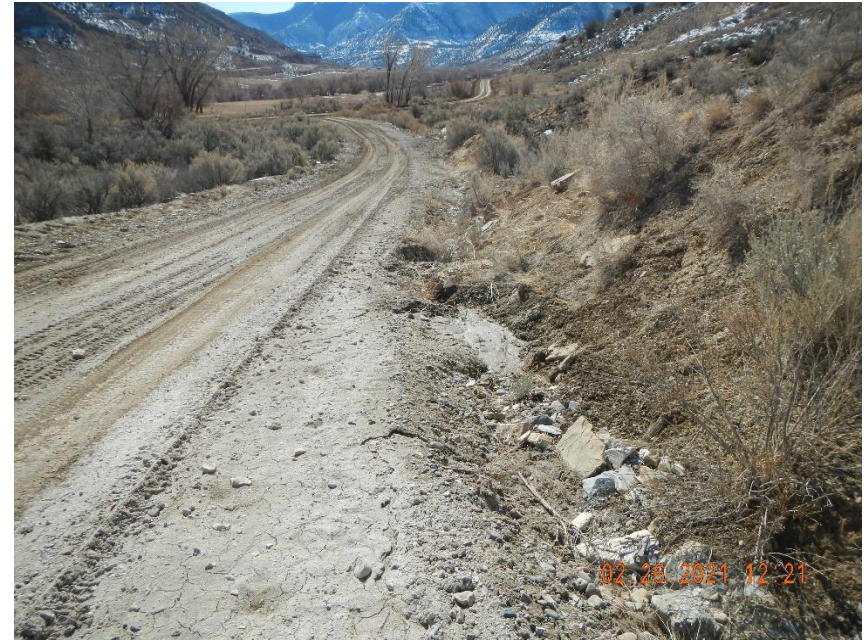
Ditch needs maintained.

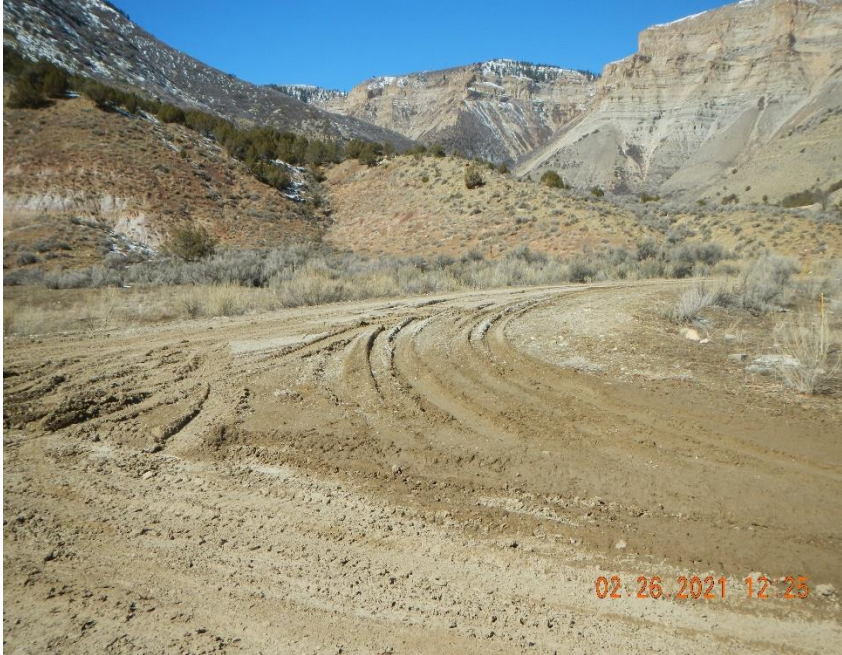
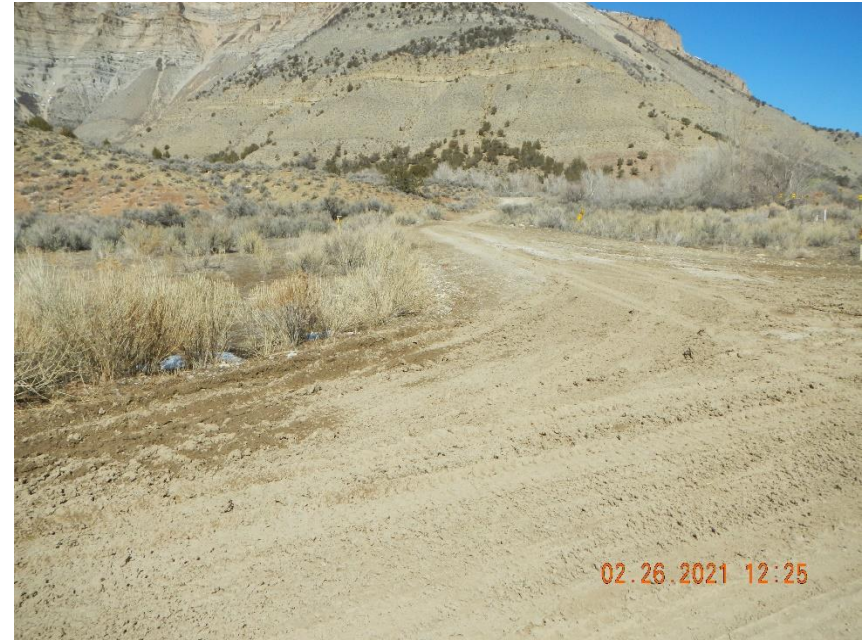
No evidence of tracking BMPs. Access road shows signs of lack of stabilization BMP's in some areas (rutting is present).

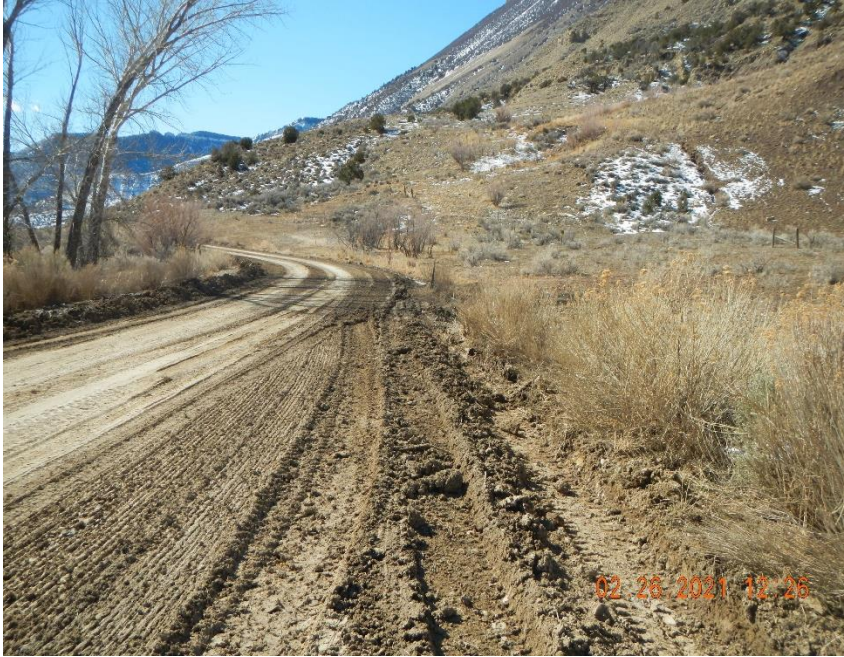
Ditch needs maintained.

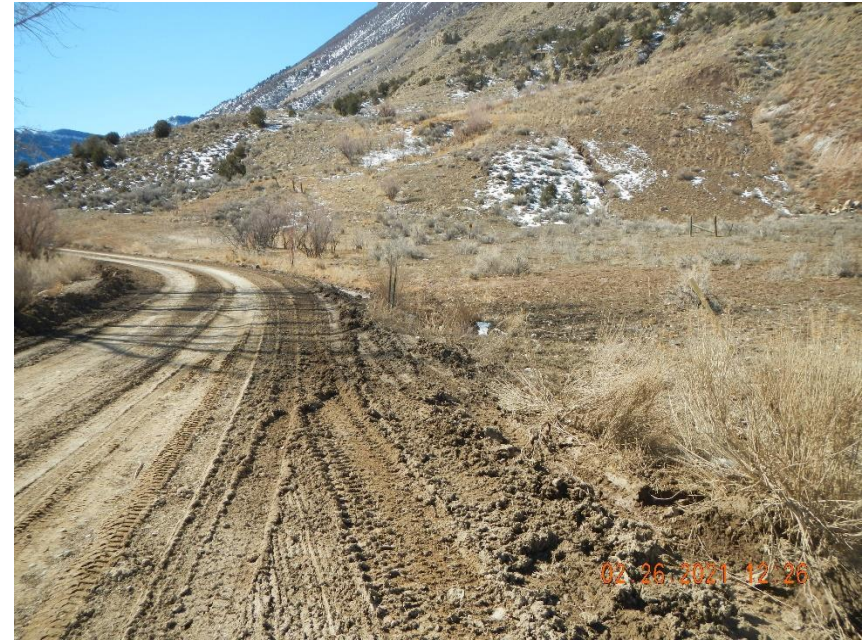
**Access road shows signs of lack of stabilization
BMP's in some areas (rutting is present).**

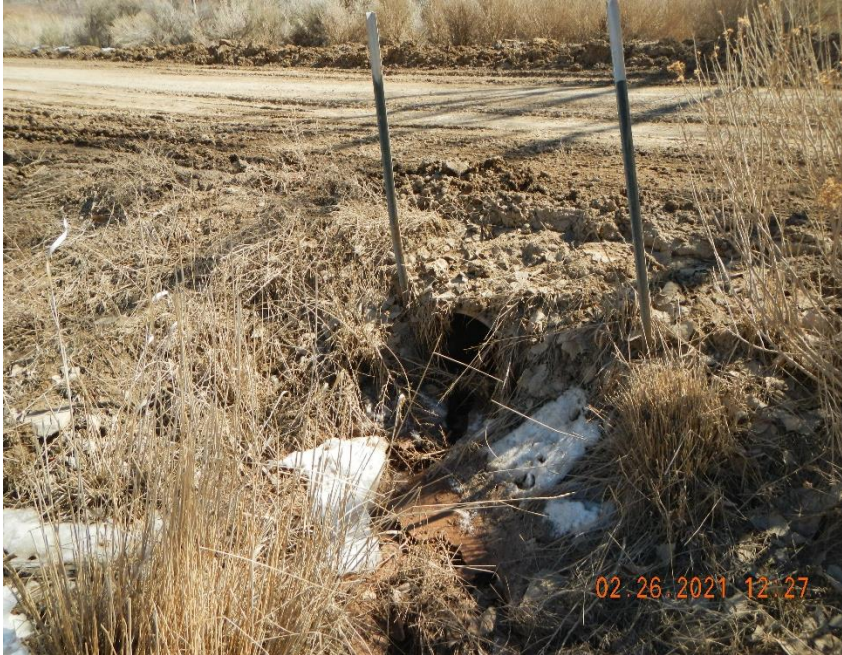
Culvert (39.53184 108.13021) Culvert basin needs maintained.

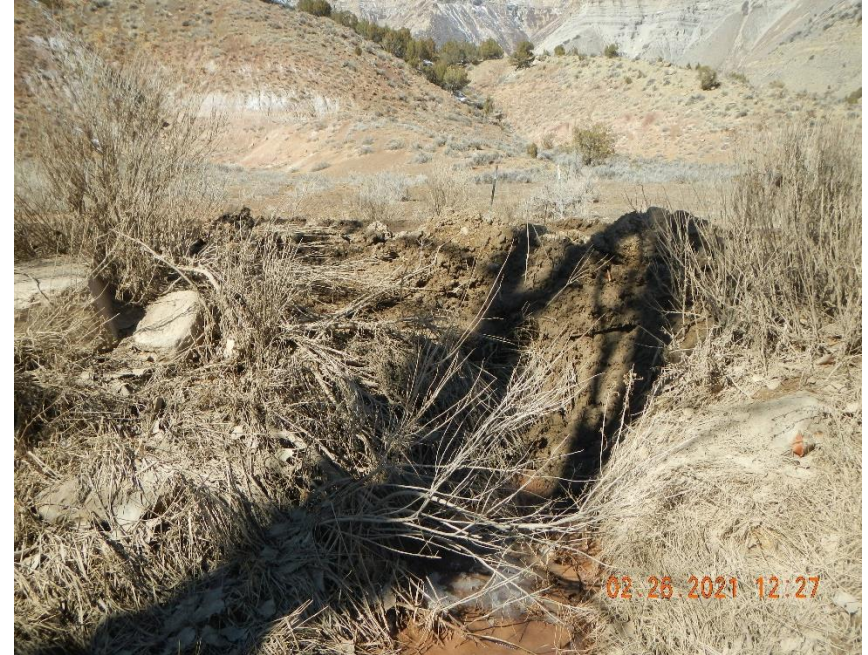
Culvert basin needs maintained.

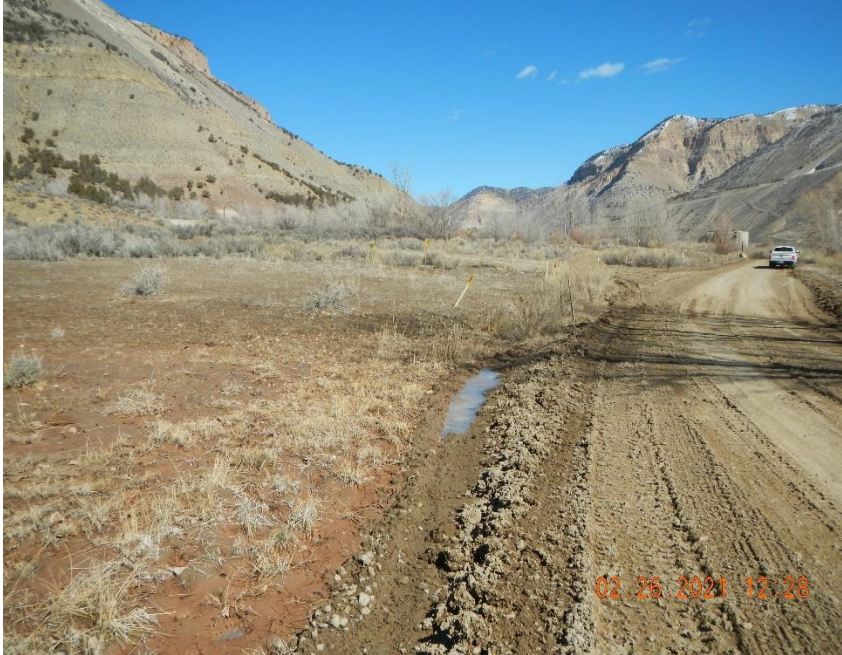
Ditch needs maintained.

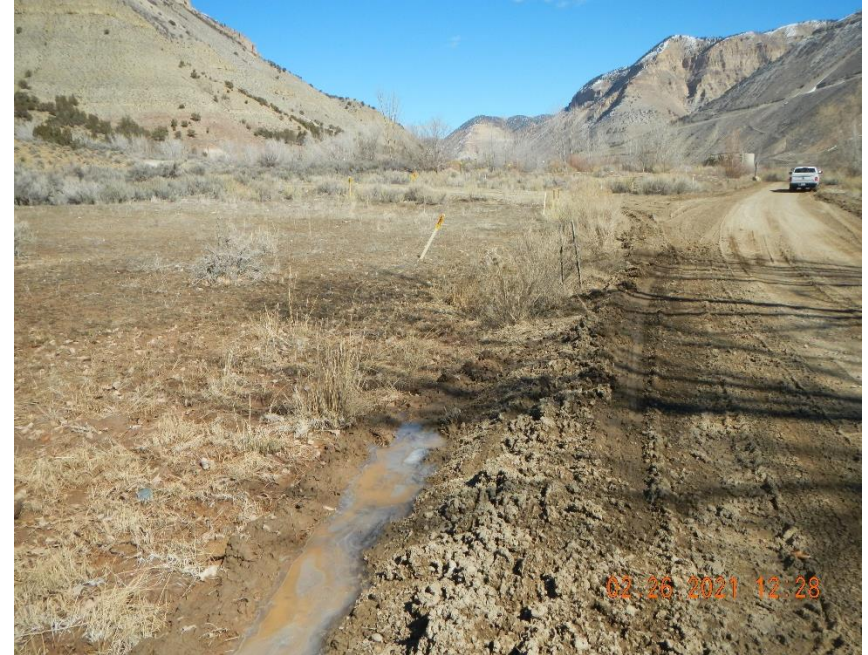
**Access road shows signs of lack of stabilization
BMP's in some areas (rutting is present).**
