TEP ROCKY MOUNTAIN LLC

CHEVRON-66S96W 8SESE

Location # 335634

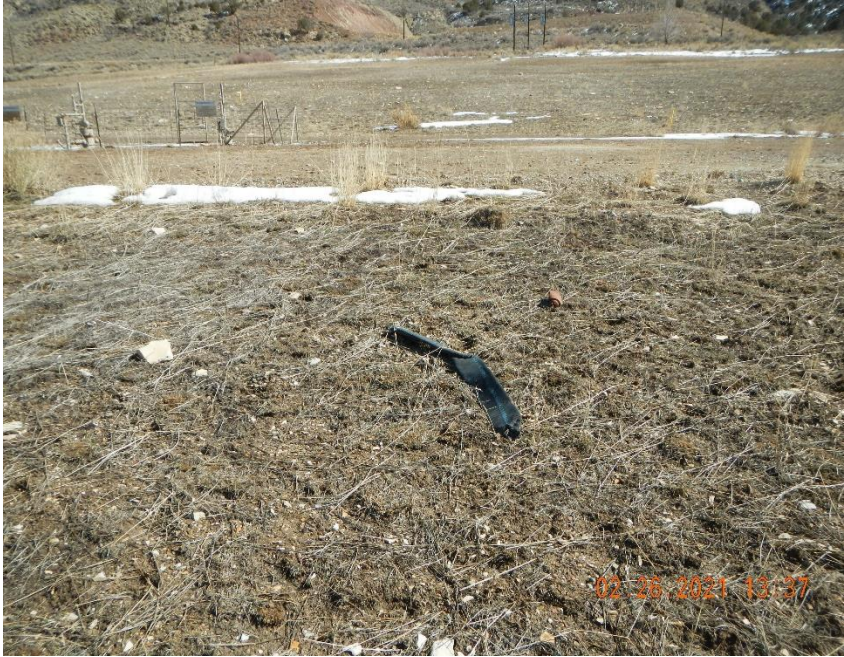
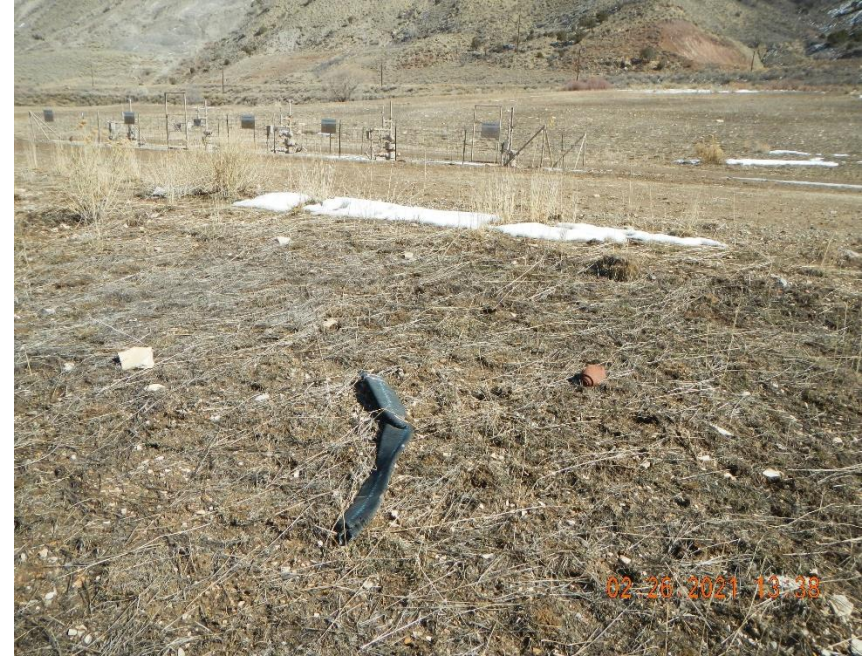
**Flattened water hose off the edge of
location.**

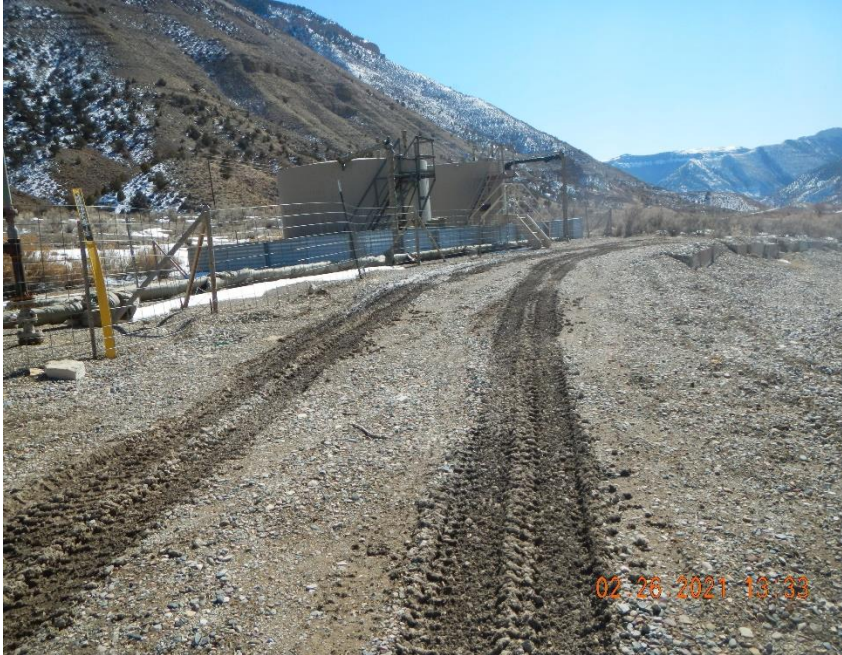
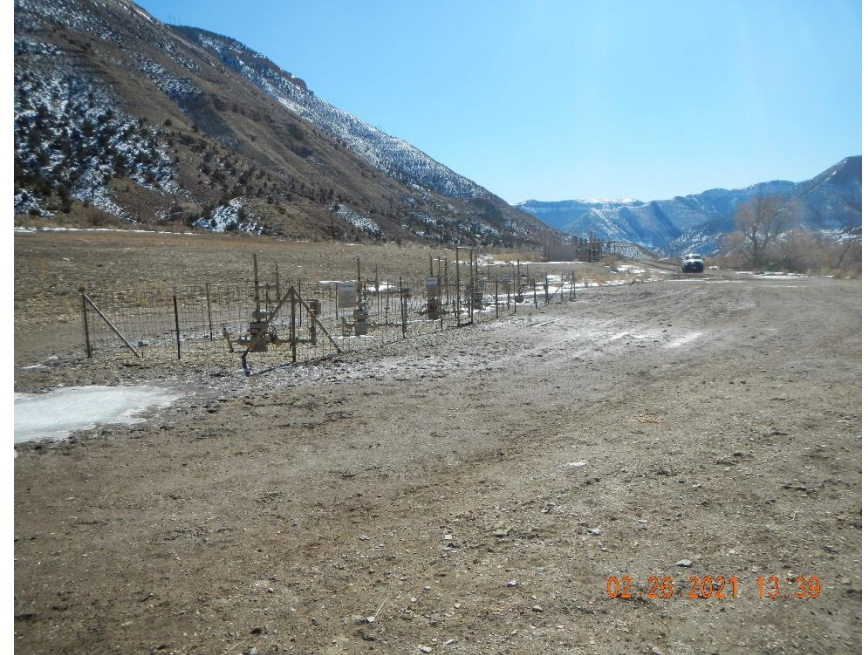
**Location shows signs of lack of stabilization
BMP's in some areas (rutting is present).**

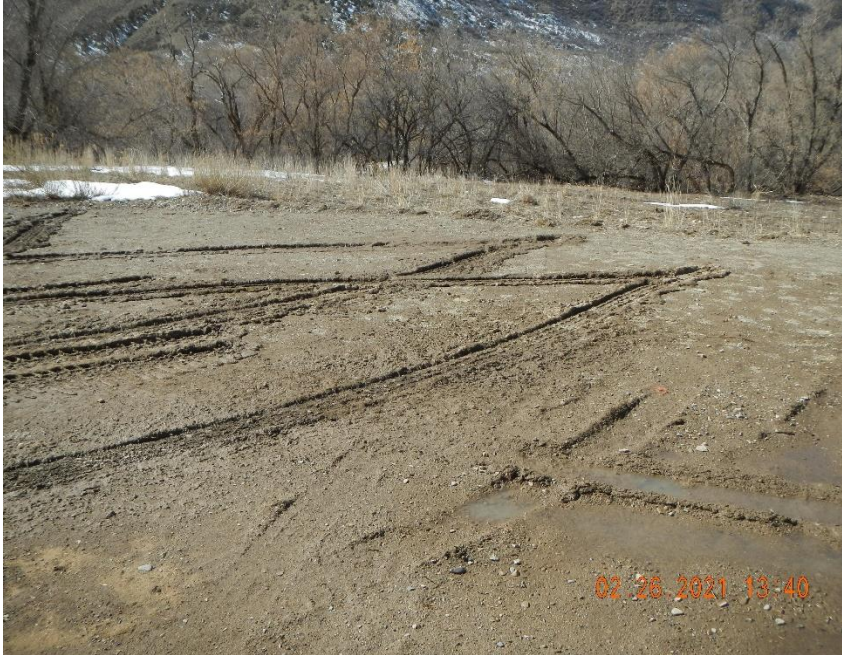
**Location shows signs of lack of stabilization
BMP's in some areas (rutting is present).**

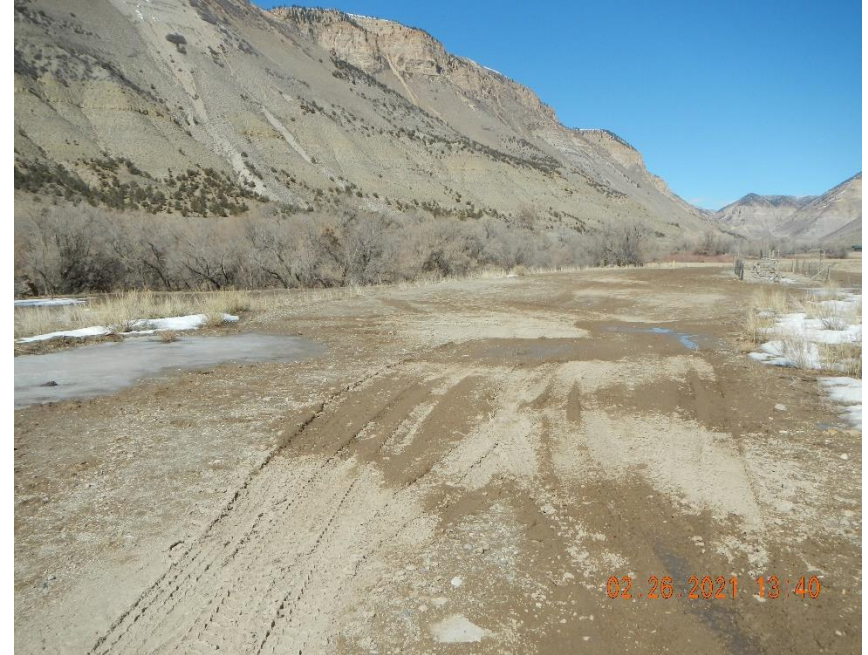
**Location shows signs of lack of stabilization
BMP's in some areas (rutting is present).**

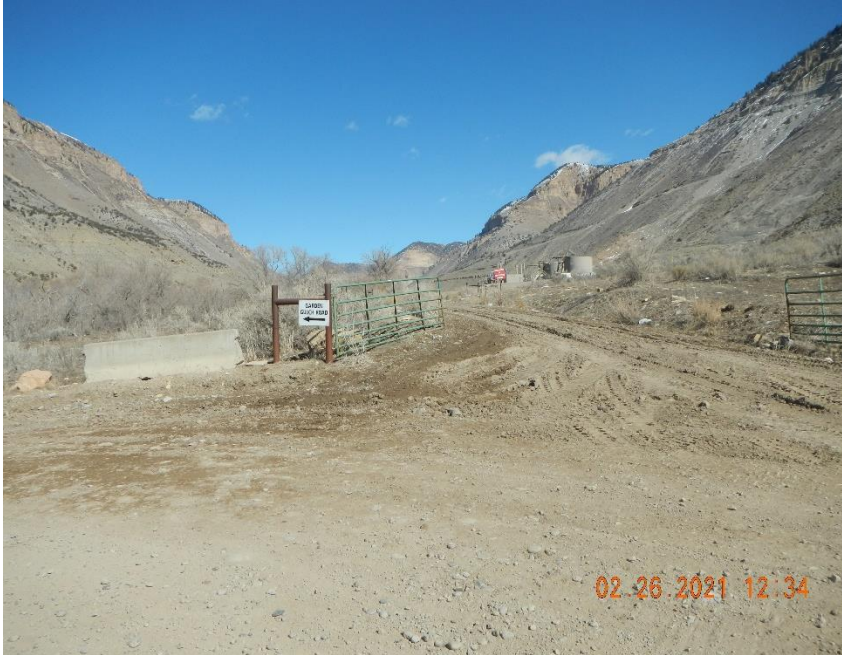
**Access road shows signs of lack of stabilization
BMP's in some areas (rutting is present).**

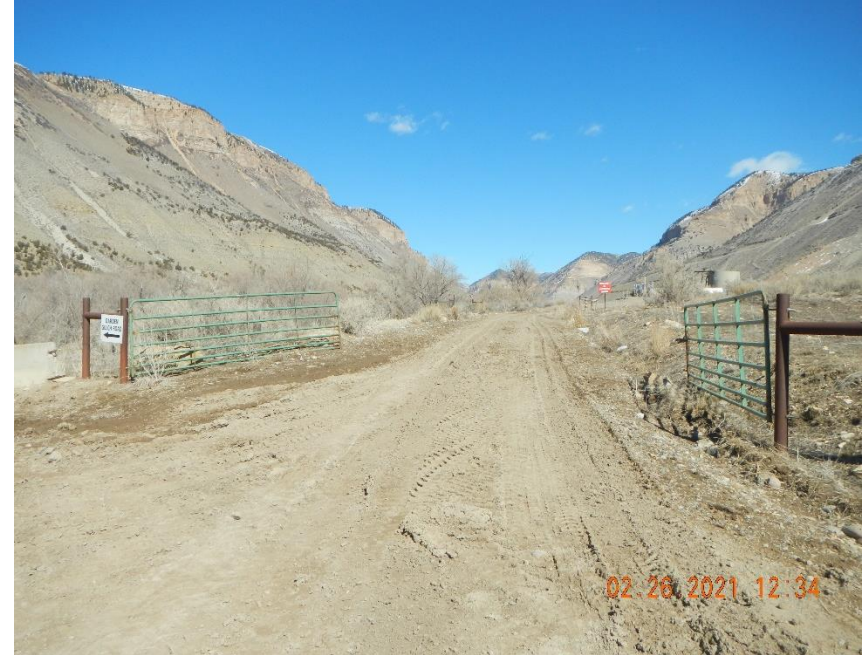
**Access road shows signs of lack of stabilization
BMP's in some areas (rutting is present).**

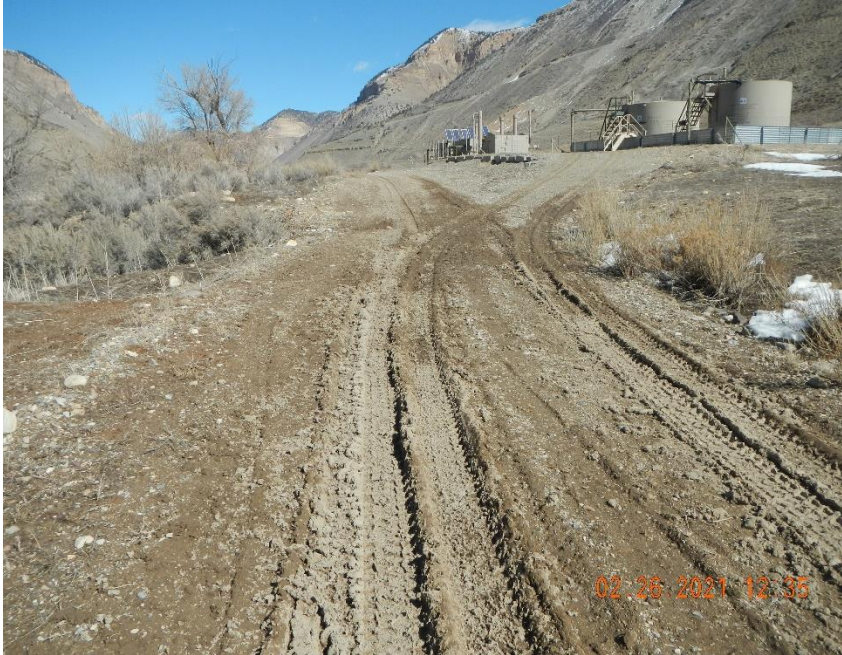
**Access road shows signs of lack of stabilization
BMP's in some areas (rutting is present).**

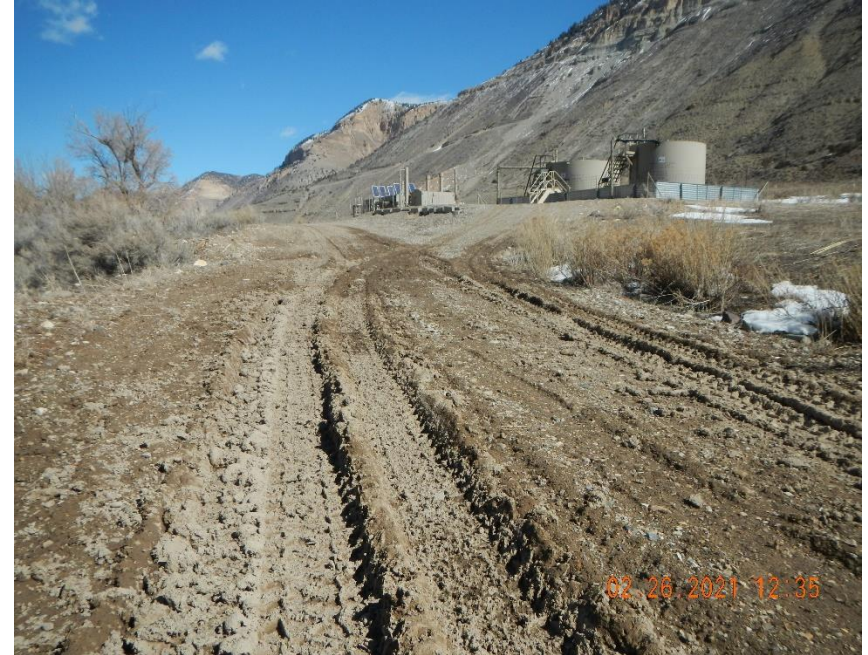
**Access road shows signs of lack of stabilization
BMP's in some areas (rutting is present).**

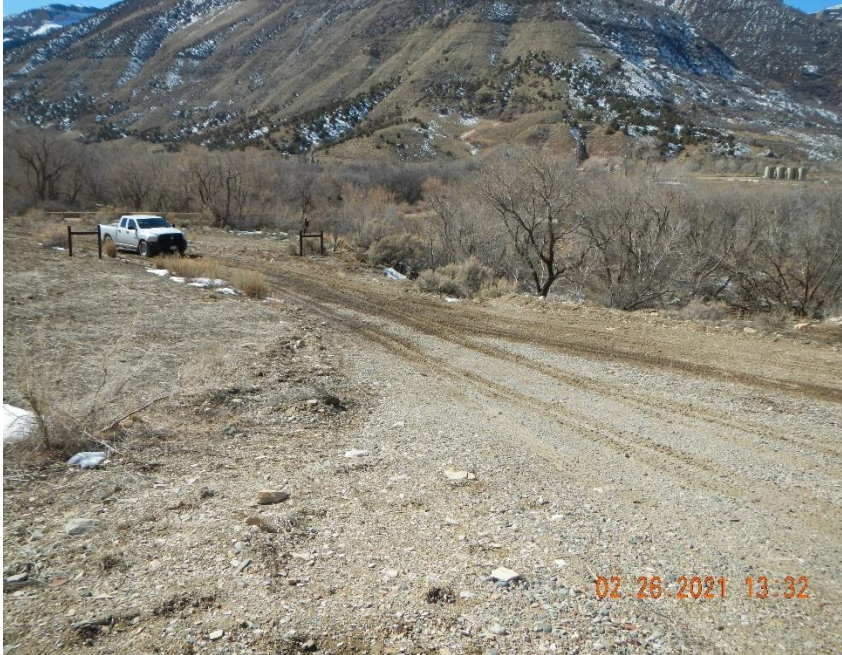
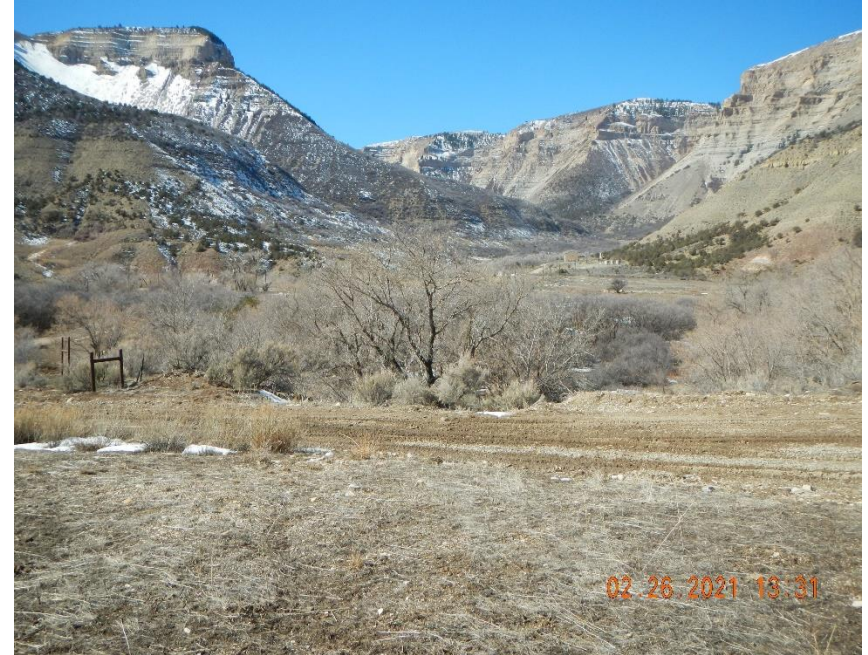
**Storm water draining over edge of access road
down eroded creek bank of Parachute Creek.**

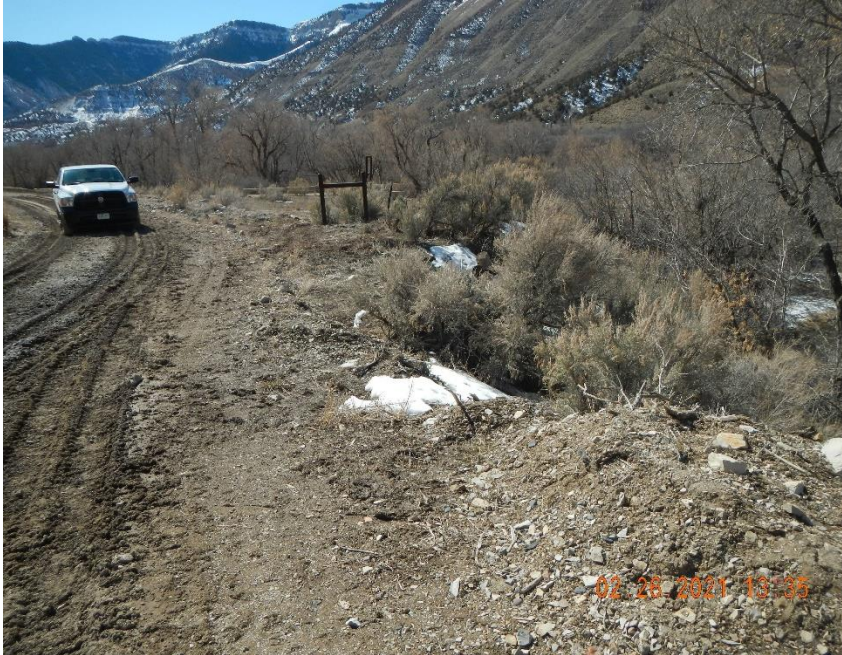
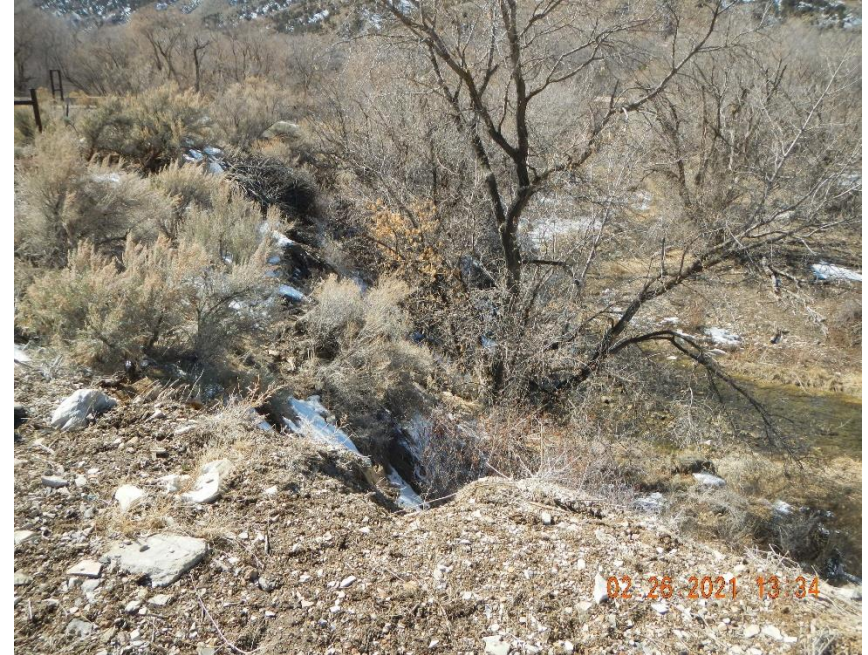
**Storm water draining over edge of access road
down eroded creek bank of Parachute Creek.**

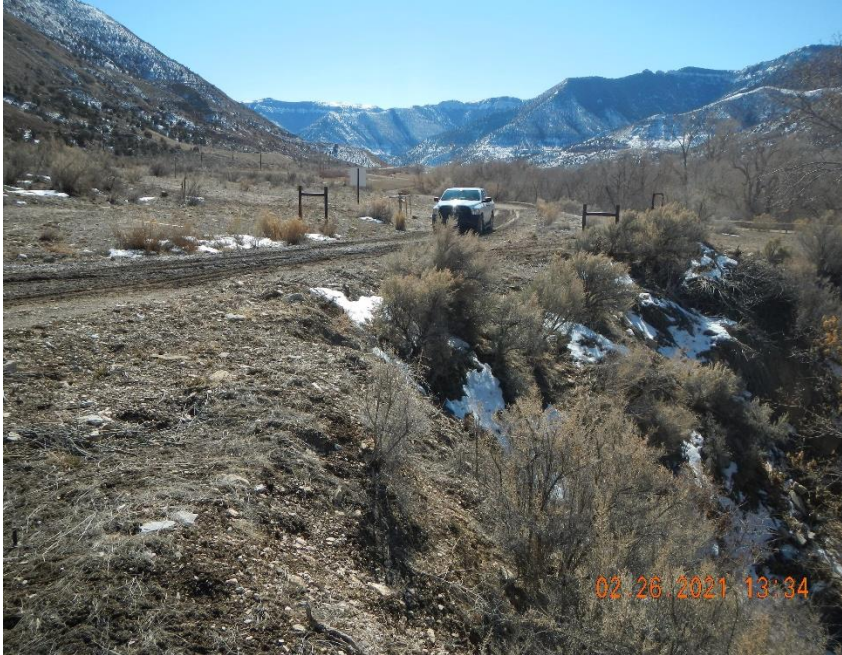
Access road along eroding creek bank.
