Inspection Photos

API: 071-08810

Operator: EVERGREEN NATURAL RESOURCES

Inspection Date: 3/1/2021

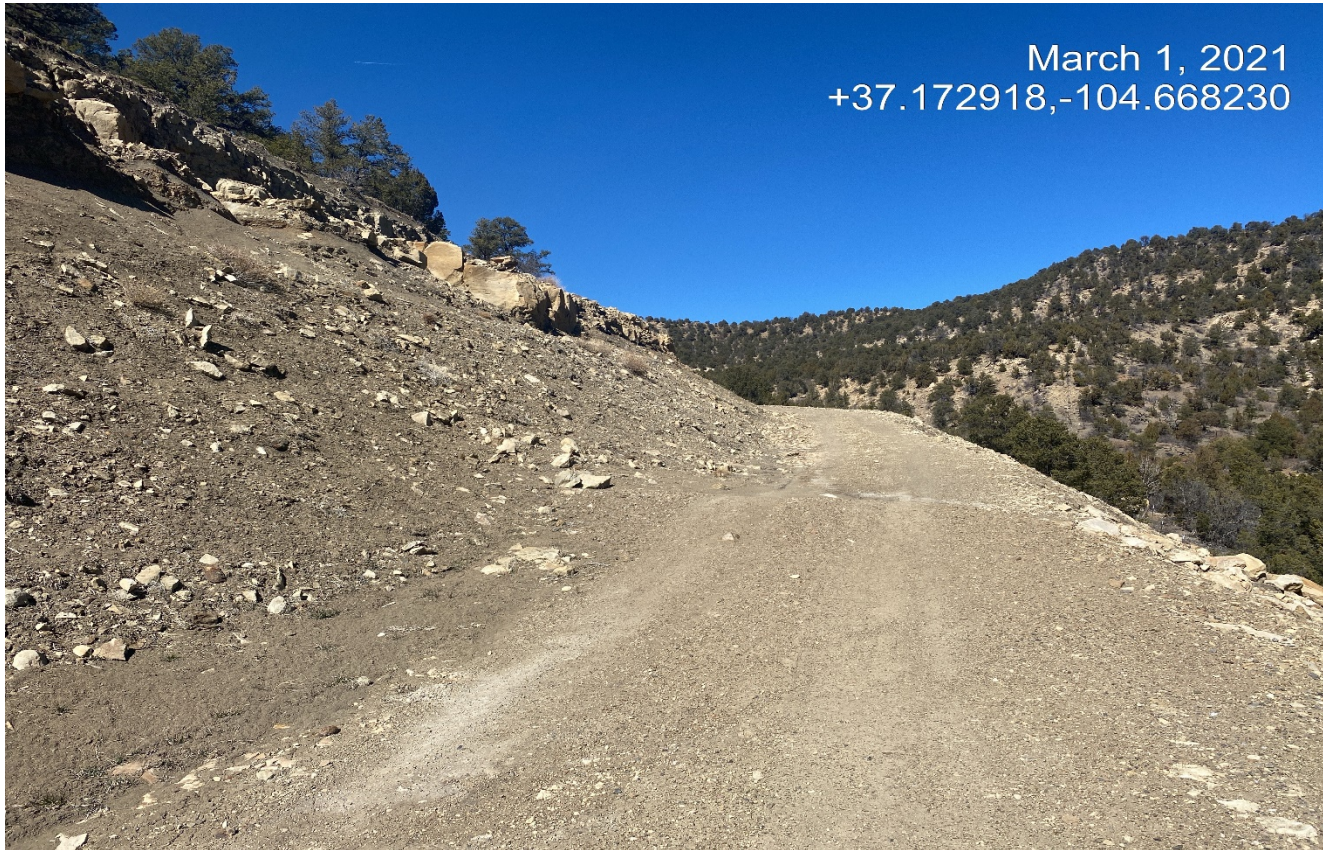
Photo 1. Facing north along the access road. The access road has not been recontoured and reclaimed.

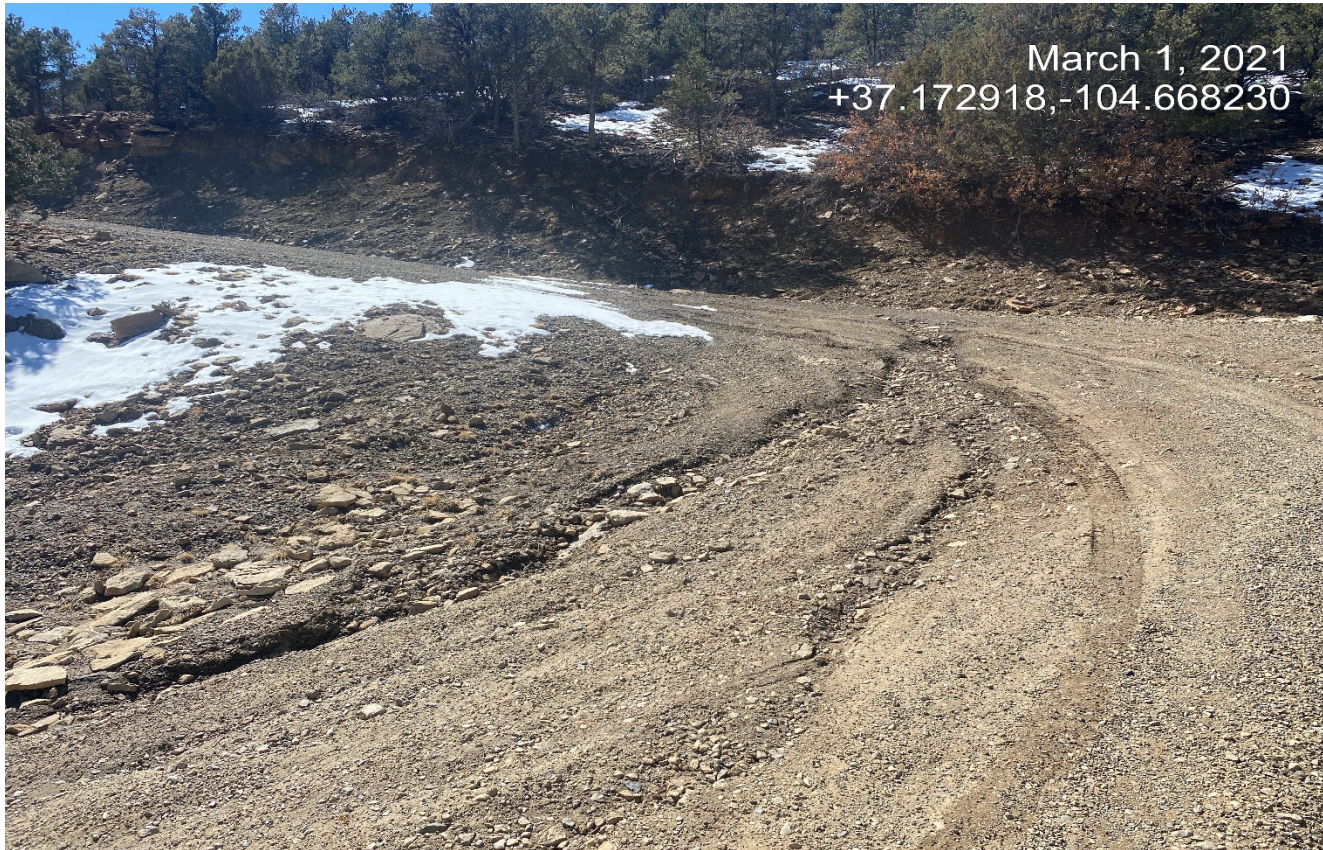
Photo 2. There is erosion along the switch back of the road. Stormwater is not being properly directed.

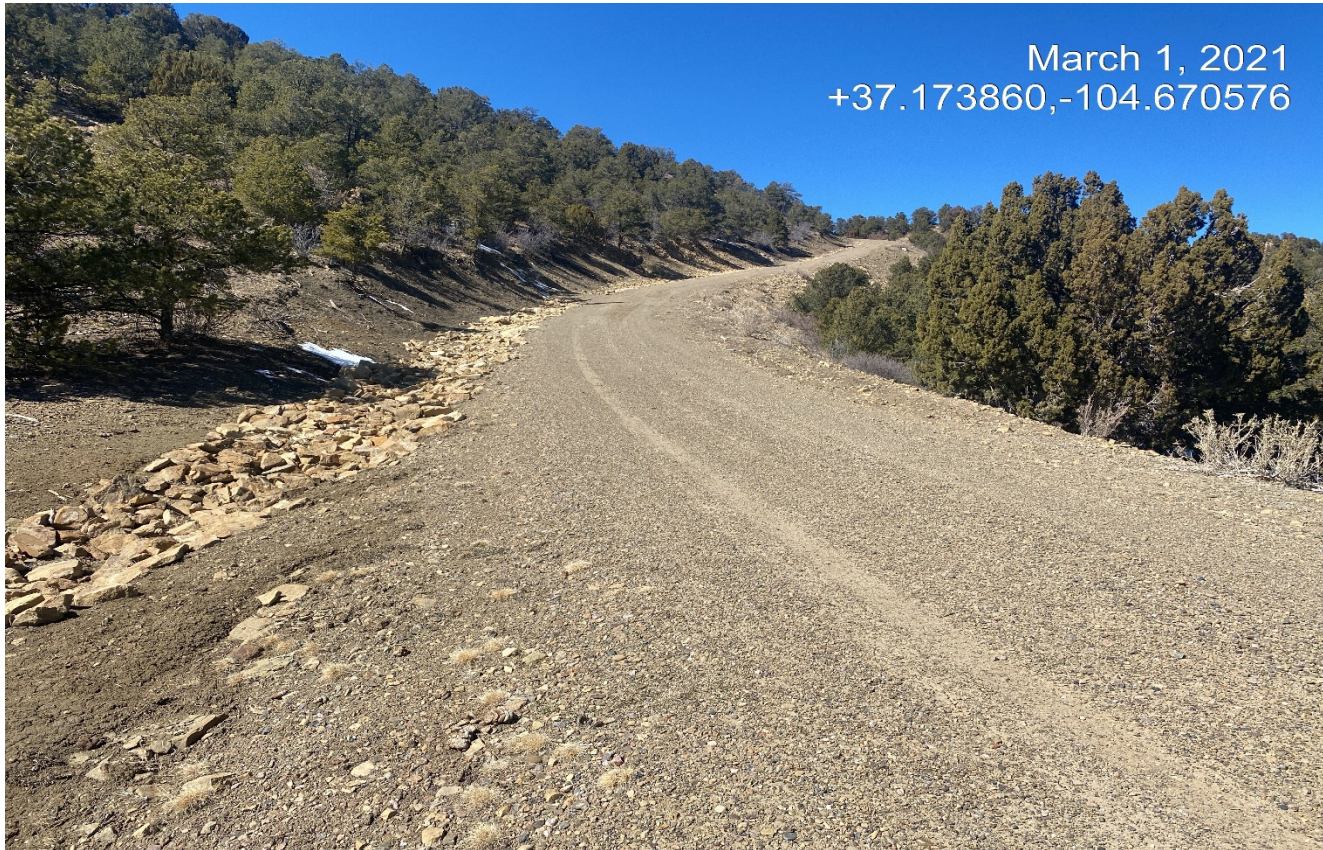
Photo 3. Facing northwest along the access road.

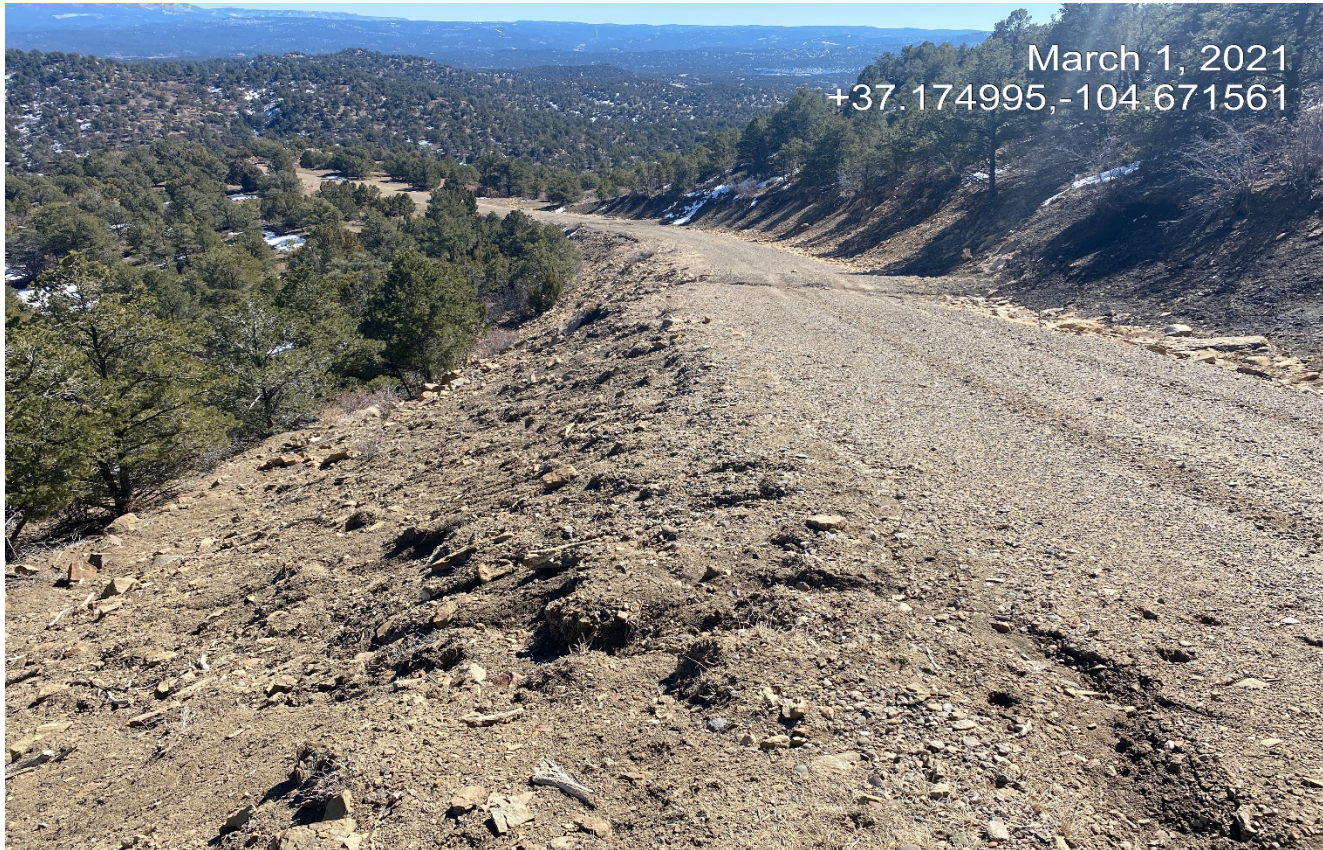
Photo 4. Facing back southeast along the access road. There is signs of erosion along the fill slope.

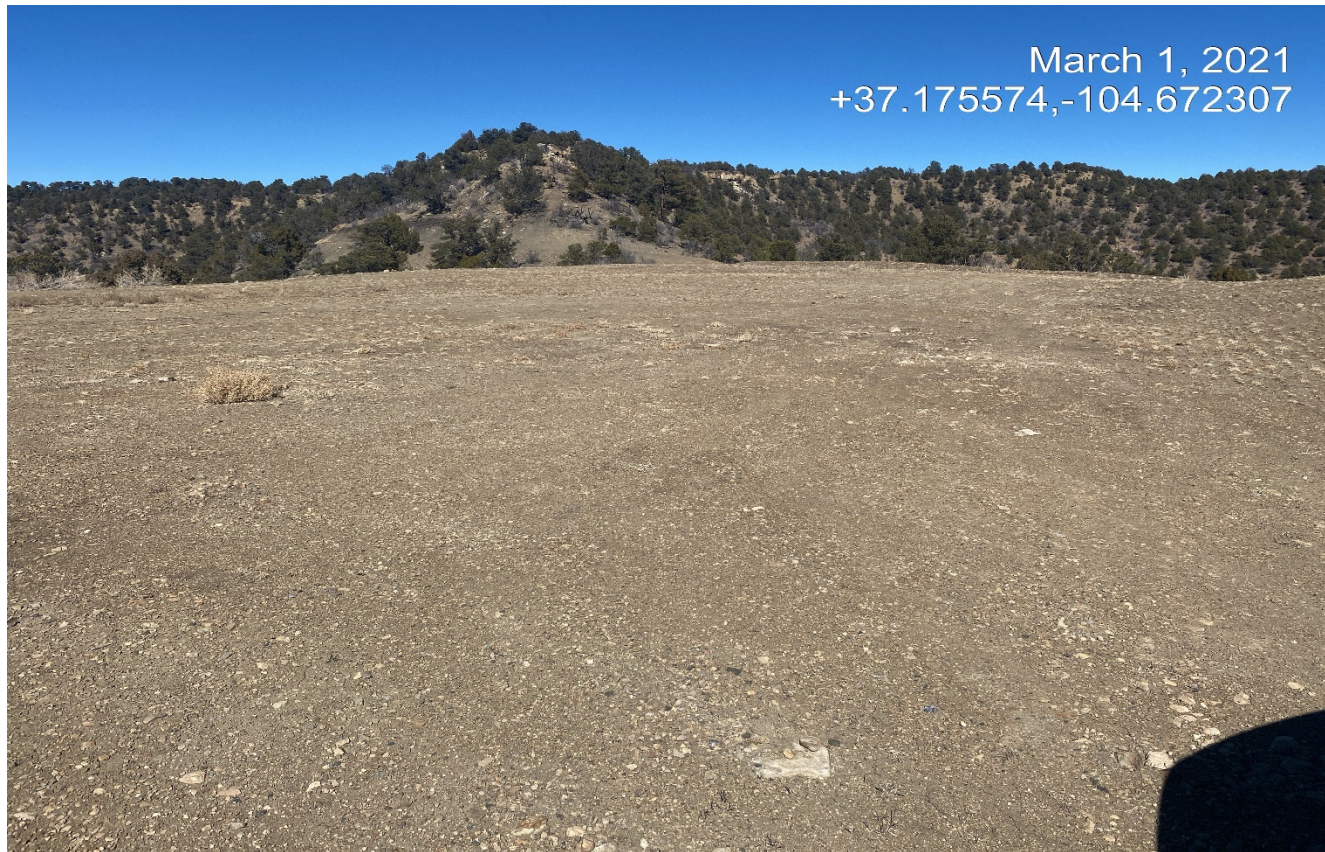
Photo 5. Facing north toward the location.

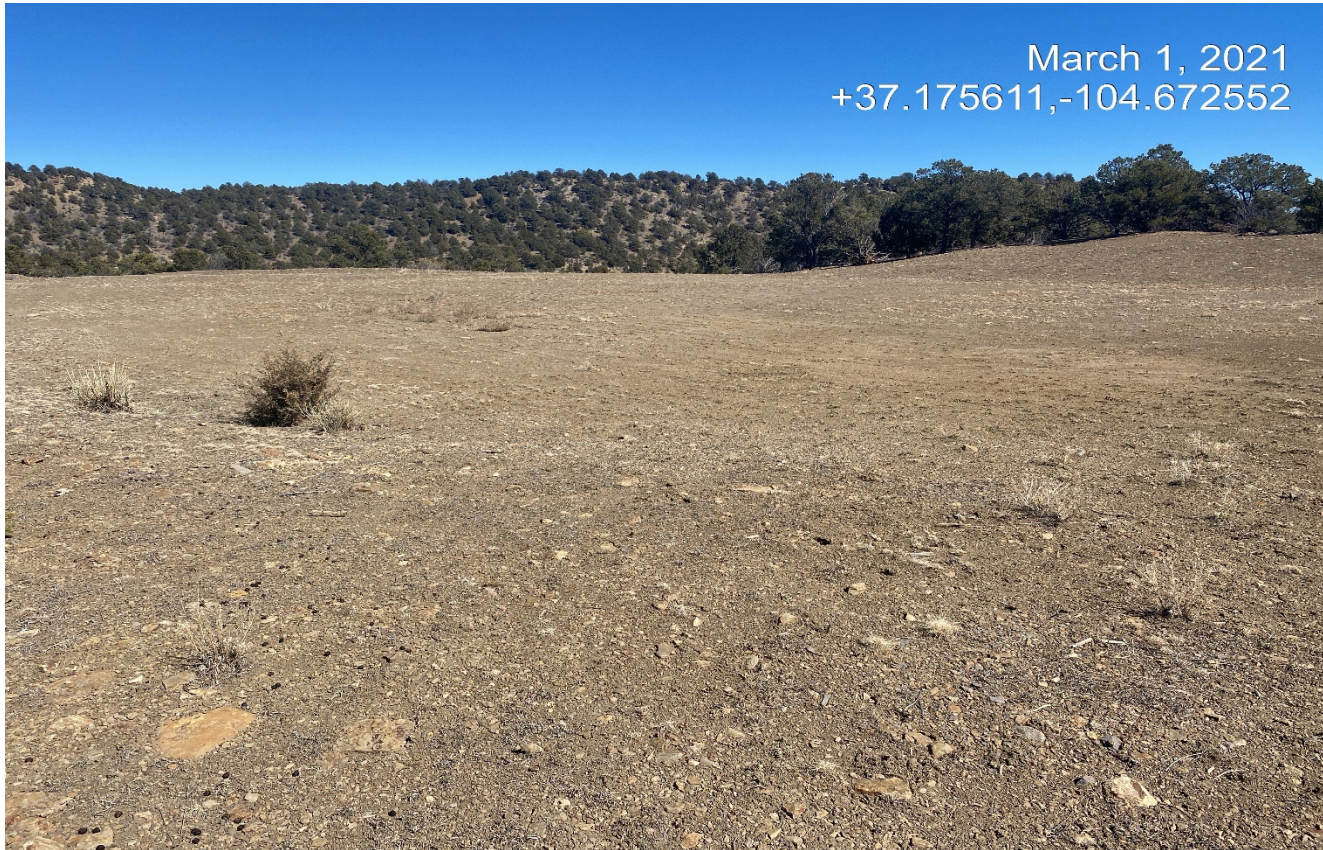
Photo 6. Facing northeast at the location.

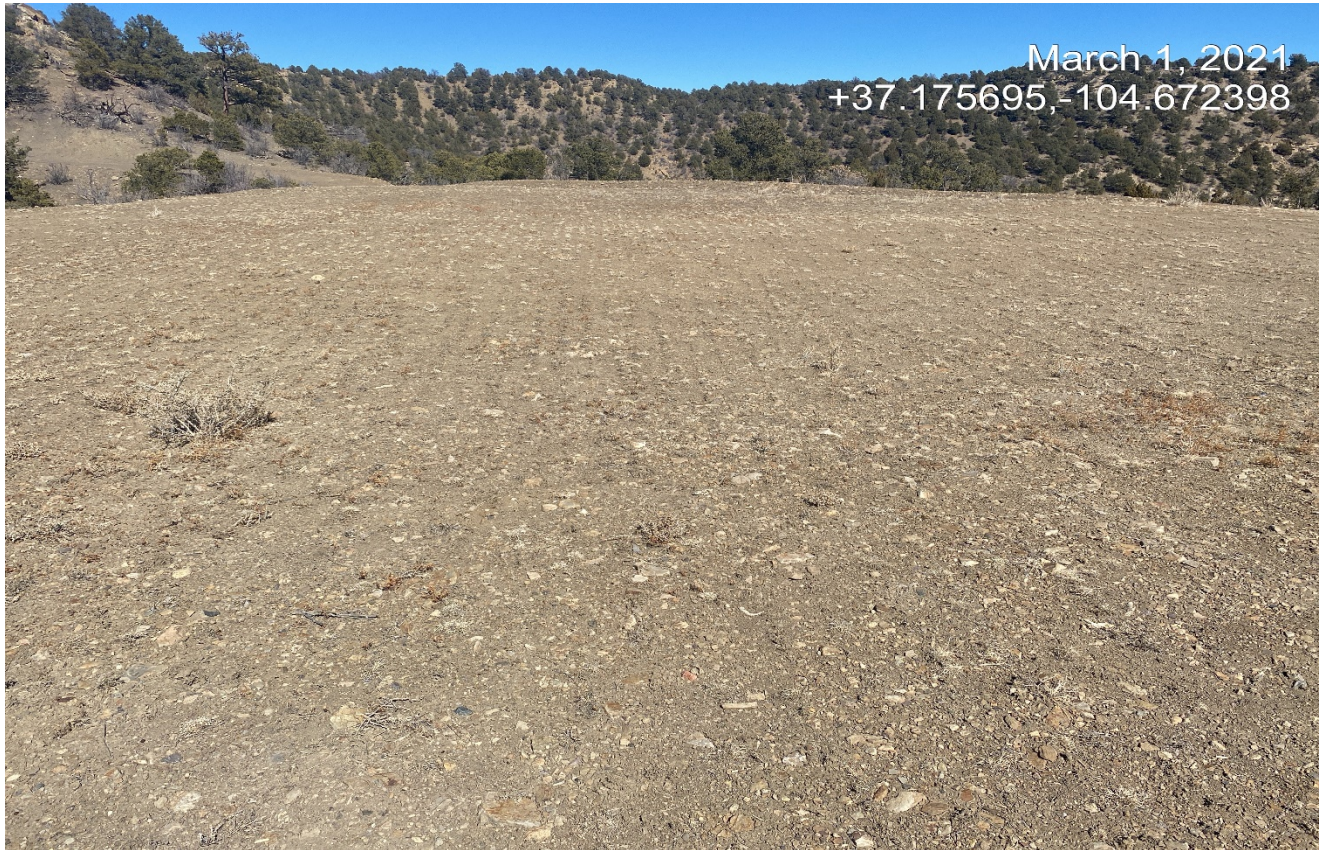
Photo 7. Facing northeast at center of the location. Vegetation has not established. Additional seeding will need to be performed.
