Issue Report

Kern State 36-16-46 #1H, 017-07729

Report created on February 9, 2021

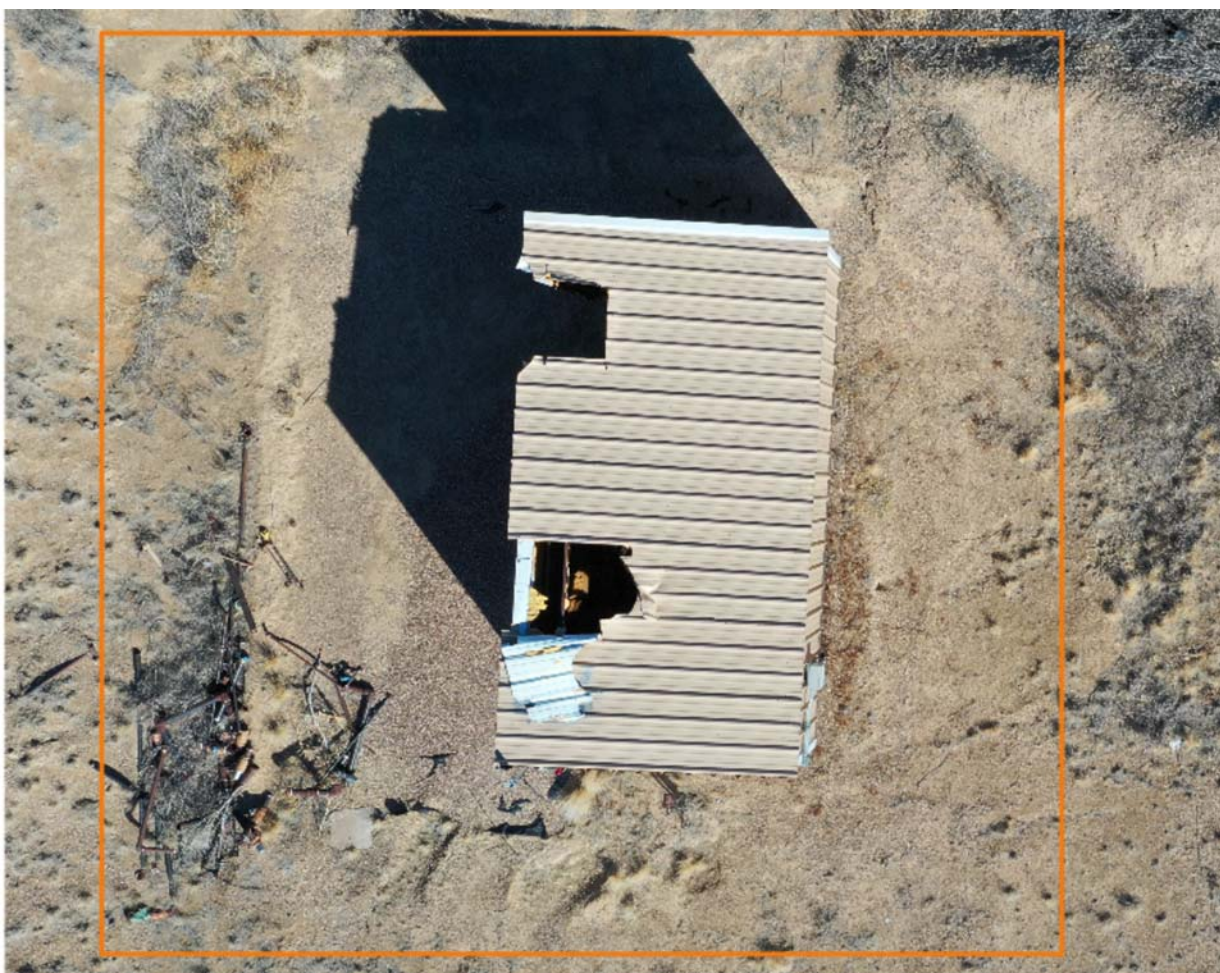
No. 1 OPEN

Control shack, misc pipe and fittings

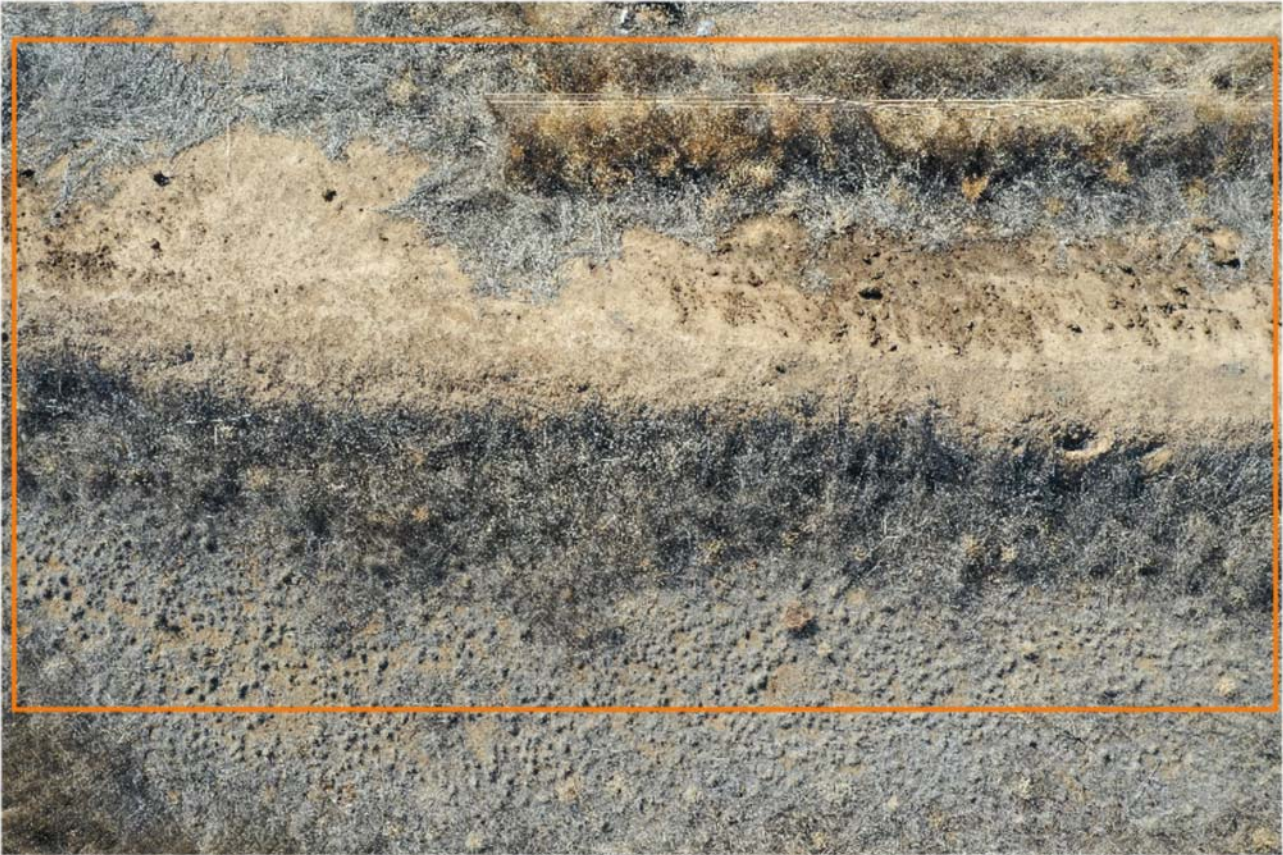
No. 3 OPEN

Area where tank battery was, steel panels and berms.

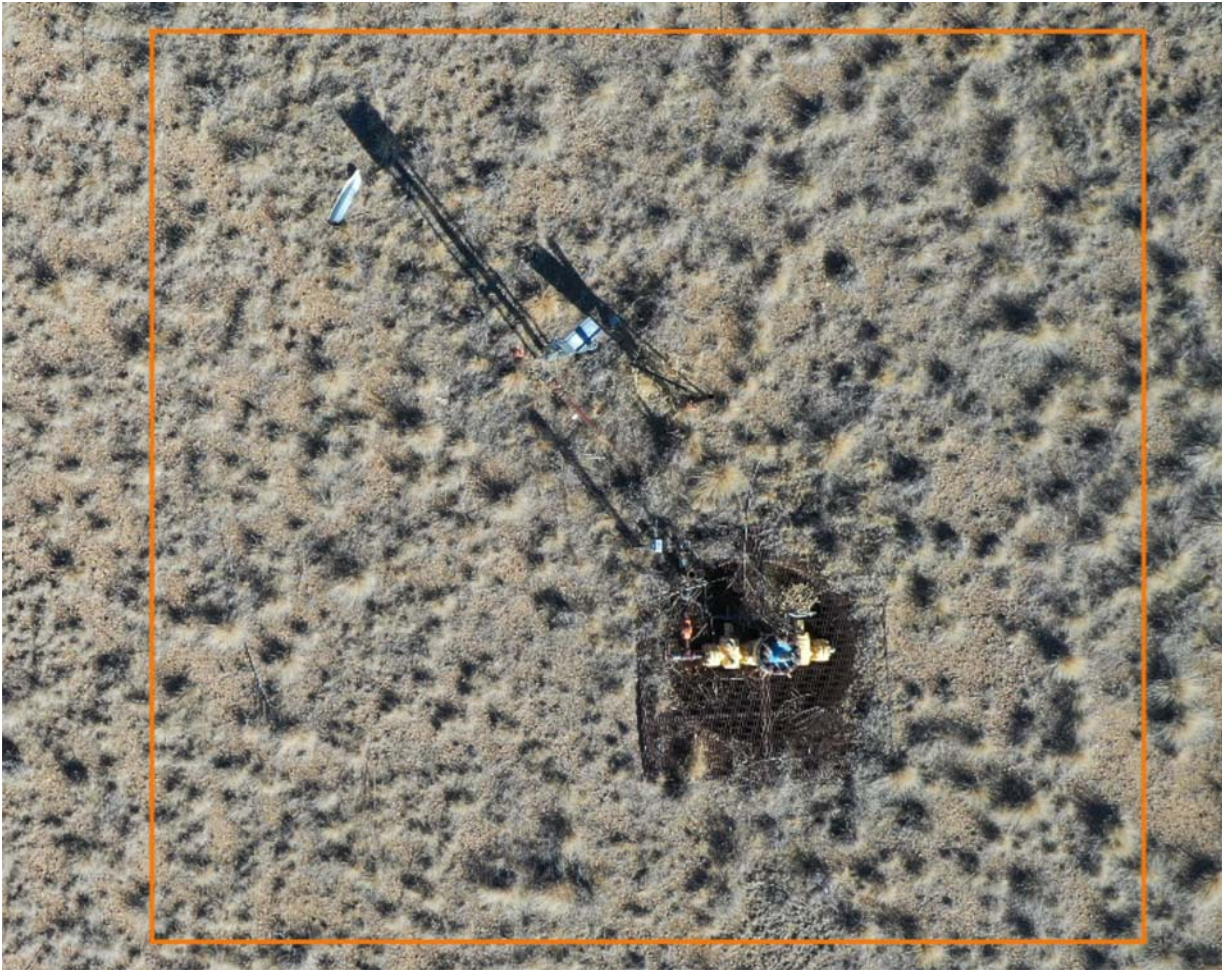
No. 4 OPEN

Summary
Wellhead area with risers and debris.

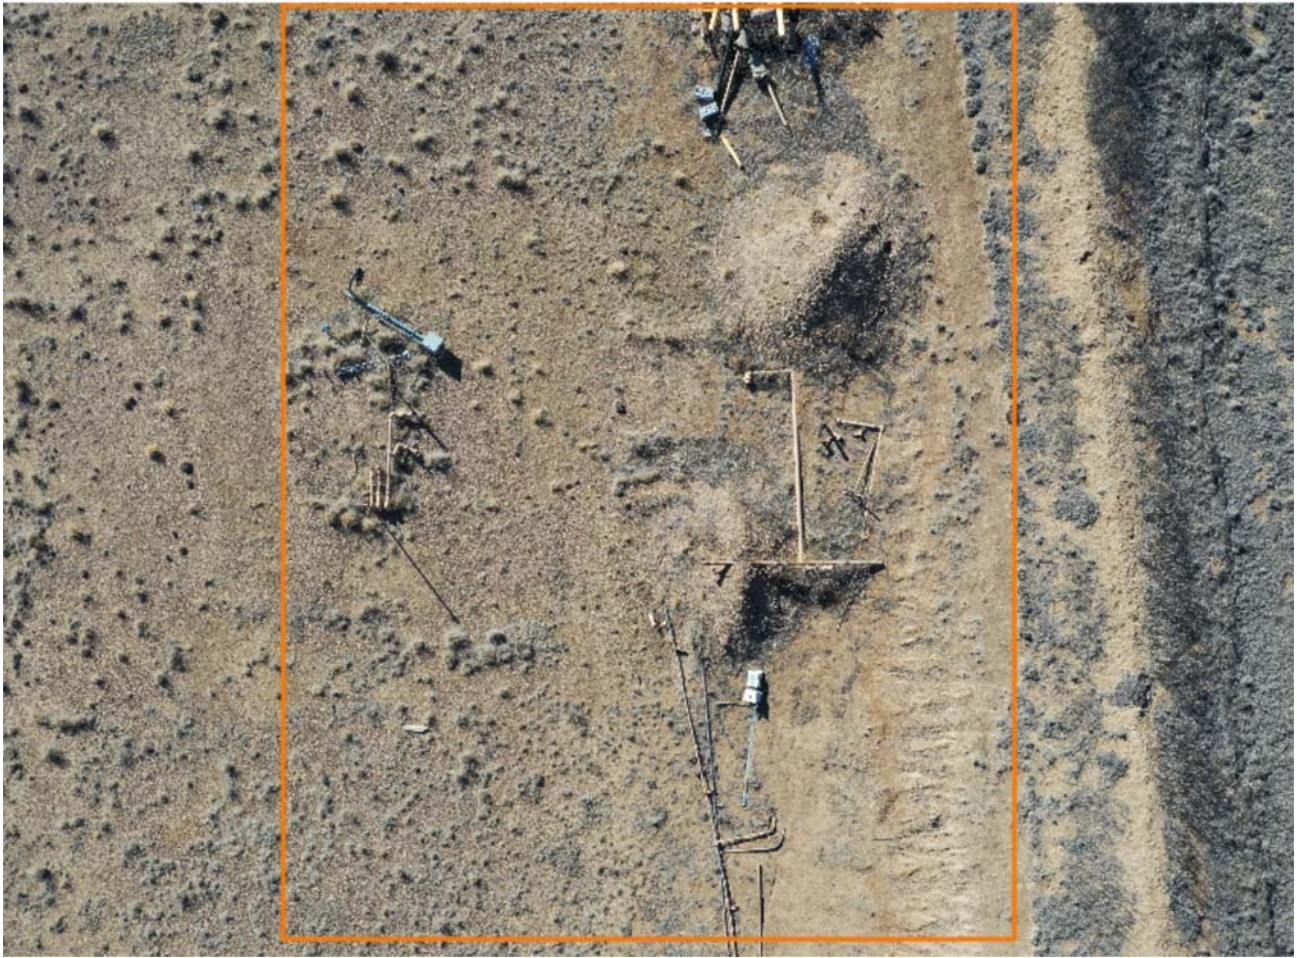
No. 5 OPEN

Summary
Risers, Pipe, Fittings and misc debris.

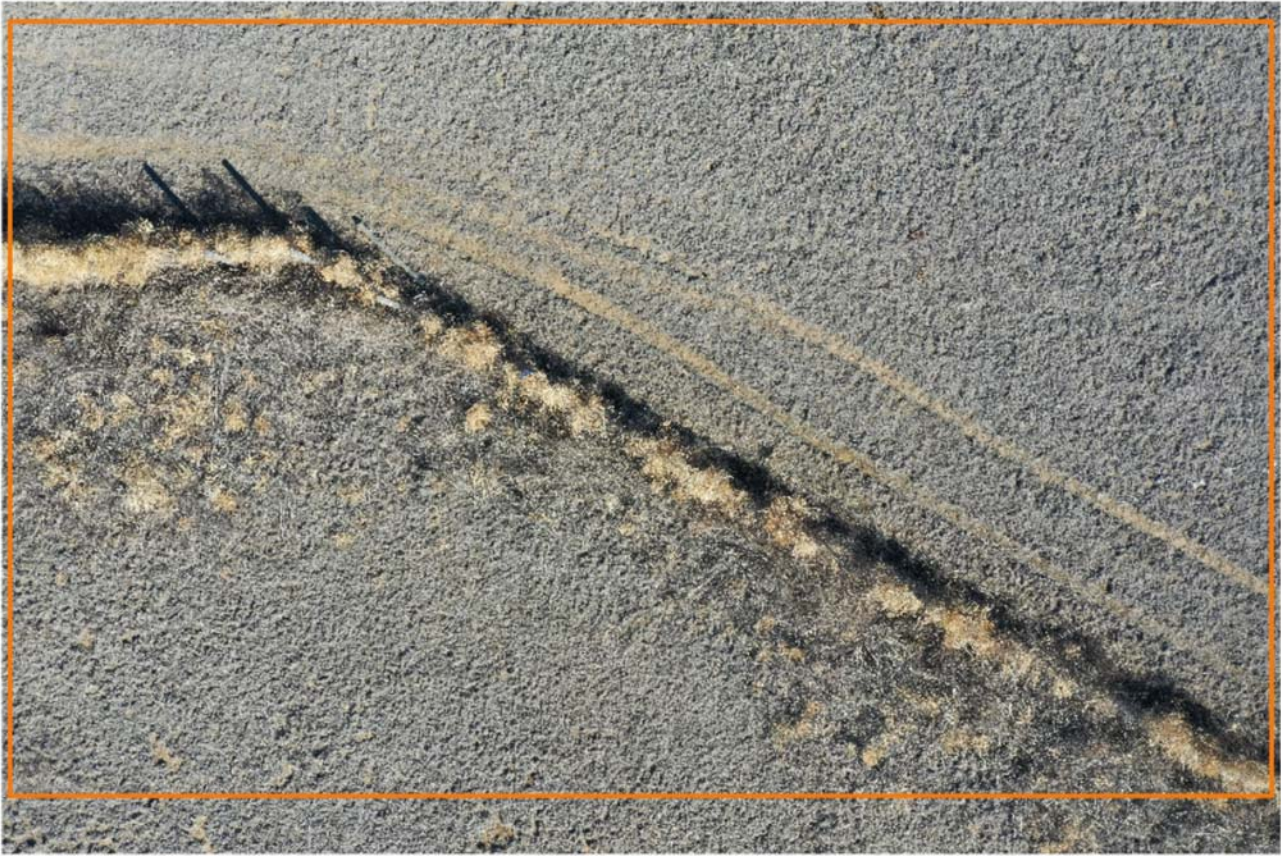
No.2 OPEN

Summary
Weeds in most of fencing
