CAERUS PICEANCE LLC
CHEVRON-66S96W 4SWSW
Location # 335766

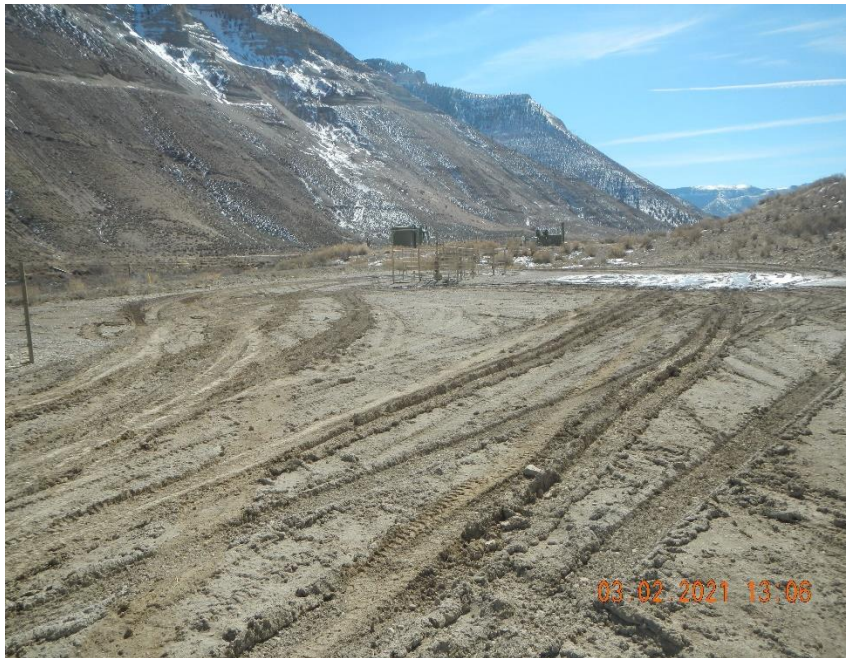
**Location shows signs of lack of stabilization
BMP's in some areas (rutting is present).**

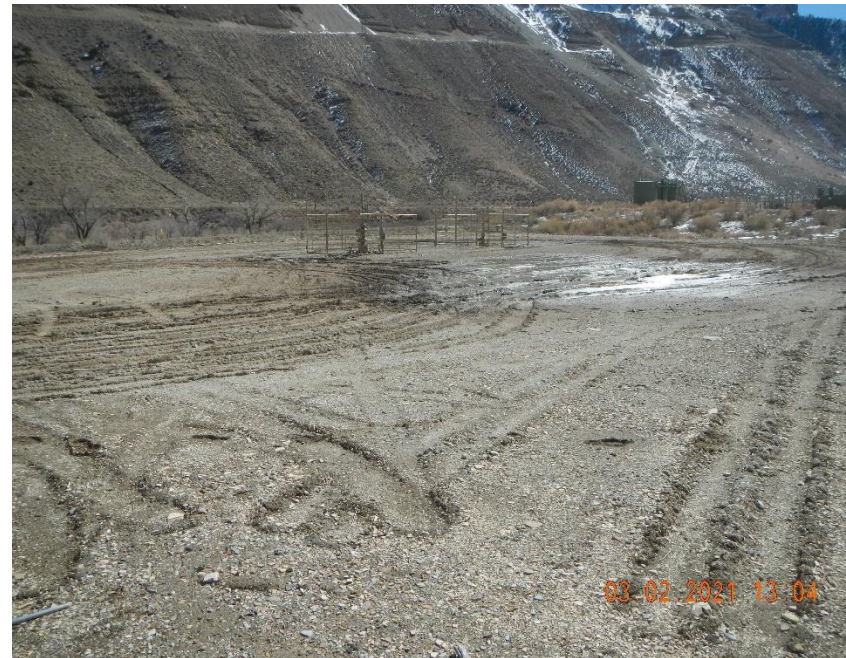
**Location shows signs of lack of stabilization
BMP's in some areas (rutting is present).**

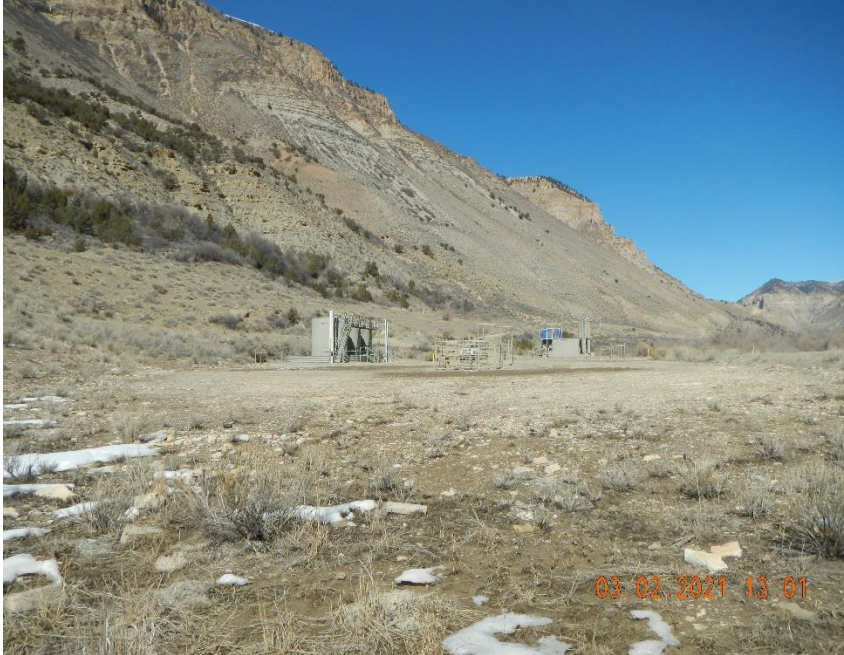
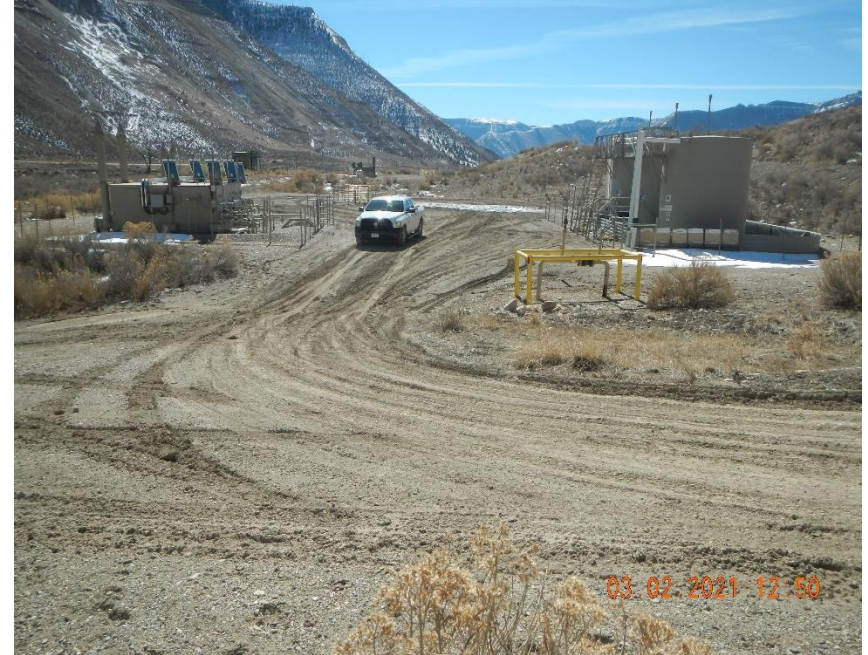
**Location shows signs of lack of stabilization
BMP's in some areas (rutting is present).**

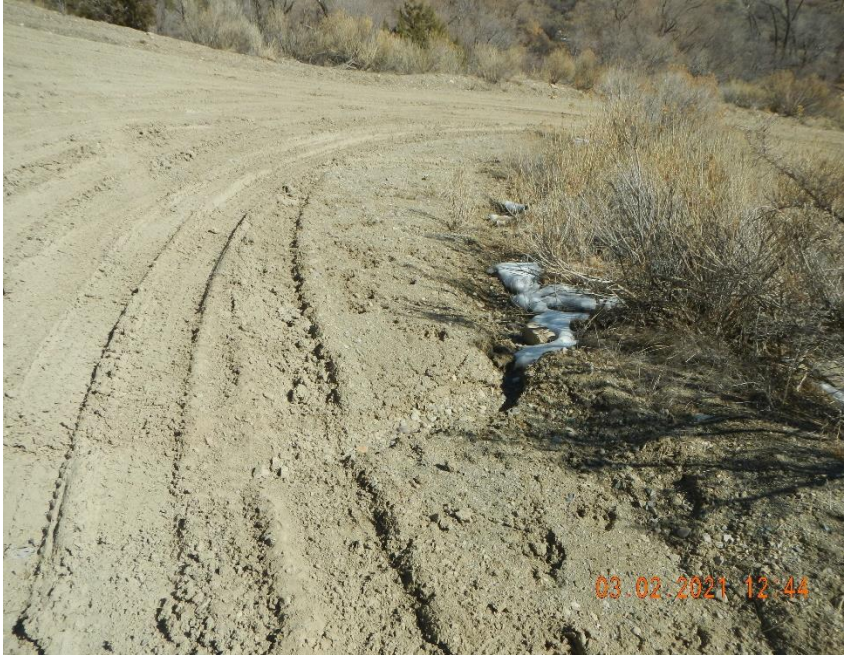
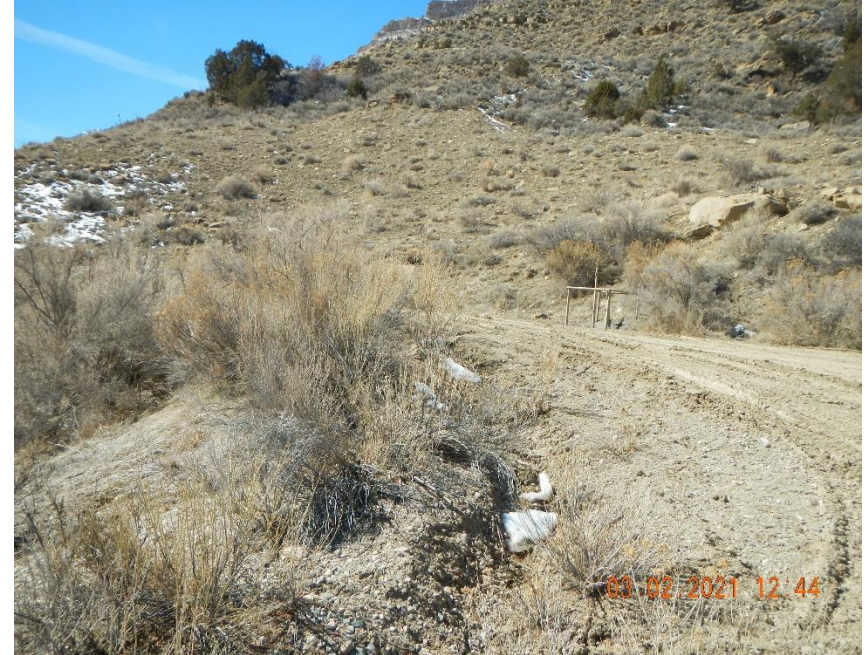
**Erosion rill along shoulder onto location
allowing sediment to move on to location.**

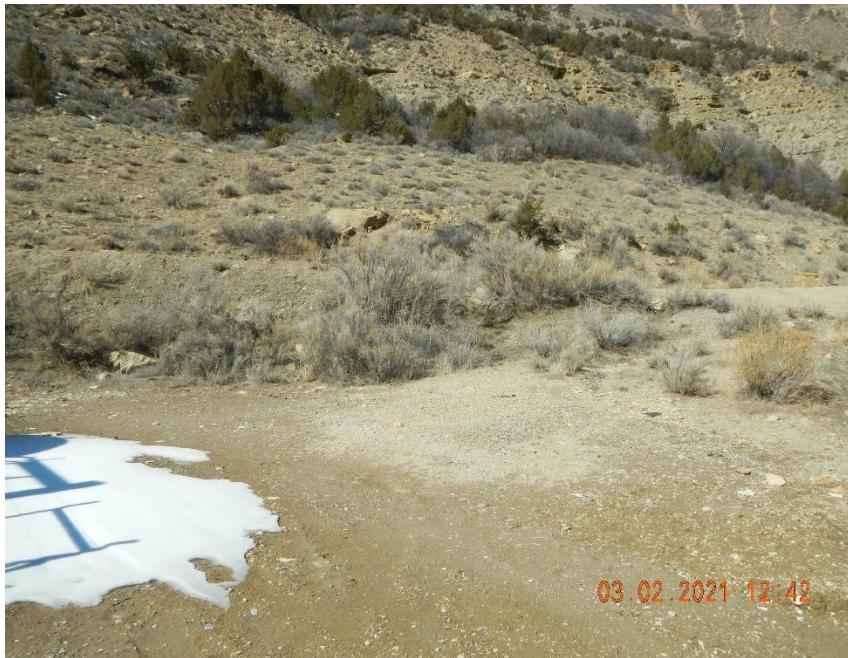
**Sediment running onto location from
shoulder of access road.**

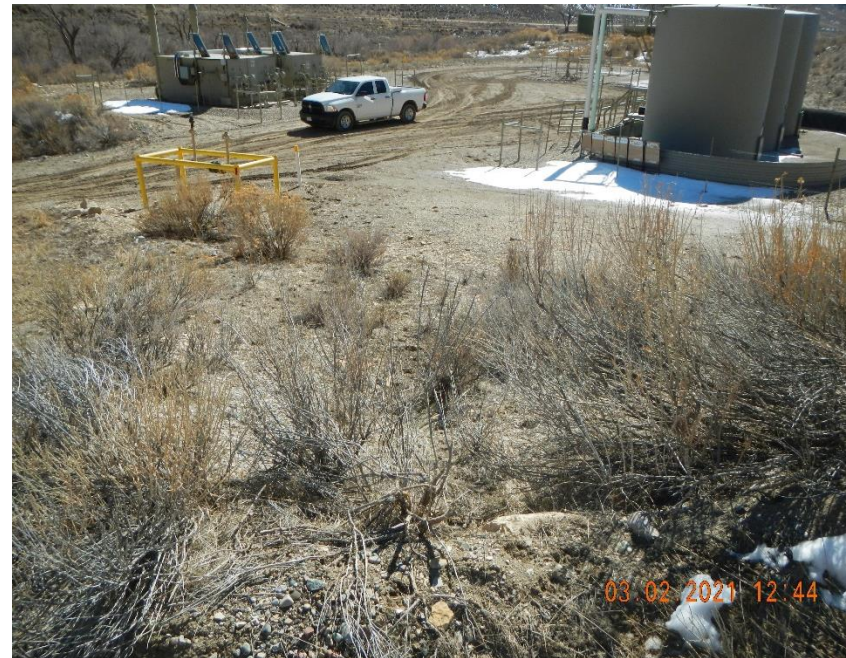
**Sediment running onto location from
shoulder of access road.**

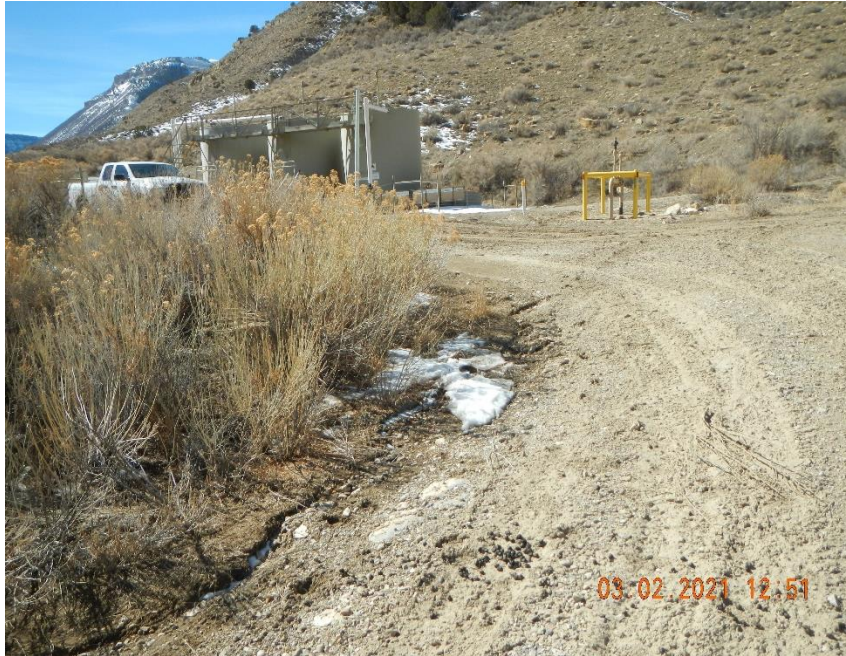
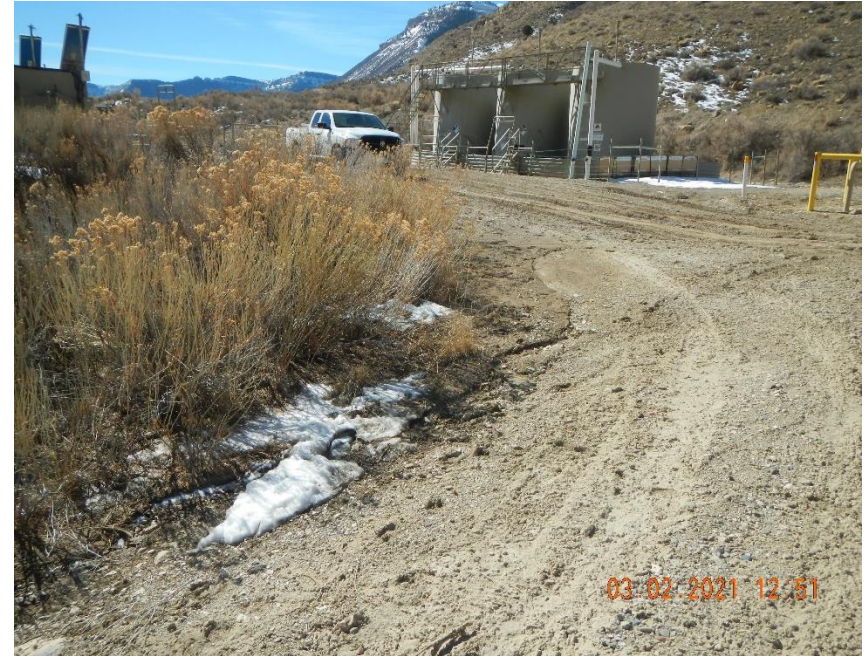
Rill running down access road to lower location.

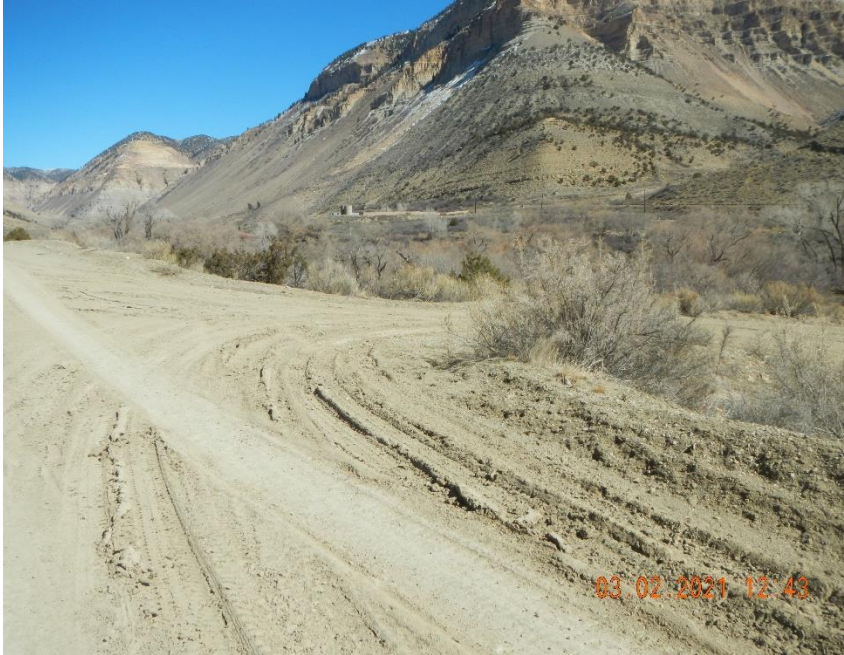
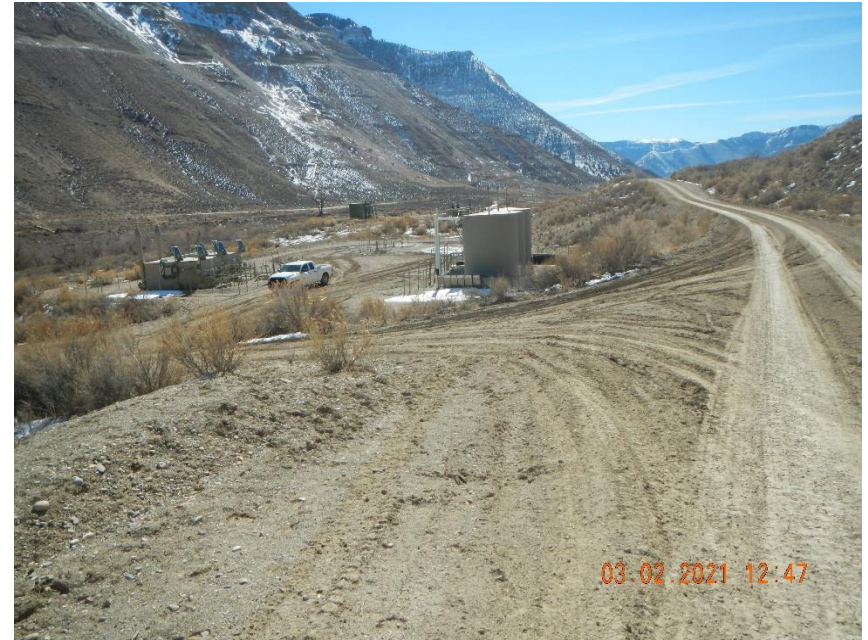
**Access road shows signs of lack of stabilization
BMP's in some areas (rutting is present).**
