Inspection Photos

Location Name: CAERUS PICEANCE LLC FEDERAL HAGEN-67S95W /16NESE,

Location ID: 335041

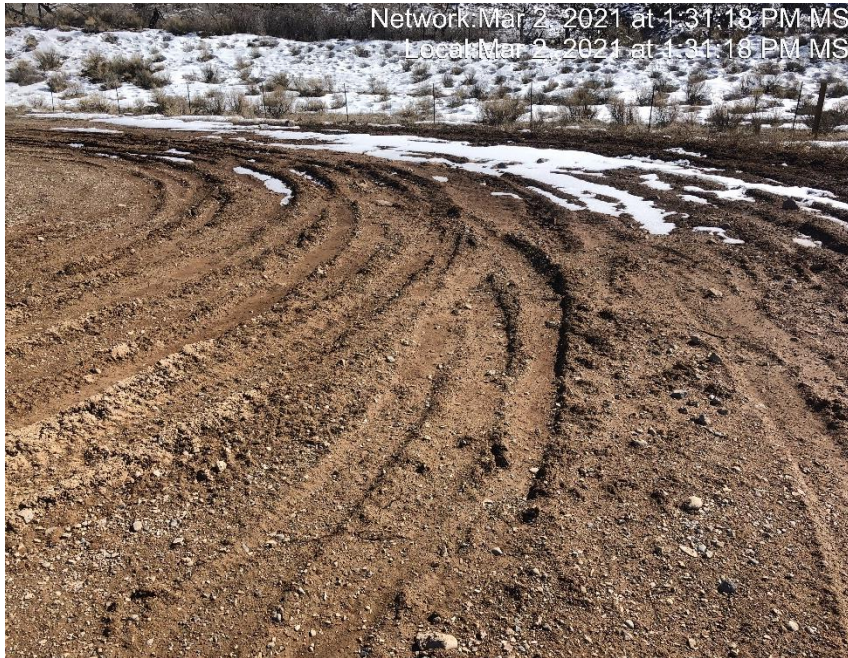
Photo #3036 Rutting present on location due to lack of stabilization

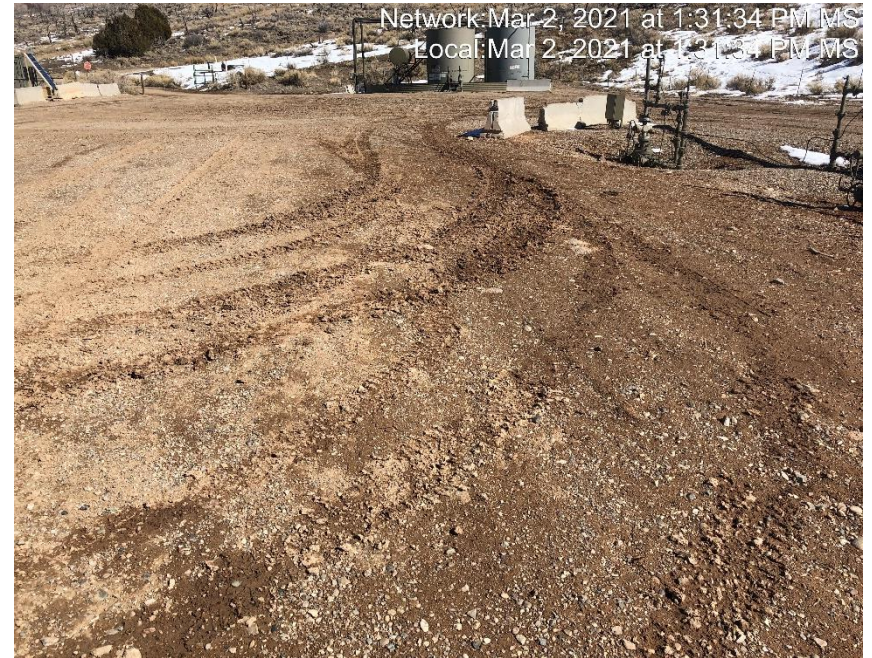
Photo #3037 Rutting present on location due to lack of stabilization

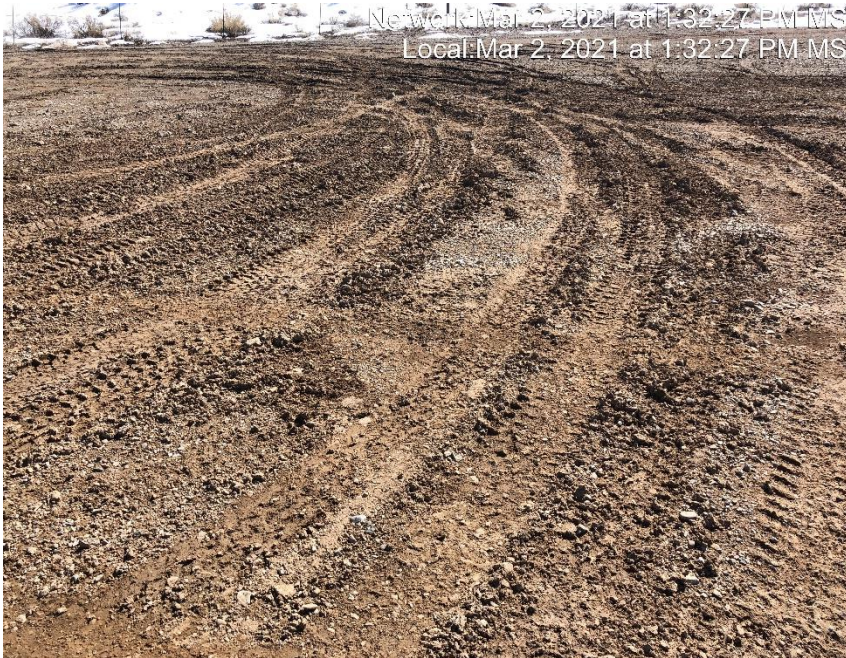
Photo #3038 Rutting present on location due to lack of stabilization

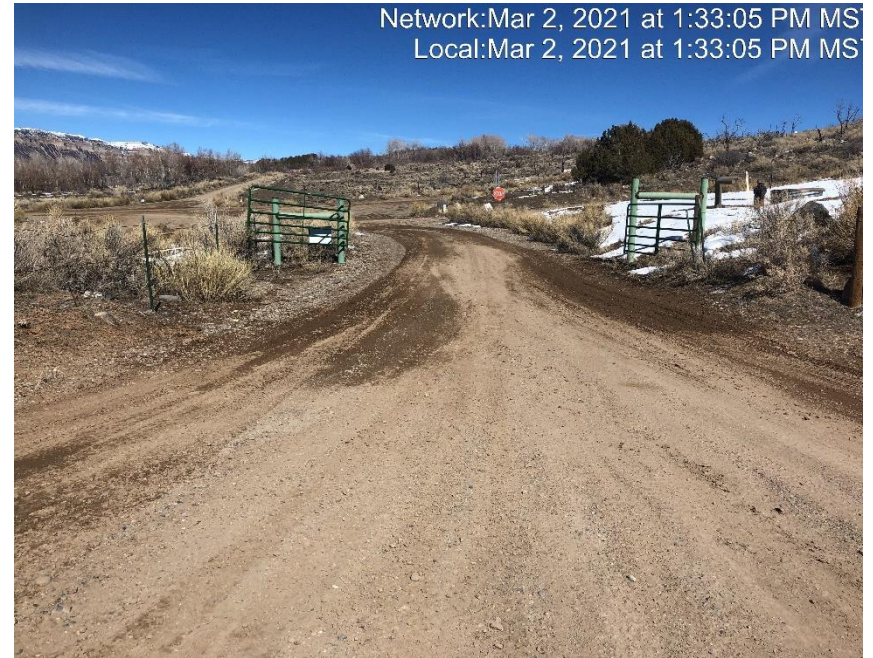
Photo #3040 No form of tracking control at entrance to location
