# Inspection Photos

API: 009-06505

Operator: MURFIN DRILLING COMPANY INC

Inspection Date: 3/3/2021

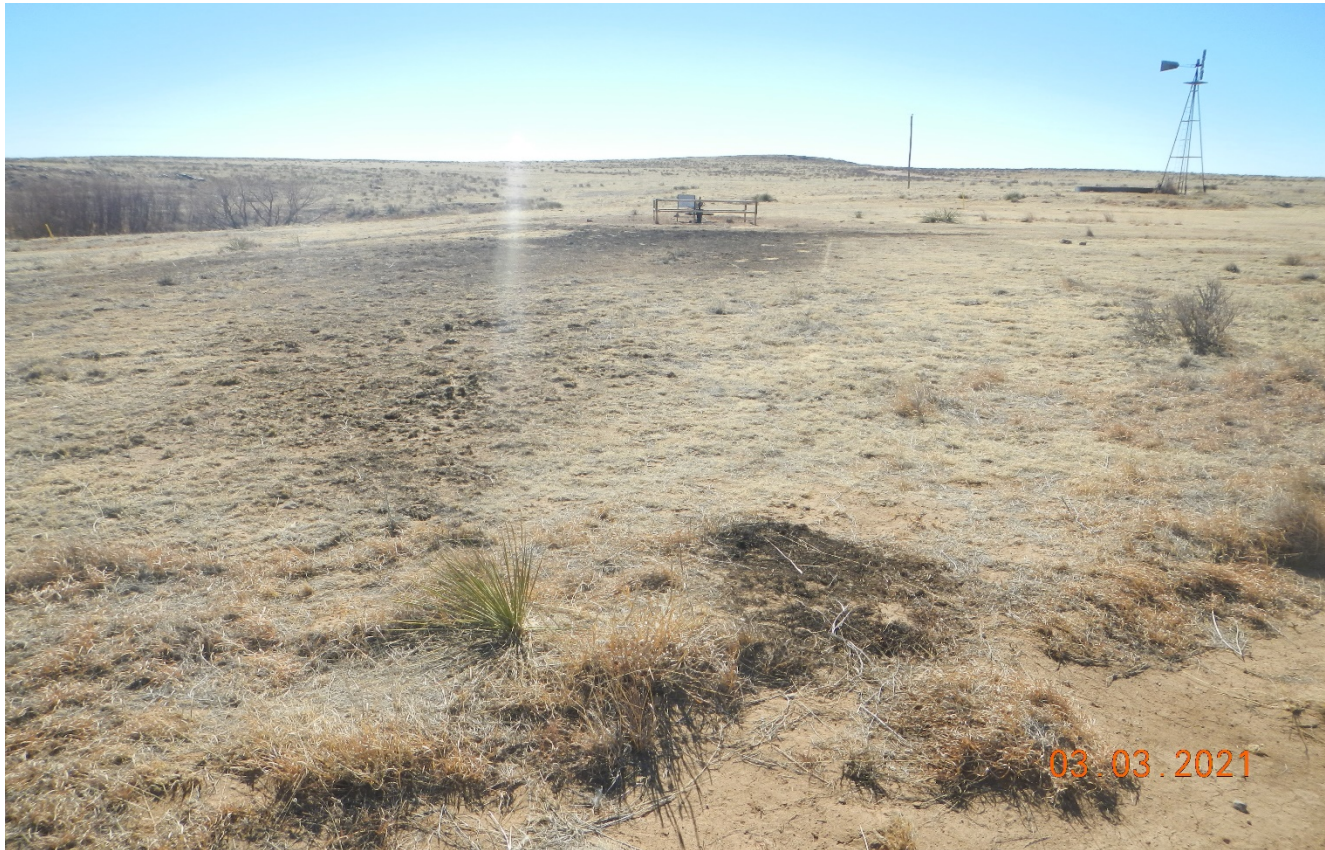
**Photo 1.** Facing southwest standing from the county road. It was observed while passing by that there was a blackend area near the well.

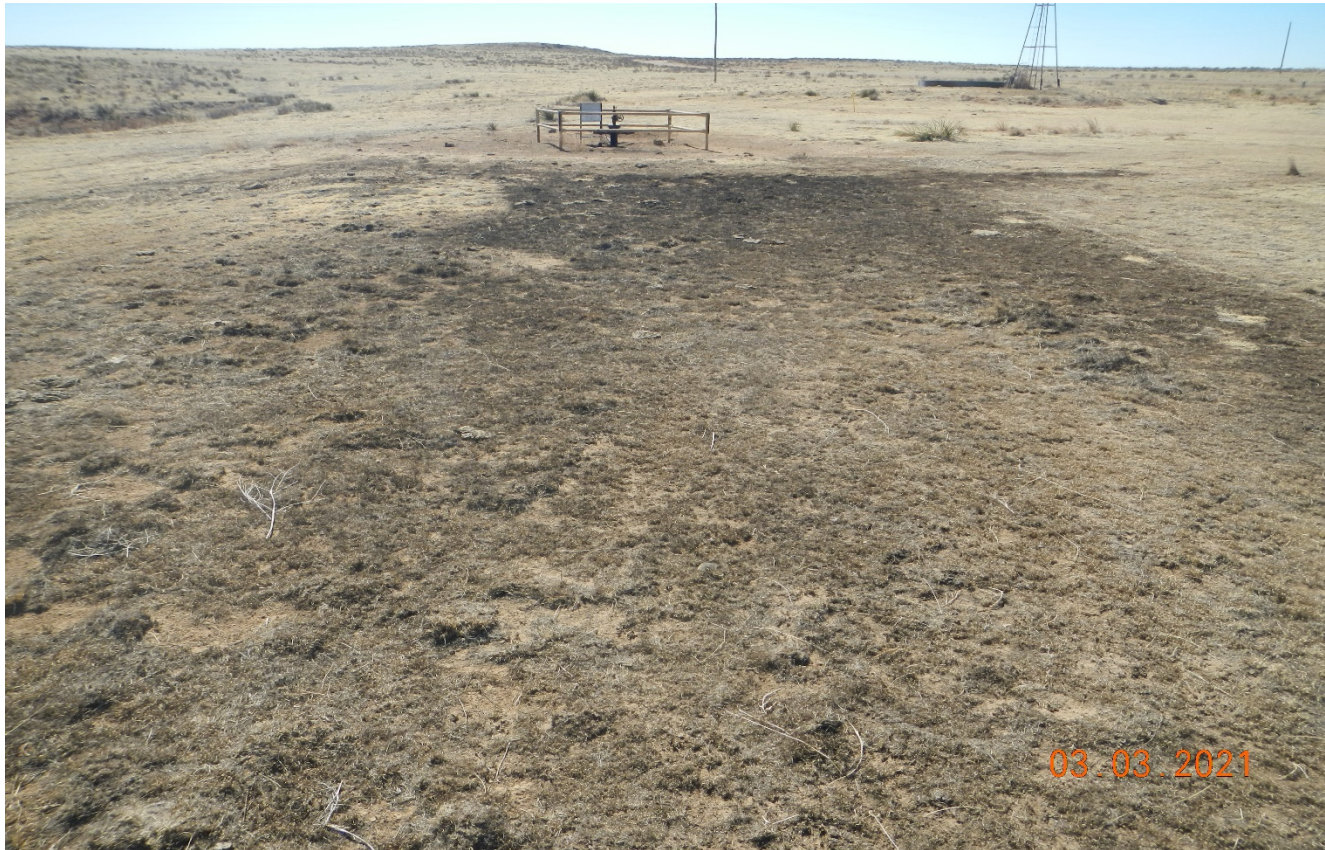
**Photo 2.** The blacken oil spilled area is approximately 60'x20'.

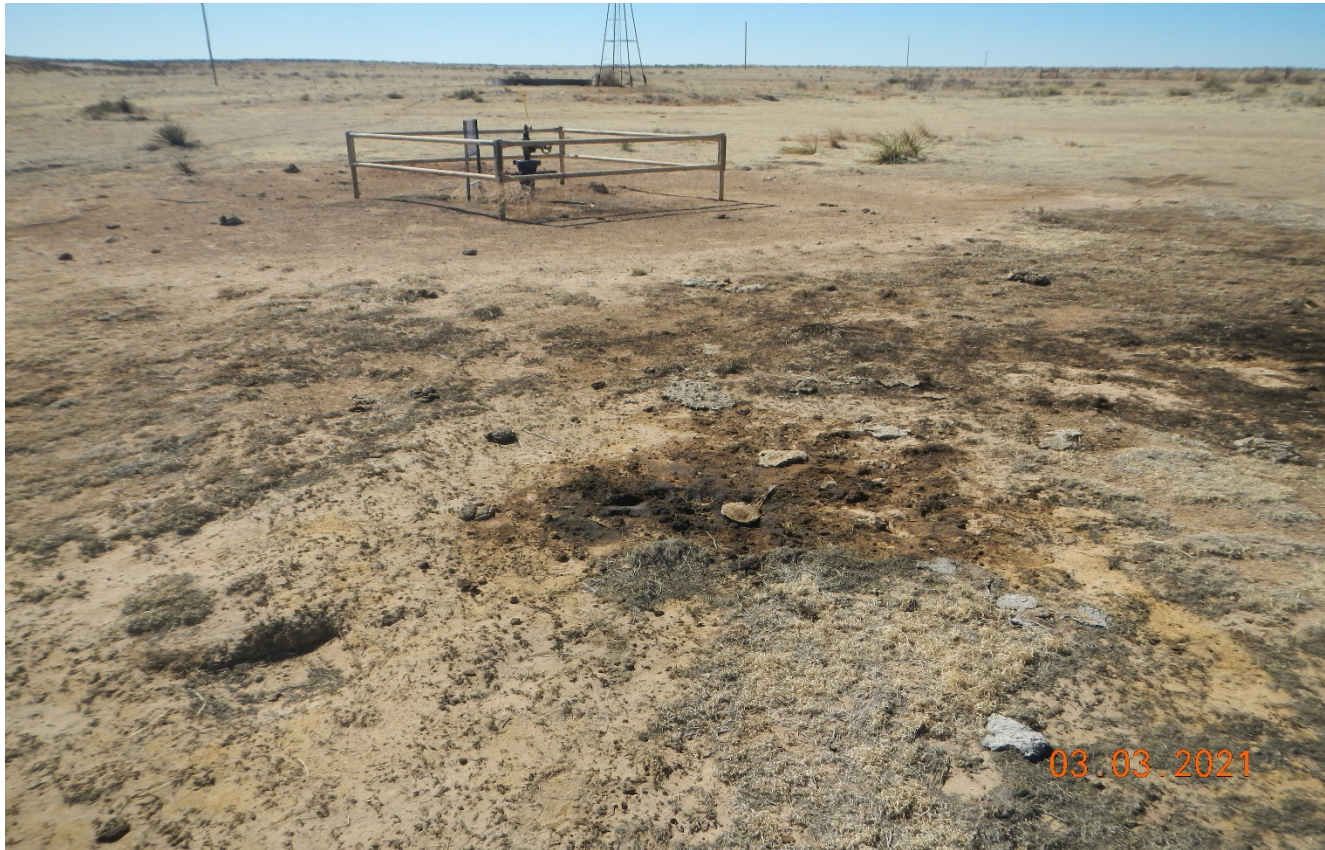
**Photo 3.** Facing southwest toward the well.

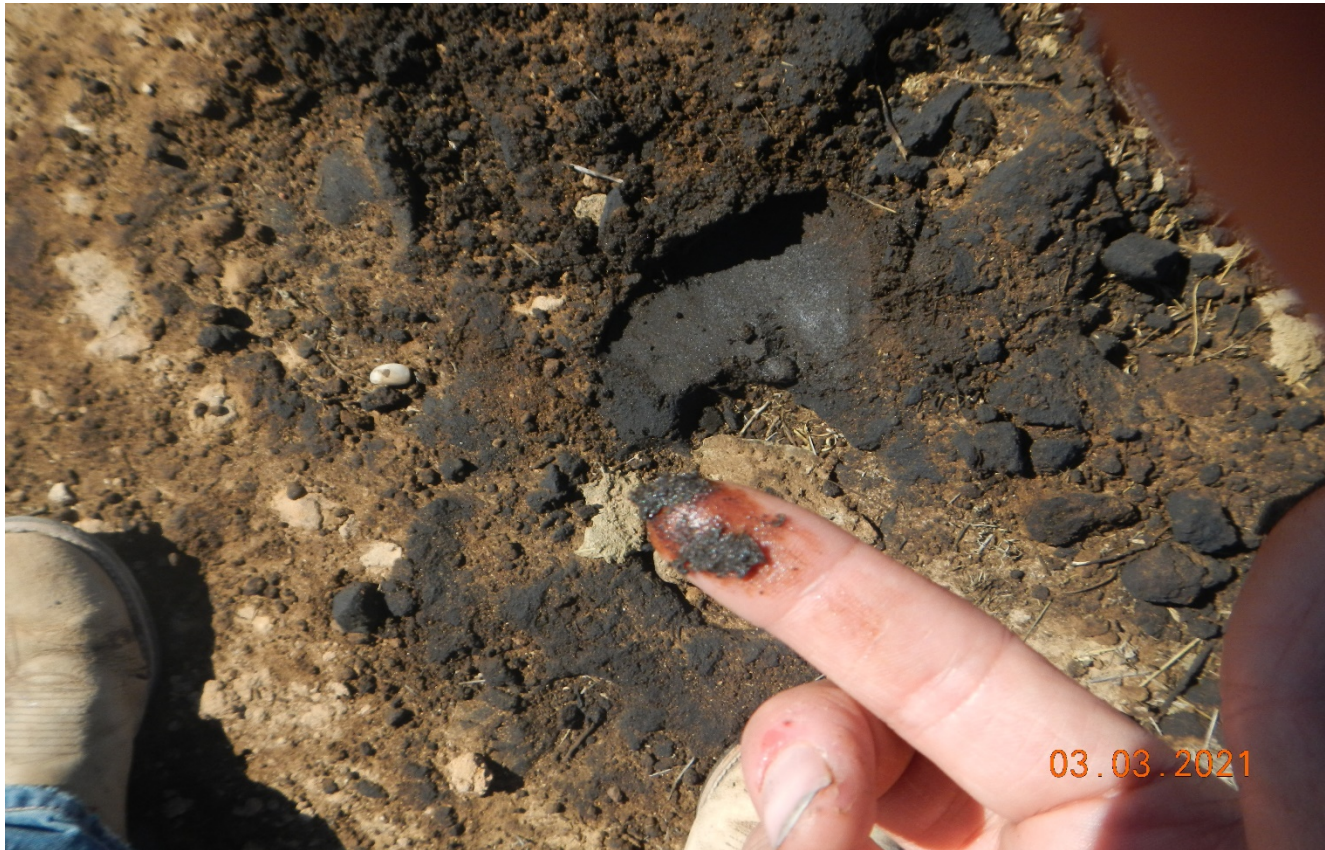
**Photo 4.** View of oily soil found near the well.

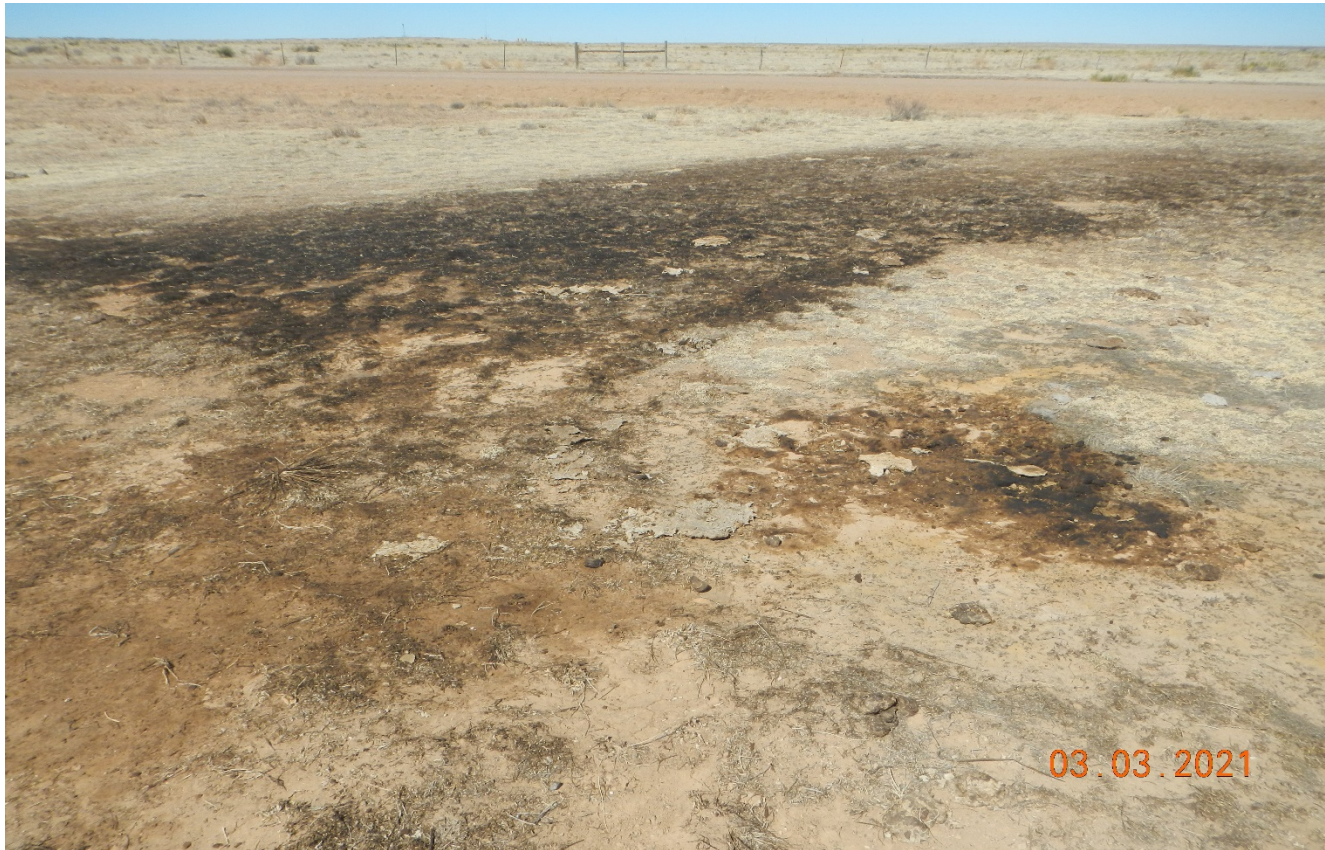
**Photo 5.** blacken oil spilled area is approximately 60'x30'.

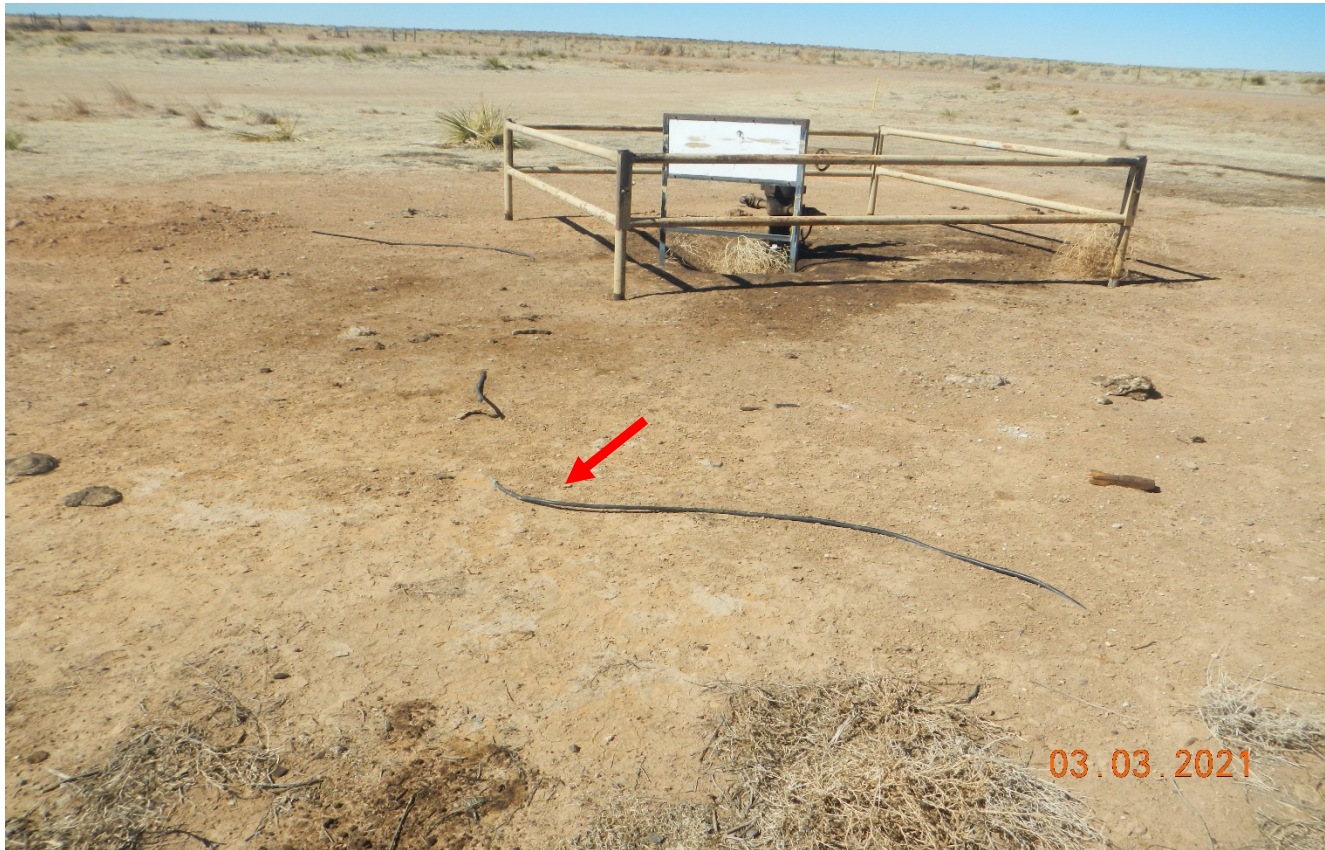
**Photo 6.** There is an electric cable shown at red arrow which is cut in half.

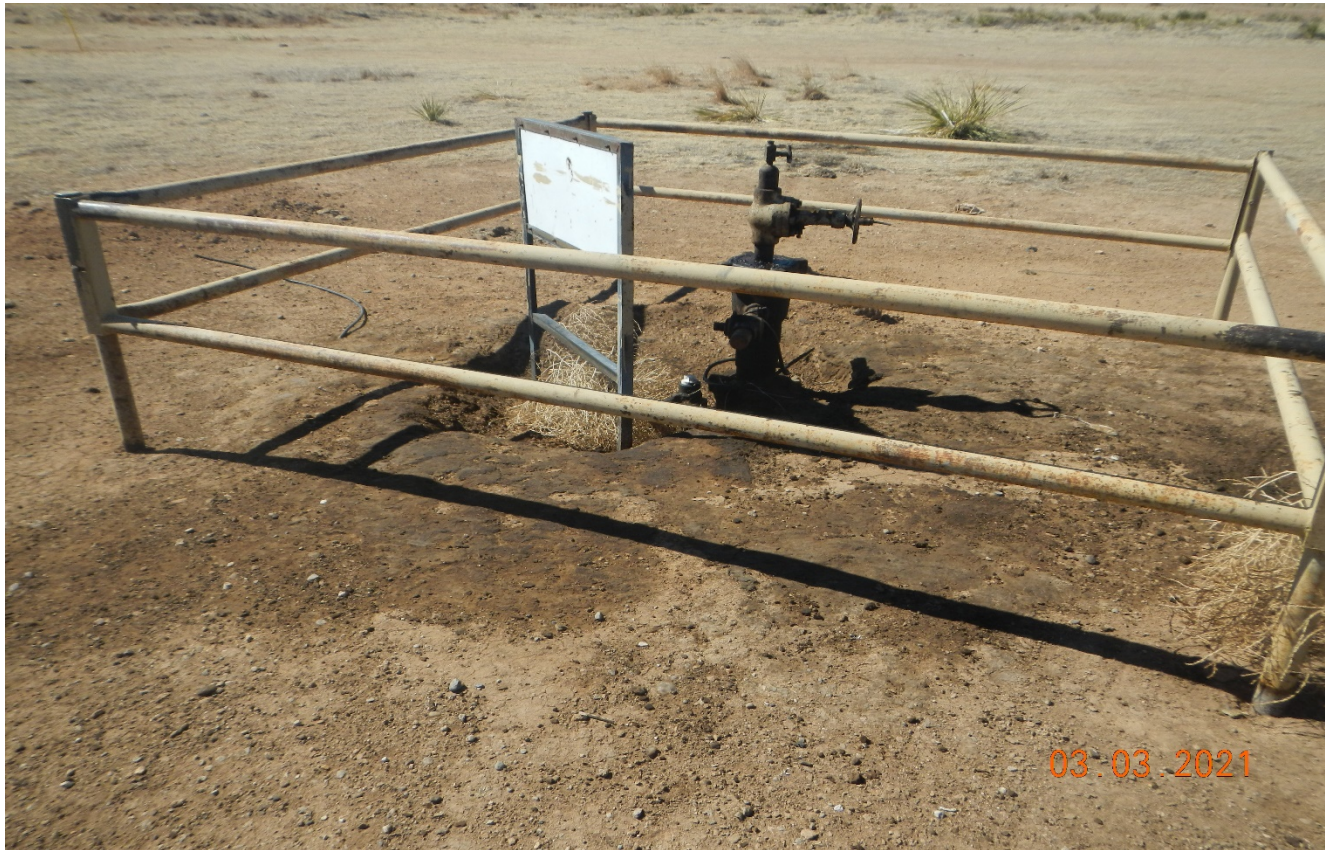
**Photo 7.** There is oil stained soil around the wellhead.

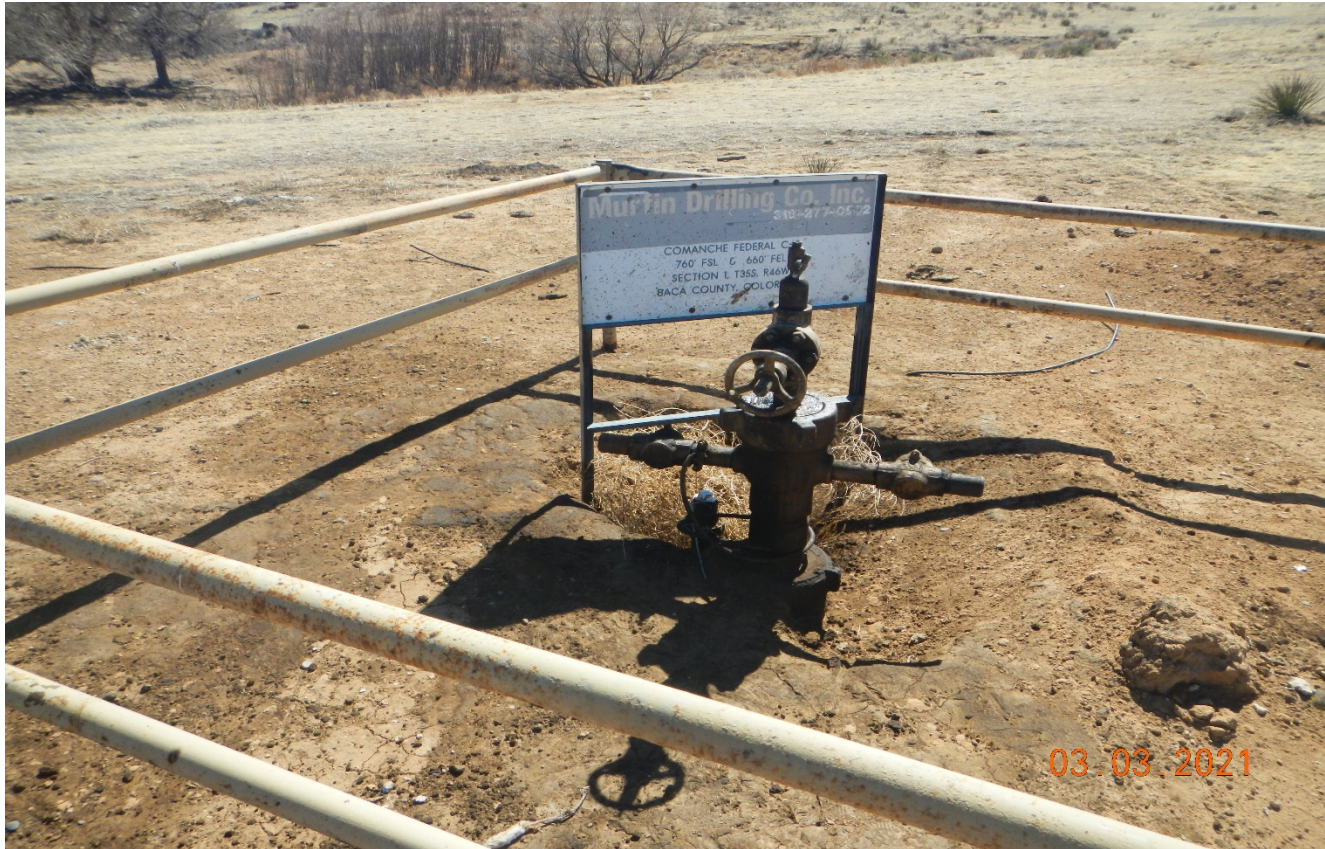
**Photo 8.** The well sign is posted at wellhead. The emergency number is faded and unidentifiable.
