Inspection Photos  
Operator: Williford  
API: 067-06698  
Date: 3/3/2021

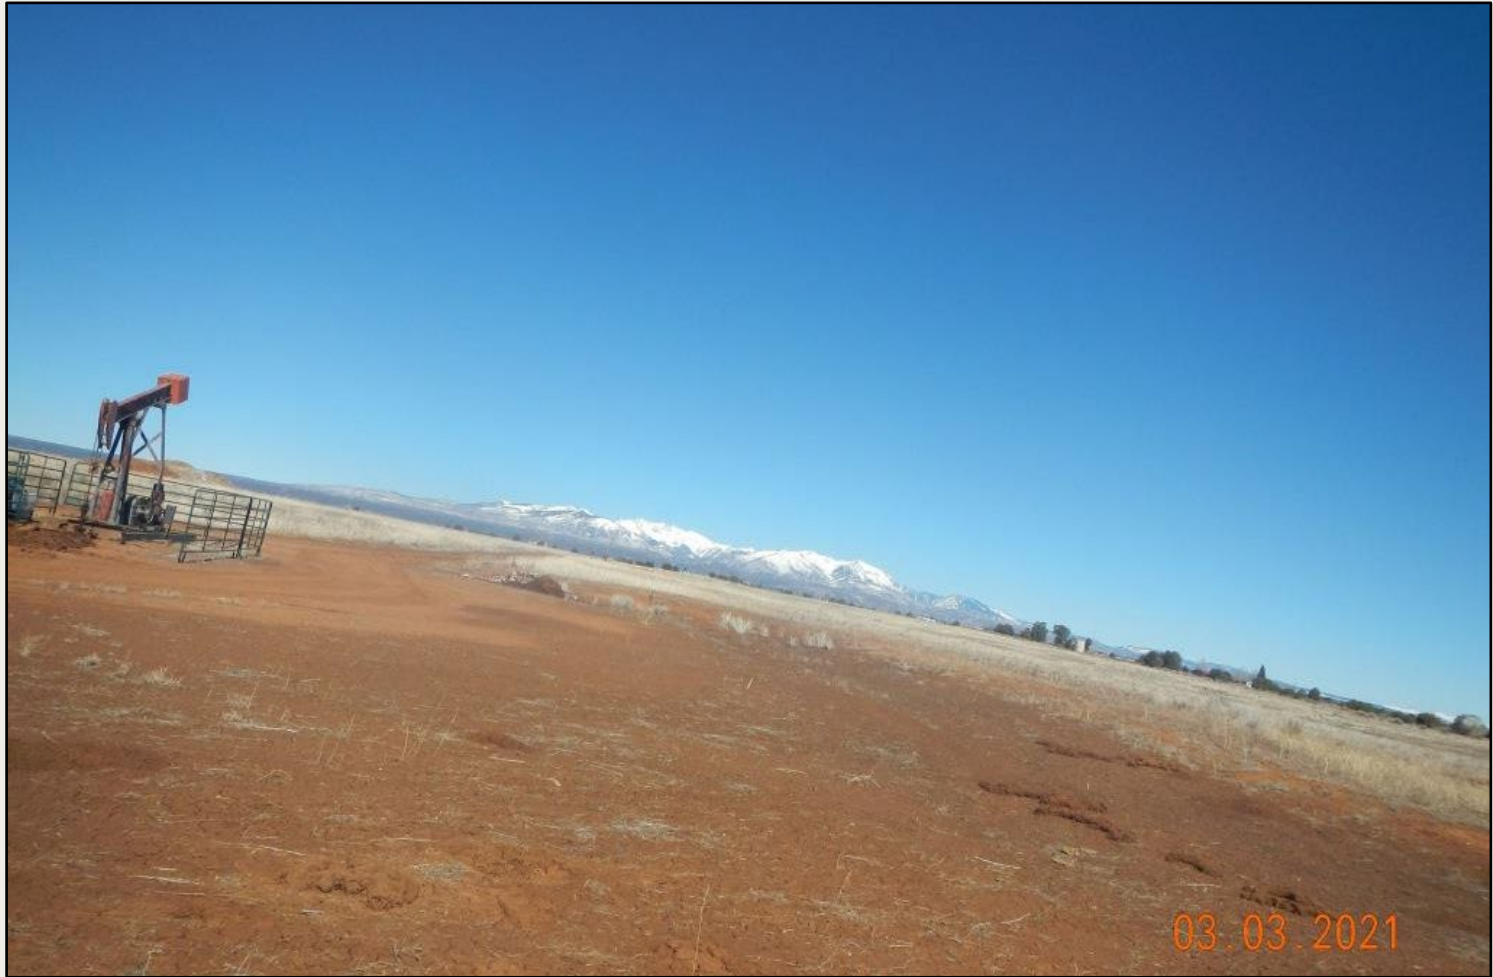
Photo 1. View of the project area from the southwestern corner facing northward.

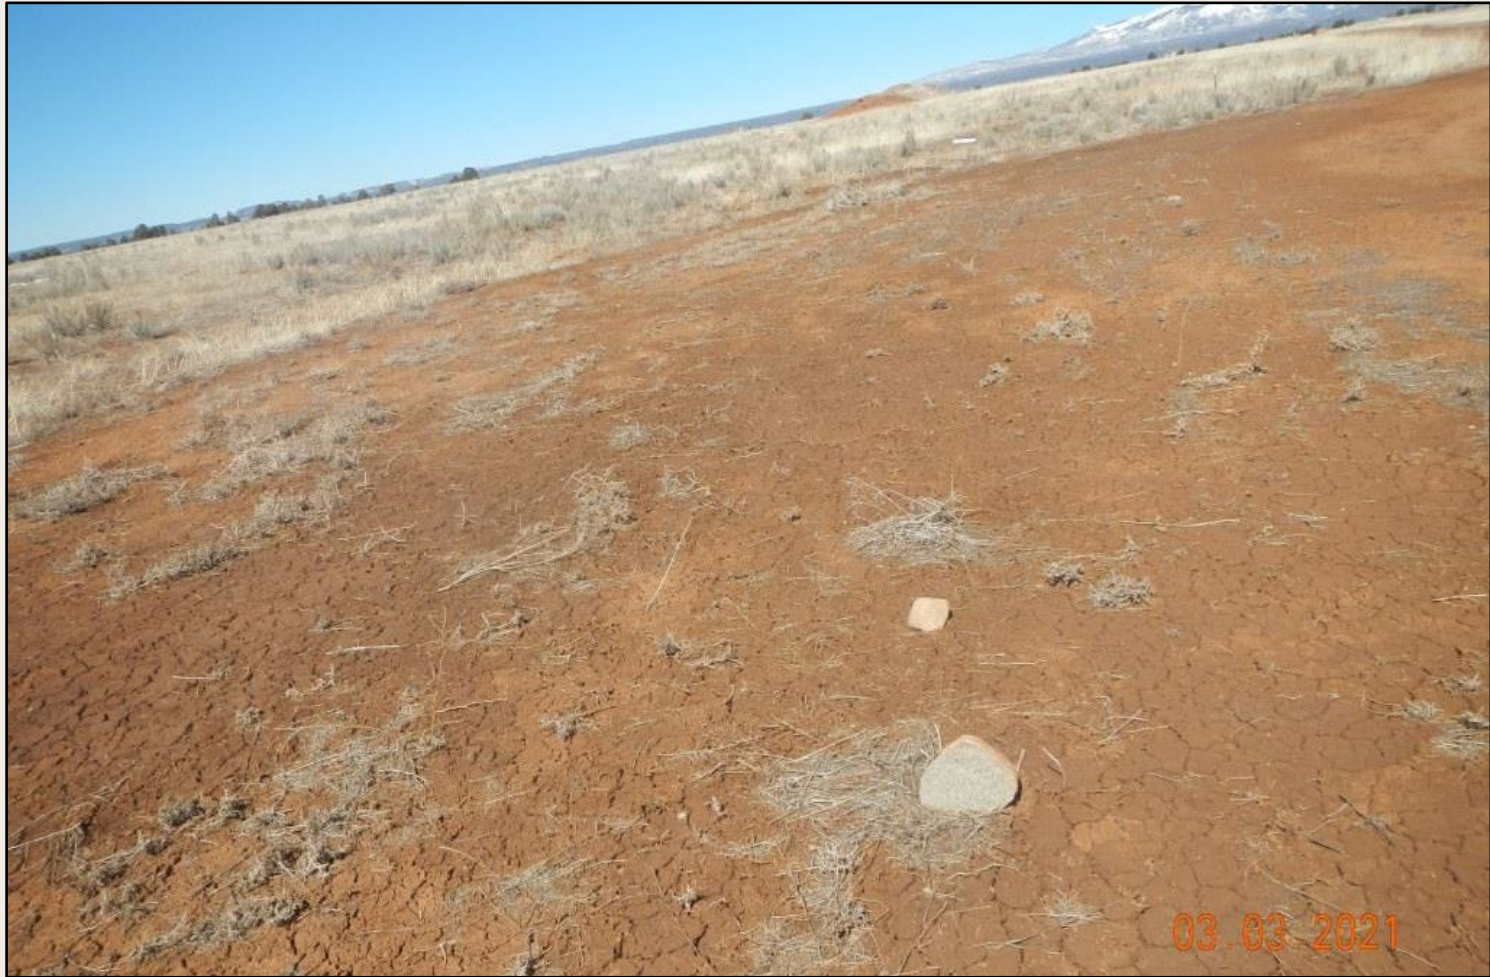
Photos 2. View of the western project area facing northward.
