Inspection Photos
Operator: Williford
API: 067-06771
Date: 3/3/2021

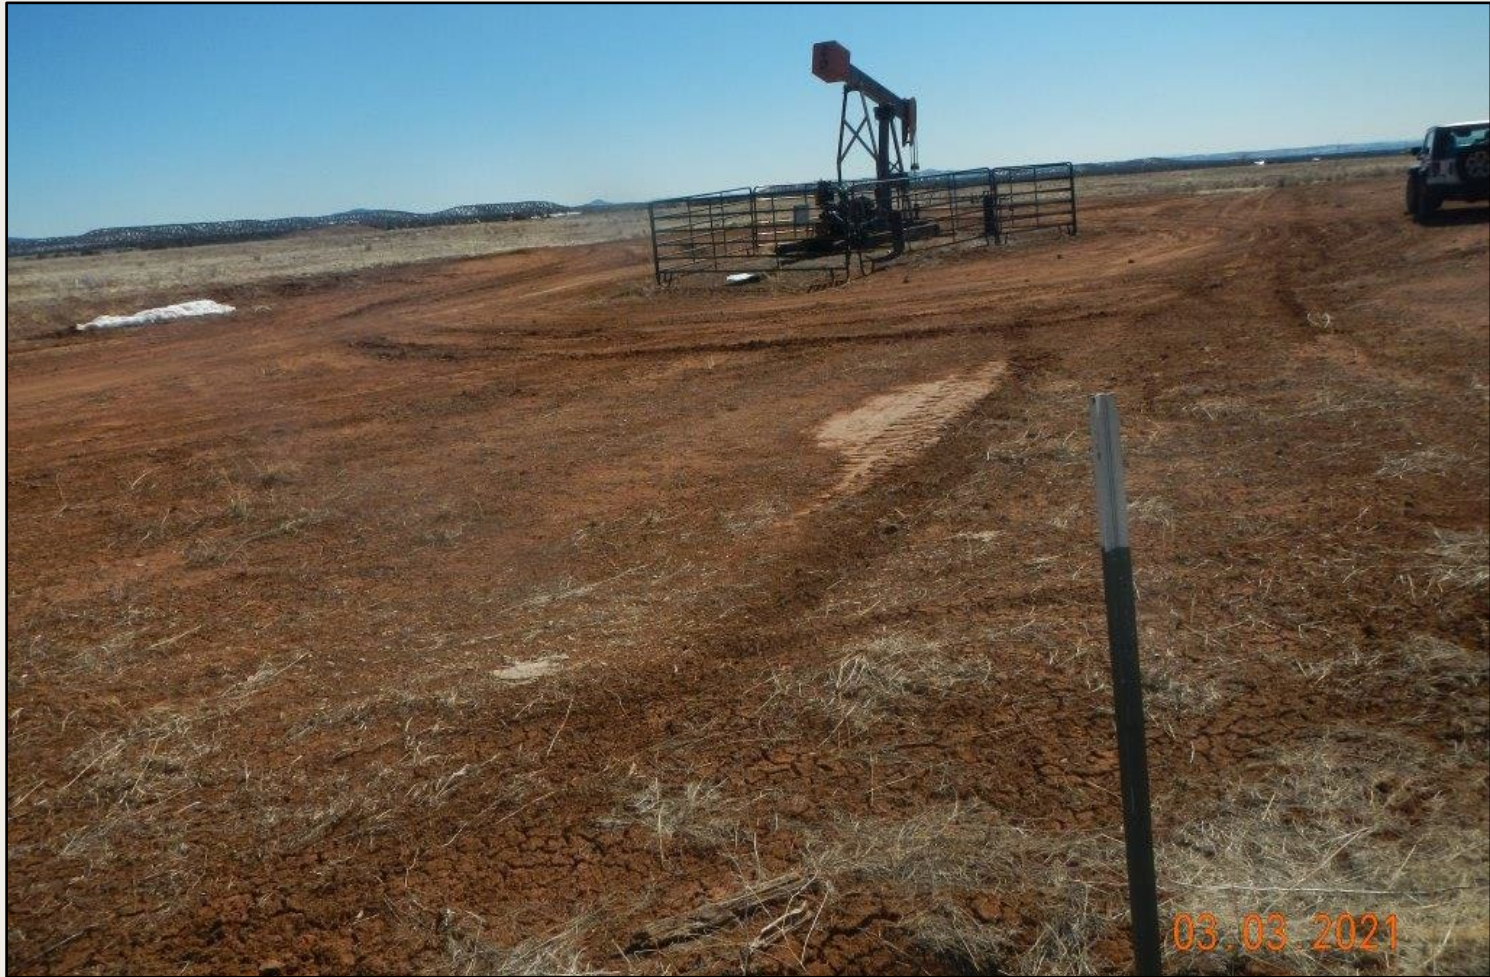
Photo 1. View of the project area from the northwestern corner facing center.

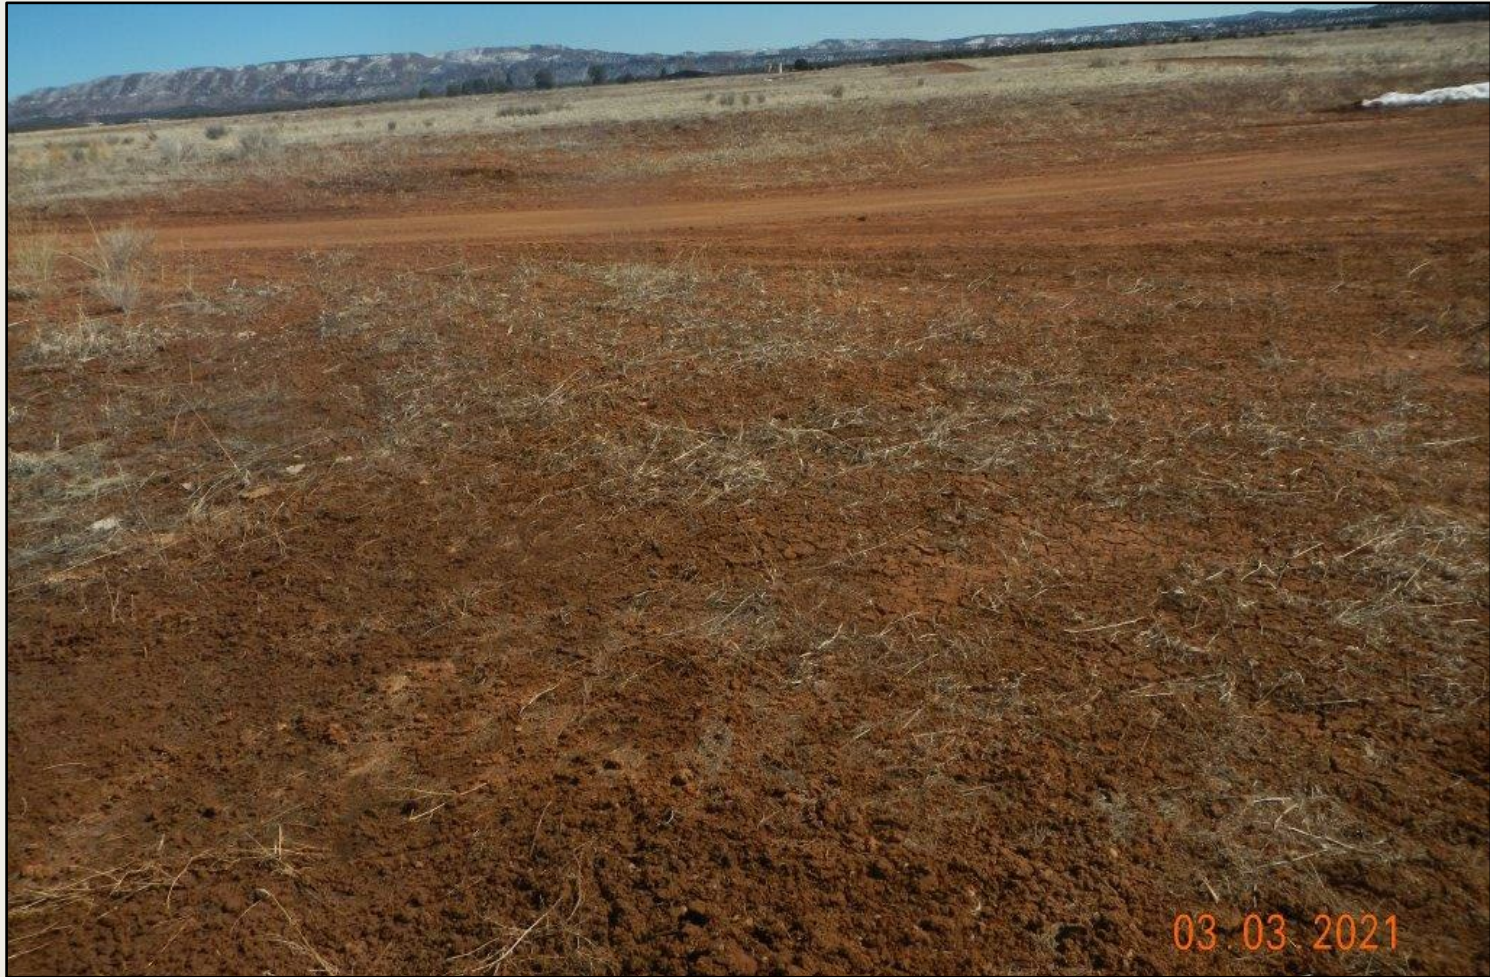
Photo 2. View of the northern project area facing eastward.

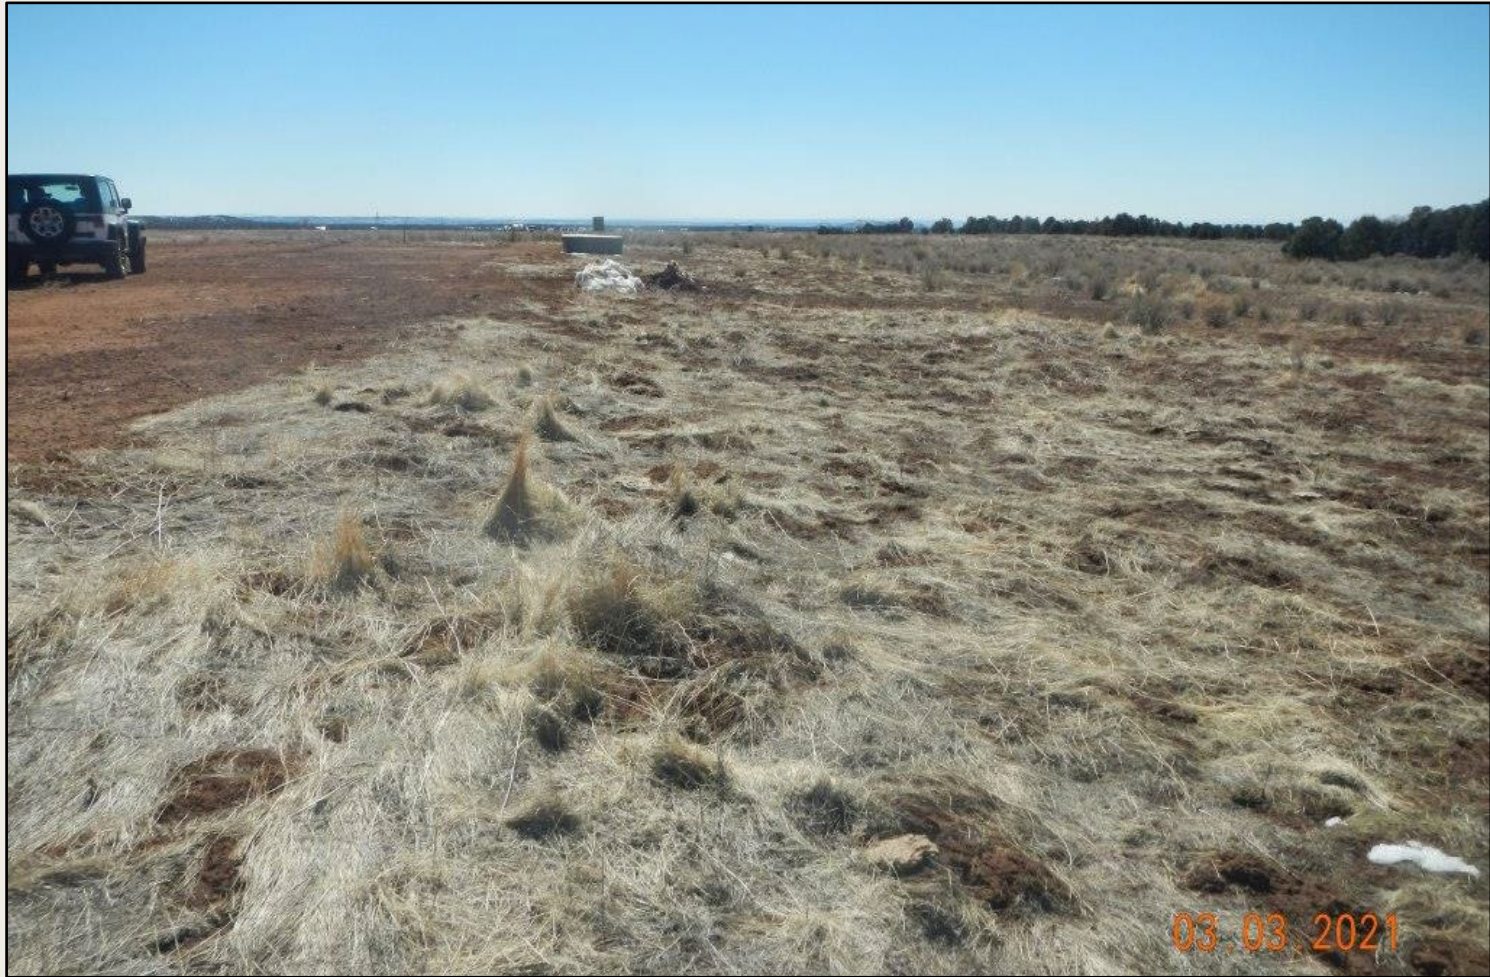
Photos 3. View of the western project area facing southward. Revegetation appears to be progressing in a dormant vegetative condition.

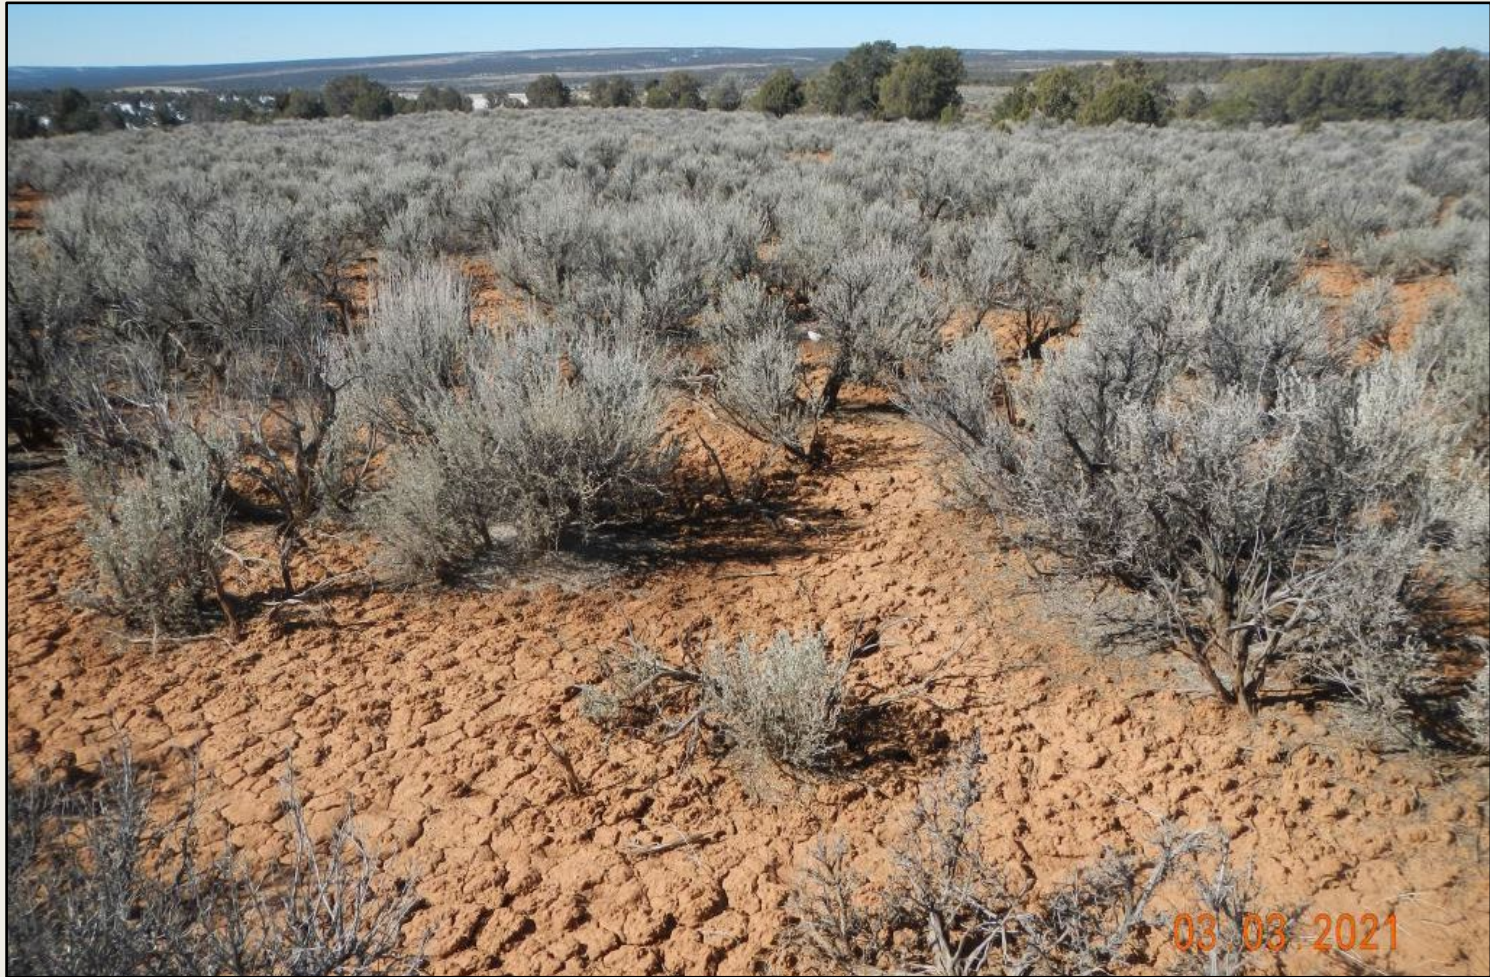
Photo 4. View of the reference area comprised of sagebrush shrubland with understory of grasses such as James galleta and forbs in a dormant condition at this time.
