Inspection Photos
Operator: Williford
API: 067-06560
Date: 3/3/2021

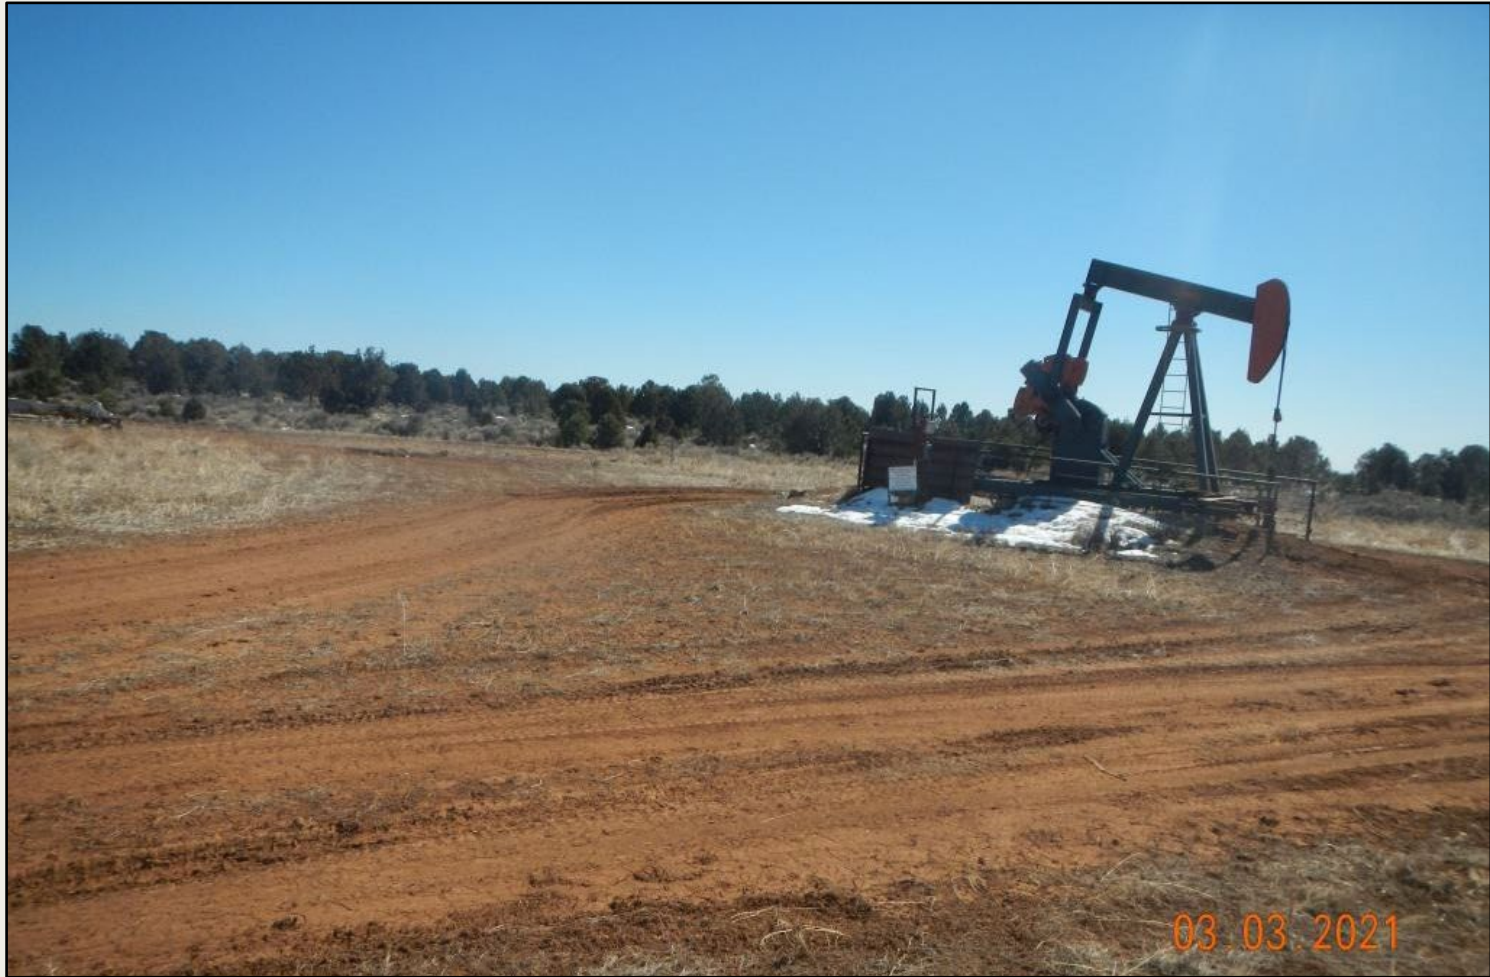
Photo 1. View of the project area from the well pad entrance facing center.

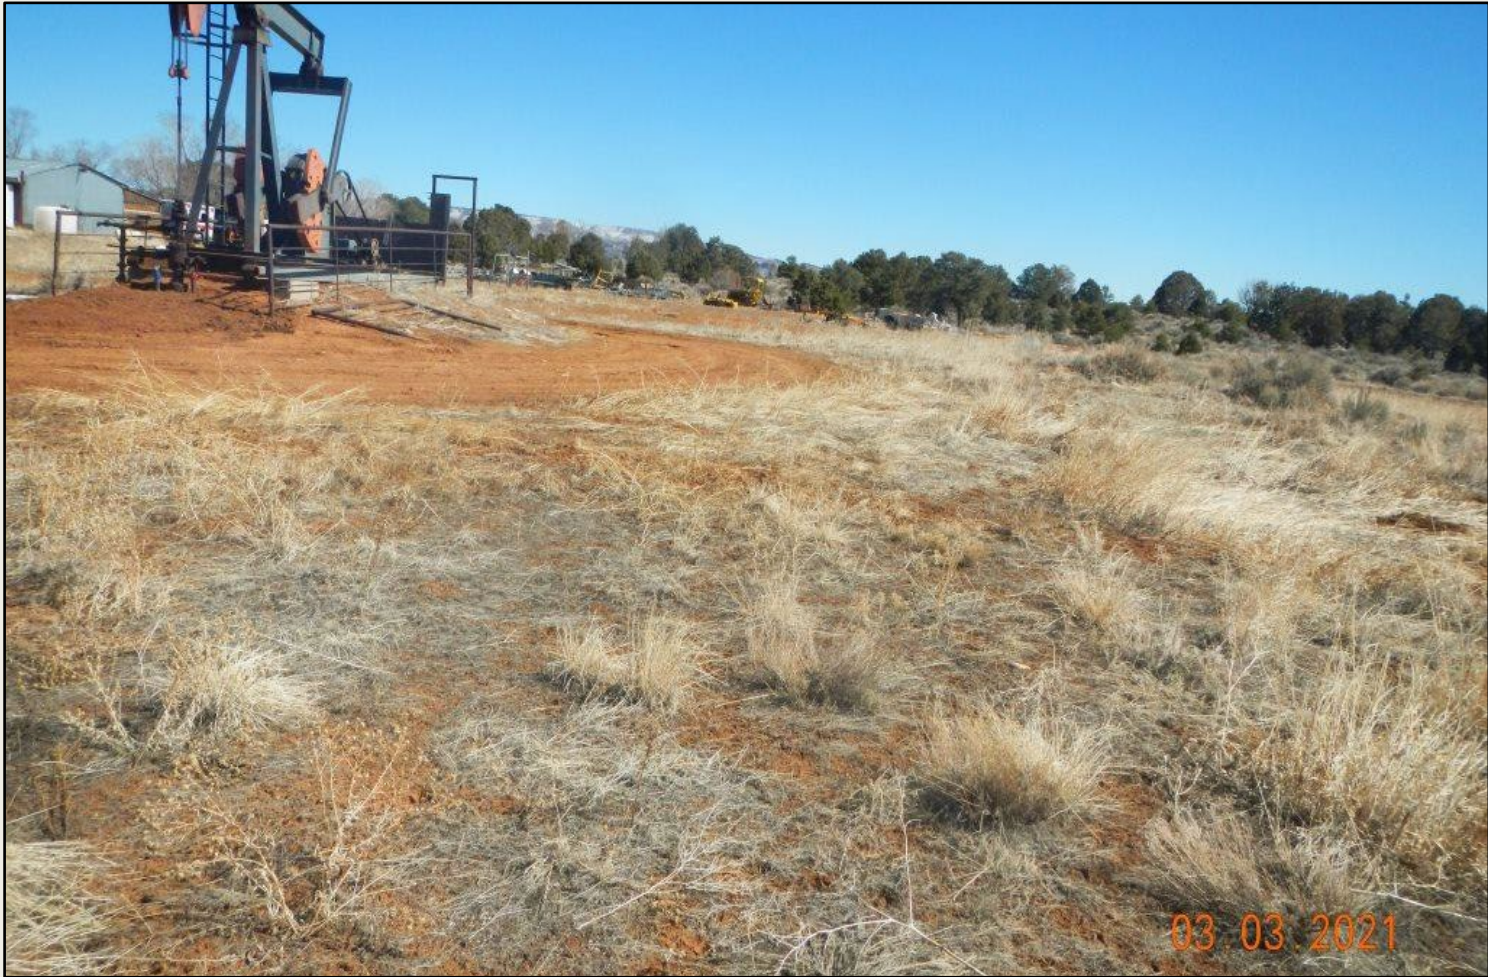
Photo 2. View of the southern project area facing eastward. Revegetation is progressing with Indian ricegrass, western wheatgrass.

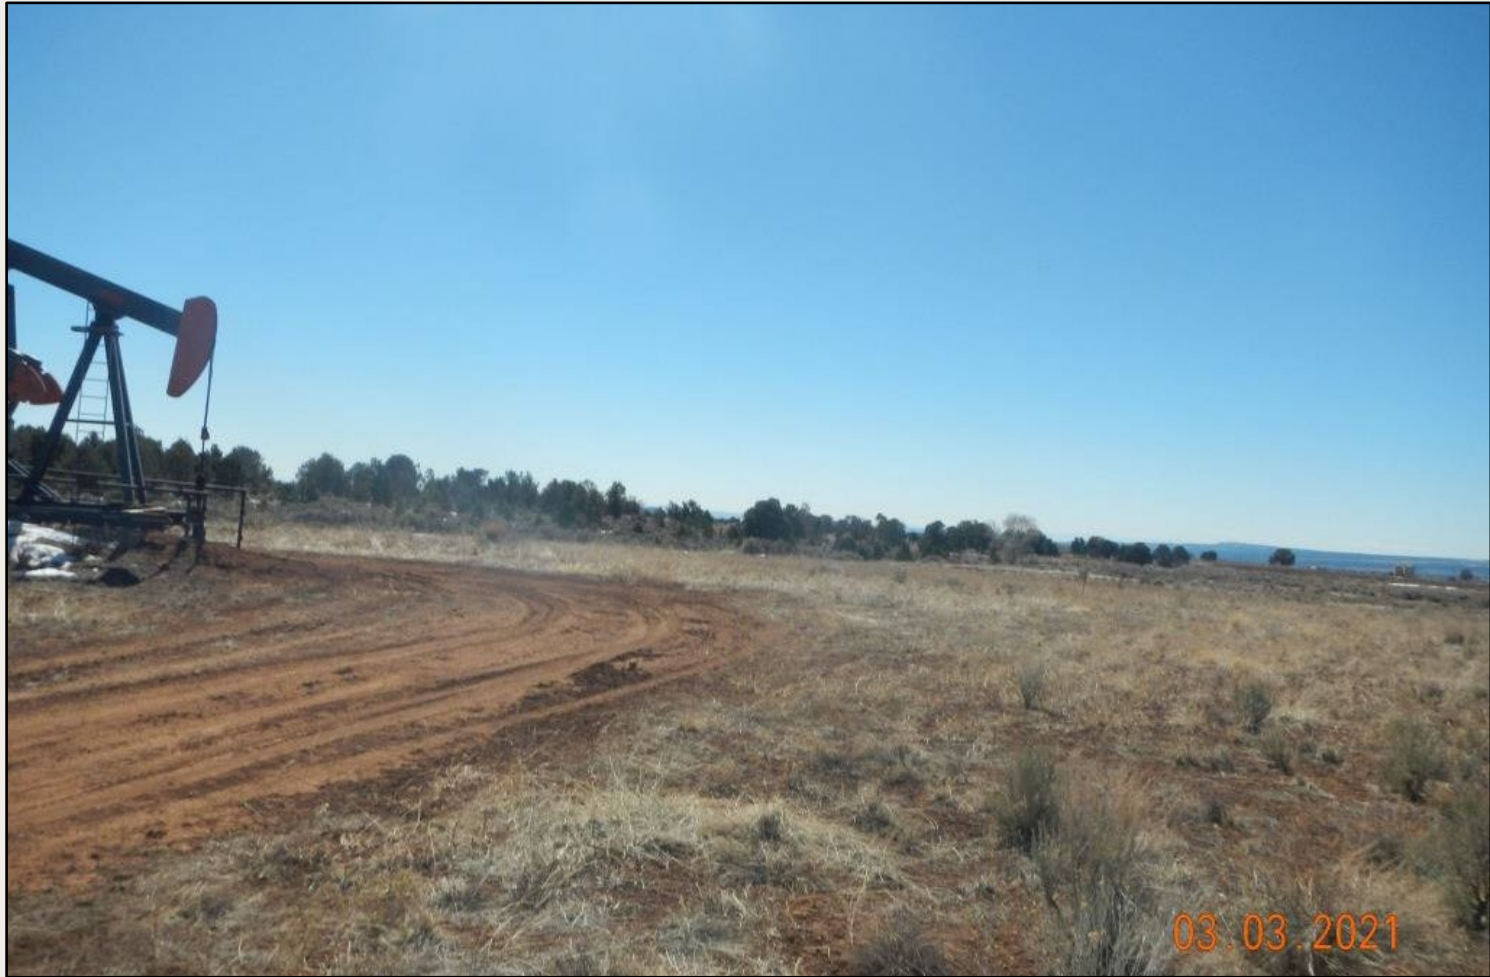
Photos 3. View of the western project area facing southward.
