**TEP ROCKY MOUNTAIN LLC
CHEVRON-66S96W 17NWSE
Location # 335587**

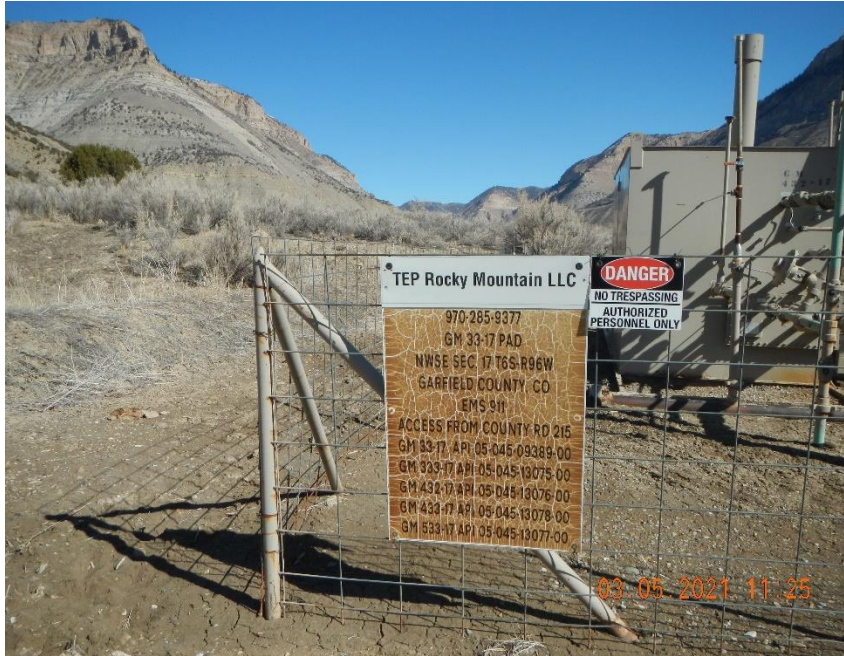
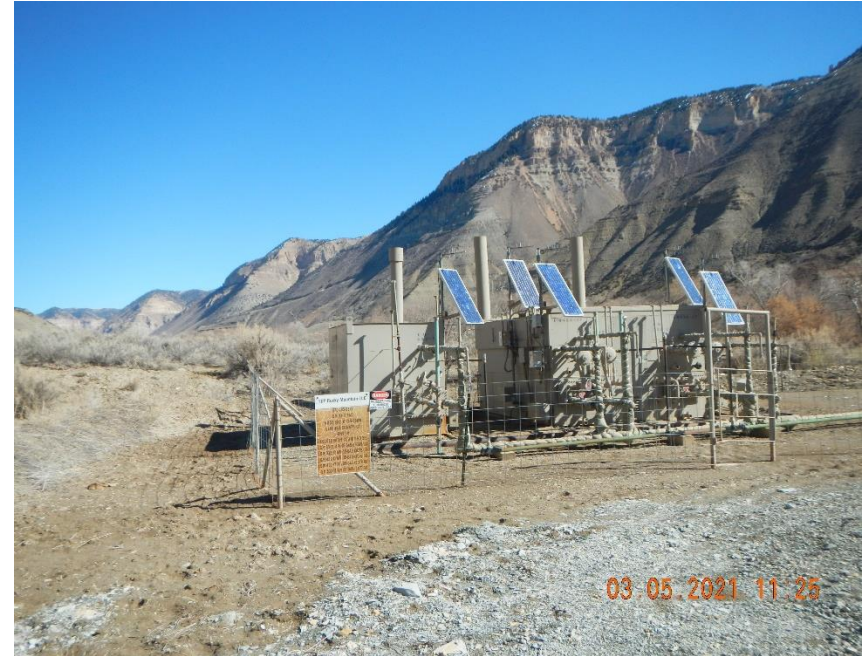
Battery sign not legible and is not at tank battery.

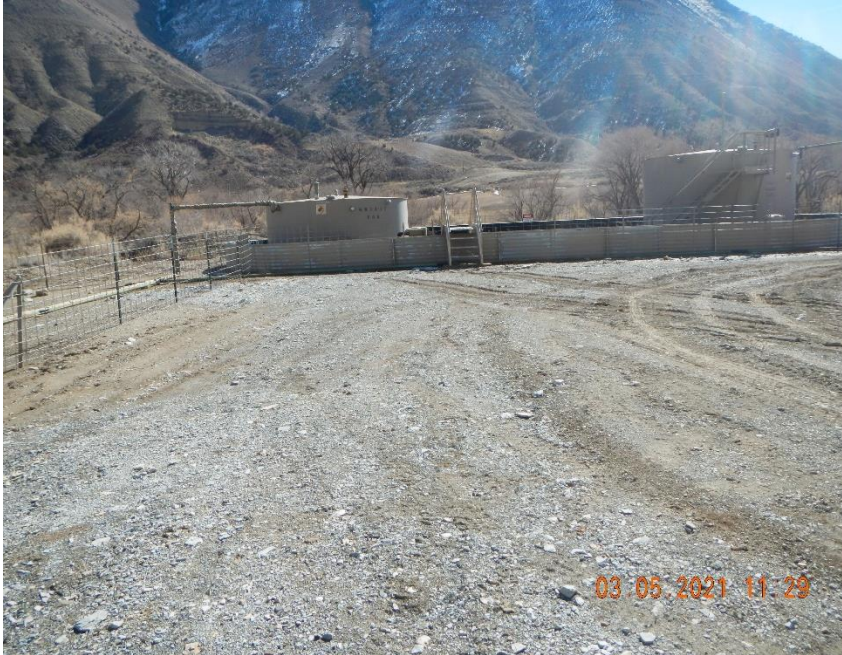
Battery sign is not at tank battery.

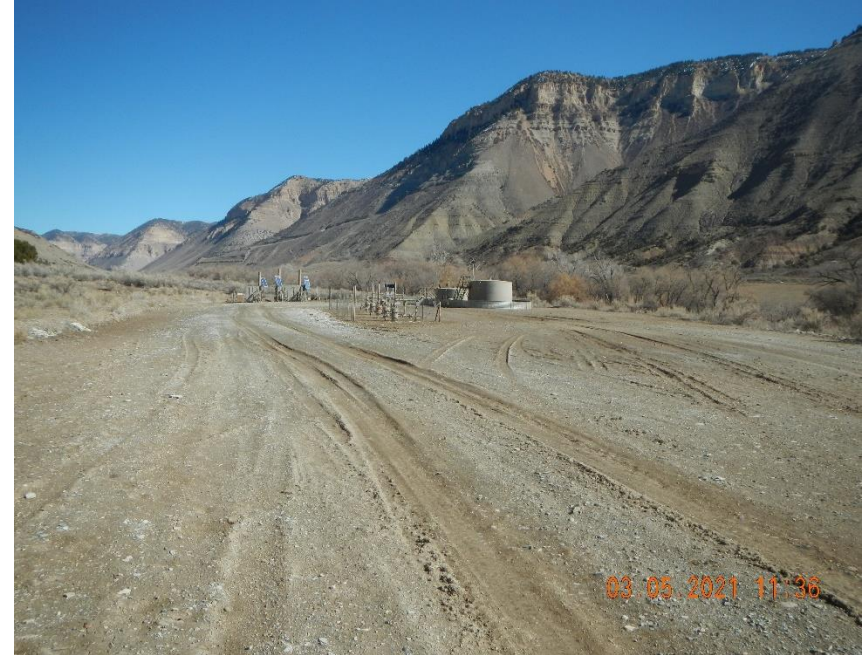
**Location shows signs of lack of stabilization
BMP's in some areas (rutting is present).**

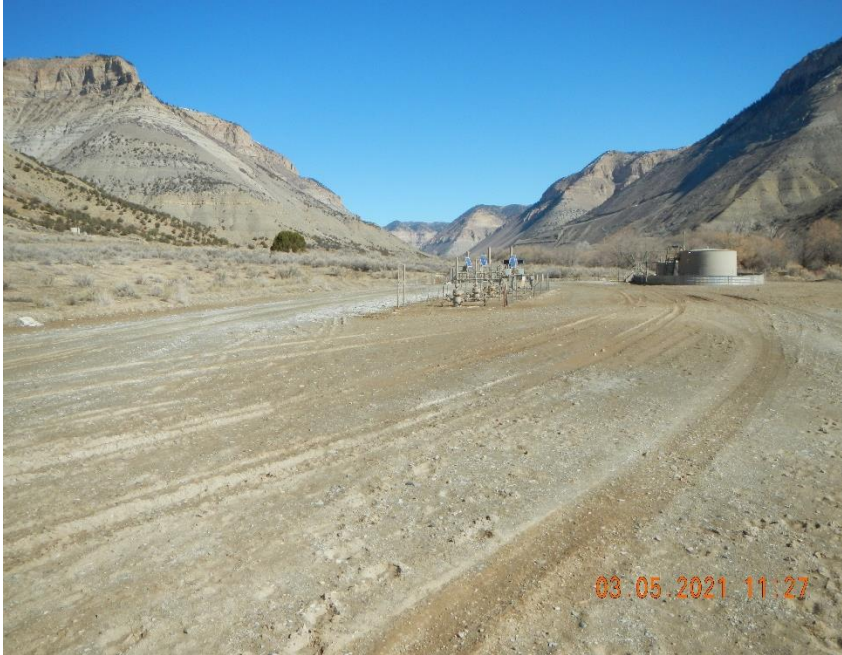
**Location shows signs of lack of stabilization
BMP's in some areas (rutting is present).**

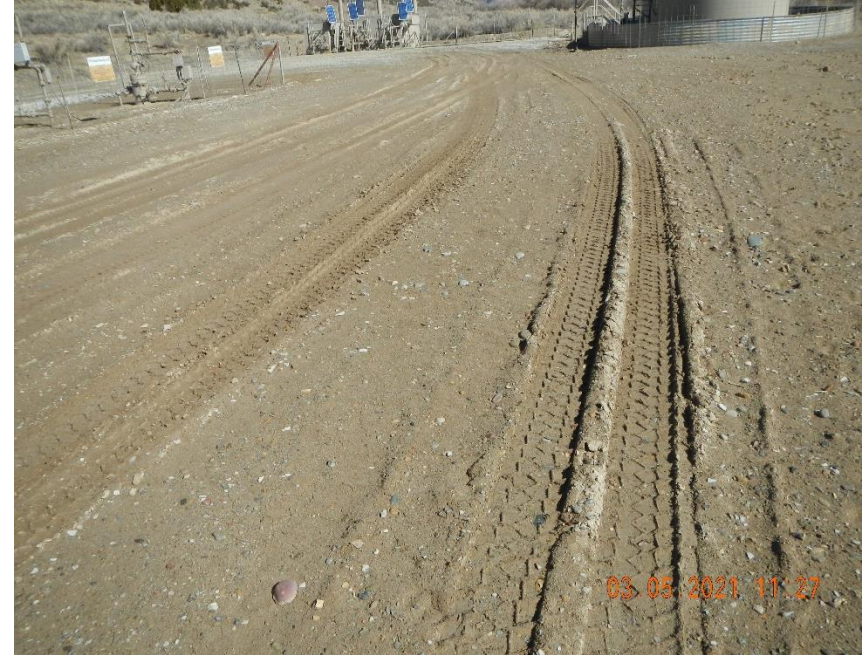
**Location shows signs of lack of stabilization
BMP's in some areas (rutting is present).**

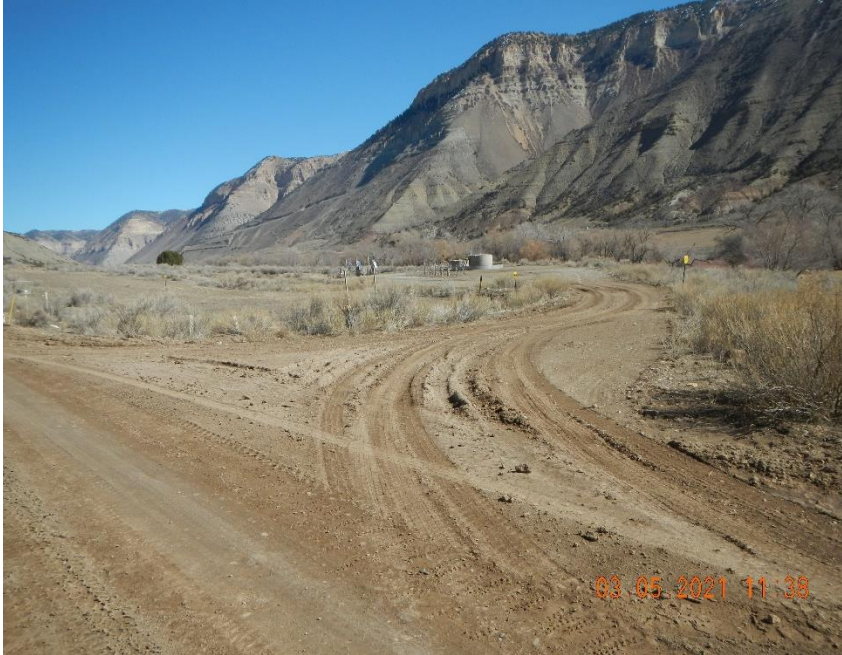
**Access road shows signs of lack of stabilization
BMP's in some areas (rutting is present).**

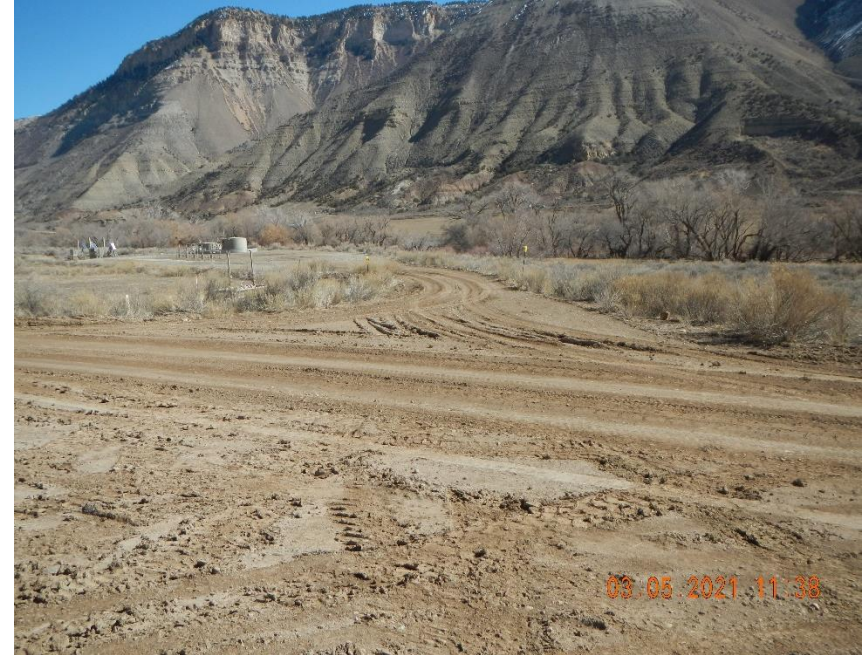
**Access road shows signs of lack of stabilization
BMP's in some areas (rutting is present).**

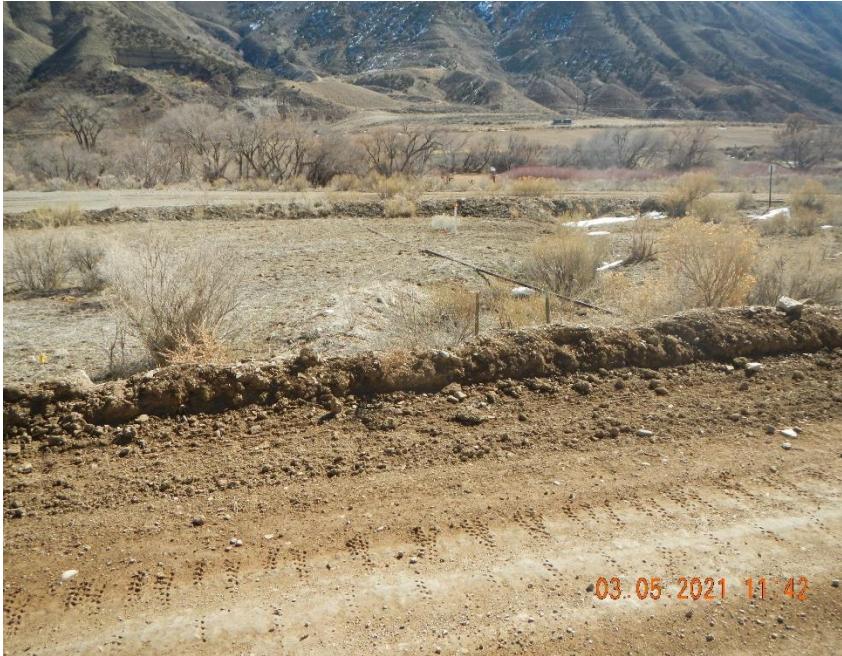
2 sticks of tubing laying between access road and location.

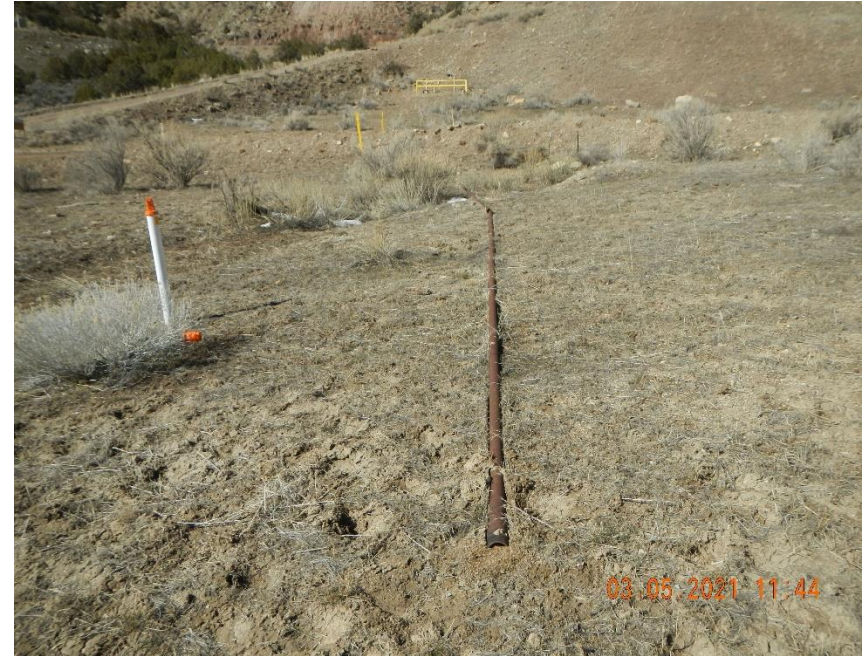
2 sticks of tubing laying between access road and location.

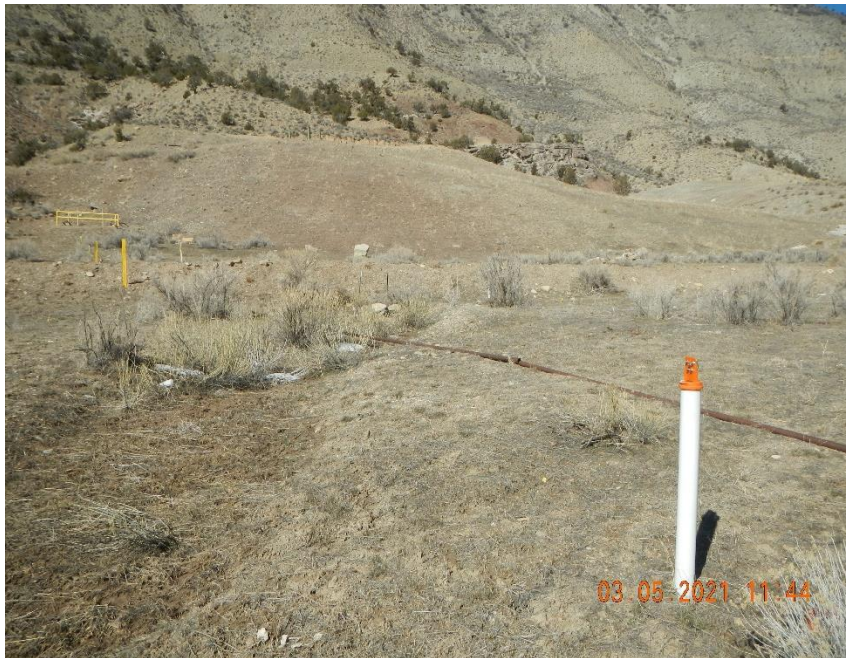
2 sticks of tubing laying between access road and location.

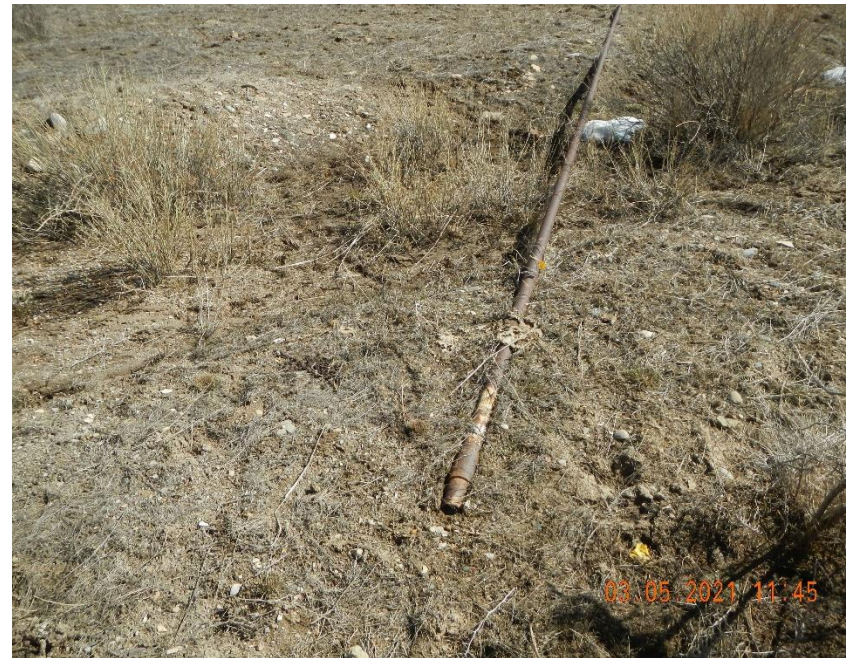
2 sticks of tubing laying between access road and location.

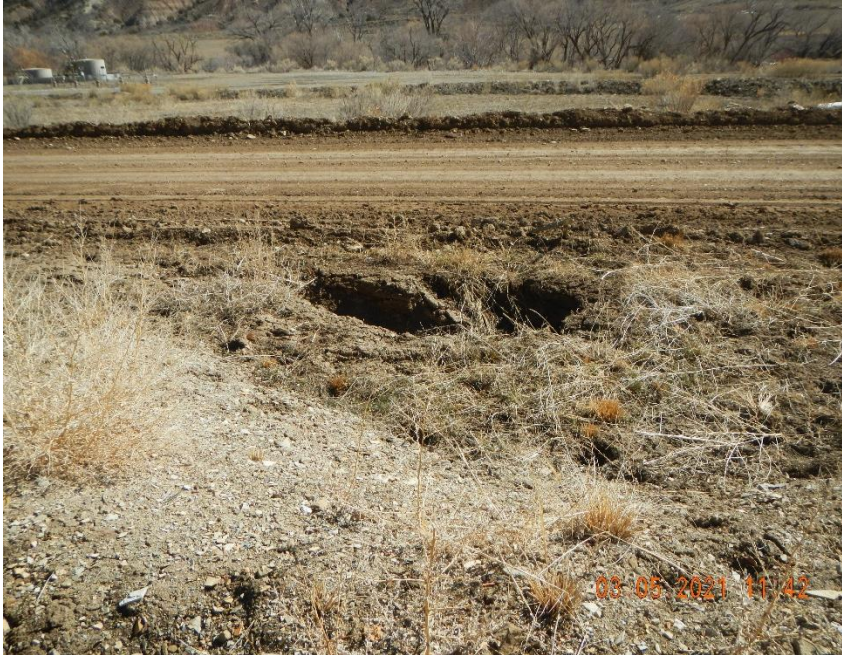
**Culvert needs maintained.
39.52242 108.13237**

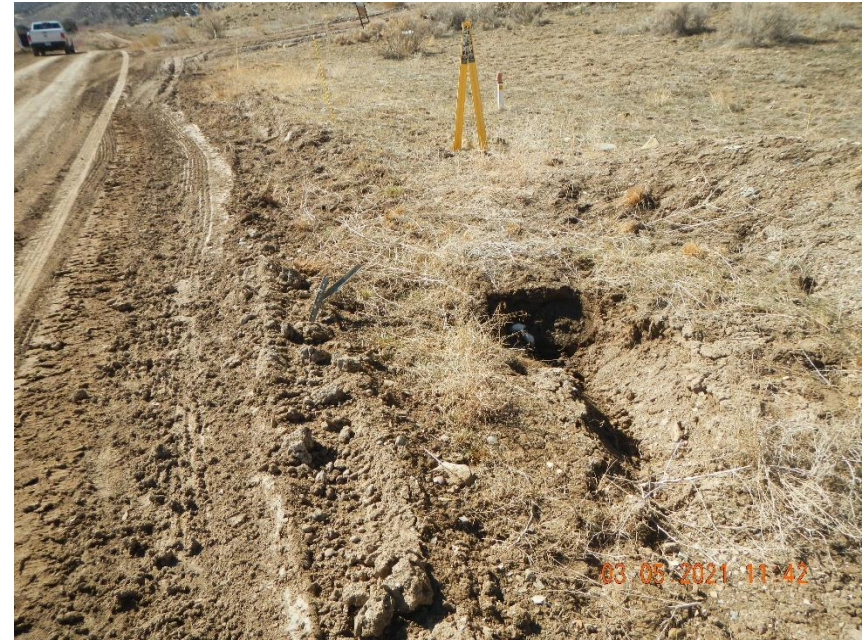
**Culvert needs maintained.
39.52242 108.13237**

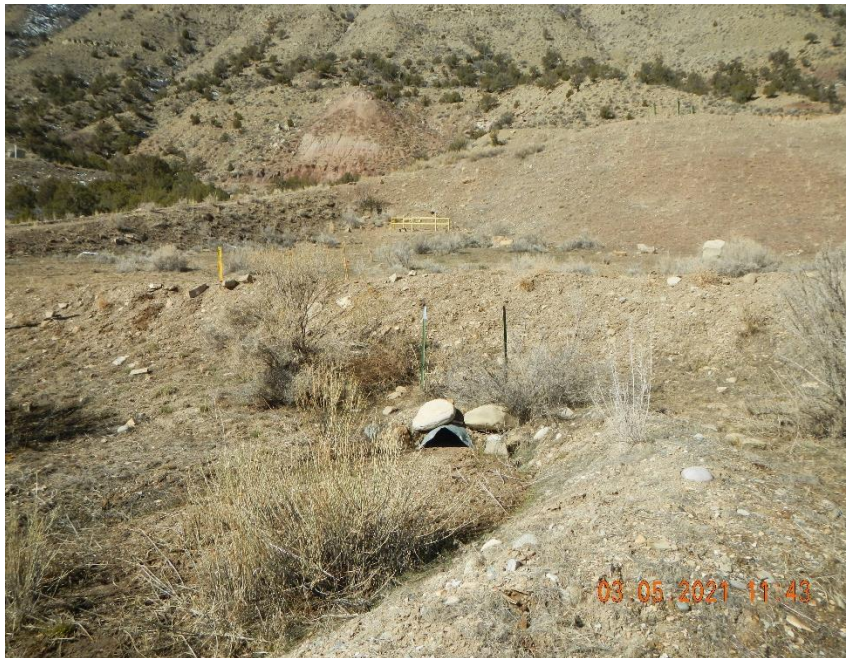
**Culvert needs maintained.
39.52242 108.13237**

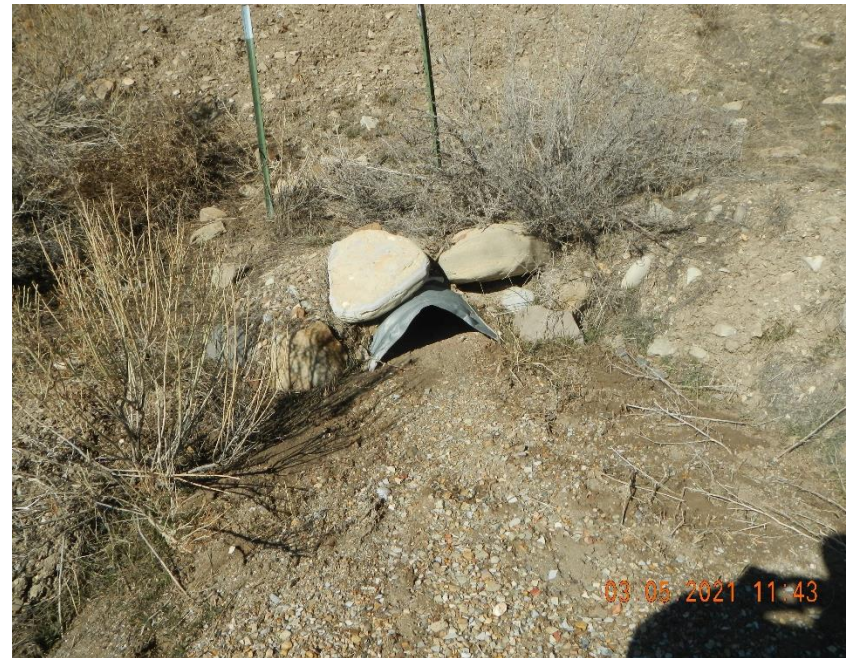
**Culvert needs maintained.
39.52242 108.13237**

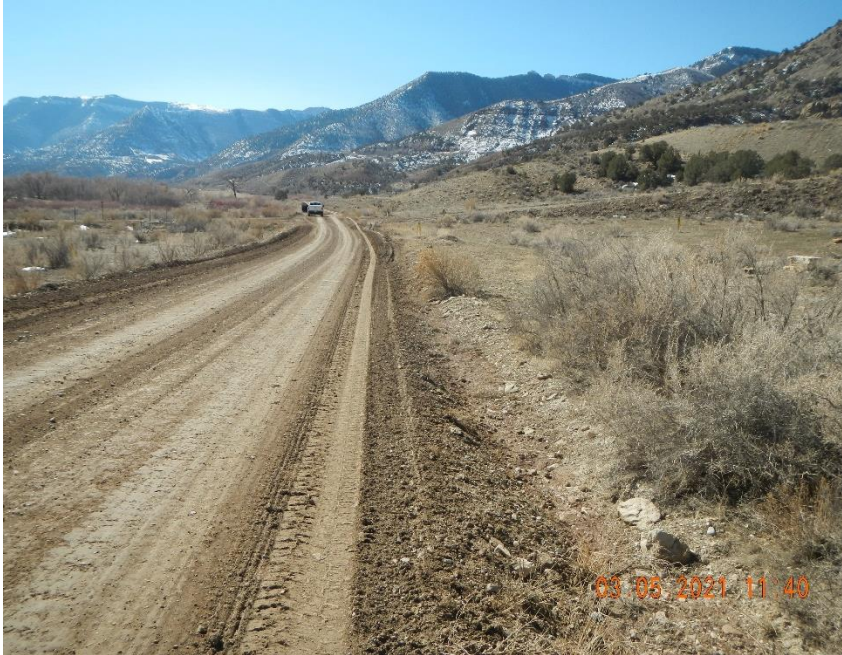
Ditch needs maintained.

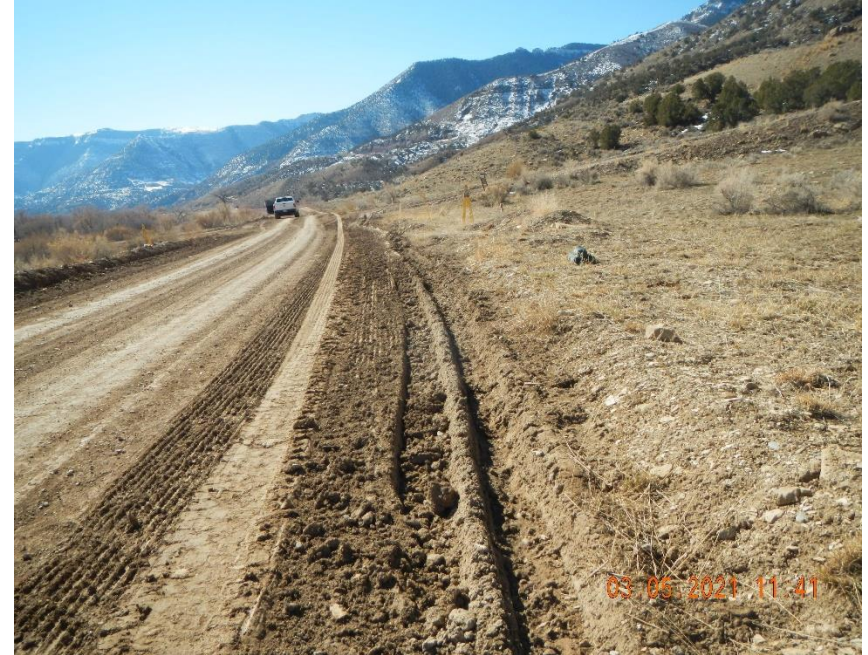
Tire ruts in roadside ditch.
