Inspection Photos

Location Name: TEP ROCKY MOUNTAIN LLC BOSELY-67S96W /23SESW

Location ID: 334579

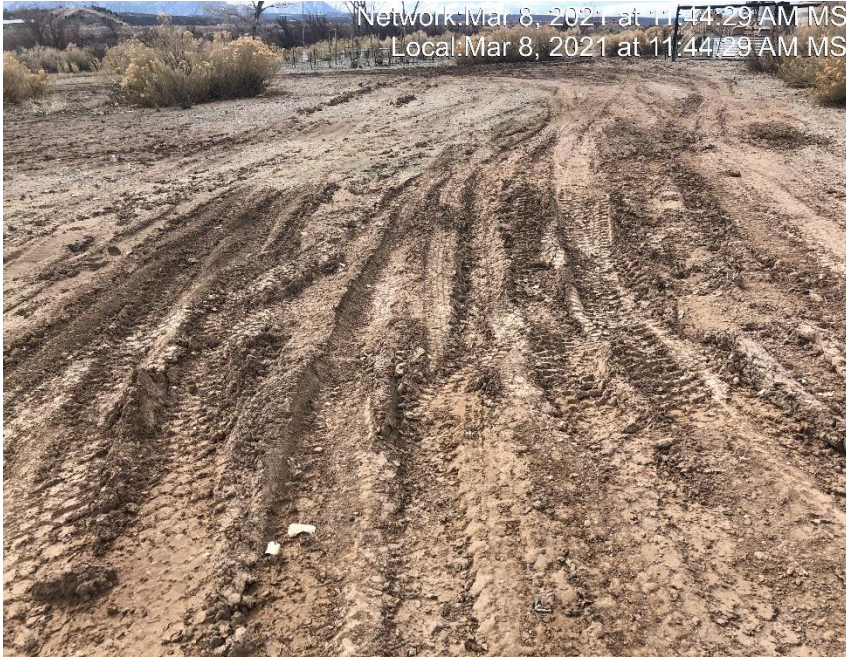
Photo #3086 Rutting present on location due to lack of stabilization.

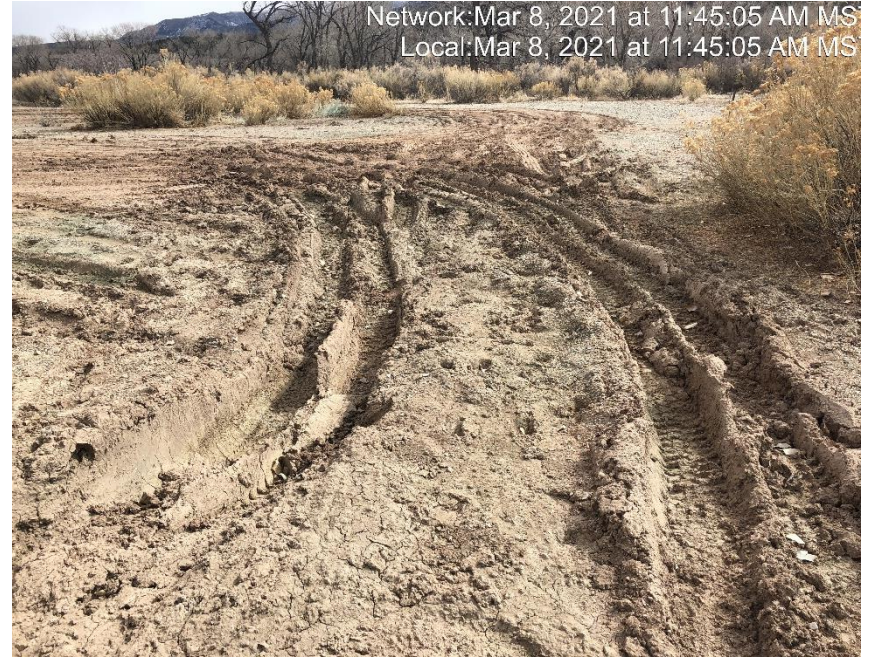
Photo #3087 3086 Rutting present on location due to lack of stabilization.

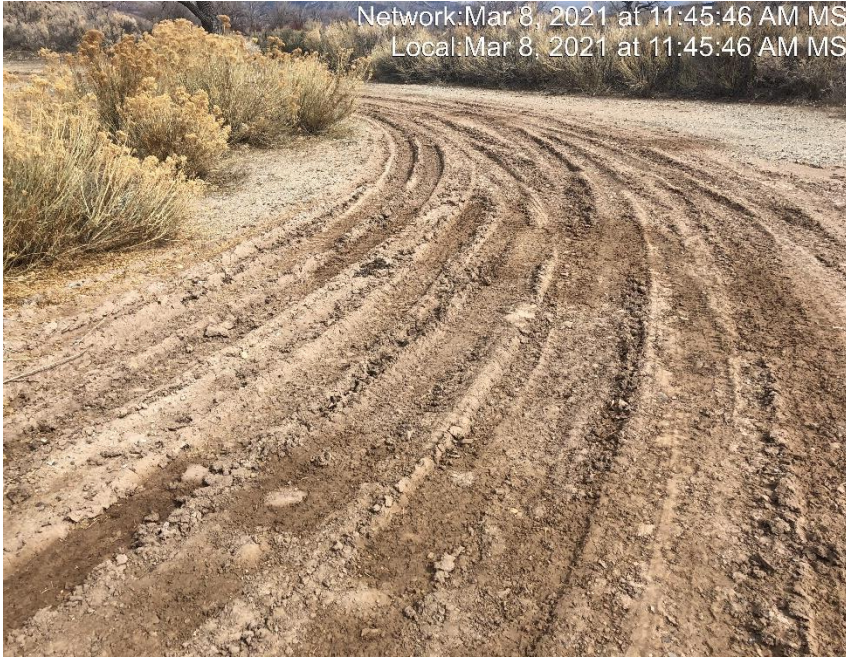
Photo #3088 3086 Rutting present on location due to lack of stabilization.

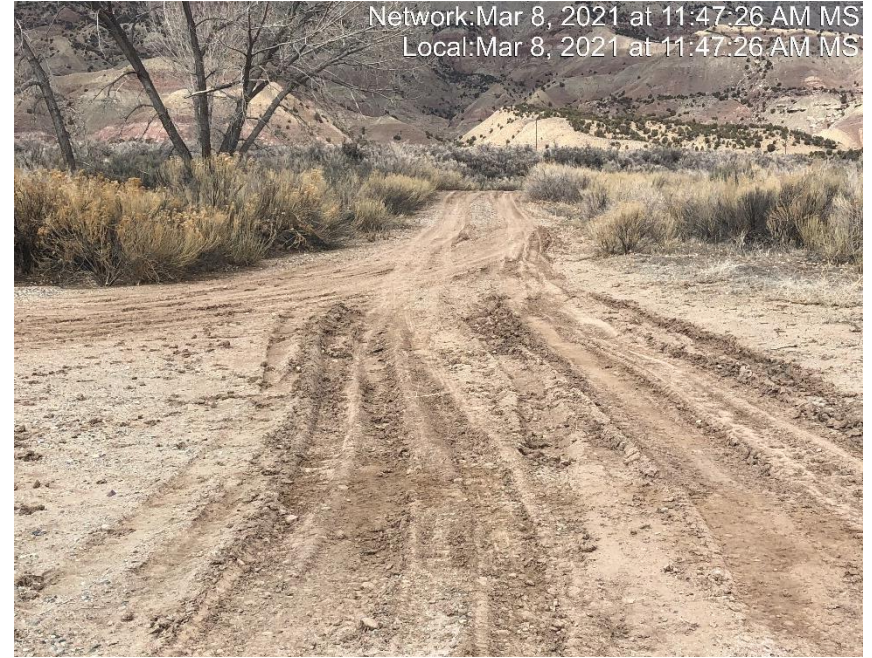
Photo #3089 No form of tracking control at entrance to location.
