# Inspection Photos

API: 009-06628

Operator: INVESTMENT EQUIPMENT LLC

Inspection Date: 3/3/2021

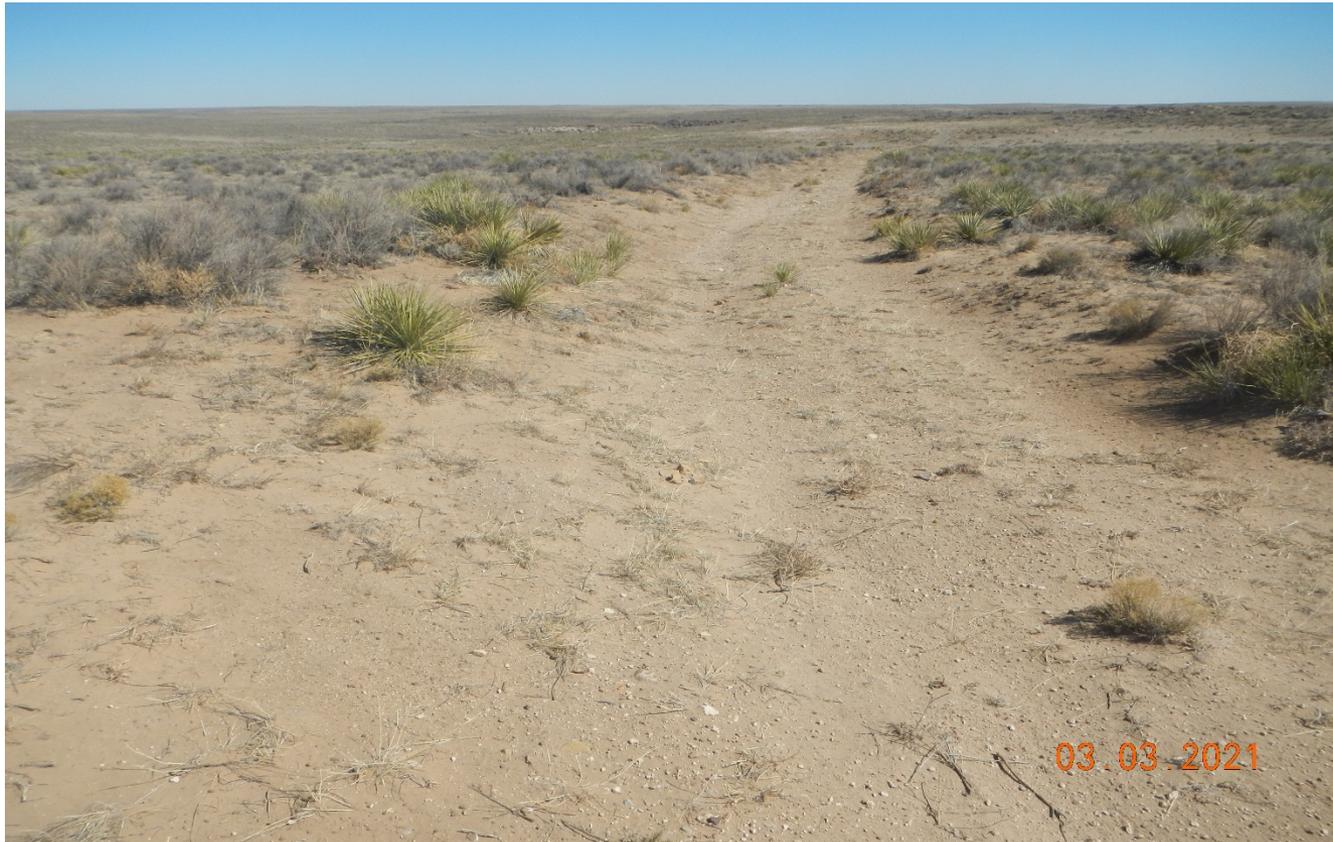
**Photo 1.** Facing northeast at the beginning of the access road. The access road has not been recontoured and reclaimed.

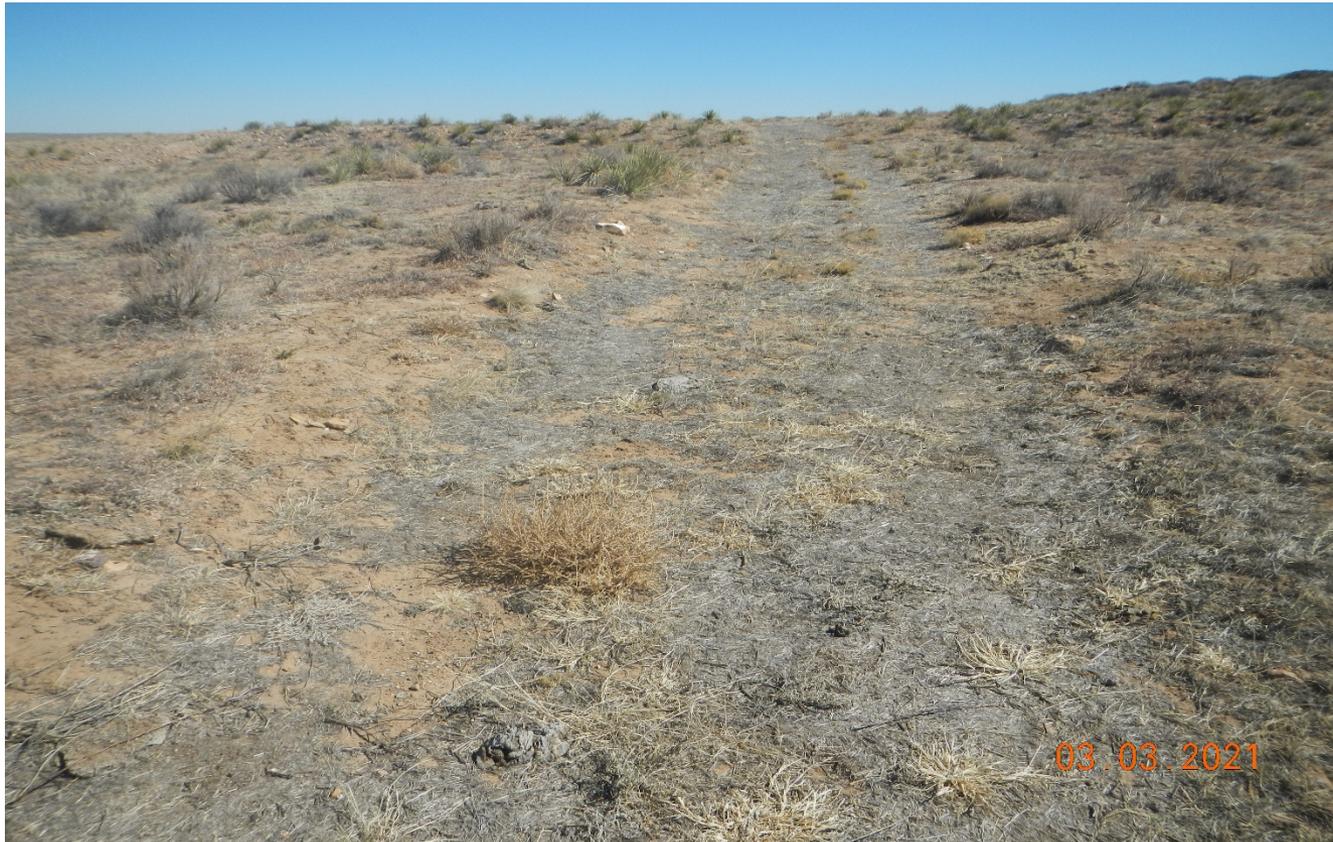
**Photo 2.** Facing east at the access road near the location. It appears mulch was applied to the area of access road near the location.

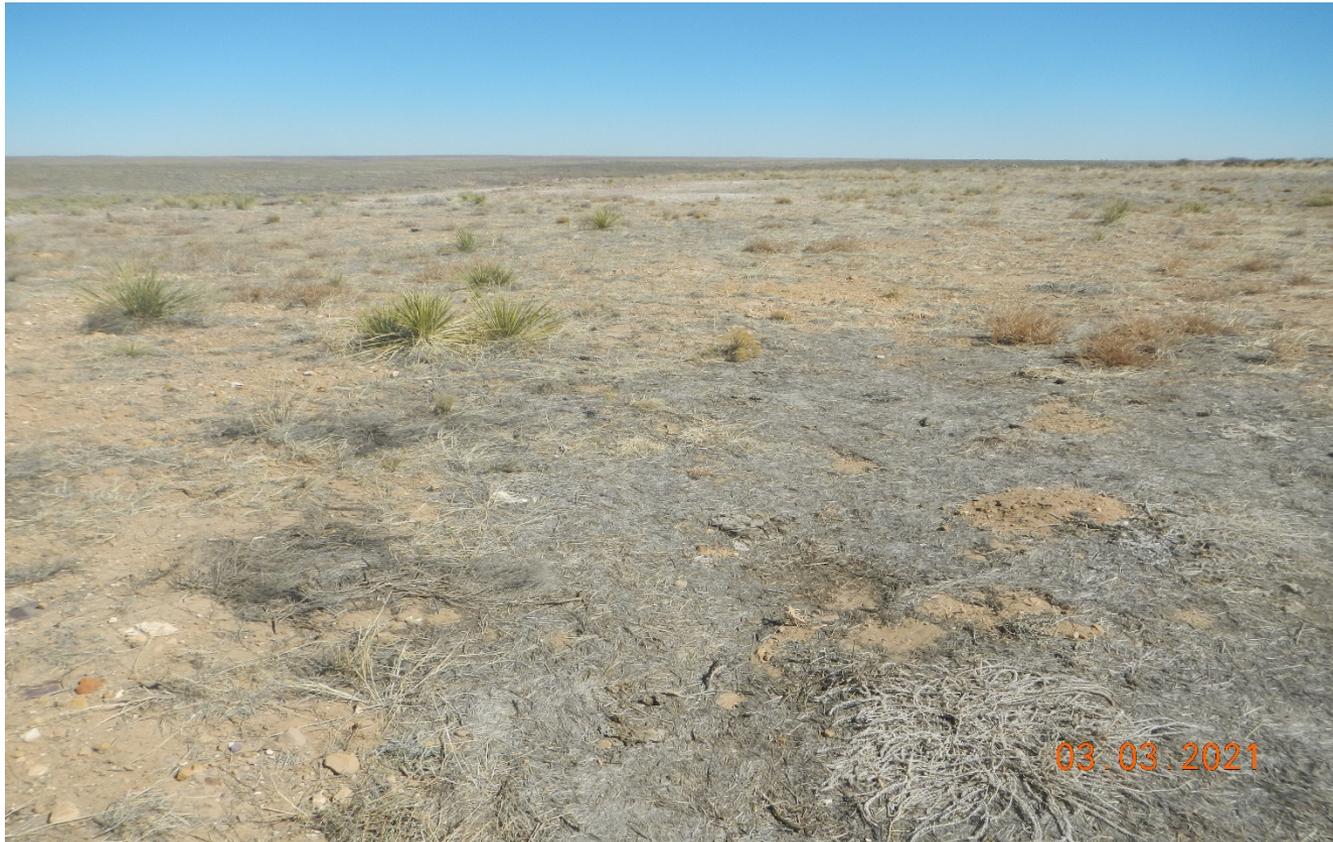
**Photo 3.** Facing northeast toward the location.

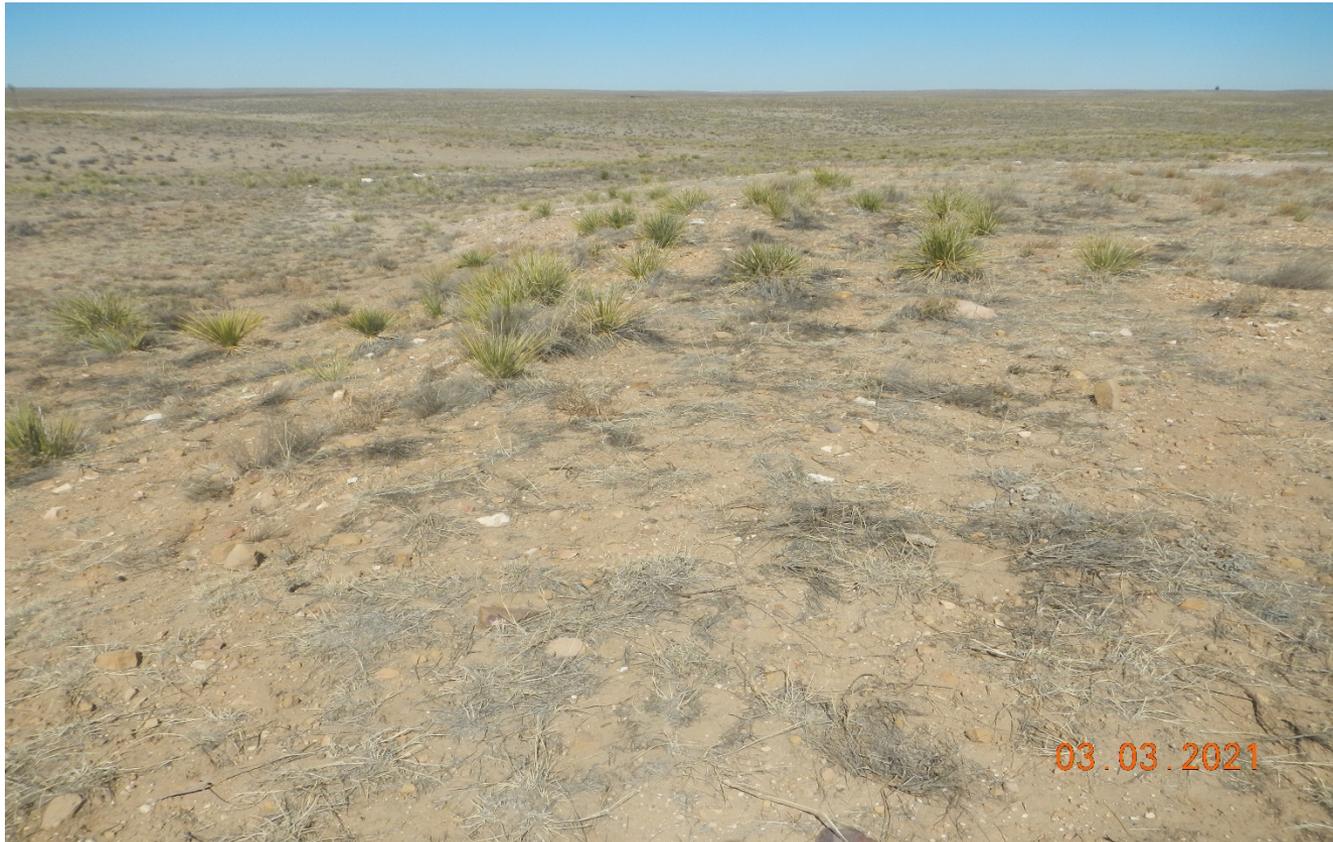
**Photo 4.** Facing toward the northwest side. The fill slope has not been recontoured.

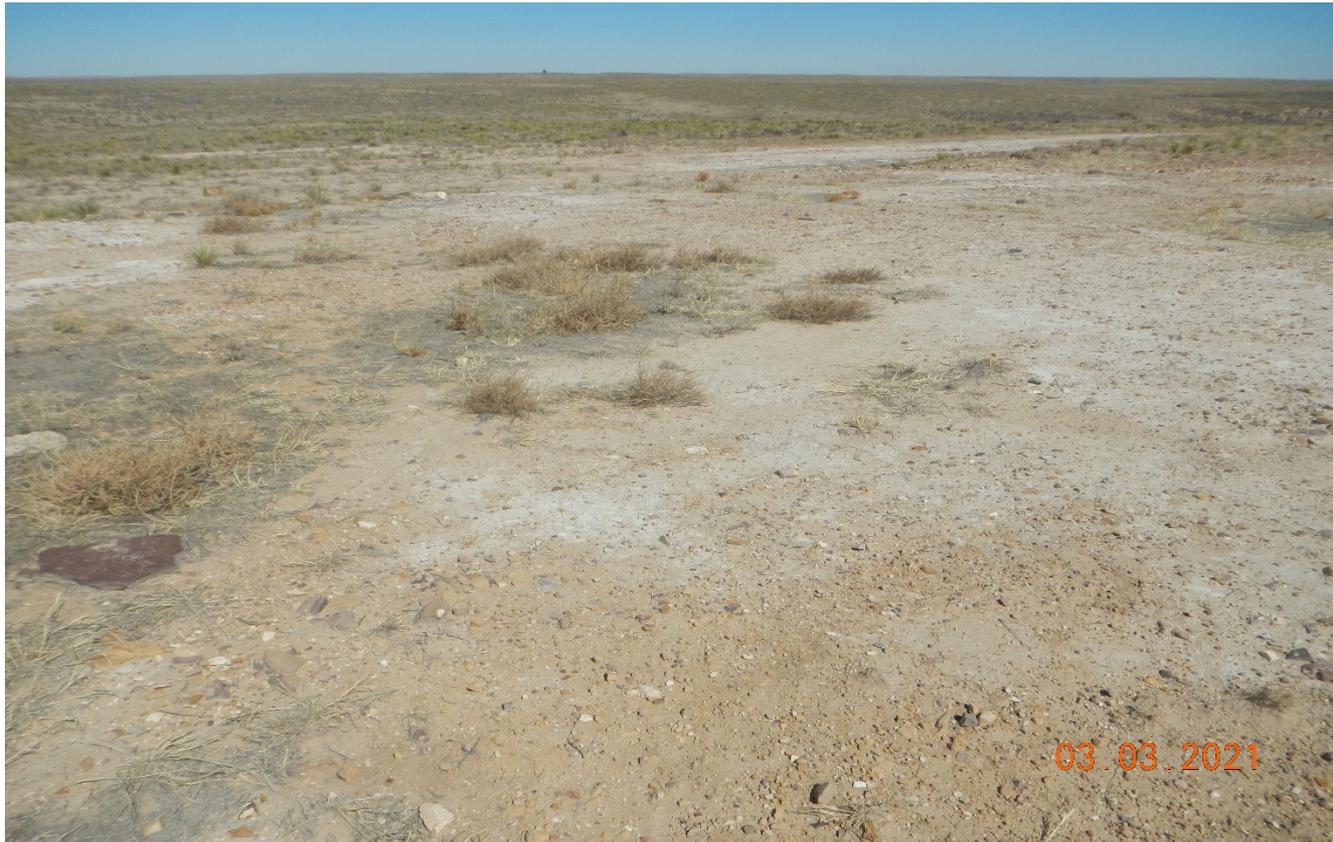
**Photo 5.** Facing northeast at the location. Vegetation is not establishing at the location.

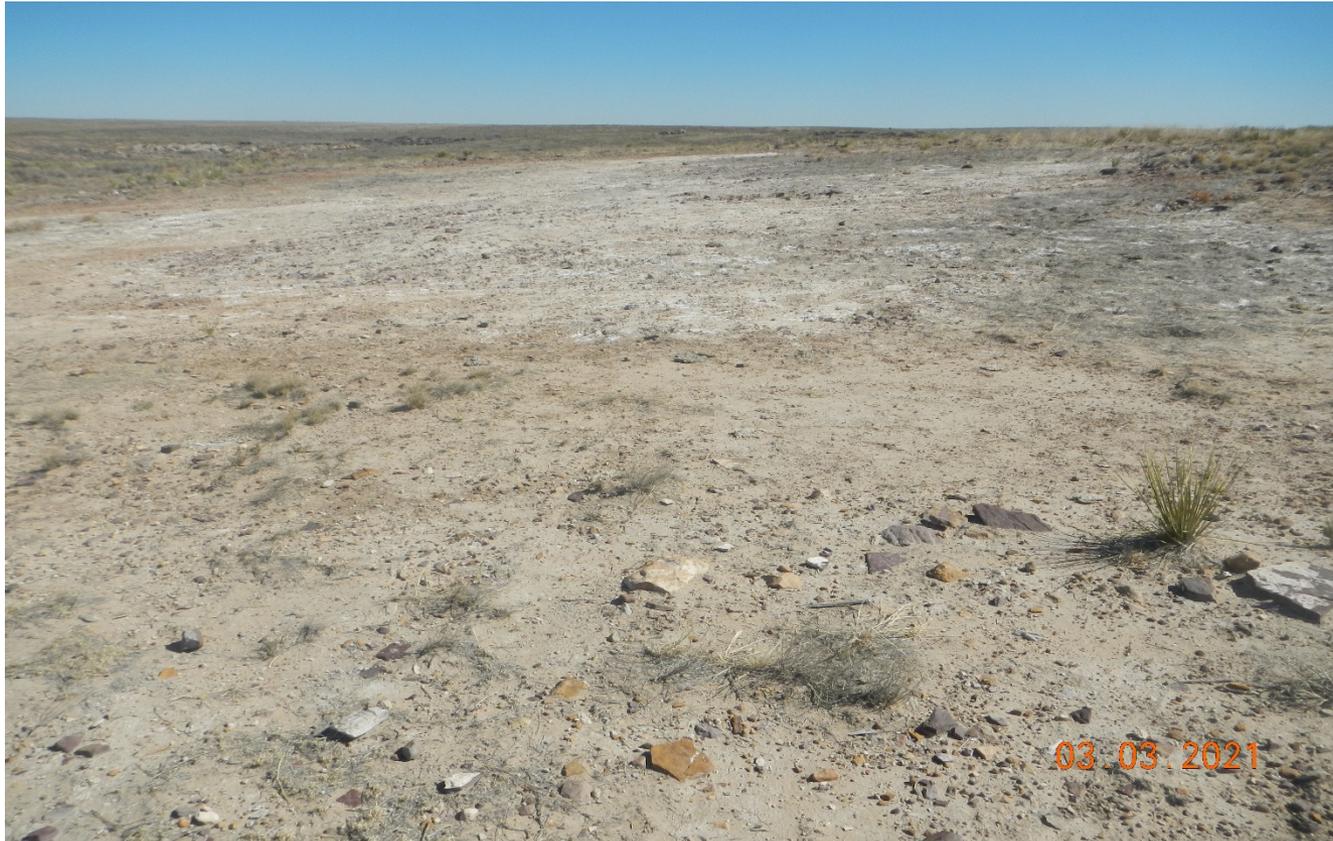
**Photo 6.** Facing east at the north side of the location. This area is approximately 150'x100' with no vegetation. It appears there is soil issues preventing vegetation growth.

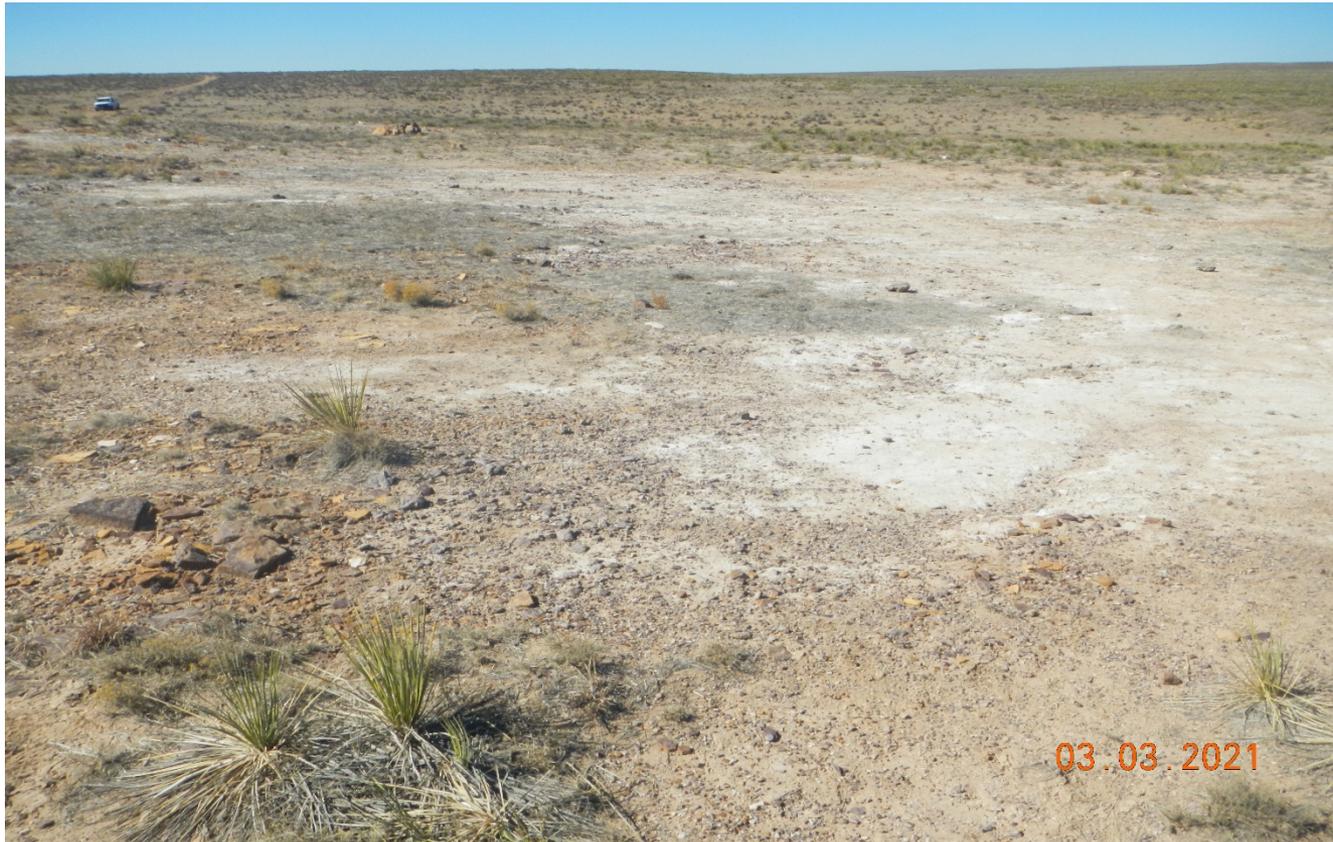
**Photo 7.** Facing west at the north side of the location. This area is approximately 150'x100' with no vegetation. It appears there is soil issues preventing vegetation growth.

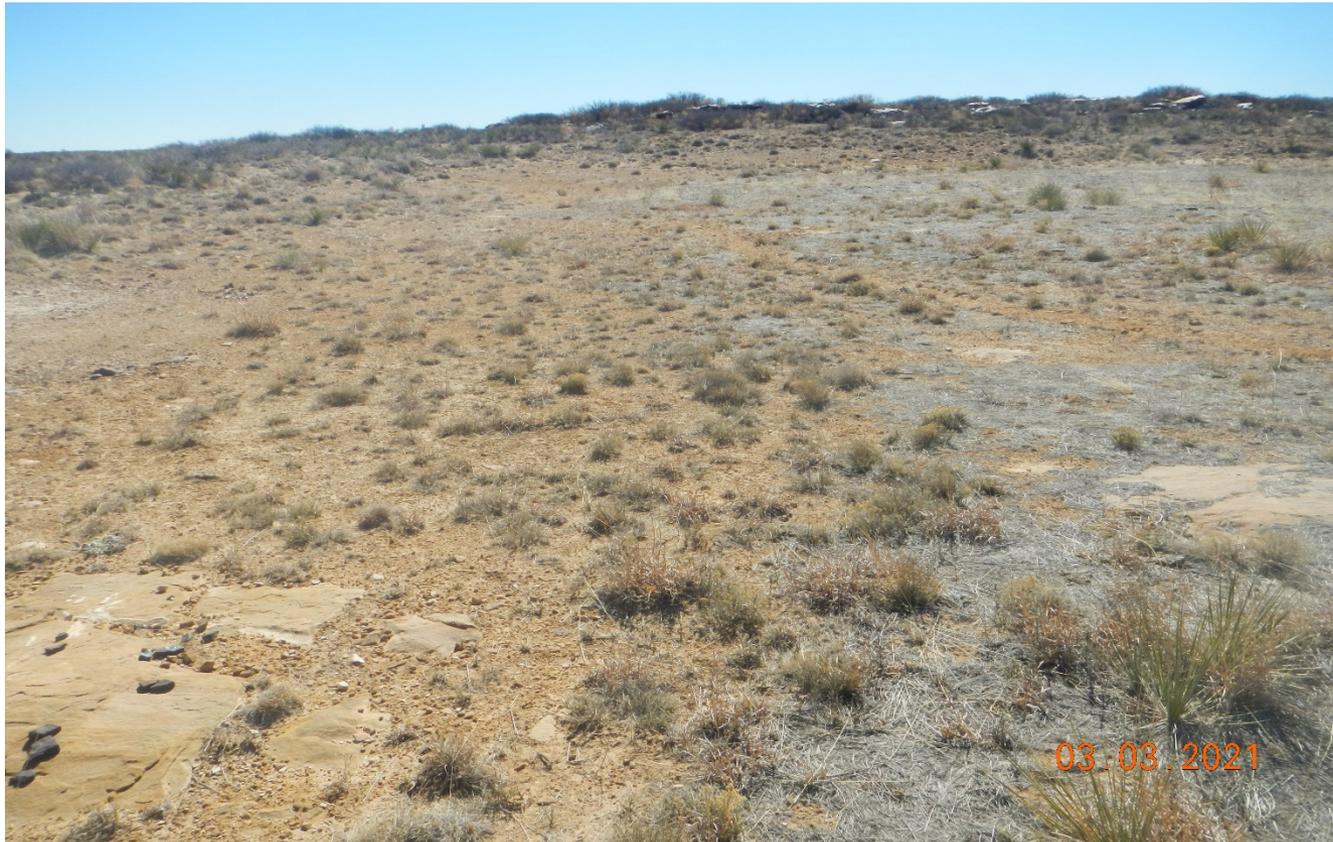
**Photo 8.** Facing south at the east side of the location.

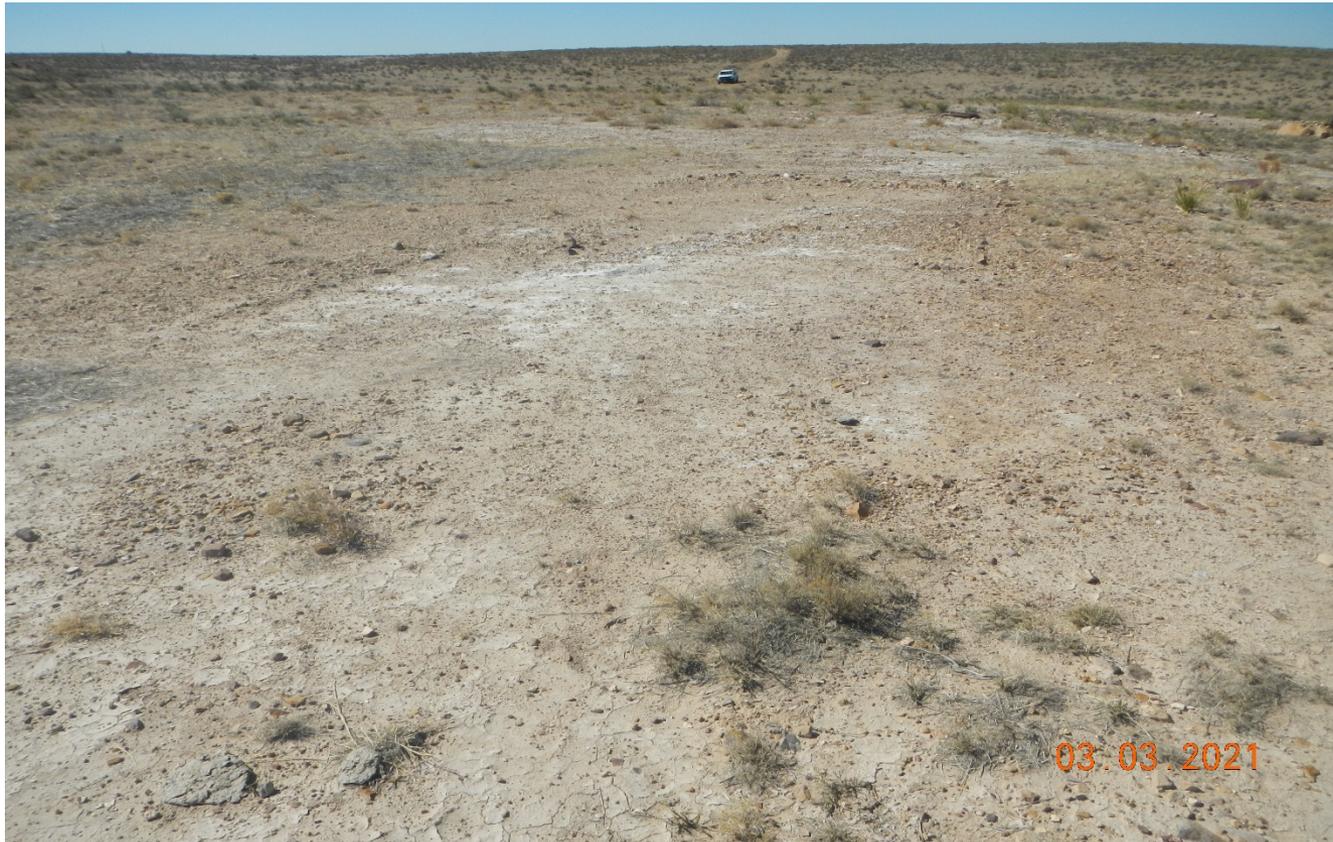
**Photo 9.** Facing west at the location.

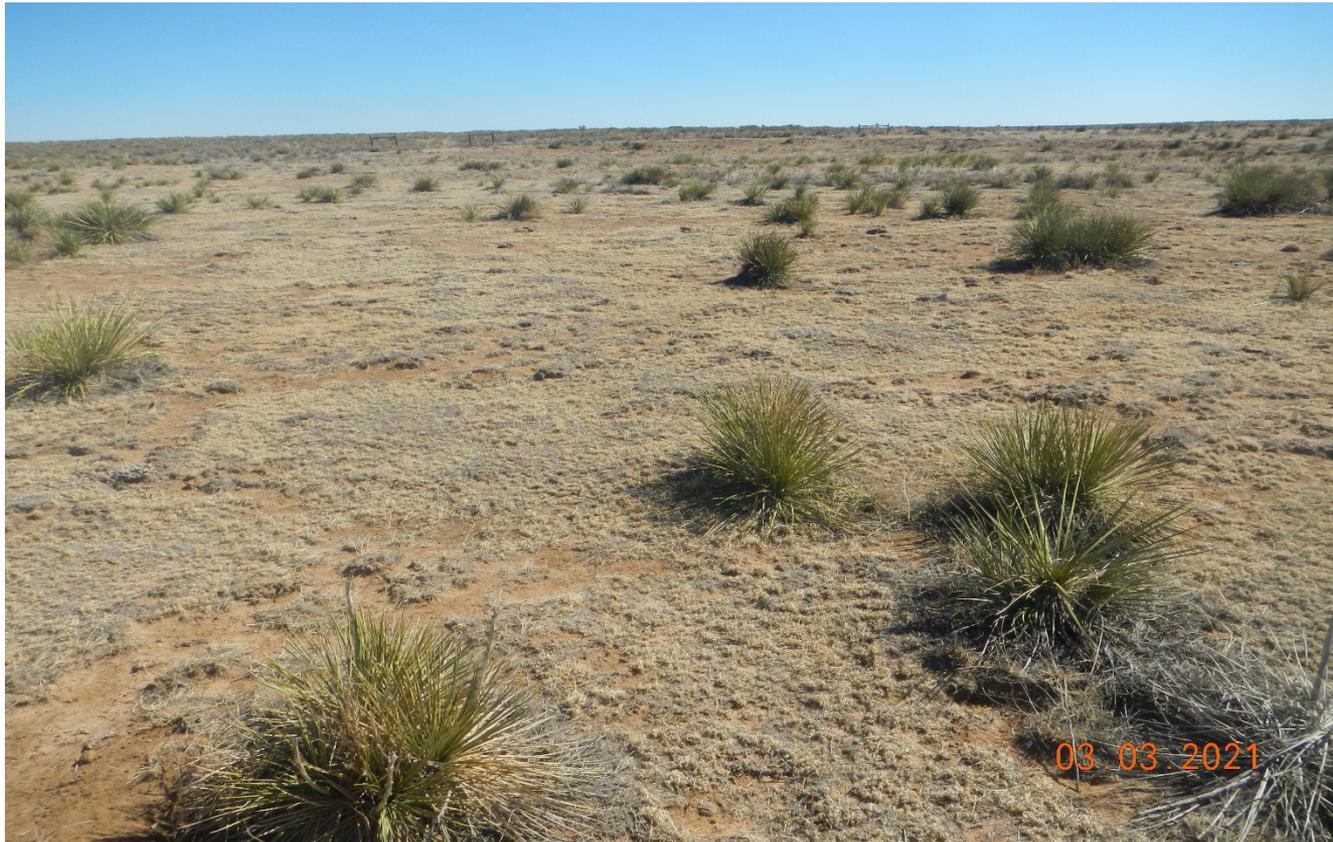
**Photo 10.** Facing south toward the surrounding undisturbed reference area.

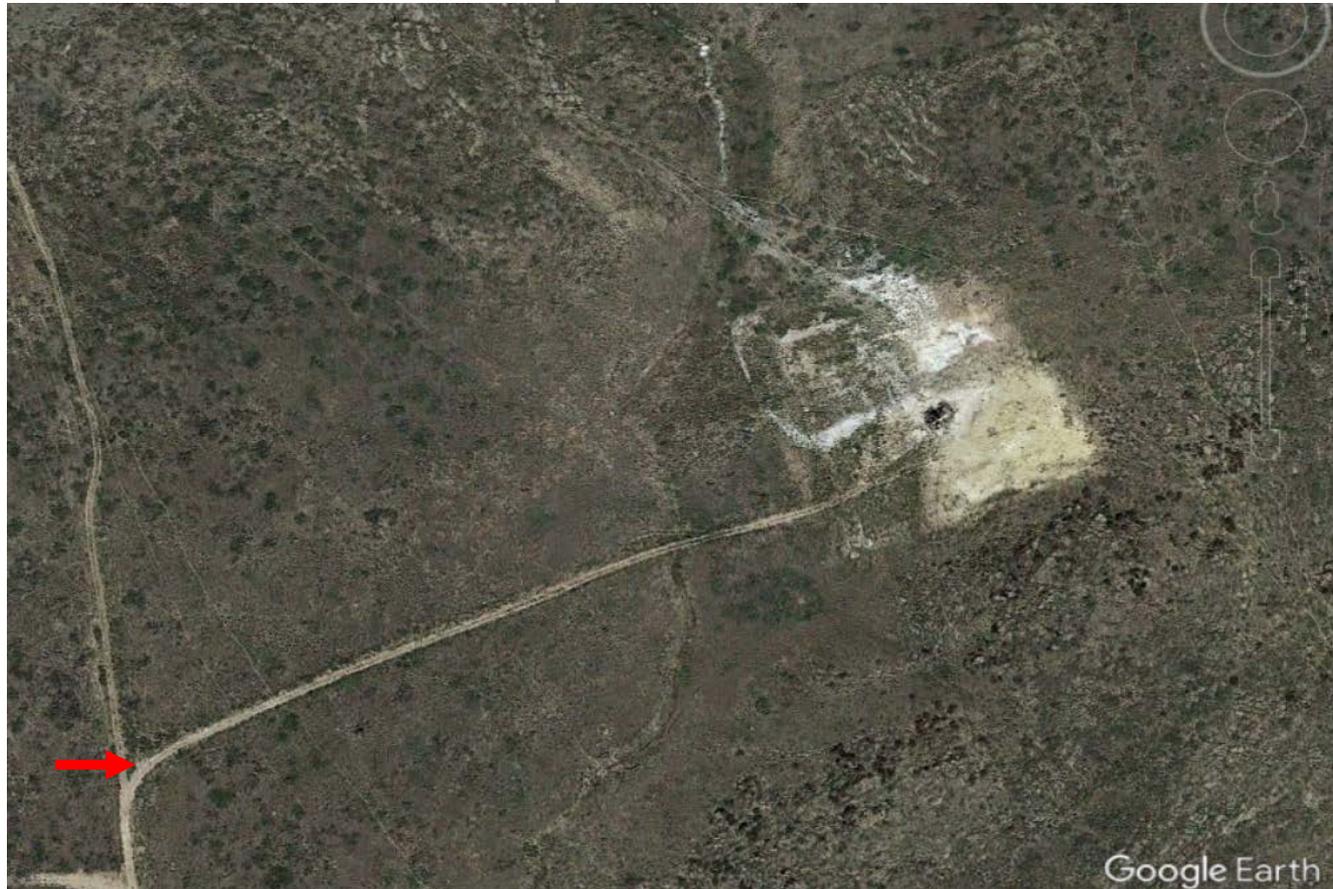
**Photo 11.** Aerial image of the access road and location. Arrow points to the beginning of the access road which needs to be reclaimed to the location.
