Inspection Photos

API: 009-06439

Operator: INVESTMENT EQUIPMENT LLC

Inspection Date: 3/3/2021

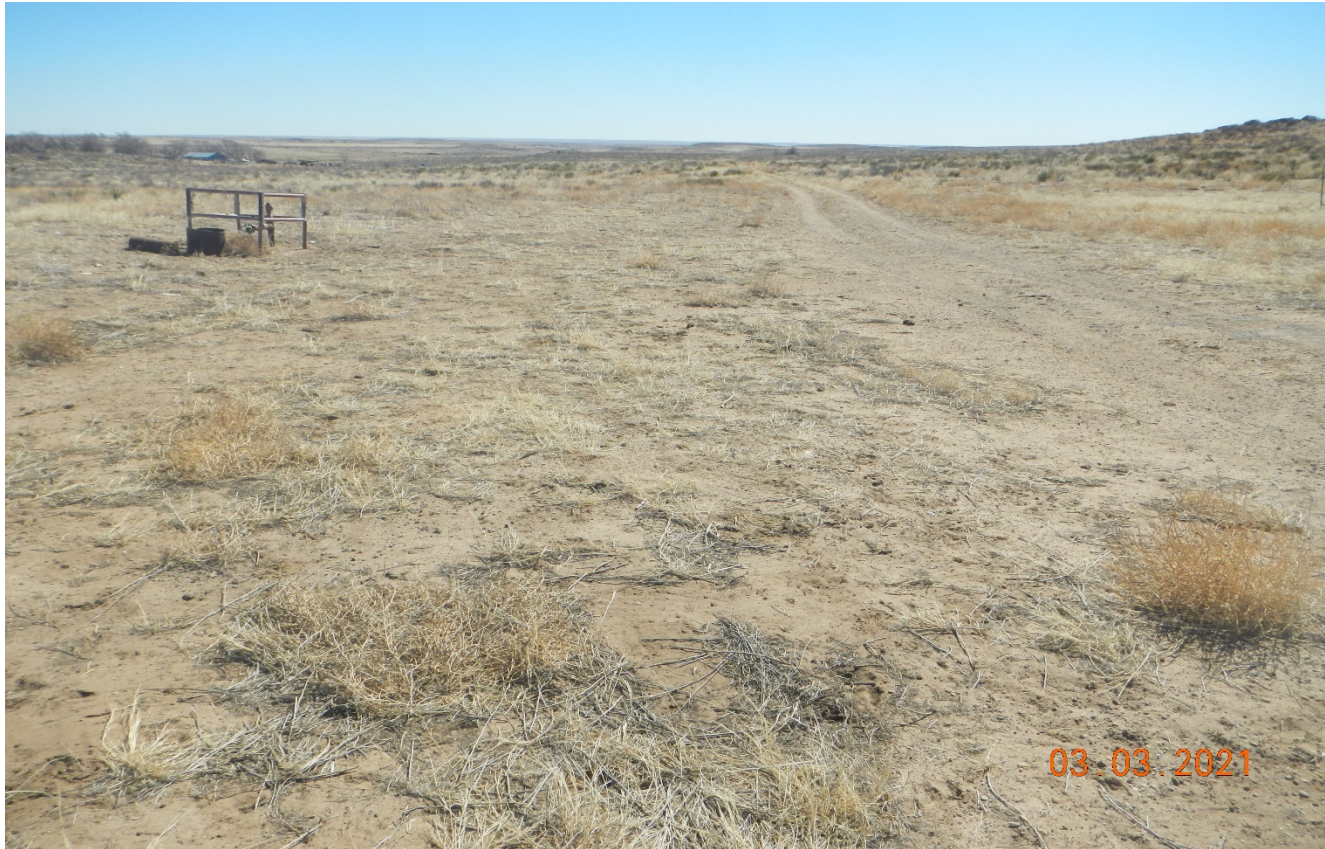
Photo 1. Facing southeast toward the location.

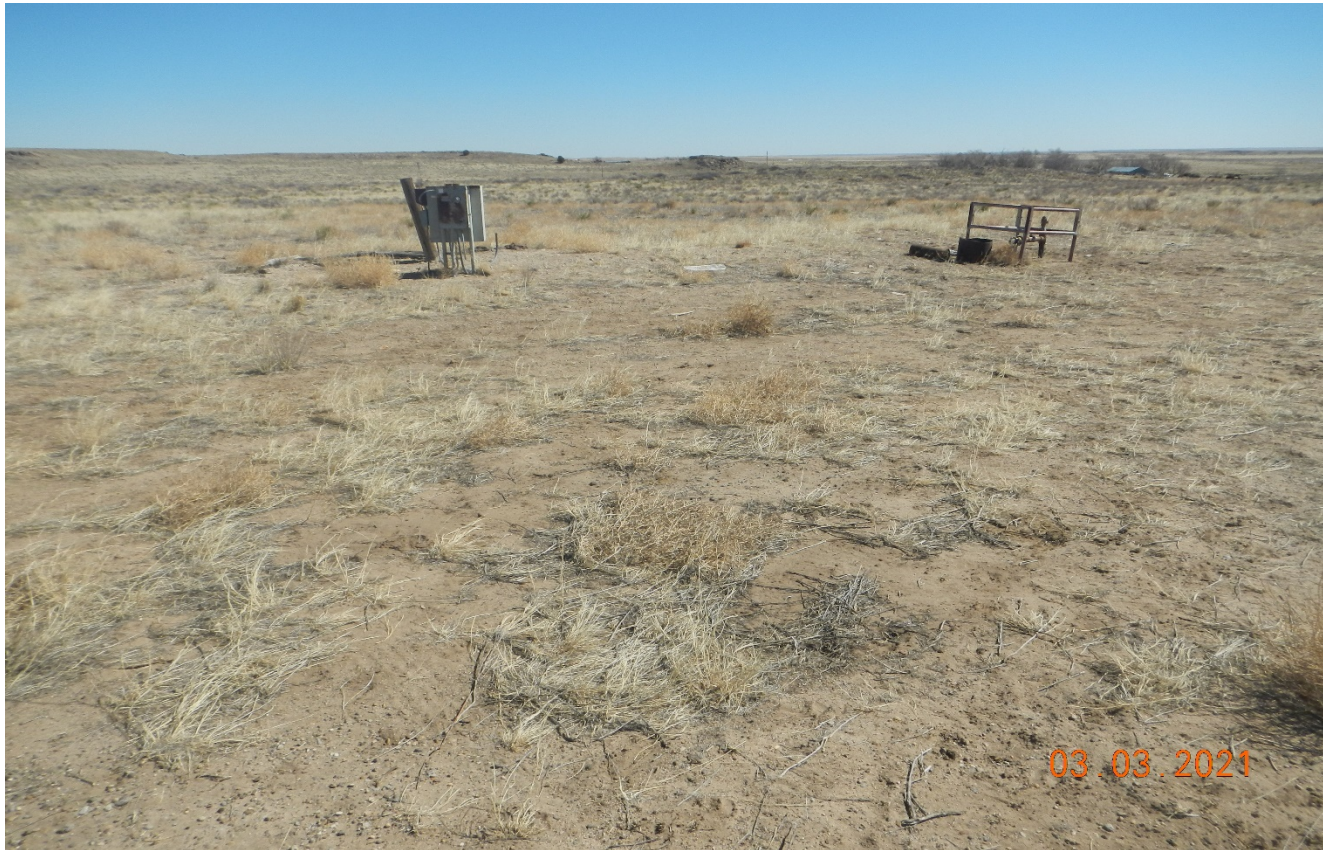
Photo 2. There is a pipe riser and electric utility that remains at the east side of the location. All equipment should have been removed within 3 months of abandoning the well.

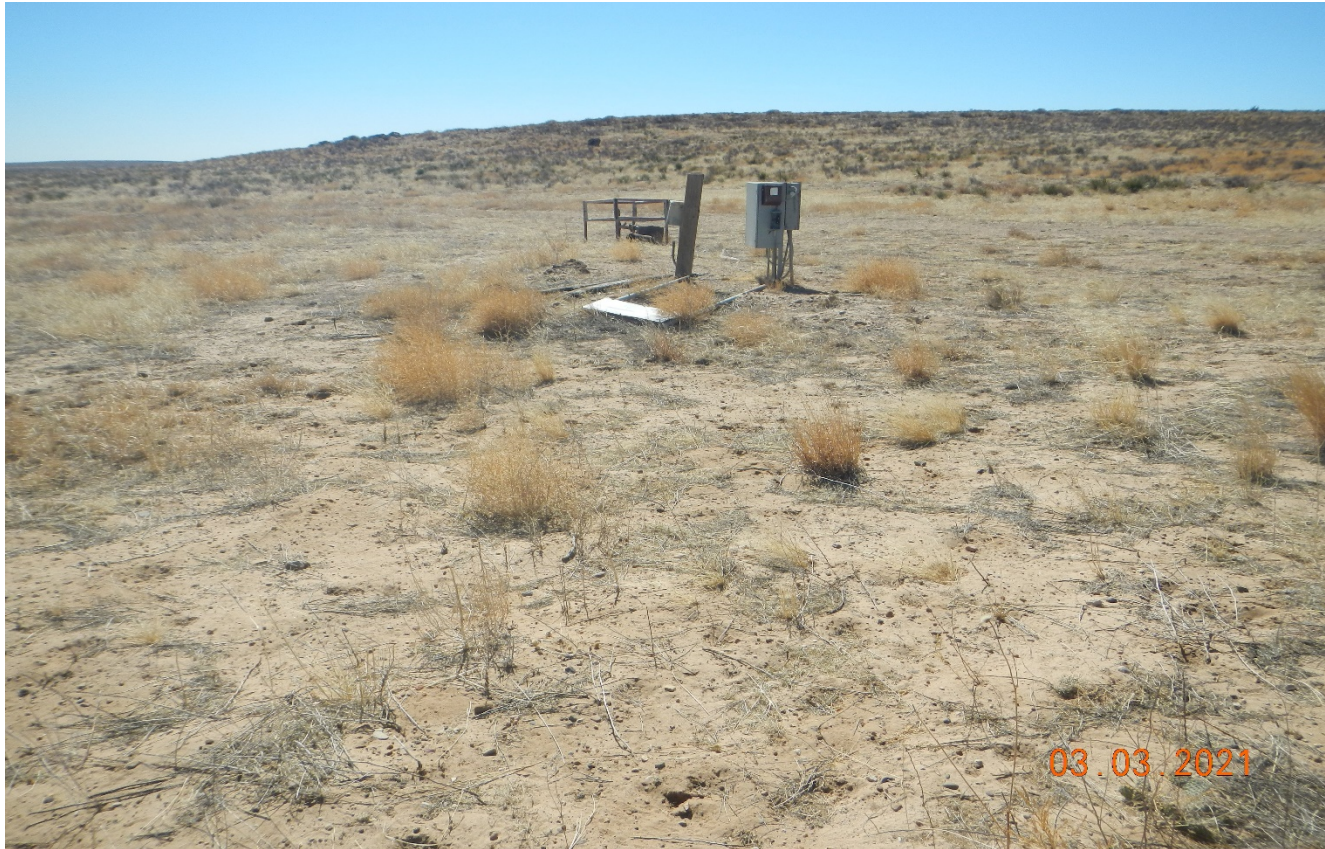
Photo 3. Facing southwest at the location. The location has not been reclaimed. Vegetation does not meet 80% standard.

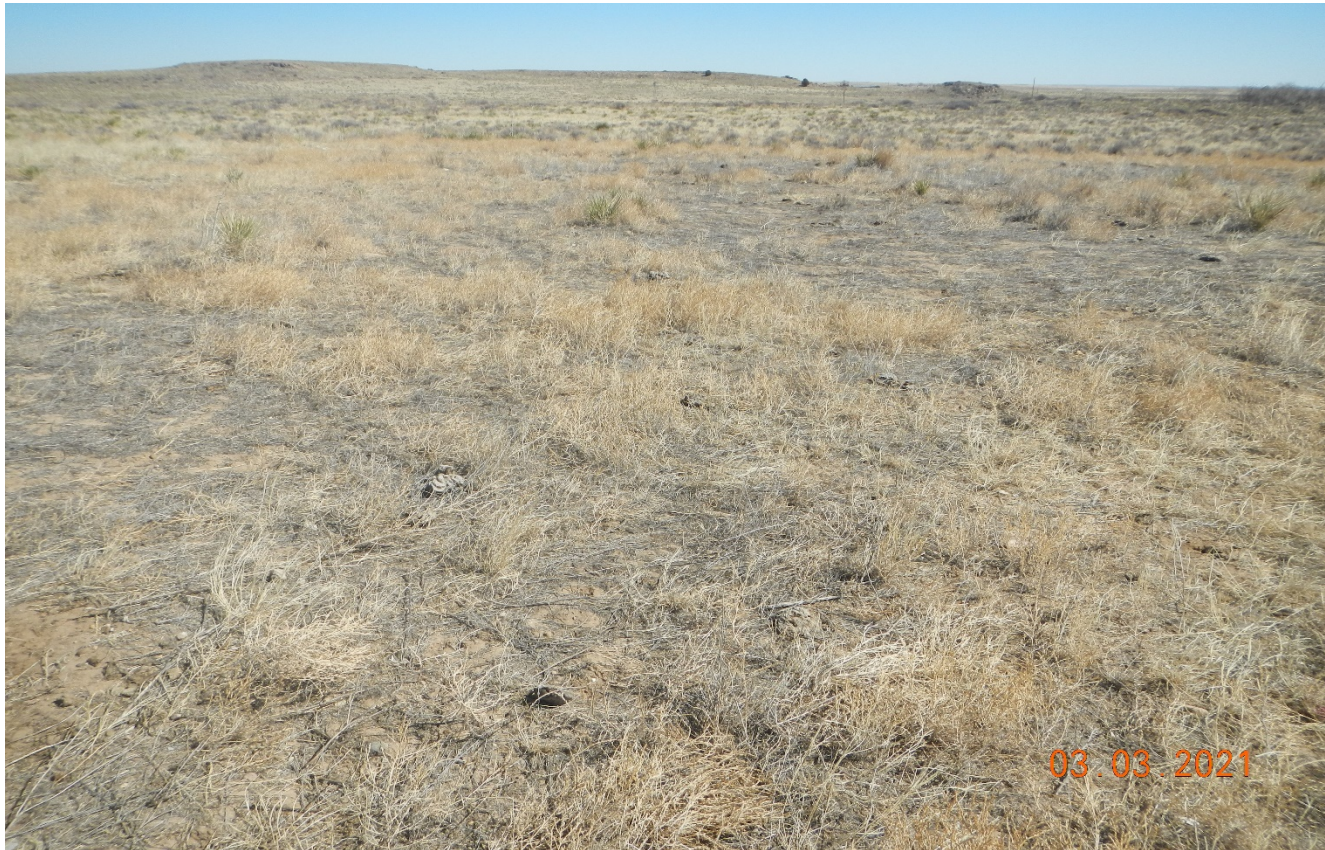
Photo 4. Facing east of the equipment shown in previous photo. It appears disturbance occurred out east of the well. This area needs to be reclaimed.

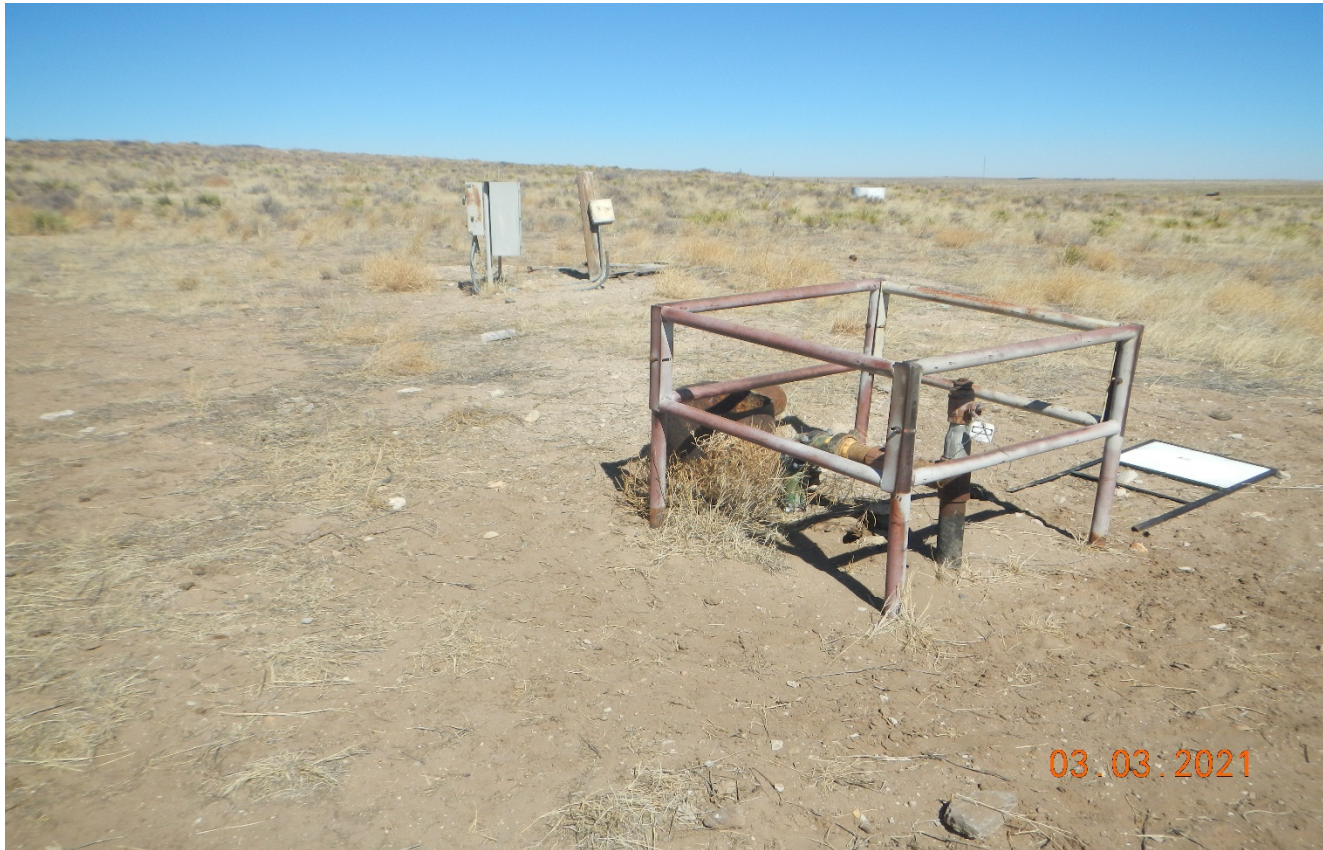
Photo 5. Facing northeast at the east side of the location. Pipe riser and electric utility needs to be removed.

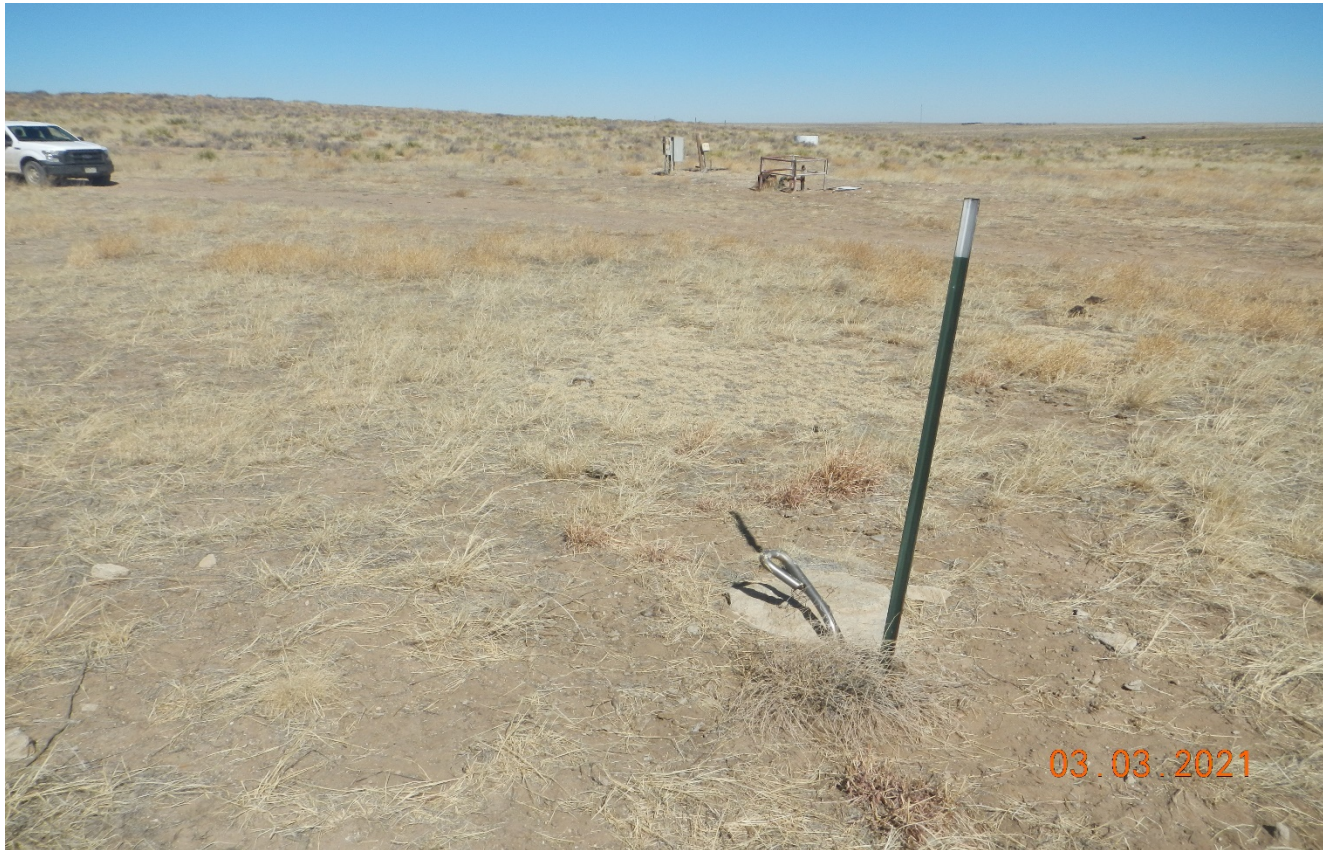
Photo 6. Facing northeast. Guy line anchor remains at the southwest side of the location.
