Inspection Photos

API: 009-06682

Operator: MEADOW DEEP LLC

Inspection Date: 3/3/2021

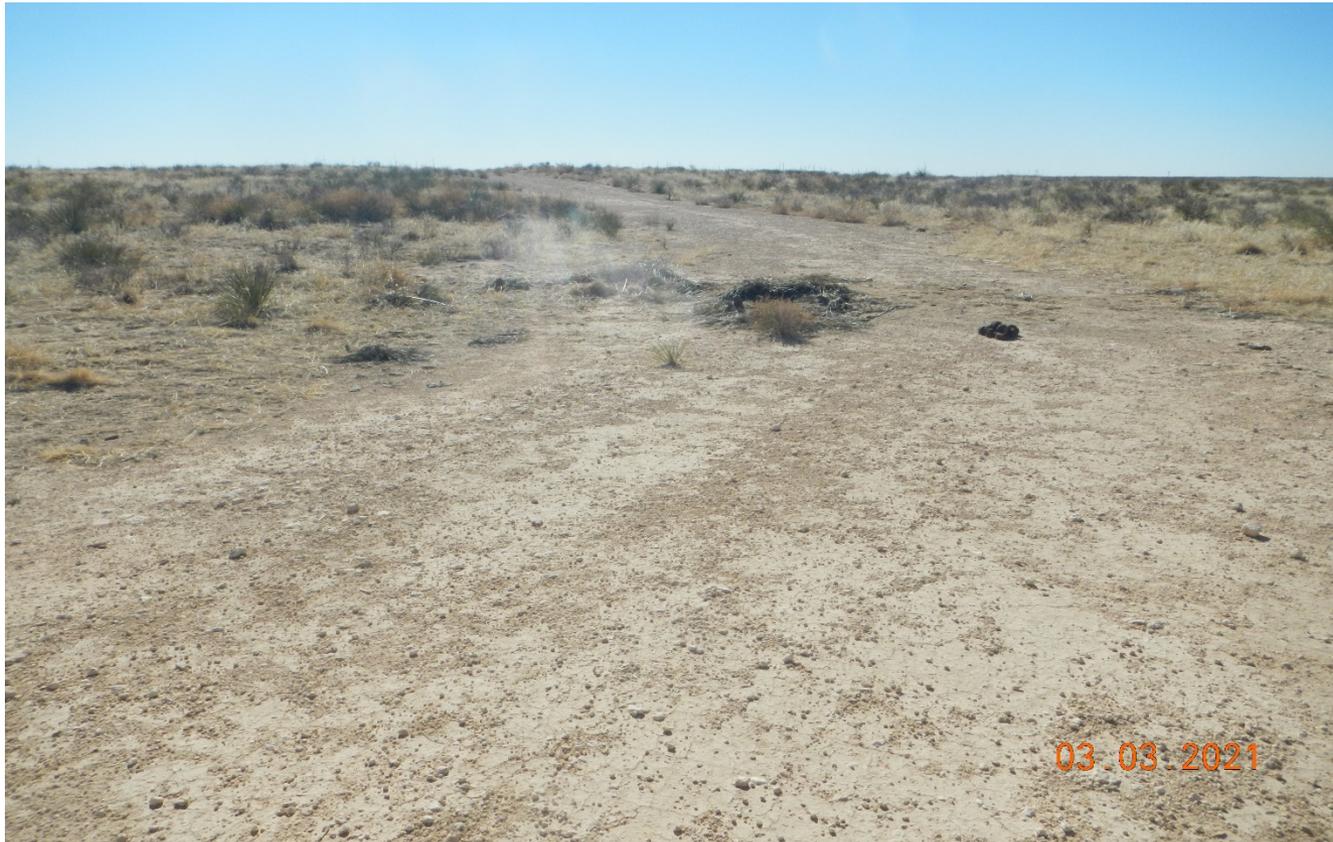
Photo 1. Facing southeast toward the access road which has not been reclaimed.

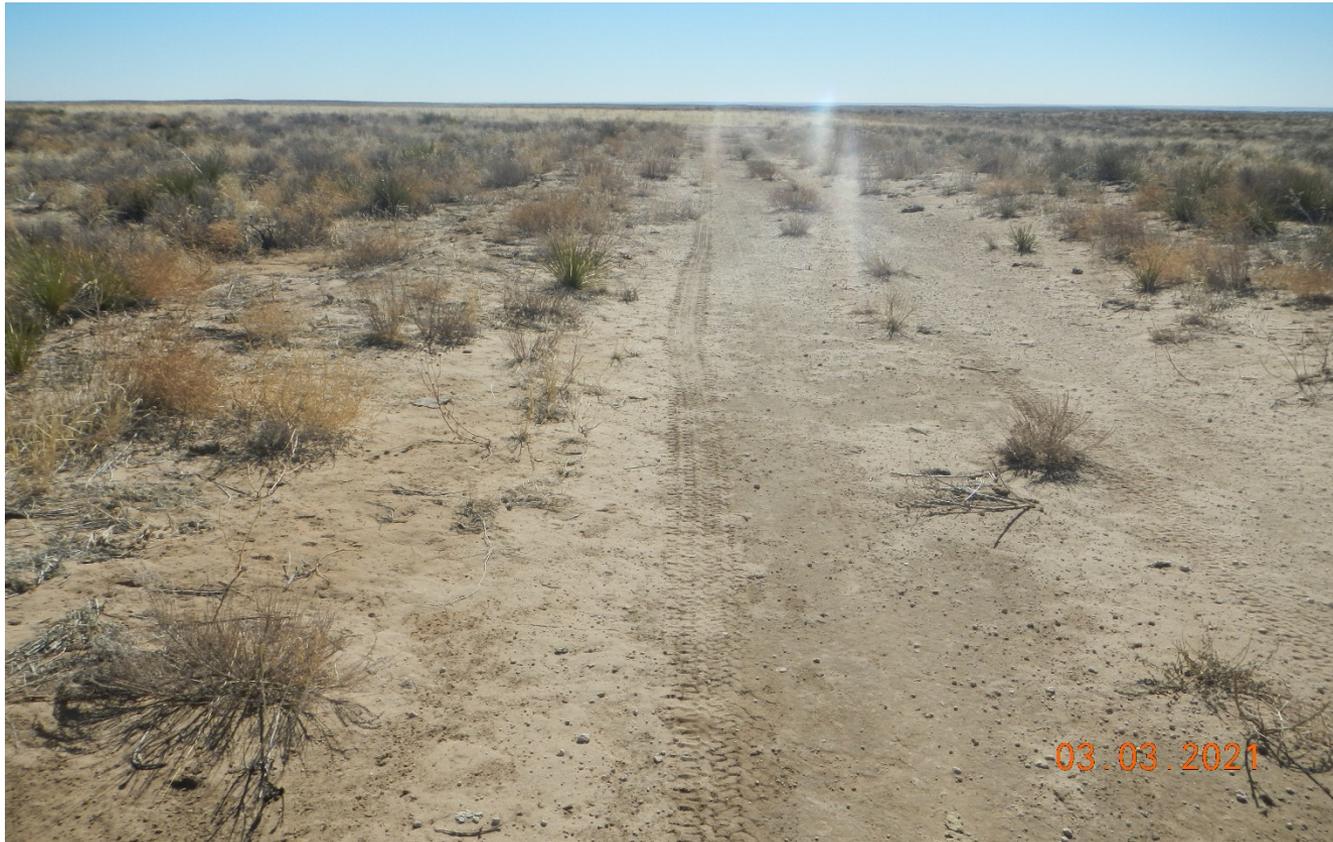
Photo 2. The access road dead ends at the location. The access road needs to be reclaimed.

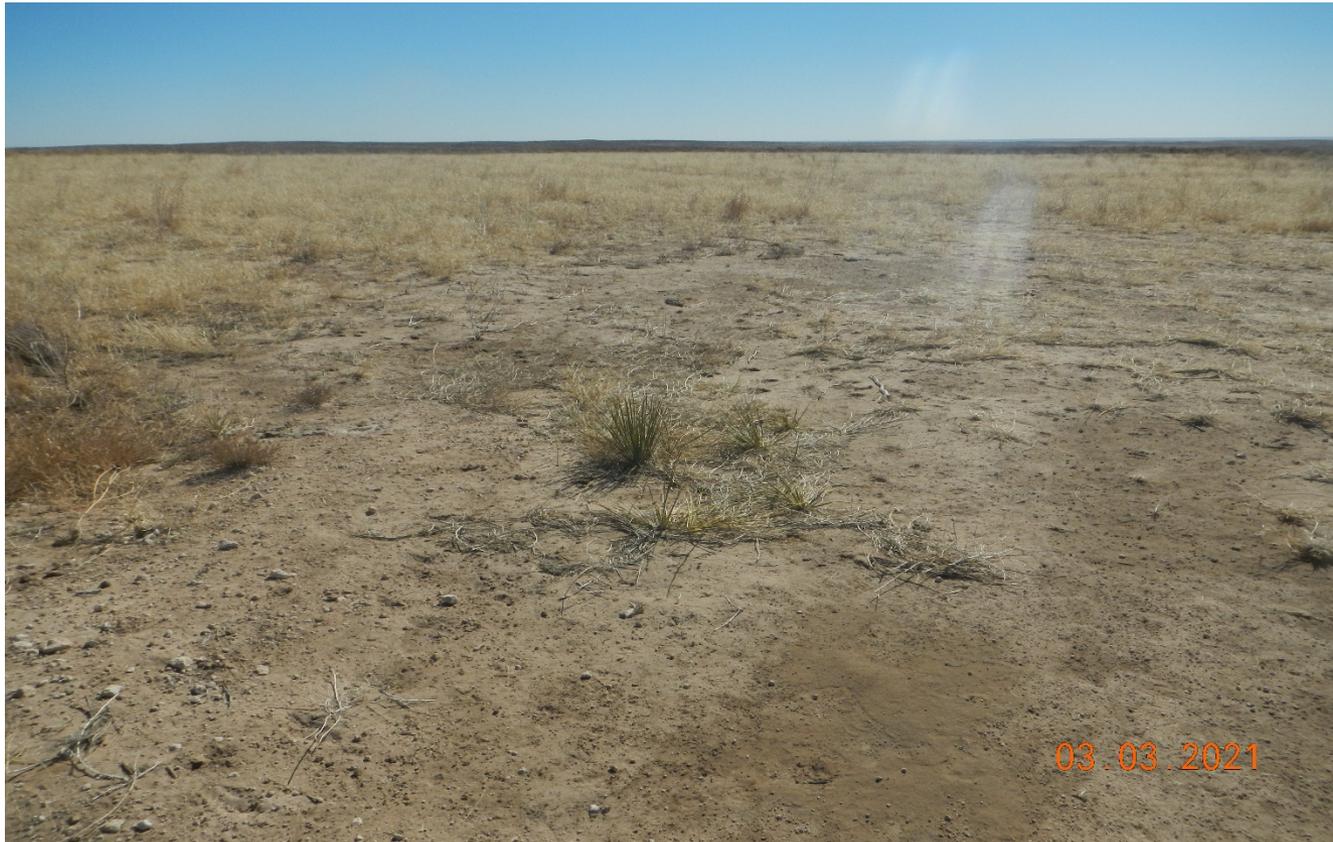
Photo 3. Facing southeast toward the location.

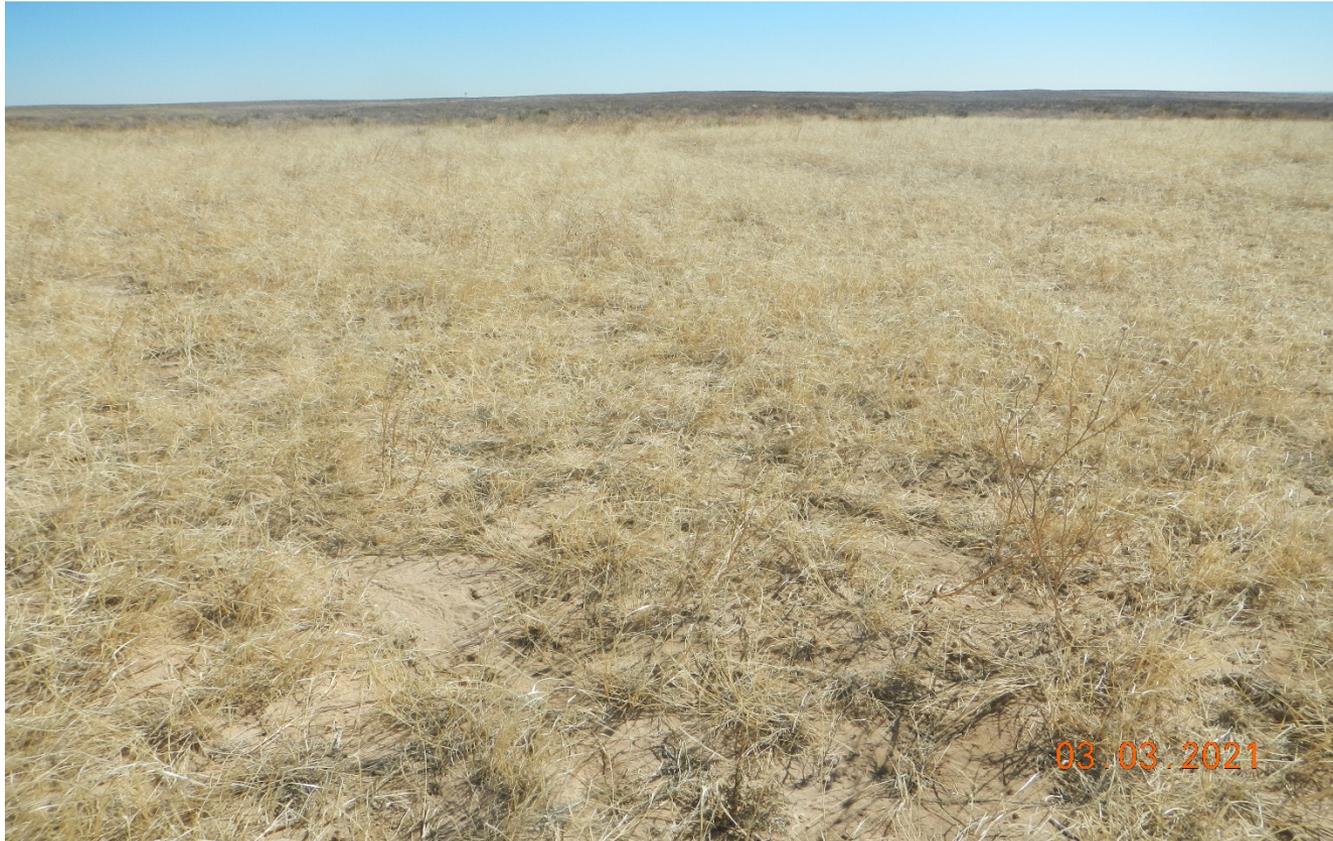
Photo 4. Center of the location facing east. Vegetation is uniformly established at the location consisting predominately of Sand dropseed.

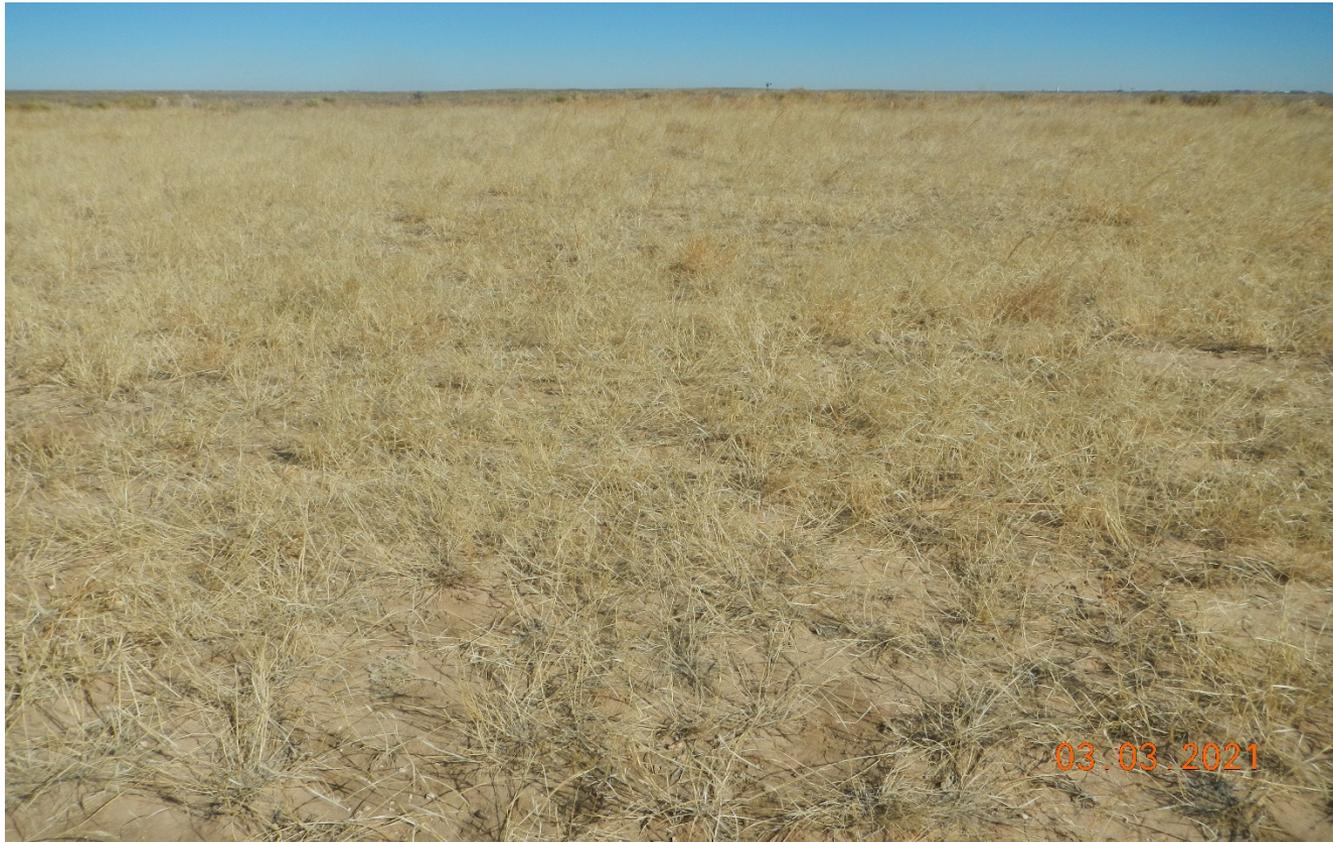
Photo 5. Center of the location facing north.

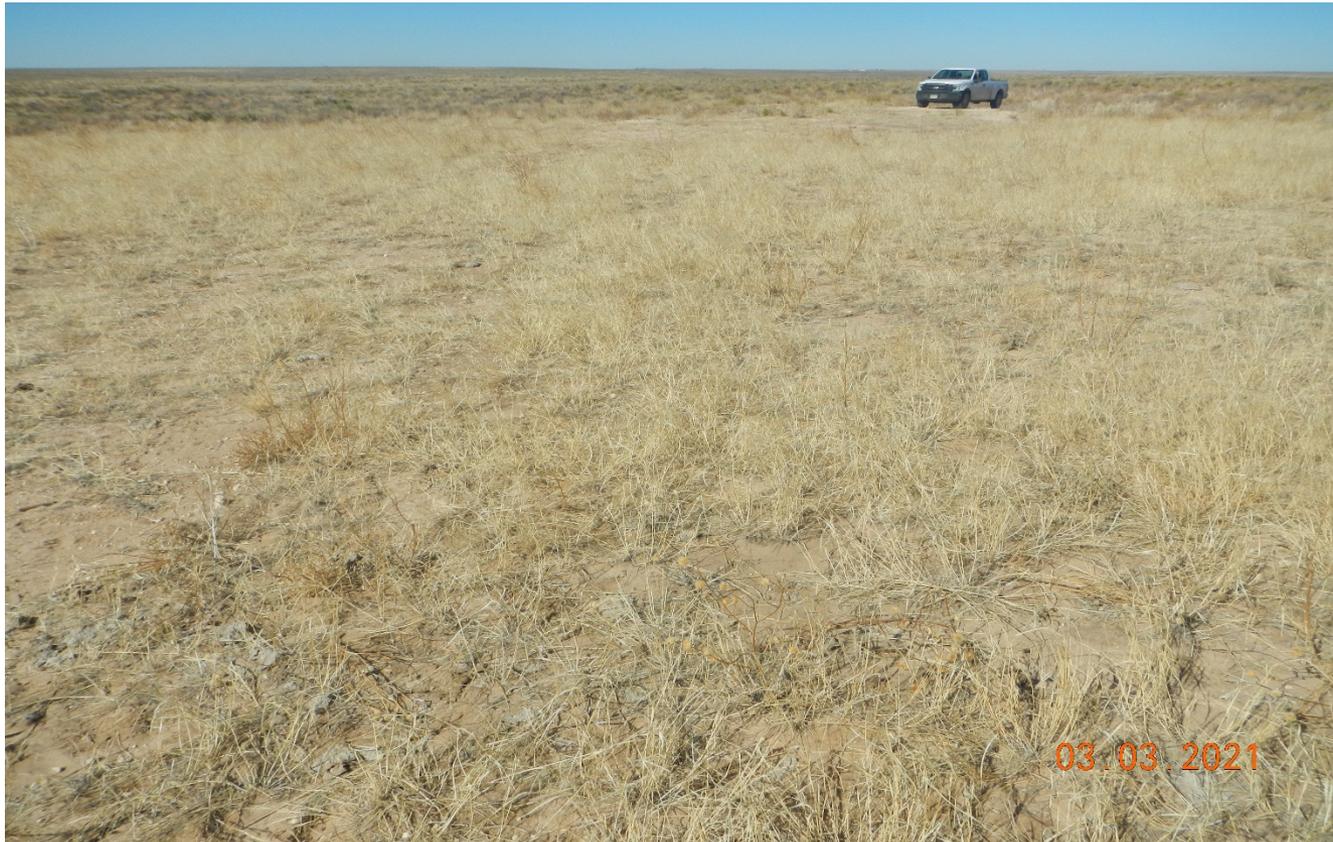
Photo 6. Center of the location facing west.

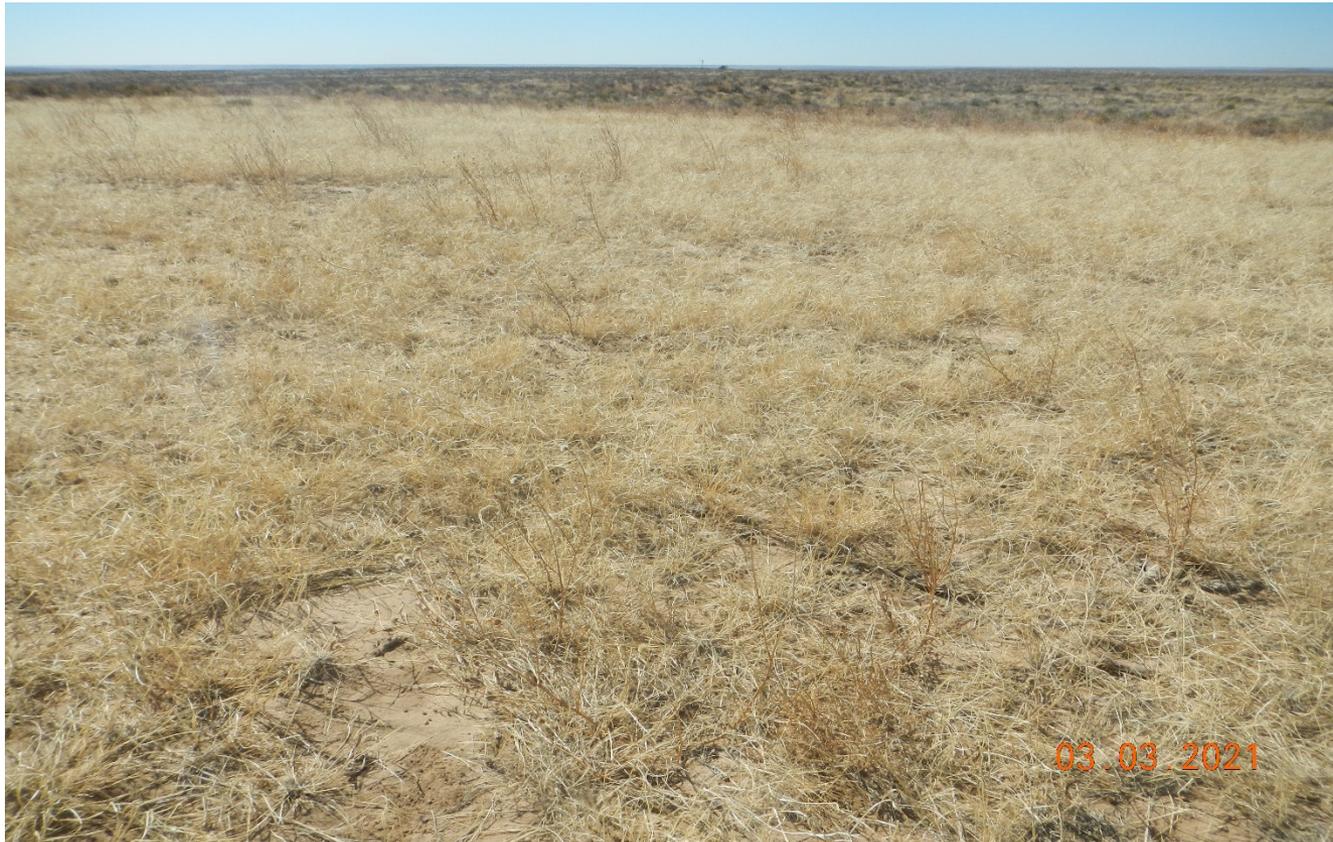
Photo 7. Center of the location facing south.

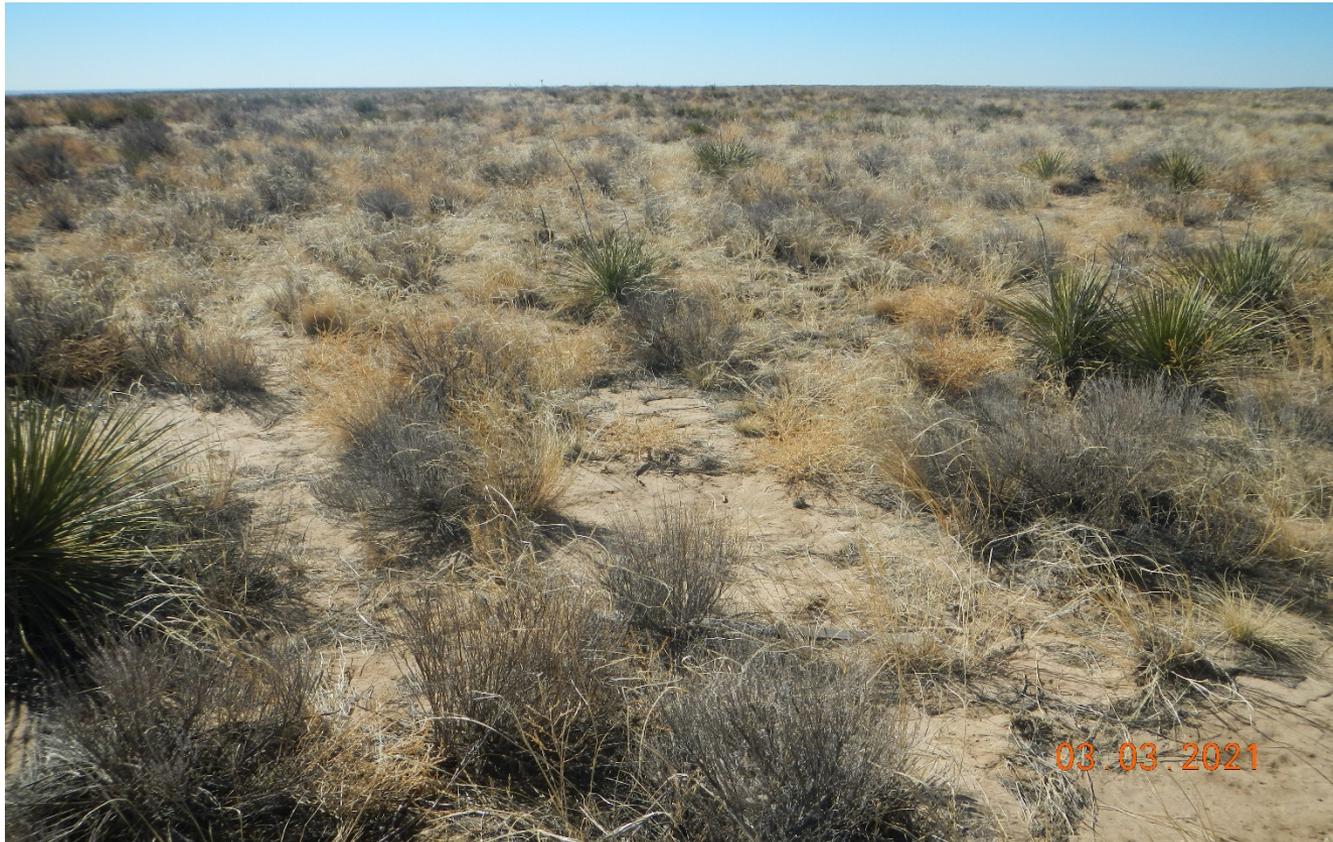
Photo 8. Facing south toward the surrounding undisturbed reference area.
