Inspection Photos

API: 071-06347

Operator: OGRIS OPERATING LLC

Inspection Date: 3/8/2021

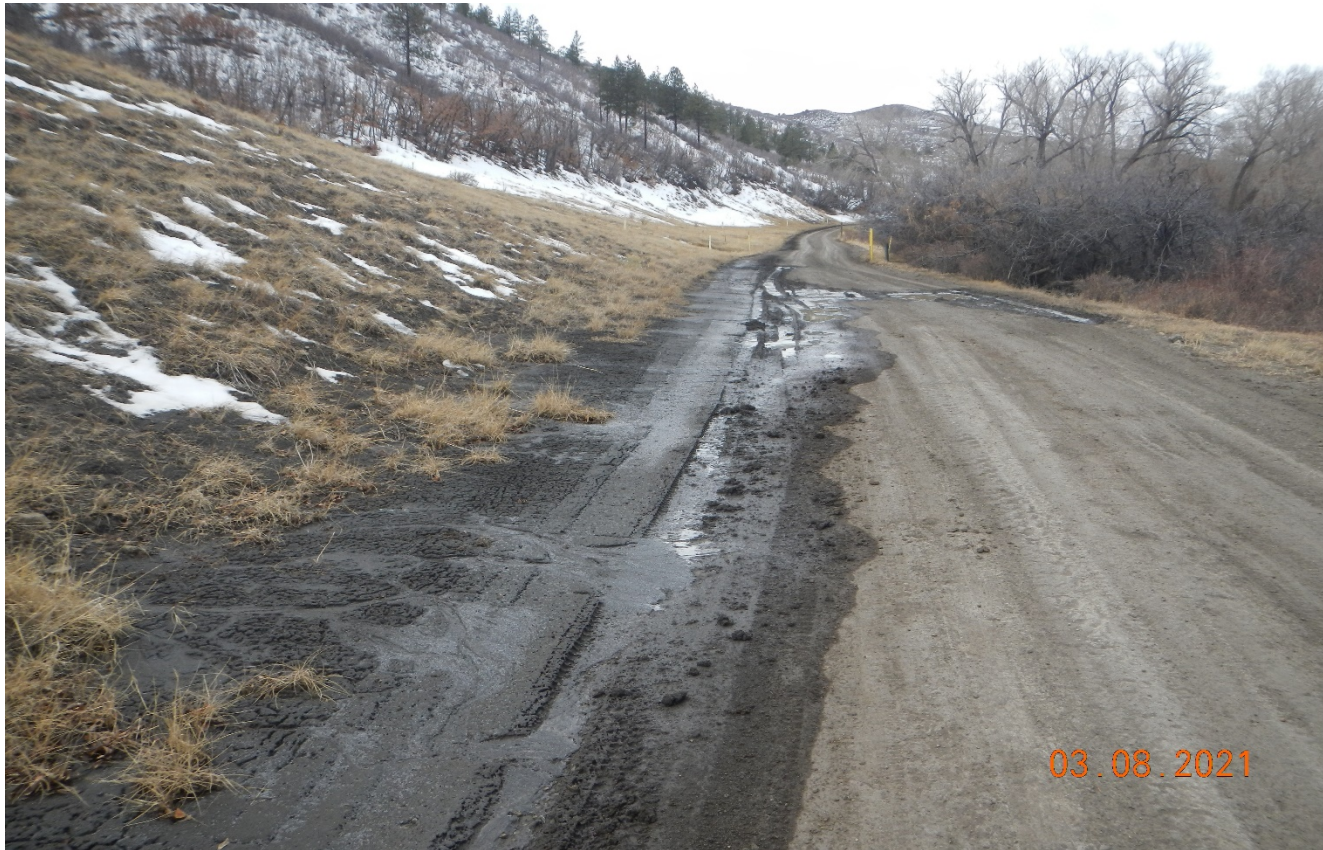
Photo 1. There is sediment deposition onto the main road. Stormwater is not properly diverted.

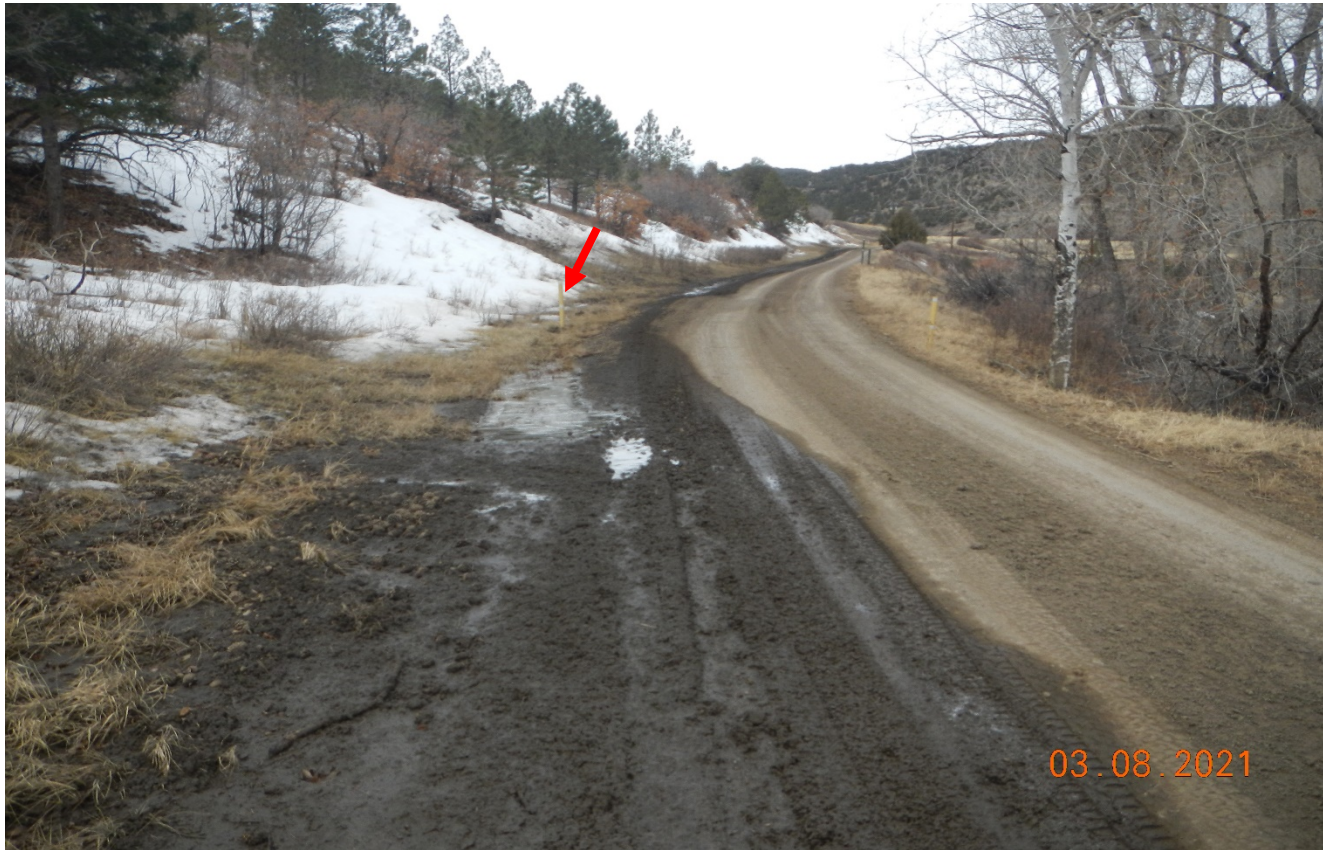
Photo 2. The culvert shown at red arrow is filled in with sediment. Stormwater is not directed toward the culvert and is flowing down the road. Lat/Long:37.06585,-104.93198.

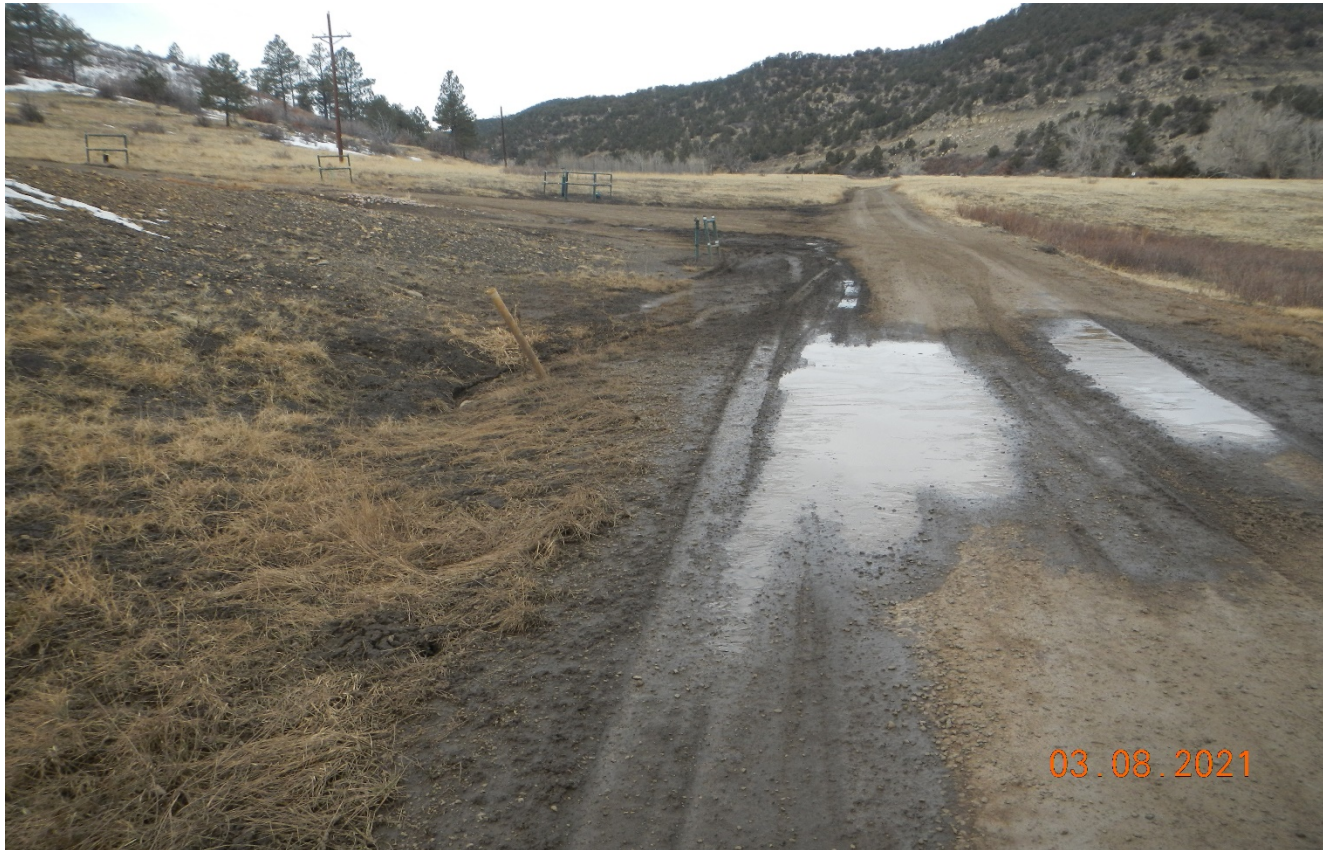
Photo 3. Facing west along main road near the location. Stormwater is not directed toward the culvert and is pooling on the road.

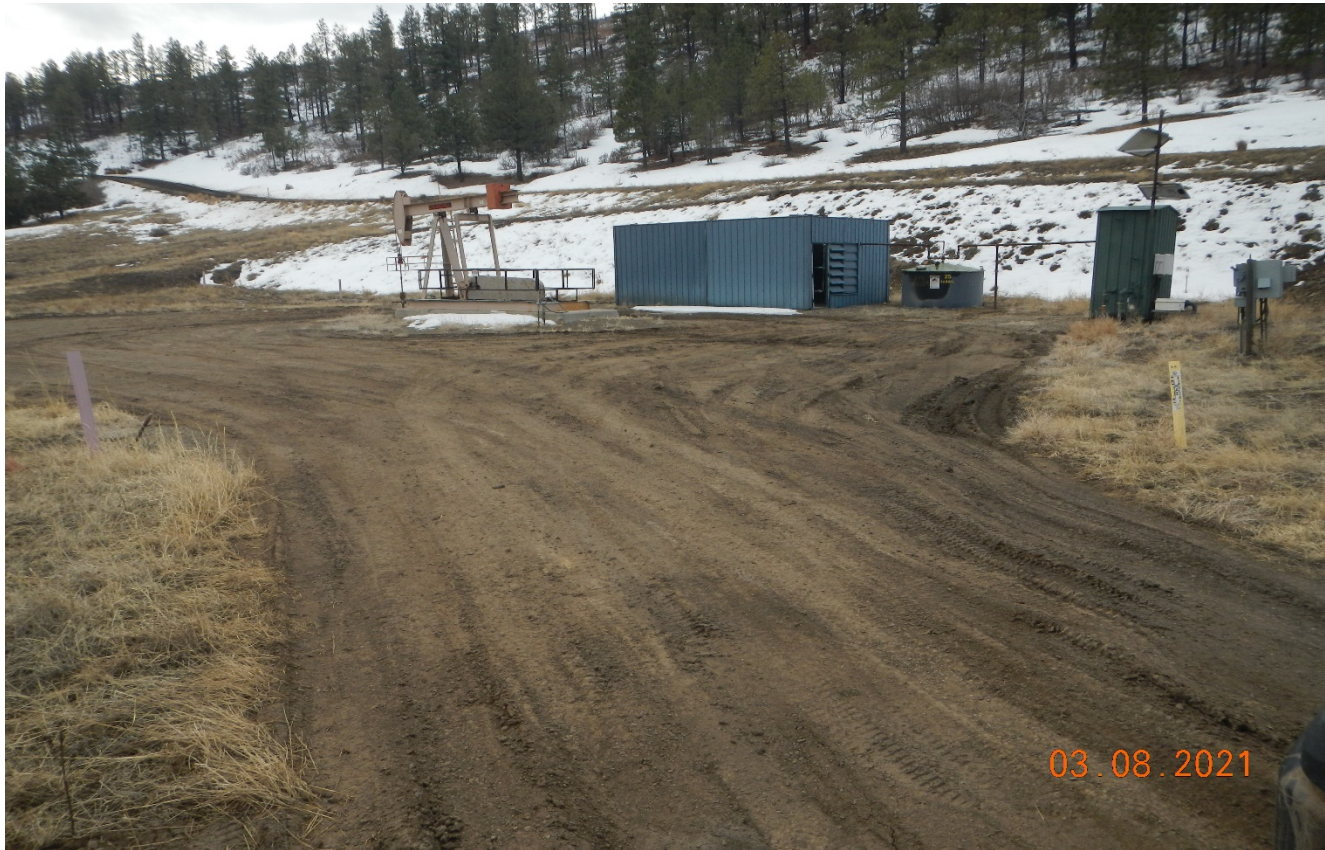
Photo 4. Facing toward the location.

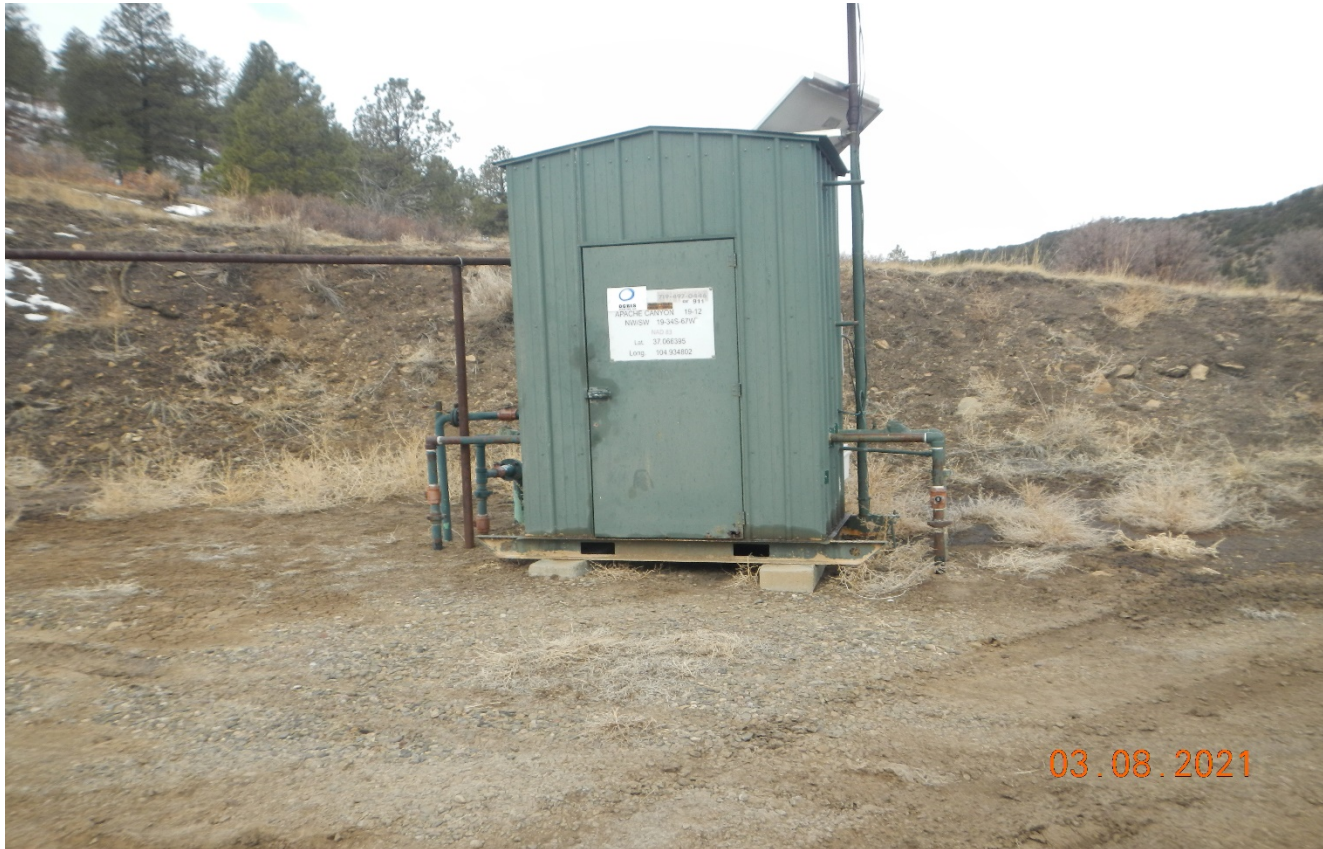
Photo 5. Sign posted on meter shed.
