Inspection Photos

Loc#335636

Operator: Terra

Insp#: 692403178

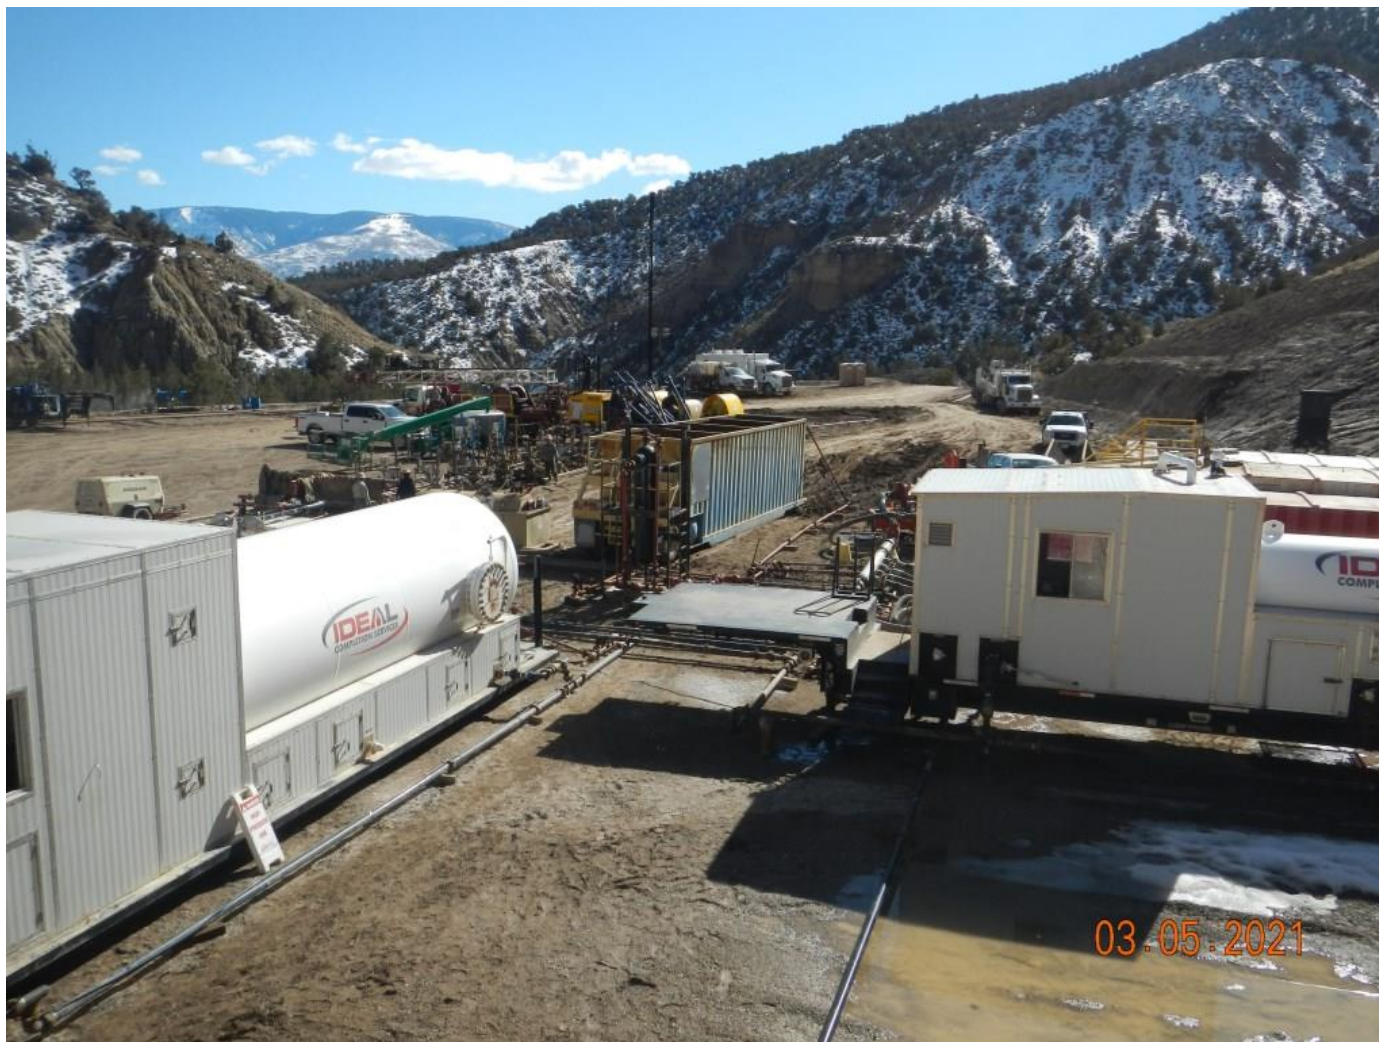
Photo#1:

View over Location to South

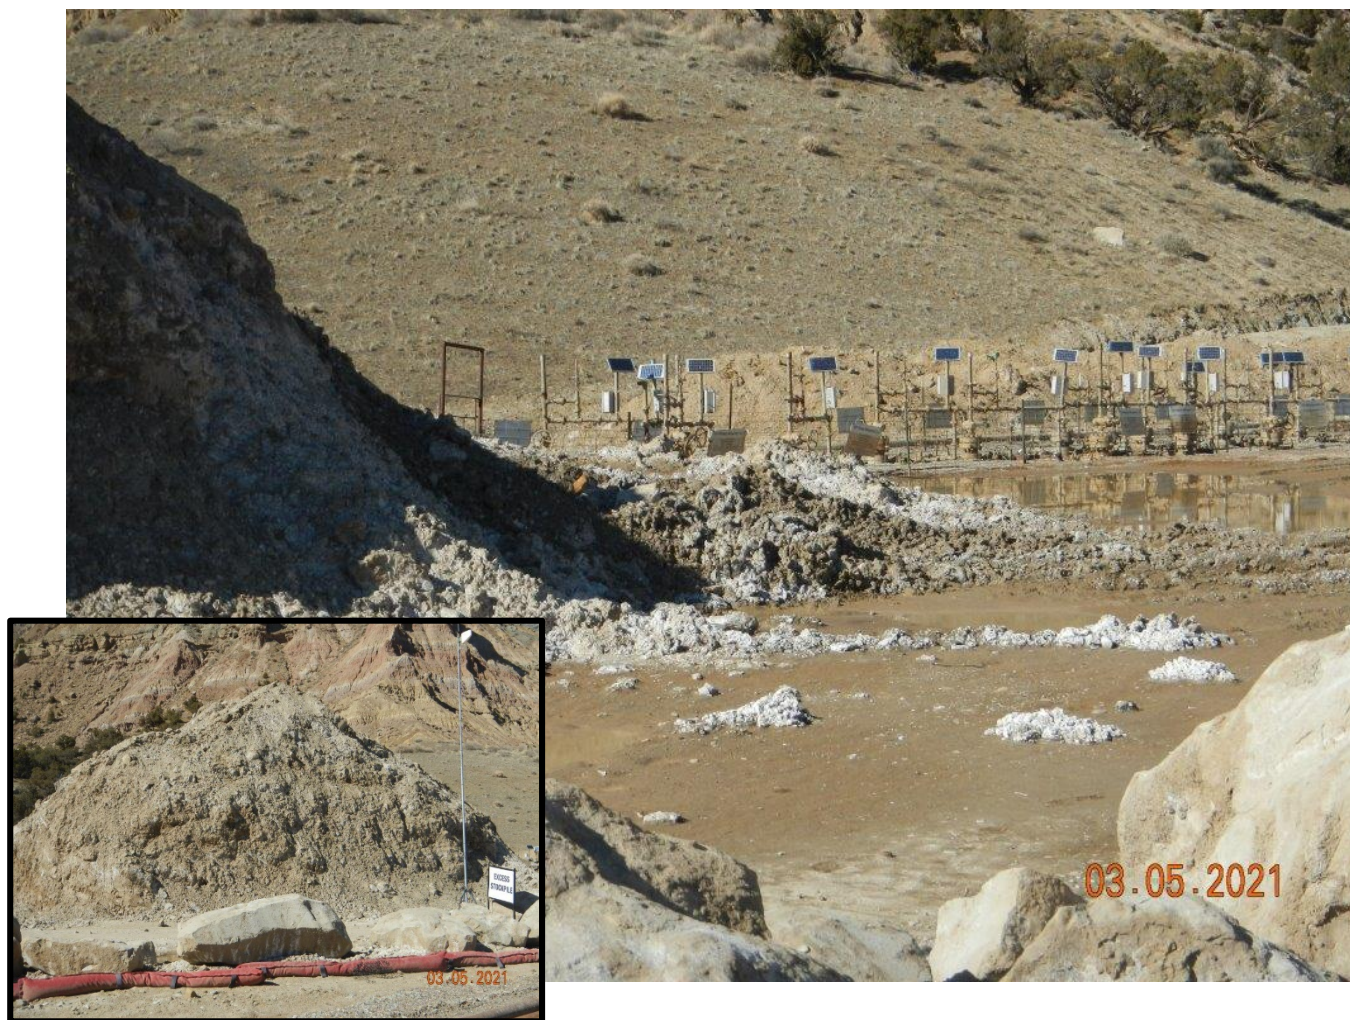
Photo#2:
Excess stockpile at entrance to lower location.

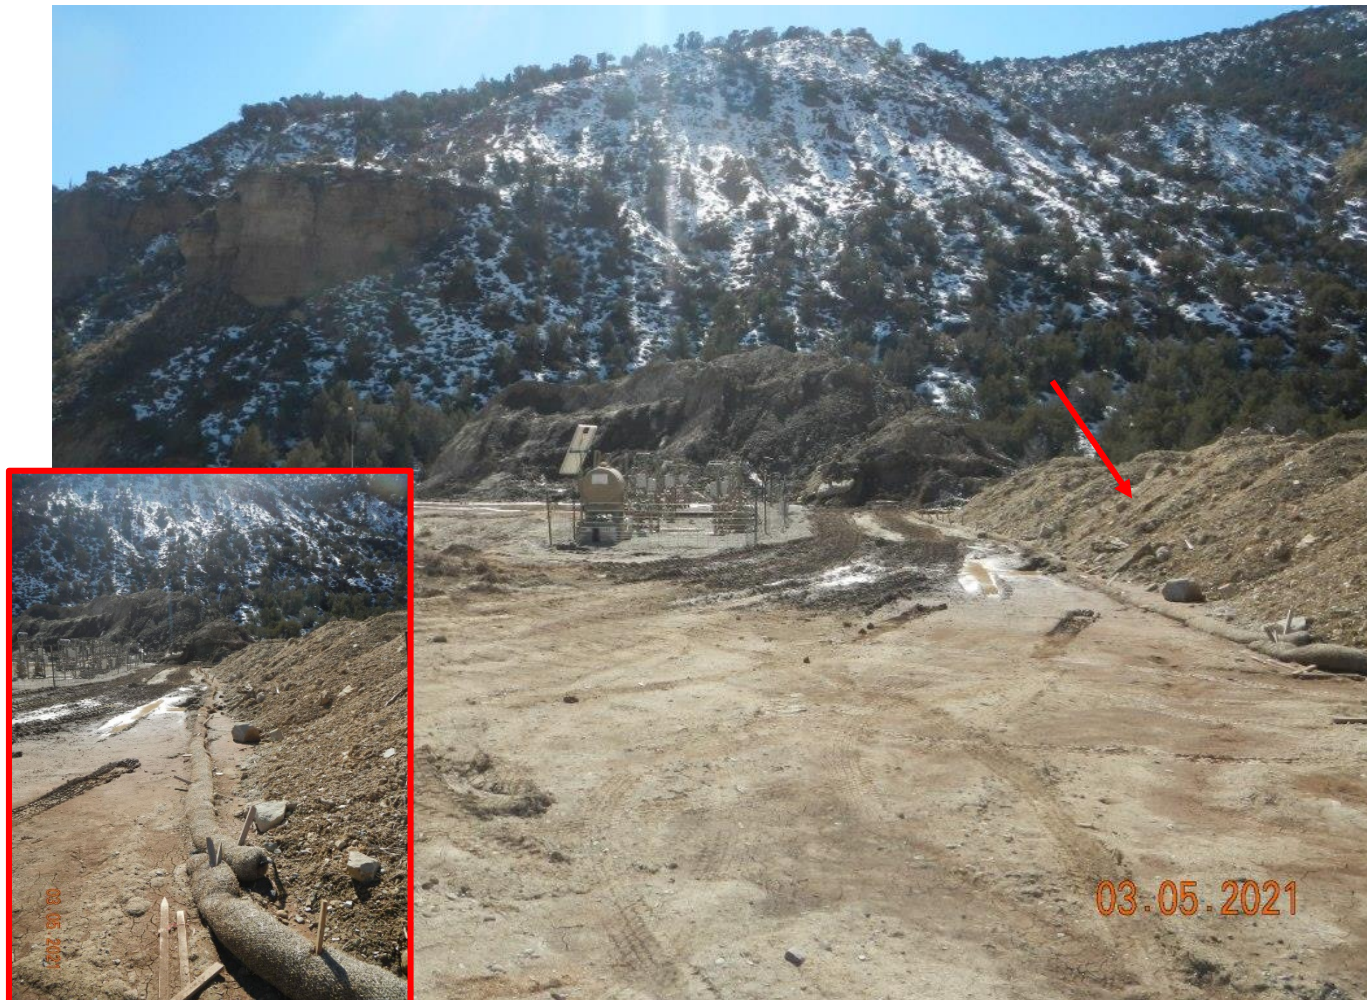
Photo#3:

View back South to Excess Stockpile in Photo #1. Stockpile indicated by arrow is labeled Topsoil. Insert, view along damaged wattles at base of Topsoil pile. Note rutting caused accessing Excess Stockpile.

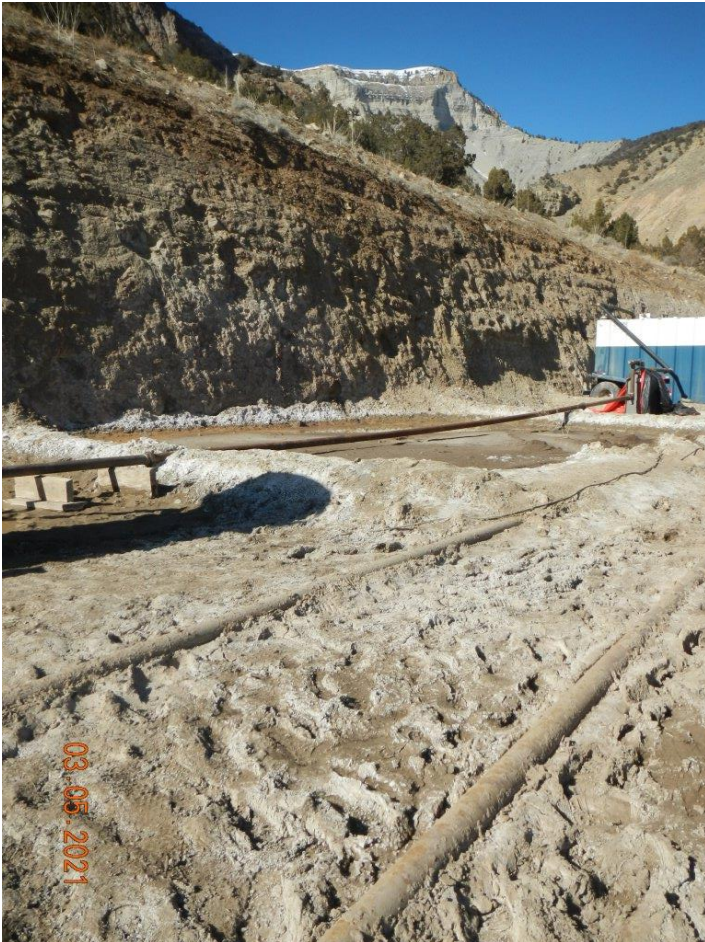
Photo#4:
Sediment migration & erosion on Cut slope.

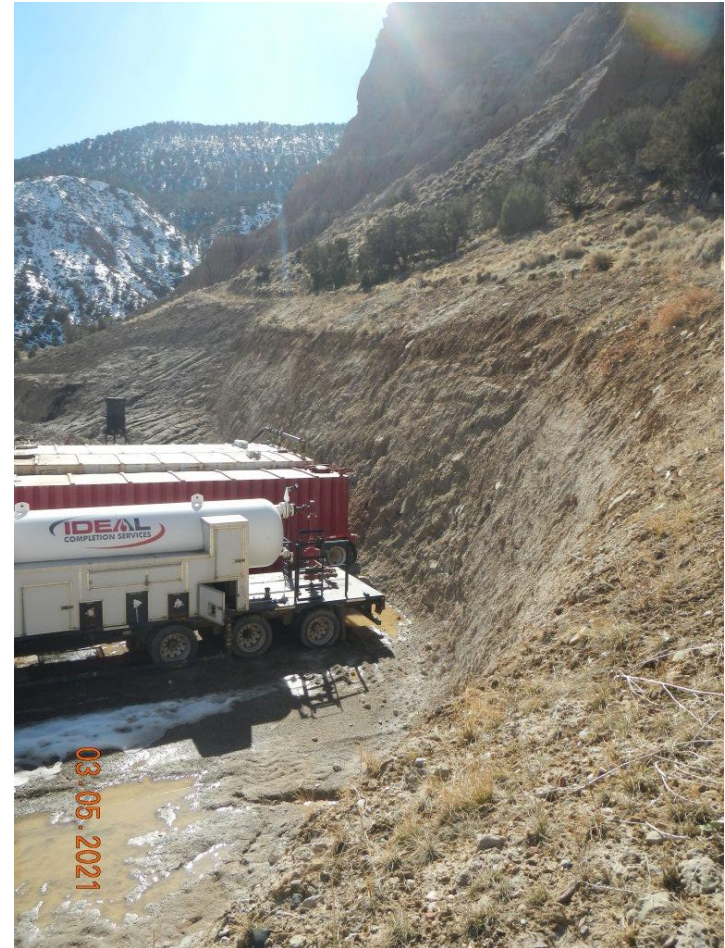
Photo#5:
Sediment migration & erosion on Cut slope.

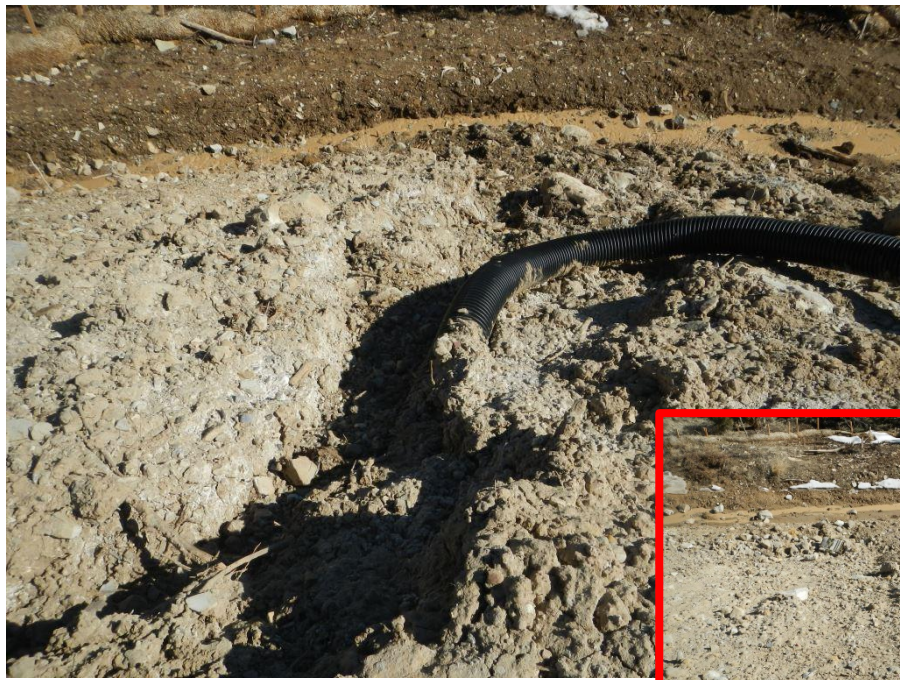
Photo#6:
Erosion, degradation of Fill slopes.

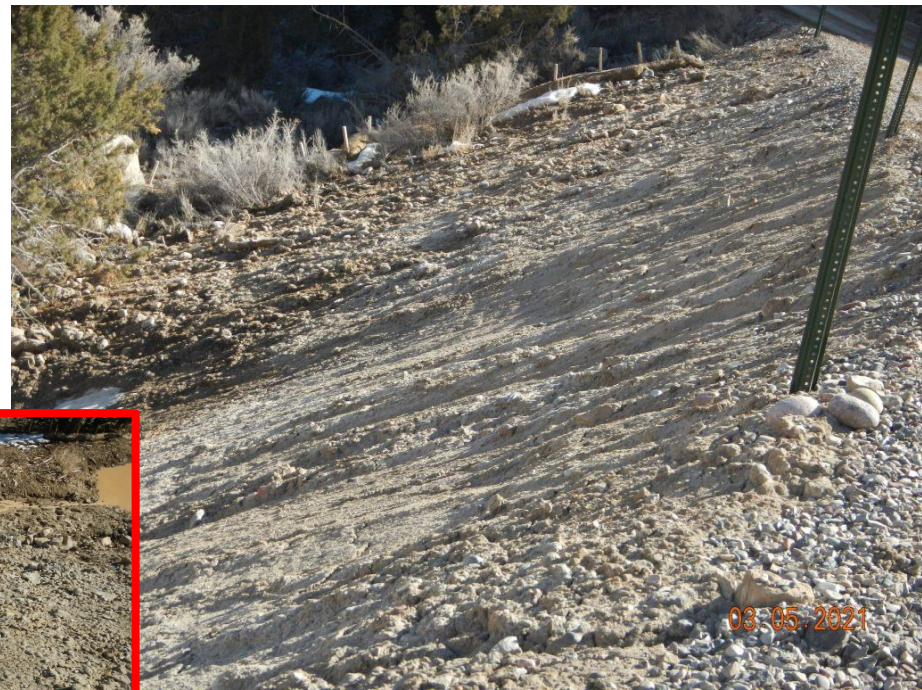
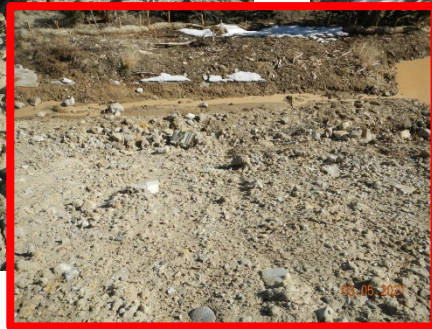
Photo#7:
Erosion, degradation of Fill slopes.

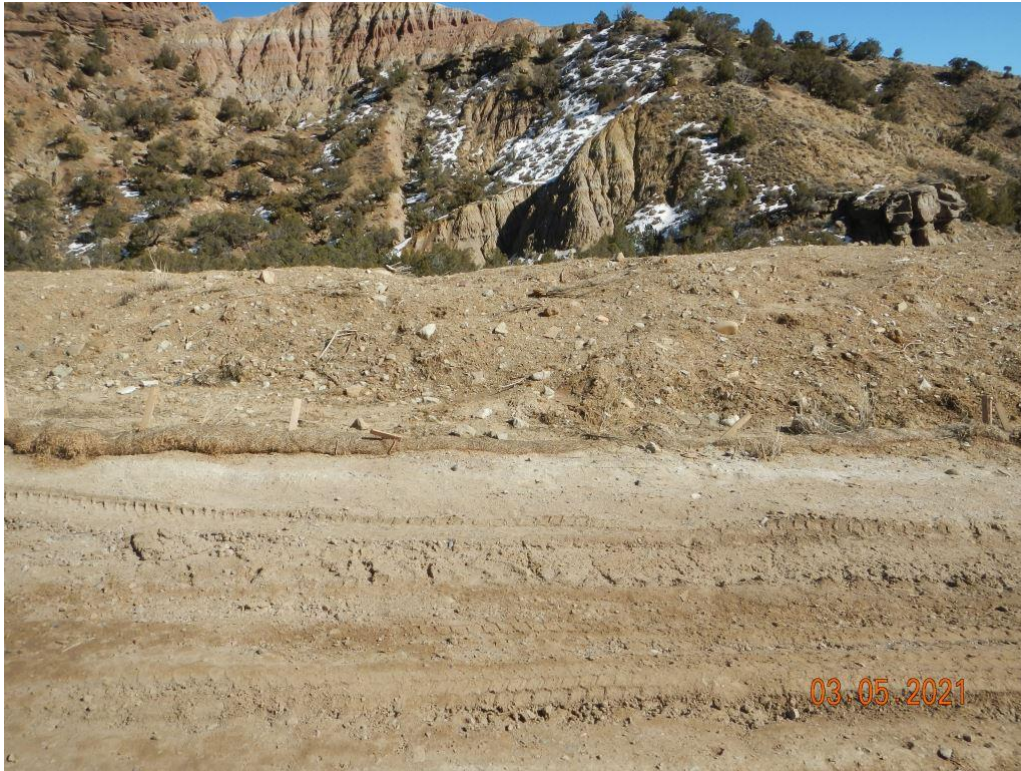
Photo#8:
Topsoil pile along road to lower Location. Note damaged wattles.

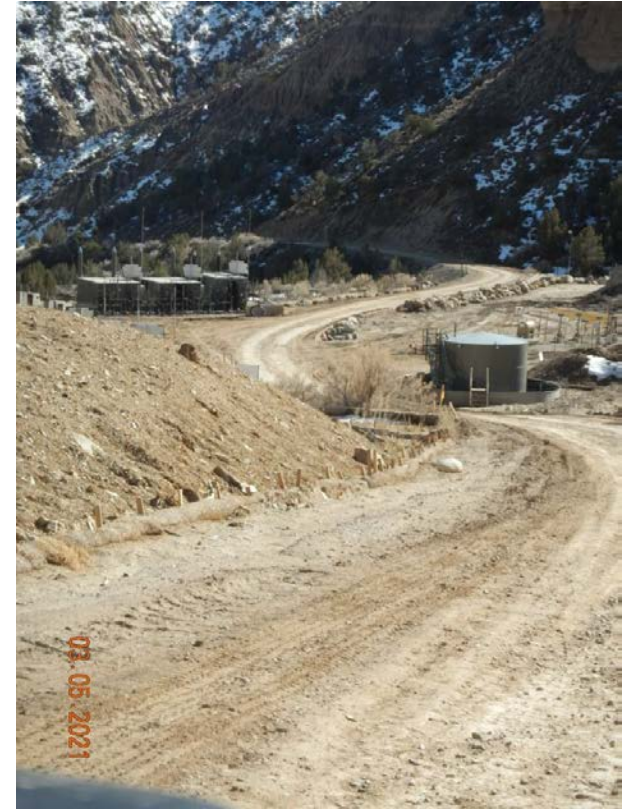
Photo#9:
Topsoil pile along road to lower Location

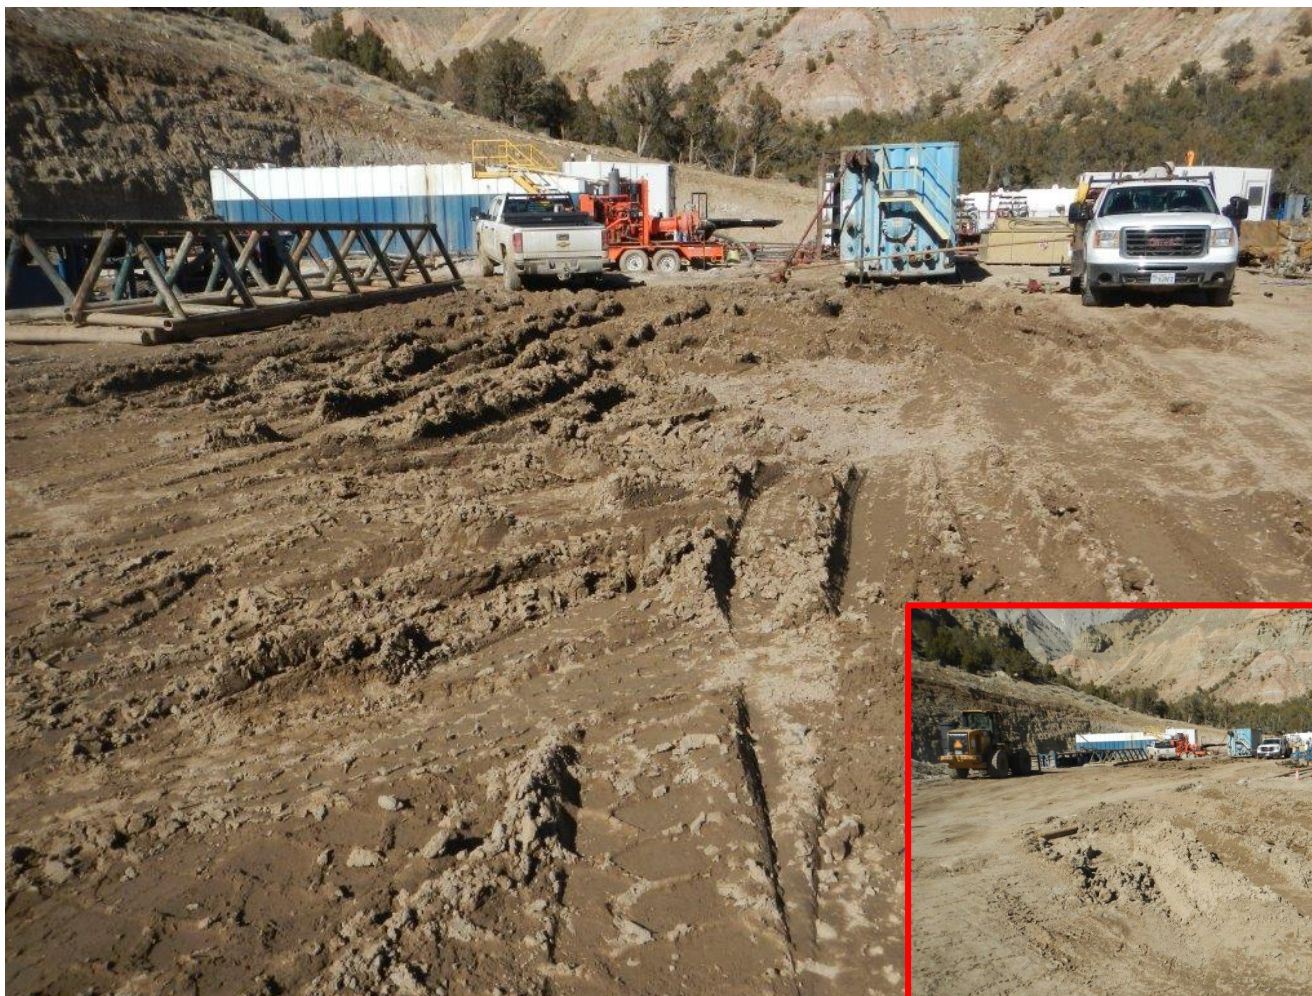
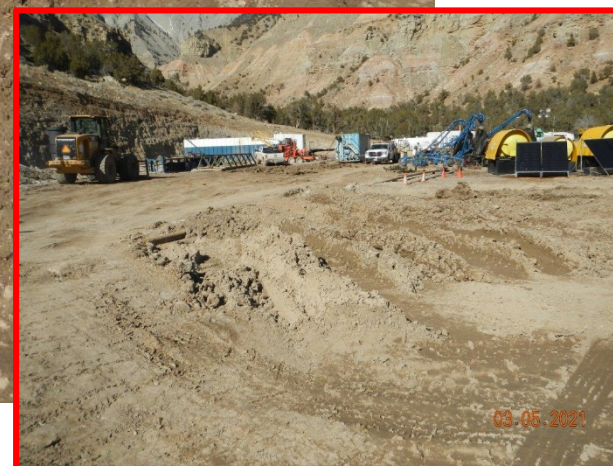
Photo#10:
Rutting on portions of pad.

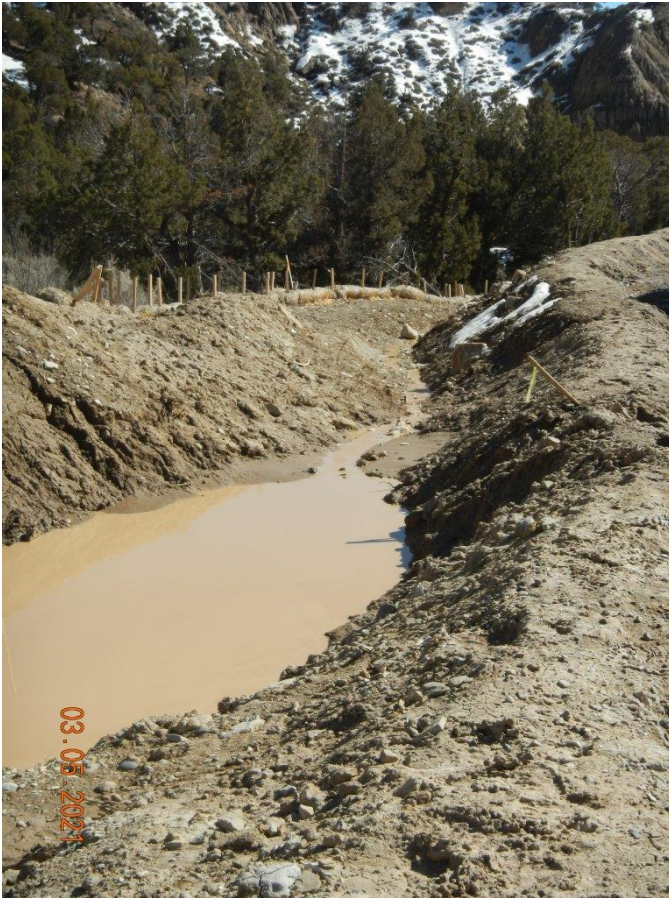
Photo#11:
BMPs needing repair/maintenance.

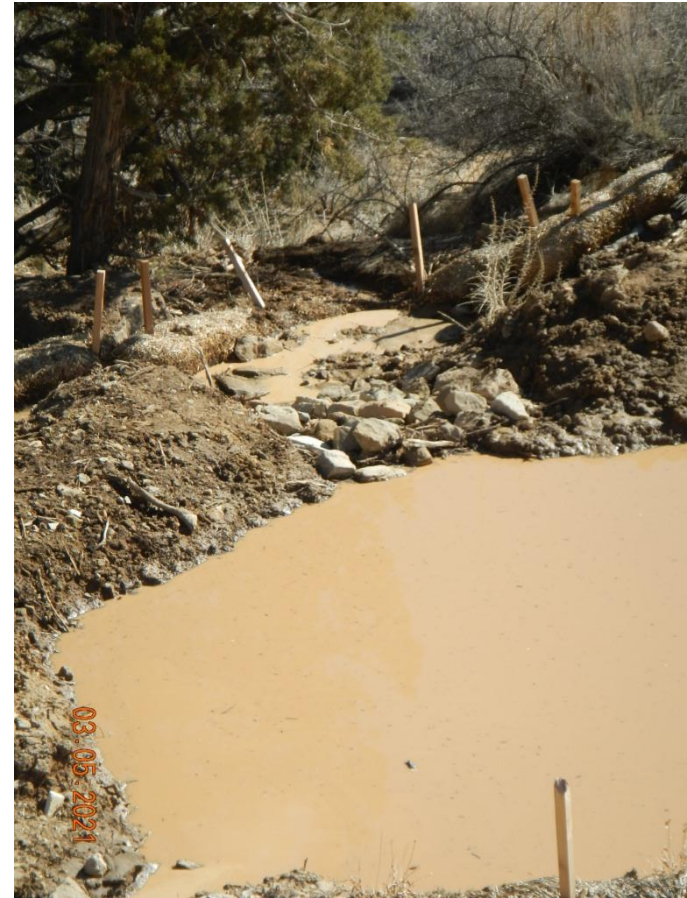
Photo#12:
BMPs needing repair/maintenance

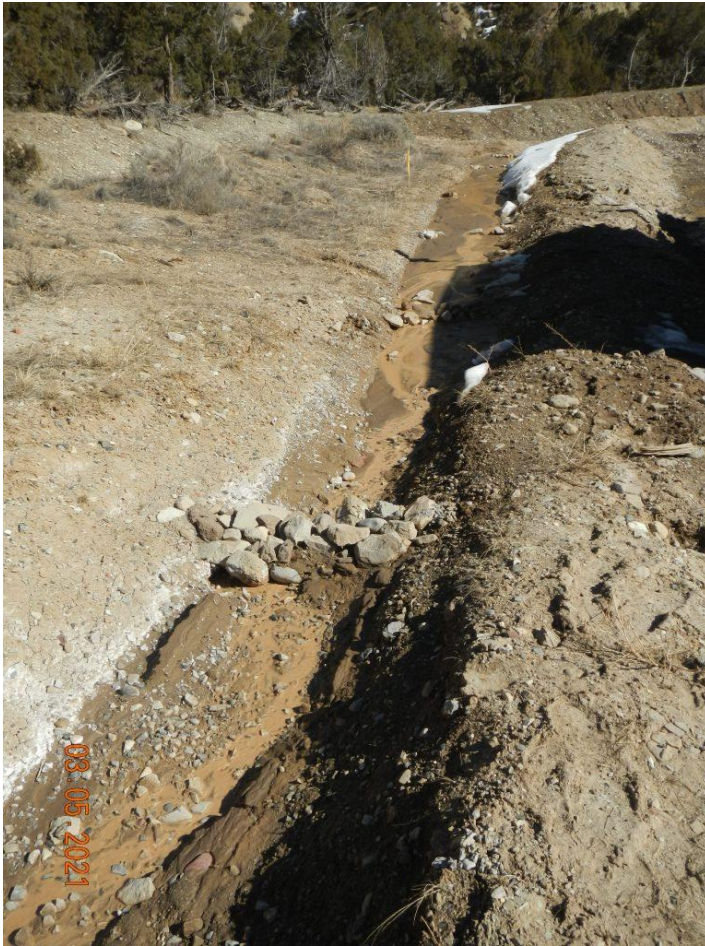
Photo#13:
BMPs needing repair/maintenance.

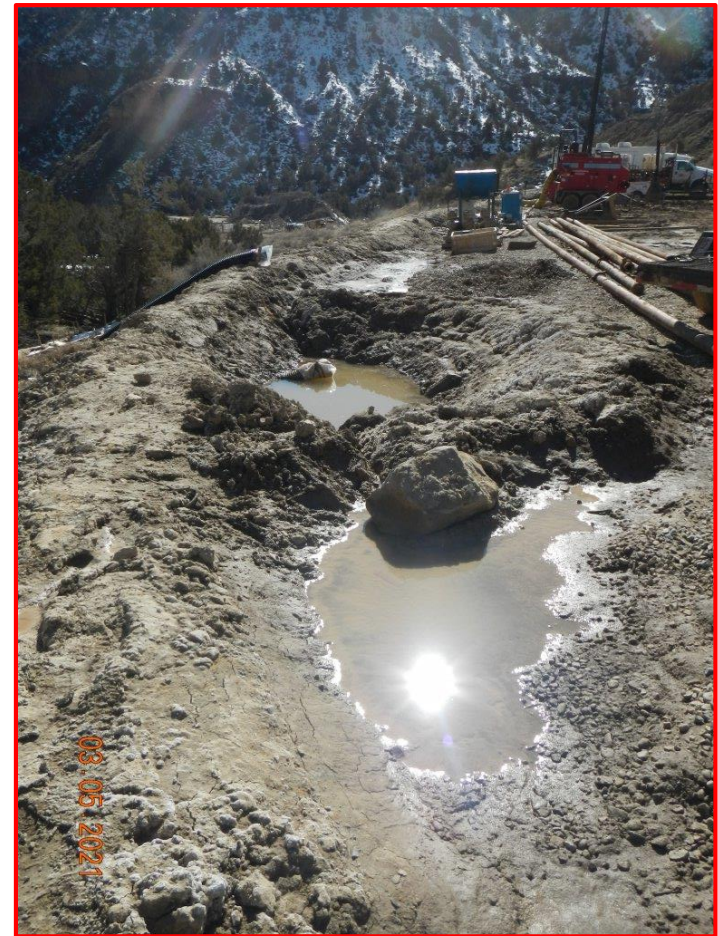
Photo#14:
BMPs needing repair/maintenance

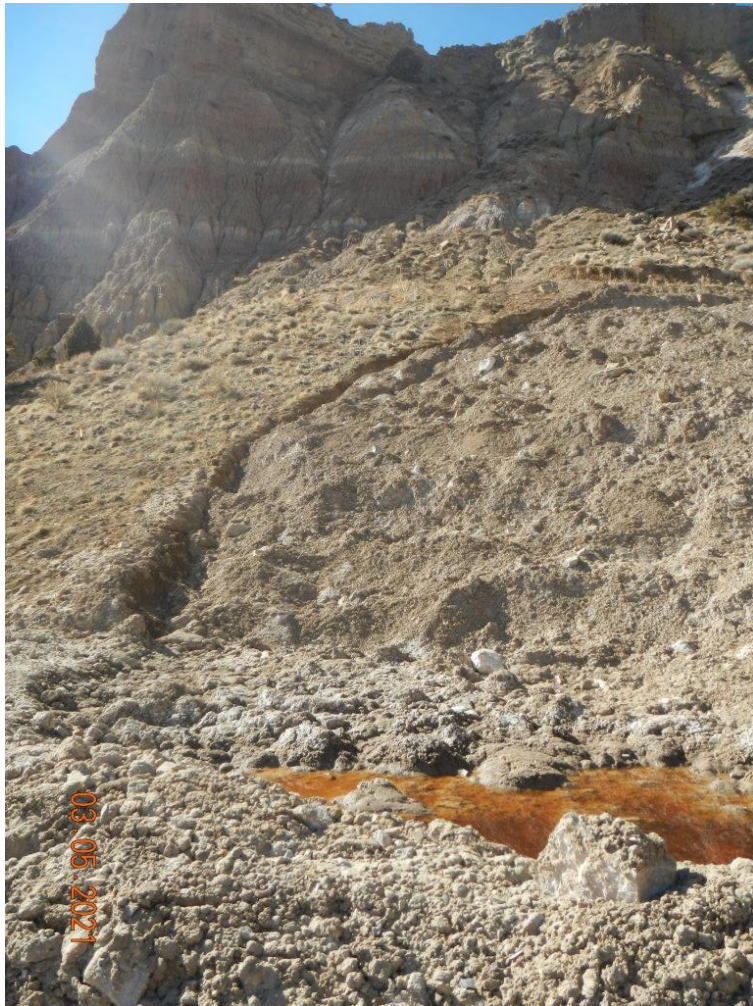
Photo#15:
Cuttings area.

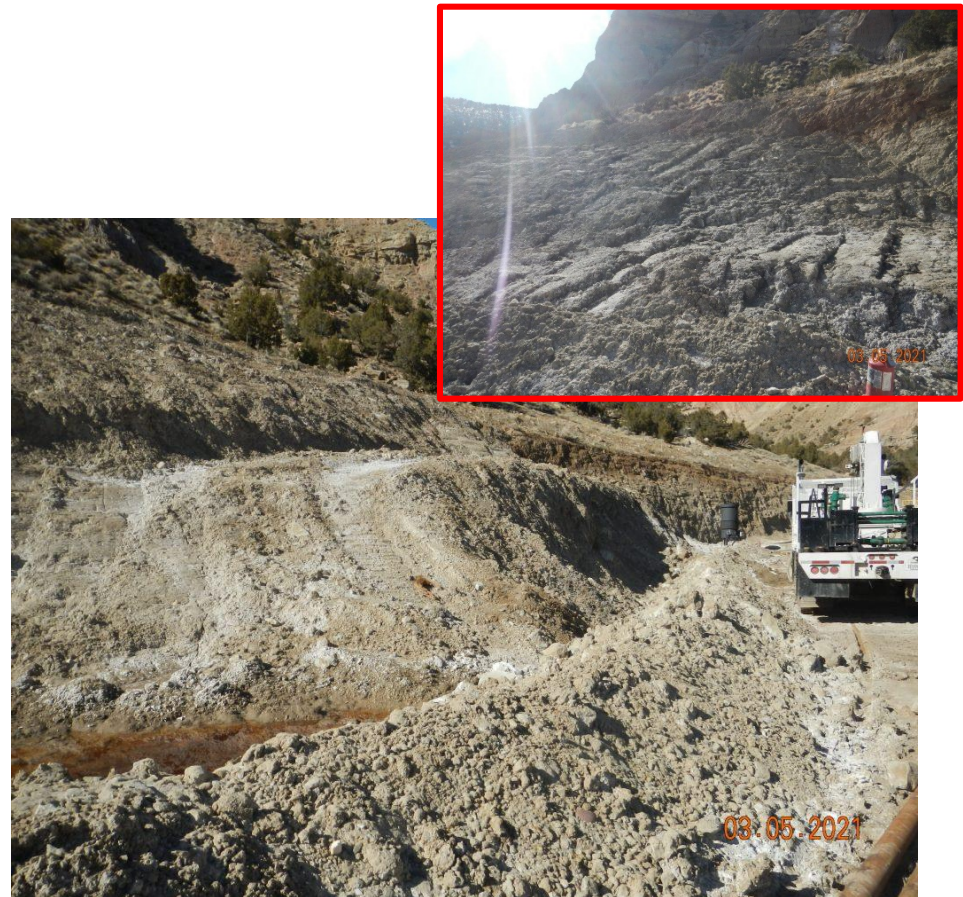
Photo#16:
Cuttings area.
