Inspection Photos

Operator: Logos Operating
API: 067-08365
Date: 3/9/2021

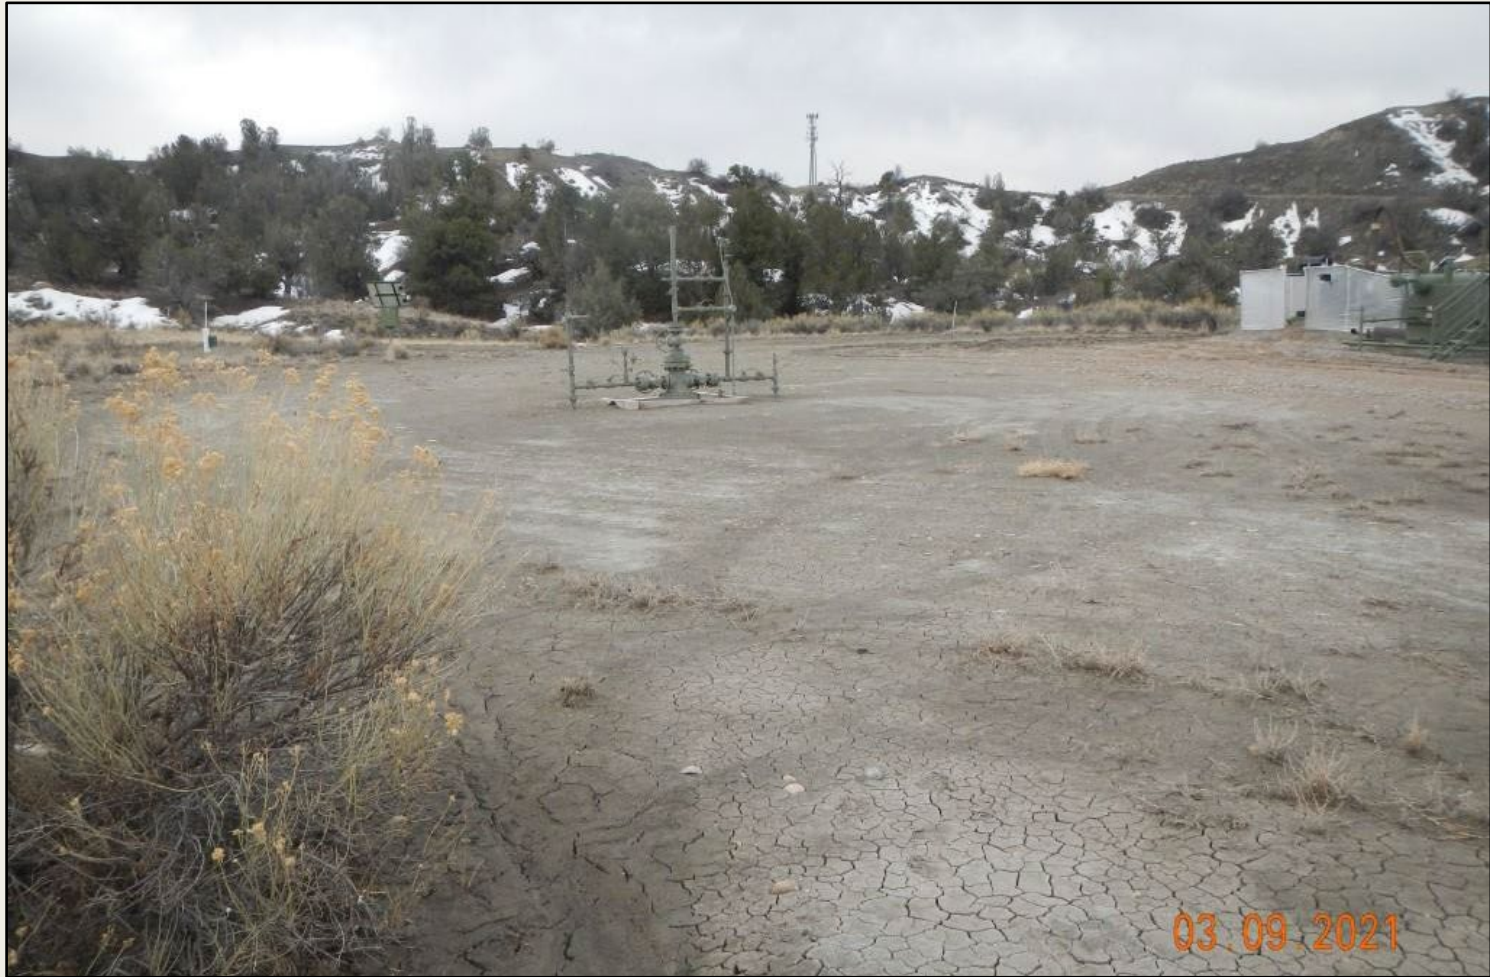
Photo 1. View of the project area from the northeastern corner facing center.

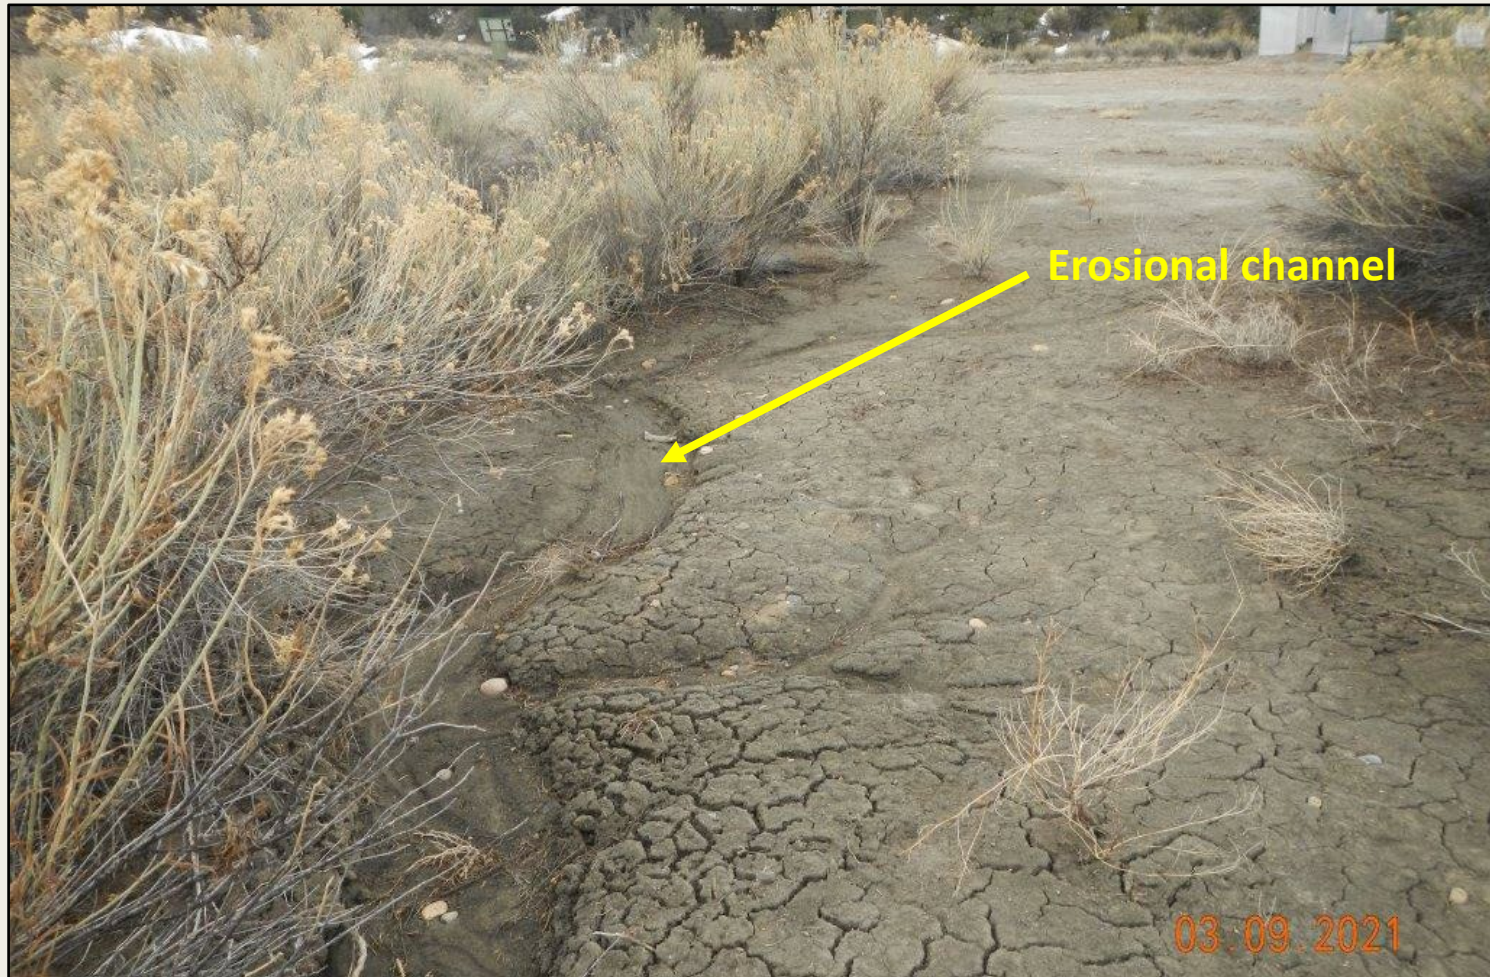
Photo 2. View of erosional channel forming within the northeastern project area, where stormwater flows off of the working area. Channel is approximately 18 inches wide and 6 inches deep.

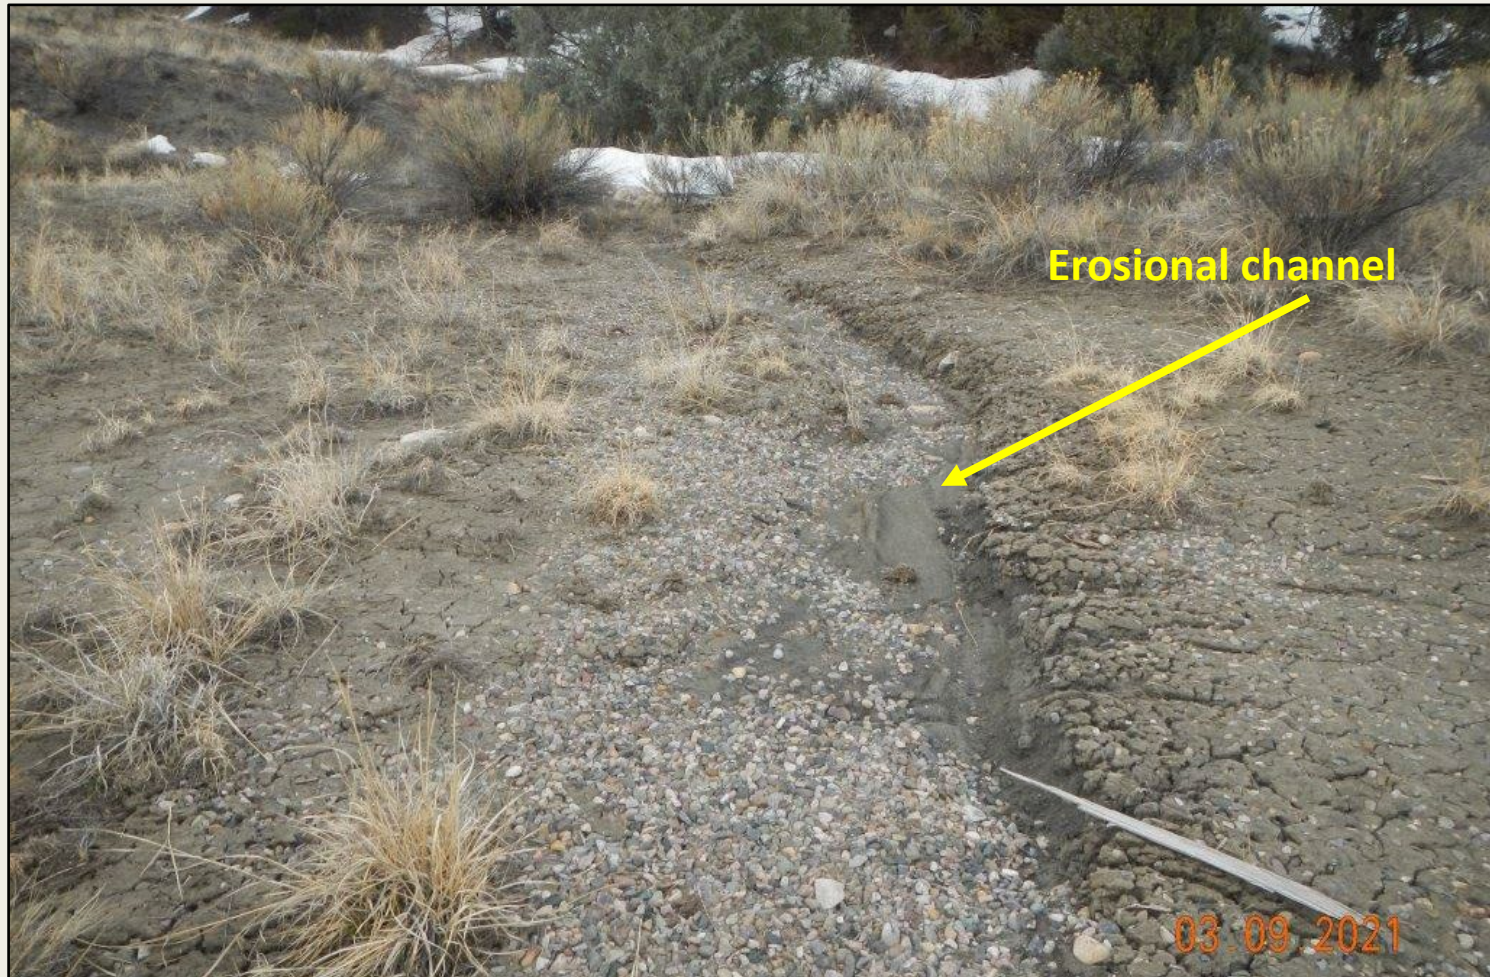
Photos 3. View of erosional channel in the southern project area, approximately 18 inches wide and 10 inches deep. Gravel placed in area is not adequate BMP.

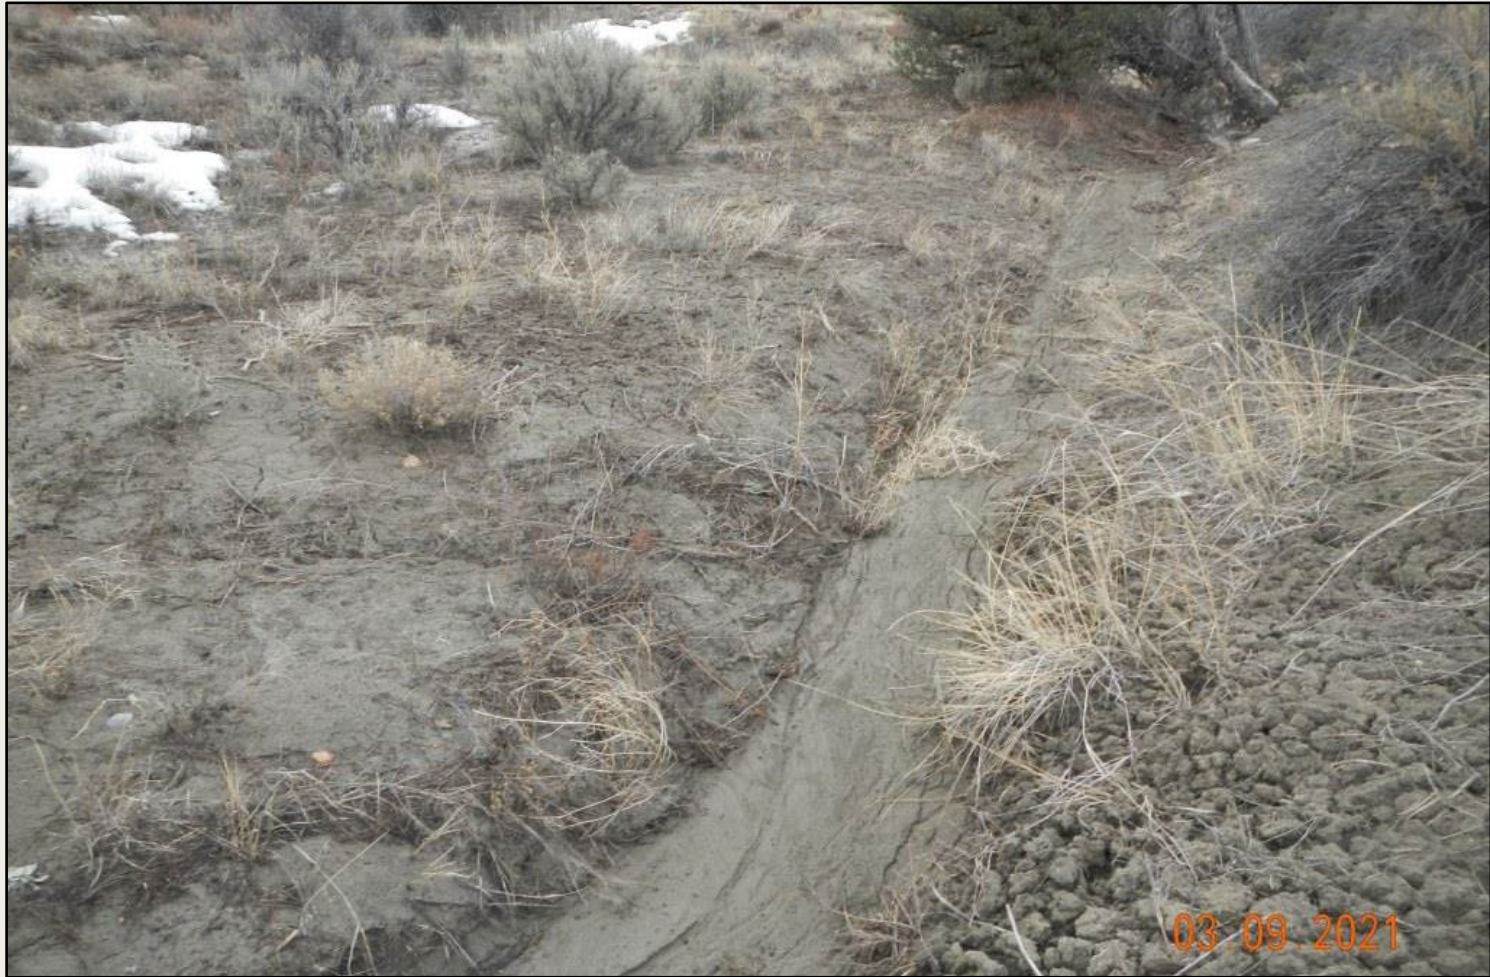
Photo 4. View of erosional channel in diversion that runs adjacent to the southern project area. Additional stabilization measures are needed here, such as channel lining.

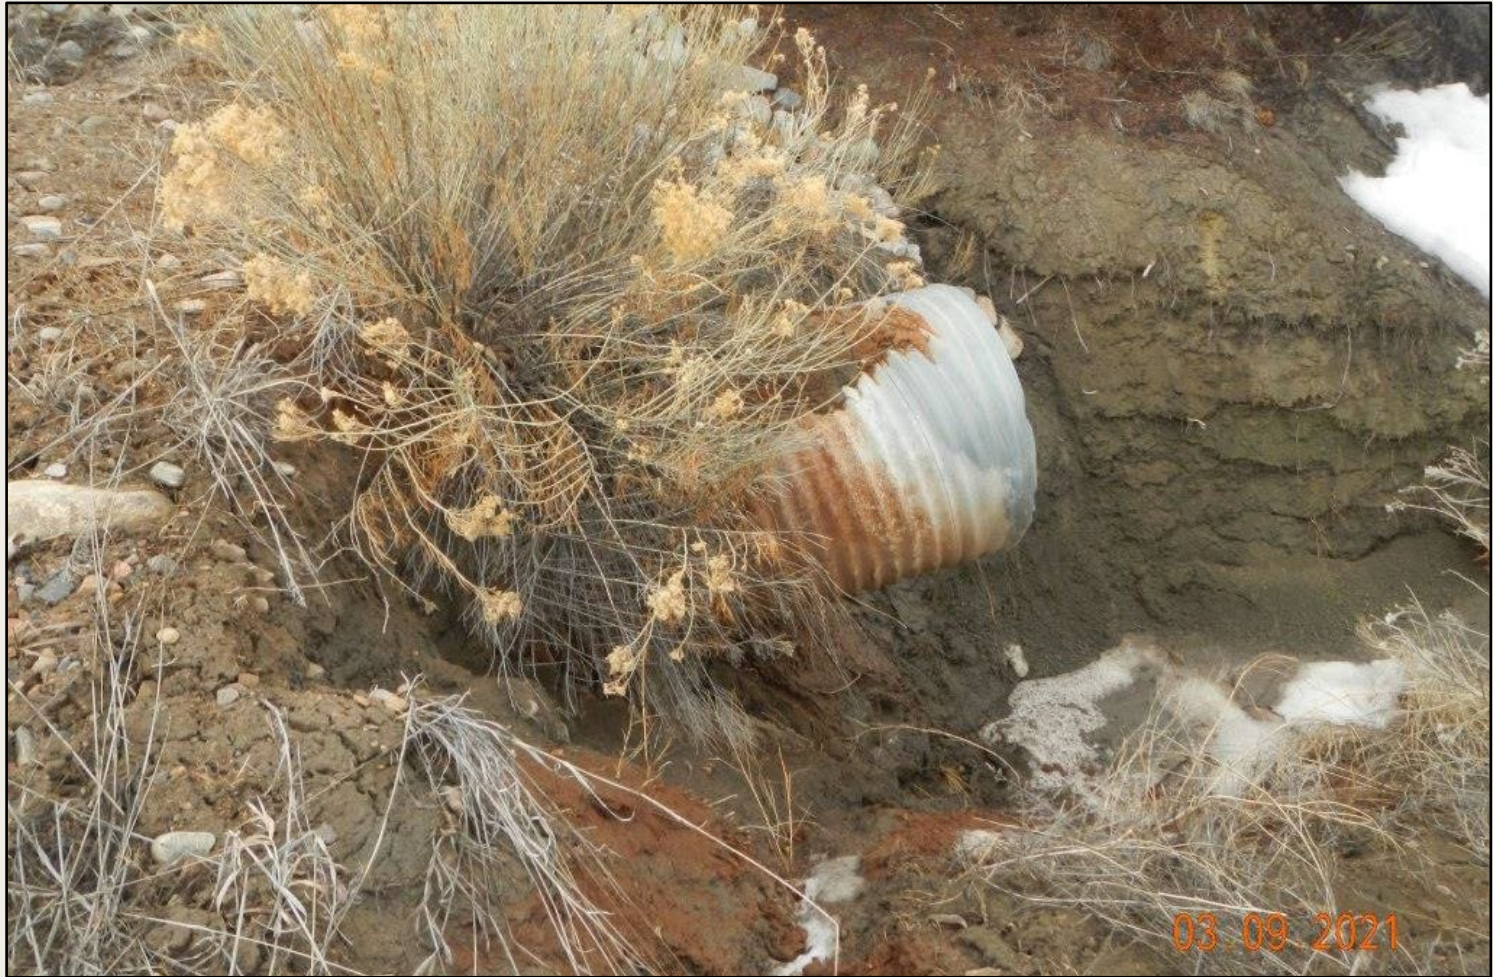
Photo 5. View of culvert outlet along the access road. Stabilization is needed around the culvert and where outflows are resulting in head-cutting from the culvert.

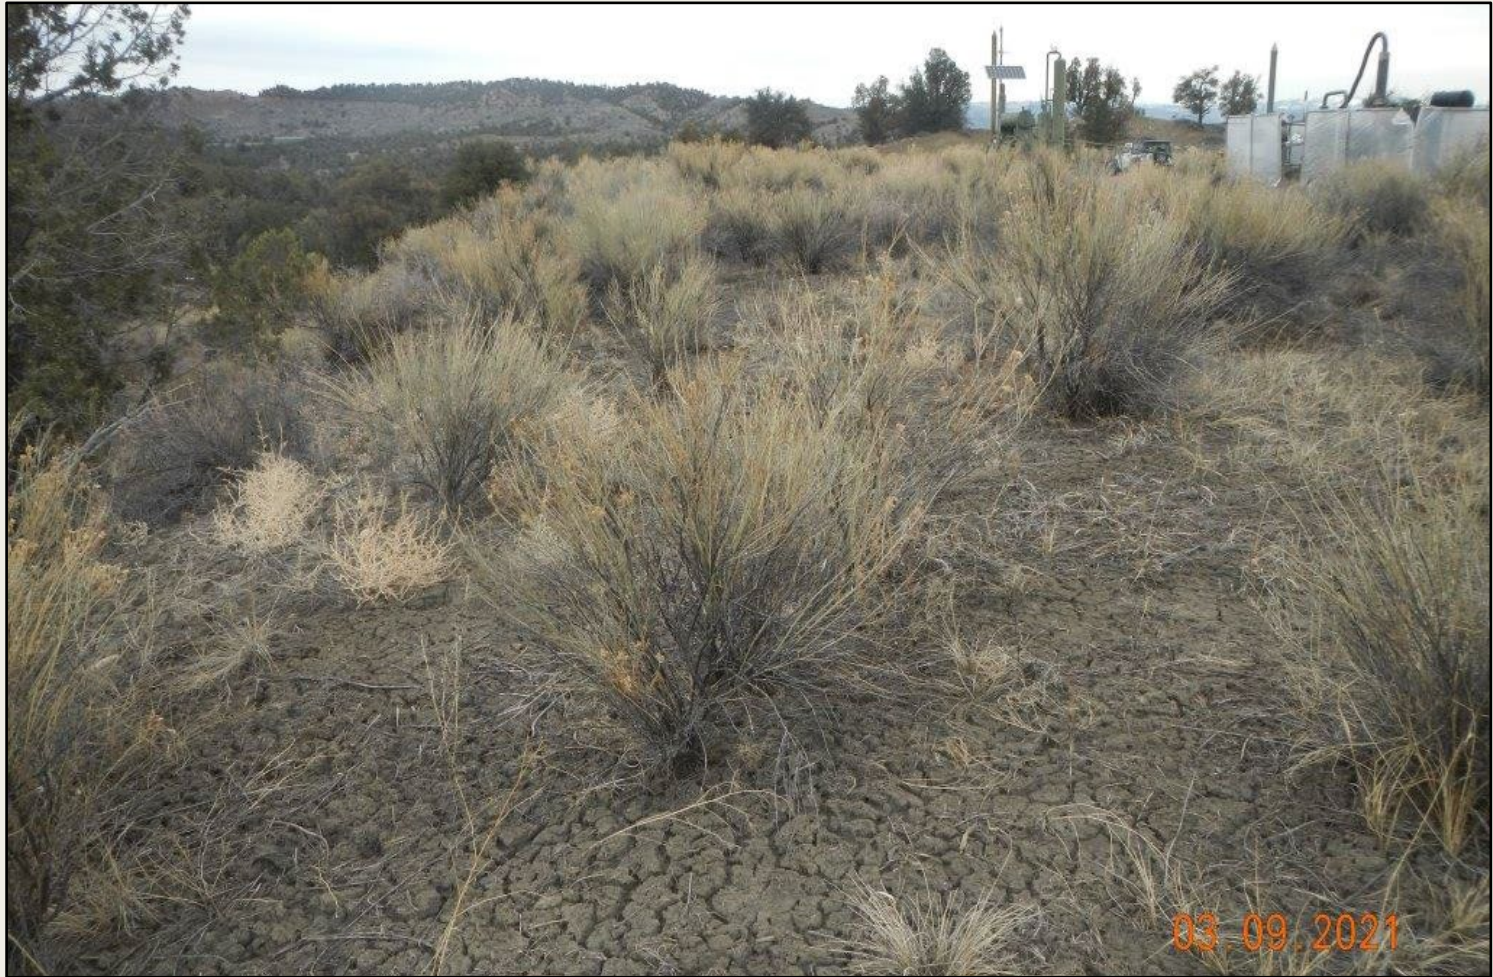
Photo 6. View of the western project area from the southwestern corner facing northward. Revegetation is progressing with rubber rabbitbrush, western wheatgrass, and Indian ricegrass.

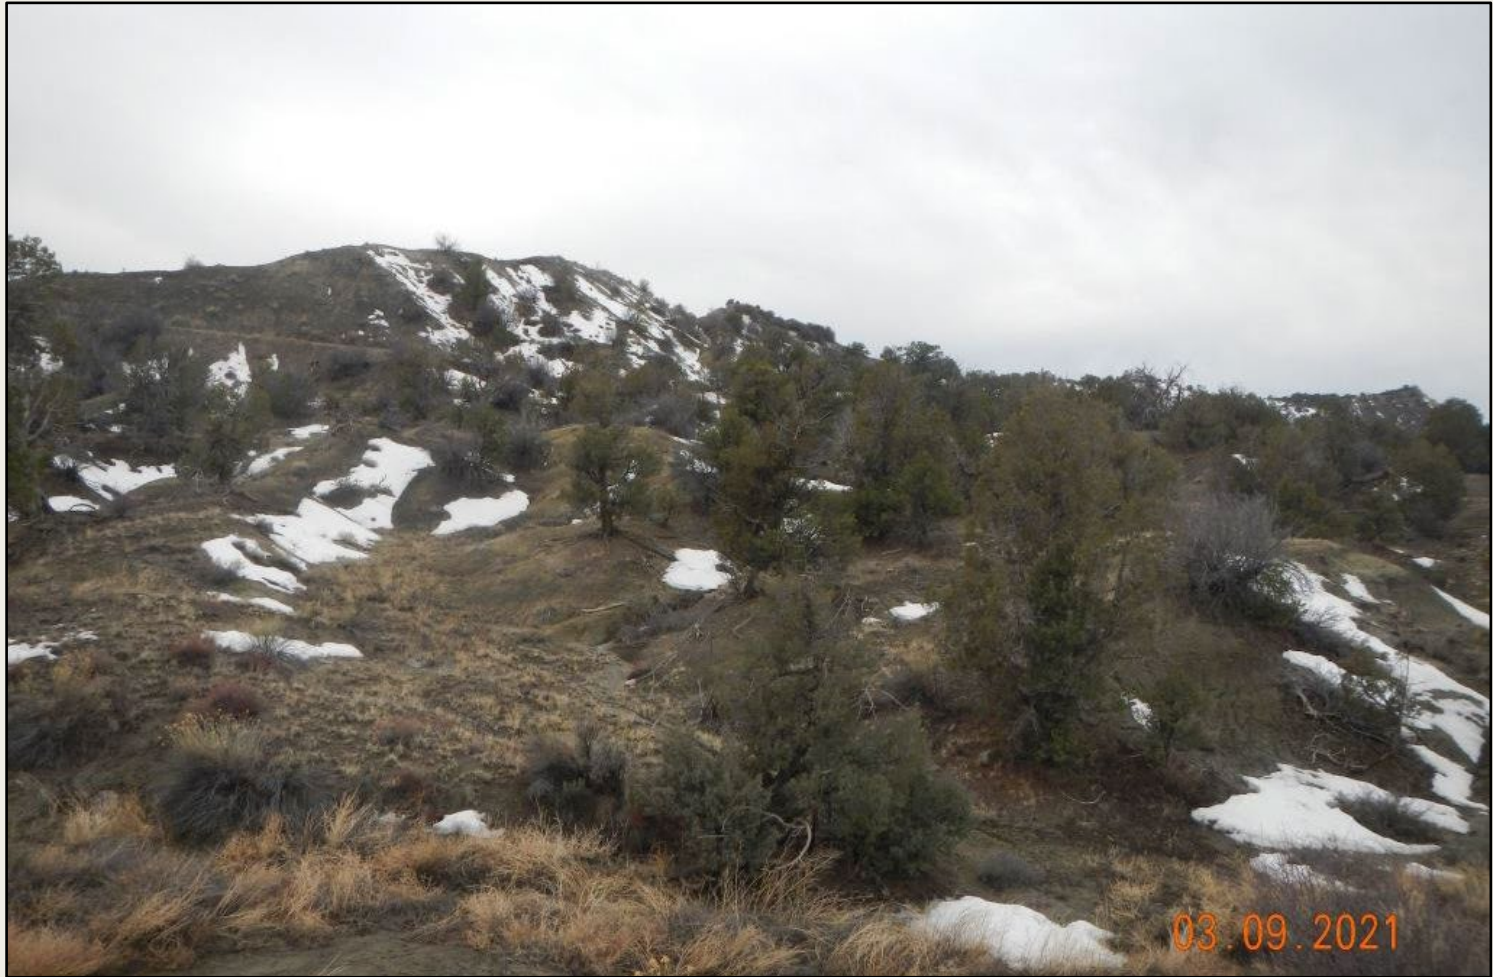
Photo 7. View of the reference area comprised of pinyon and juniper woodland, with understory of grasses and forbs such as Palmer's penstemon and Indian ricegrass.
