**Inspection Photos**  
**Operator: Logos Operating**  
**API: 067-08098**  
**Date: 3/9/2021**

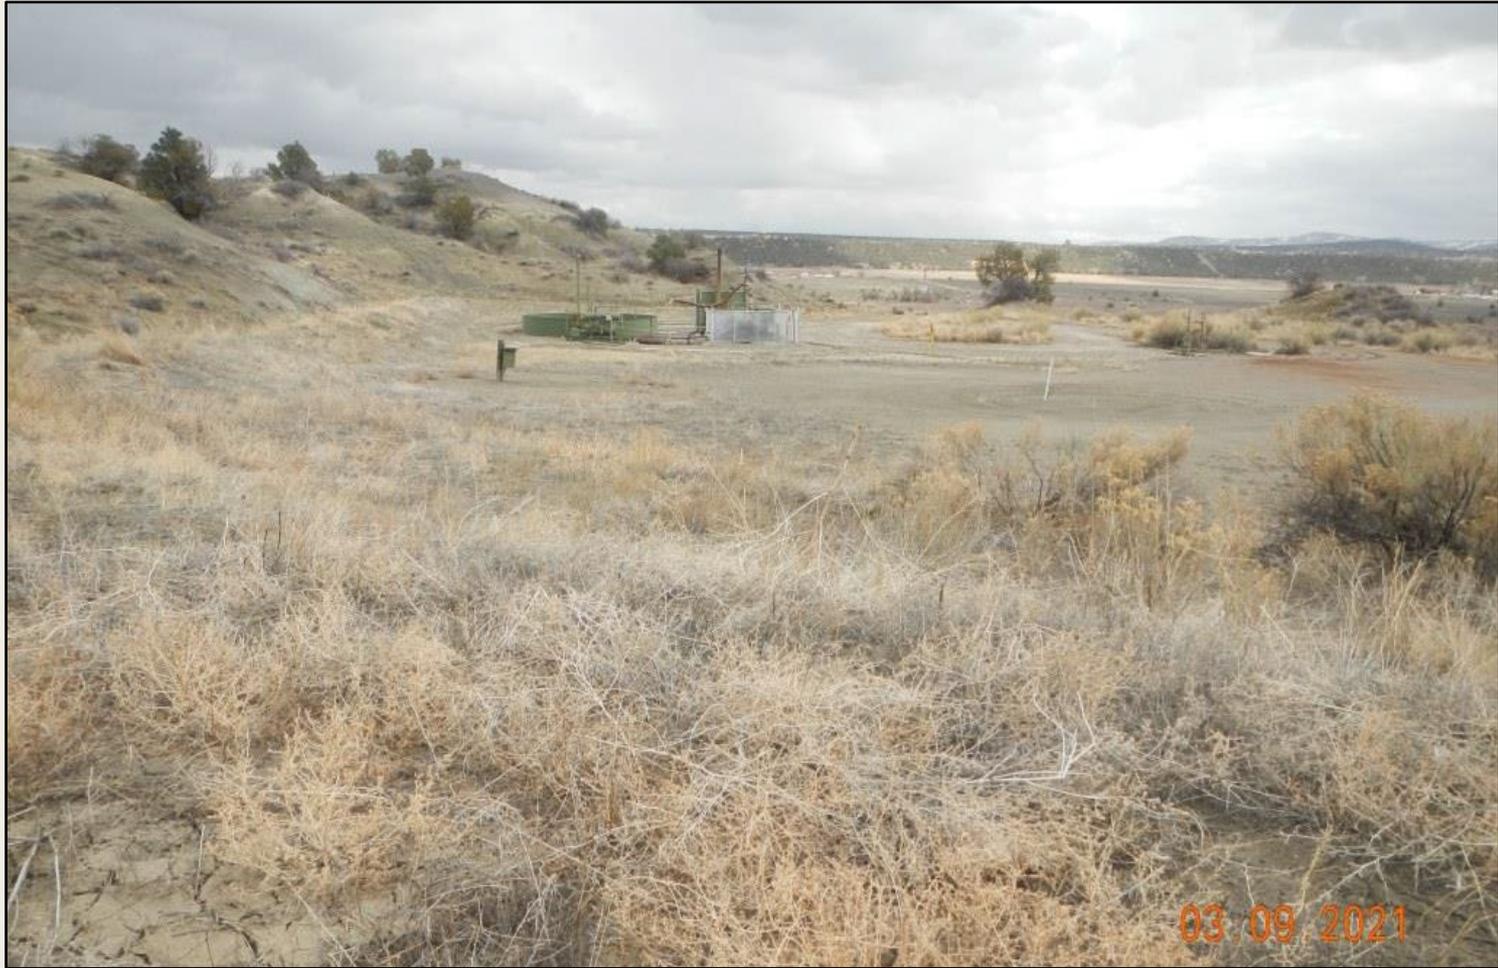
Photo 1. View of the project area from the western edge facing center. Revegetation is conducted in portions of the well pad identified during 2019 reclamation inspection, continued monitoring and management is needed. Russian thistle debris needs to be removed and managed.

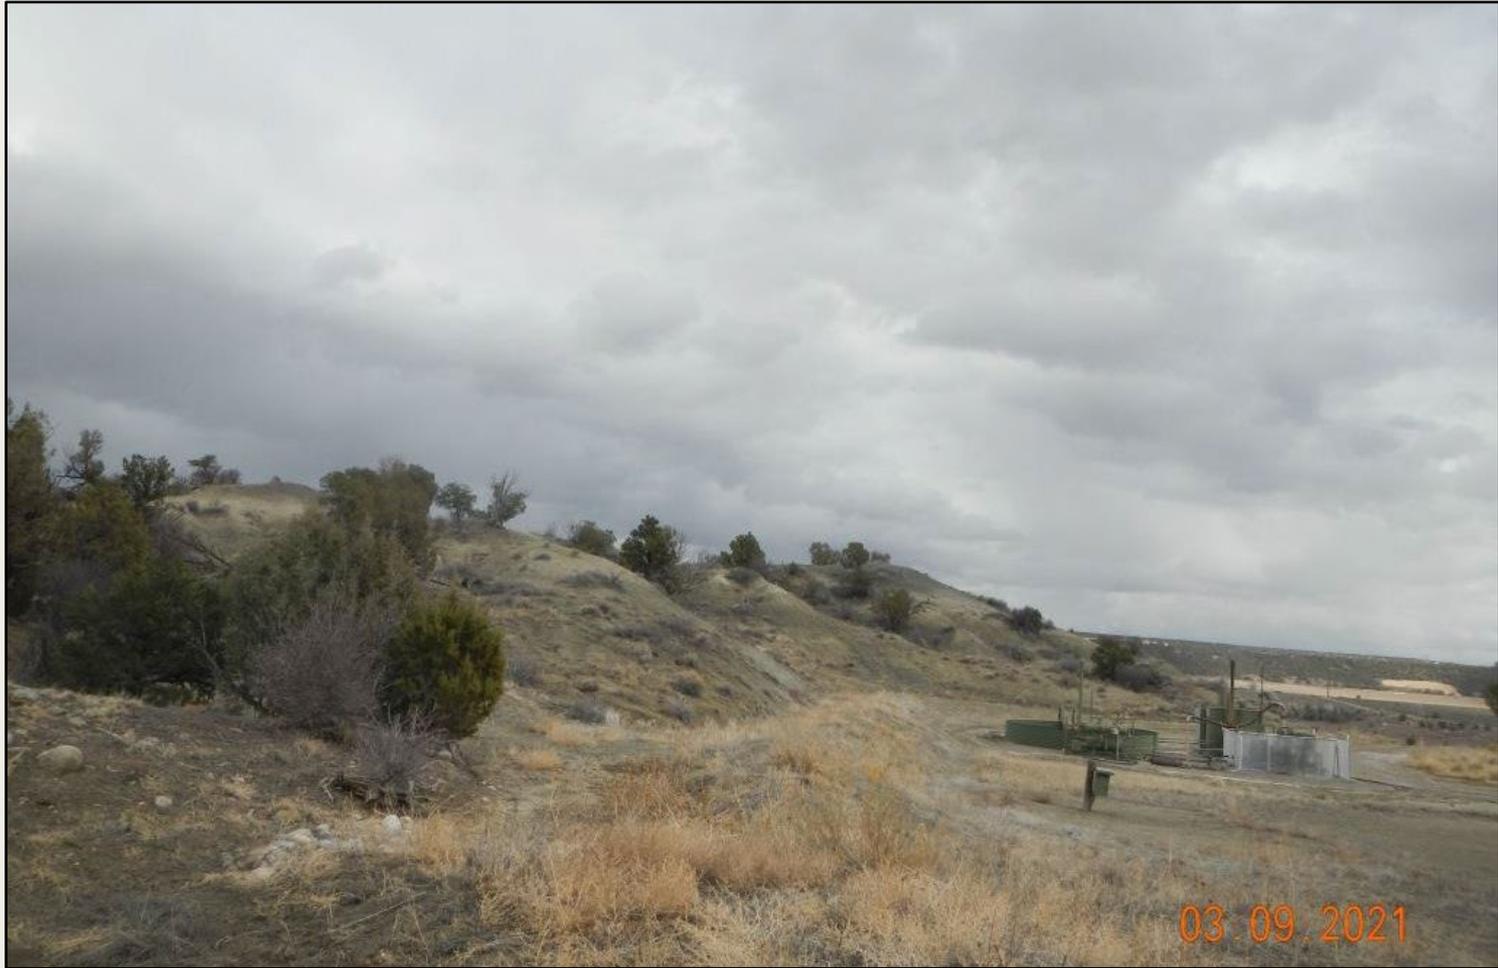
Photo 2. View of the northern project area facing eastward.

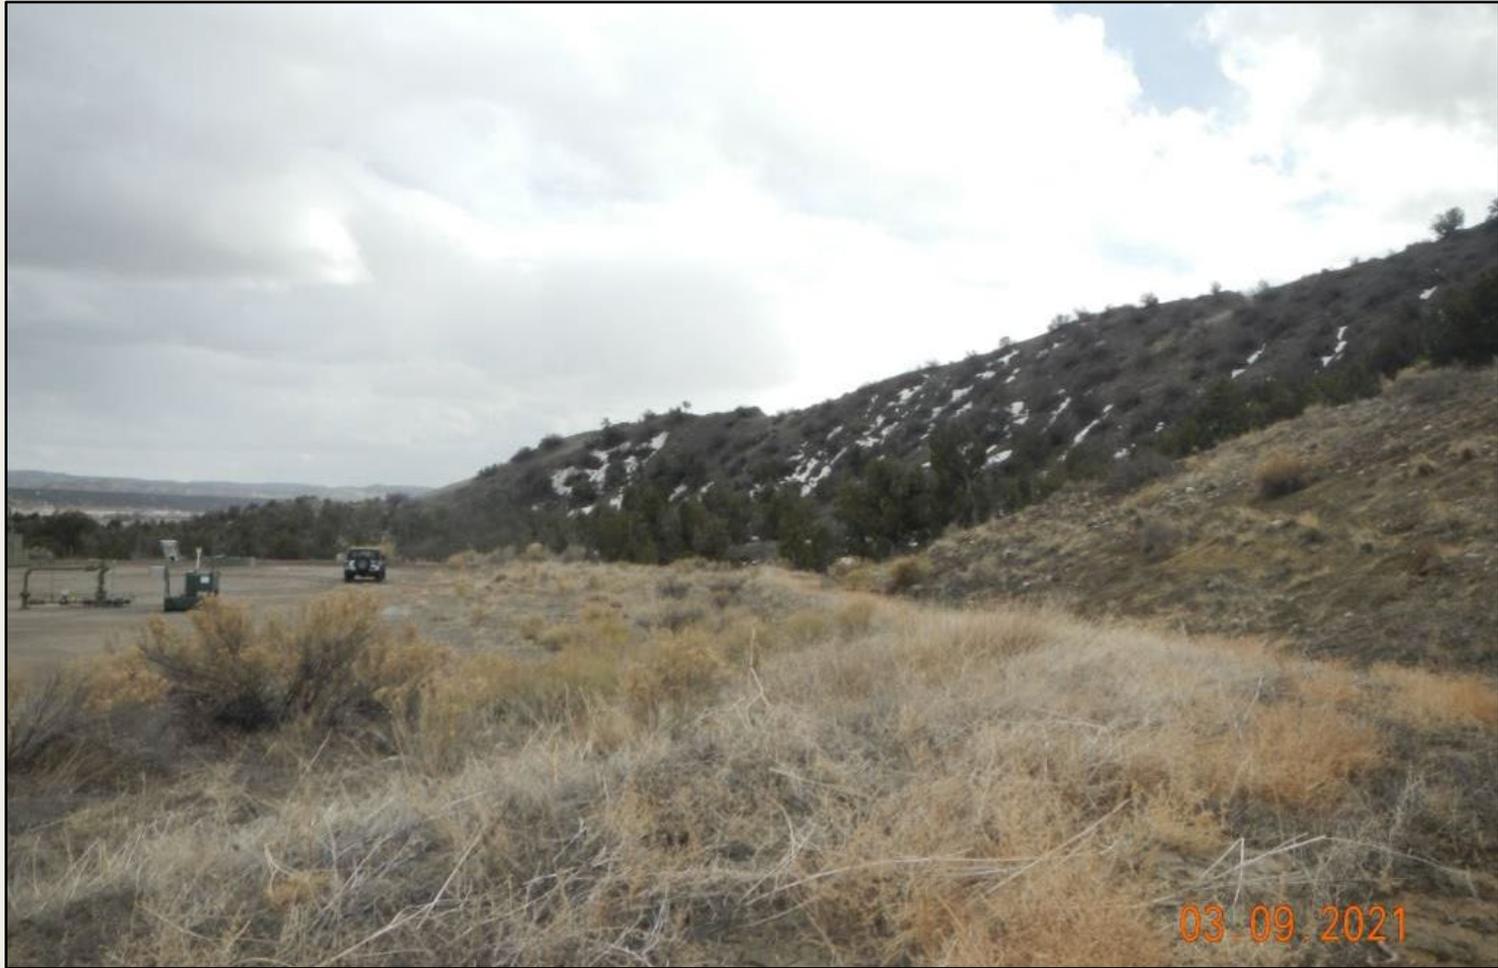
Photos 3. View of the western project area facing southward.

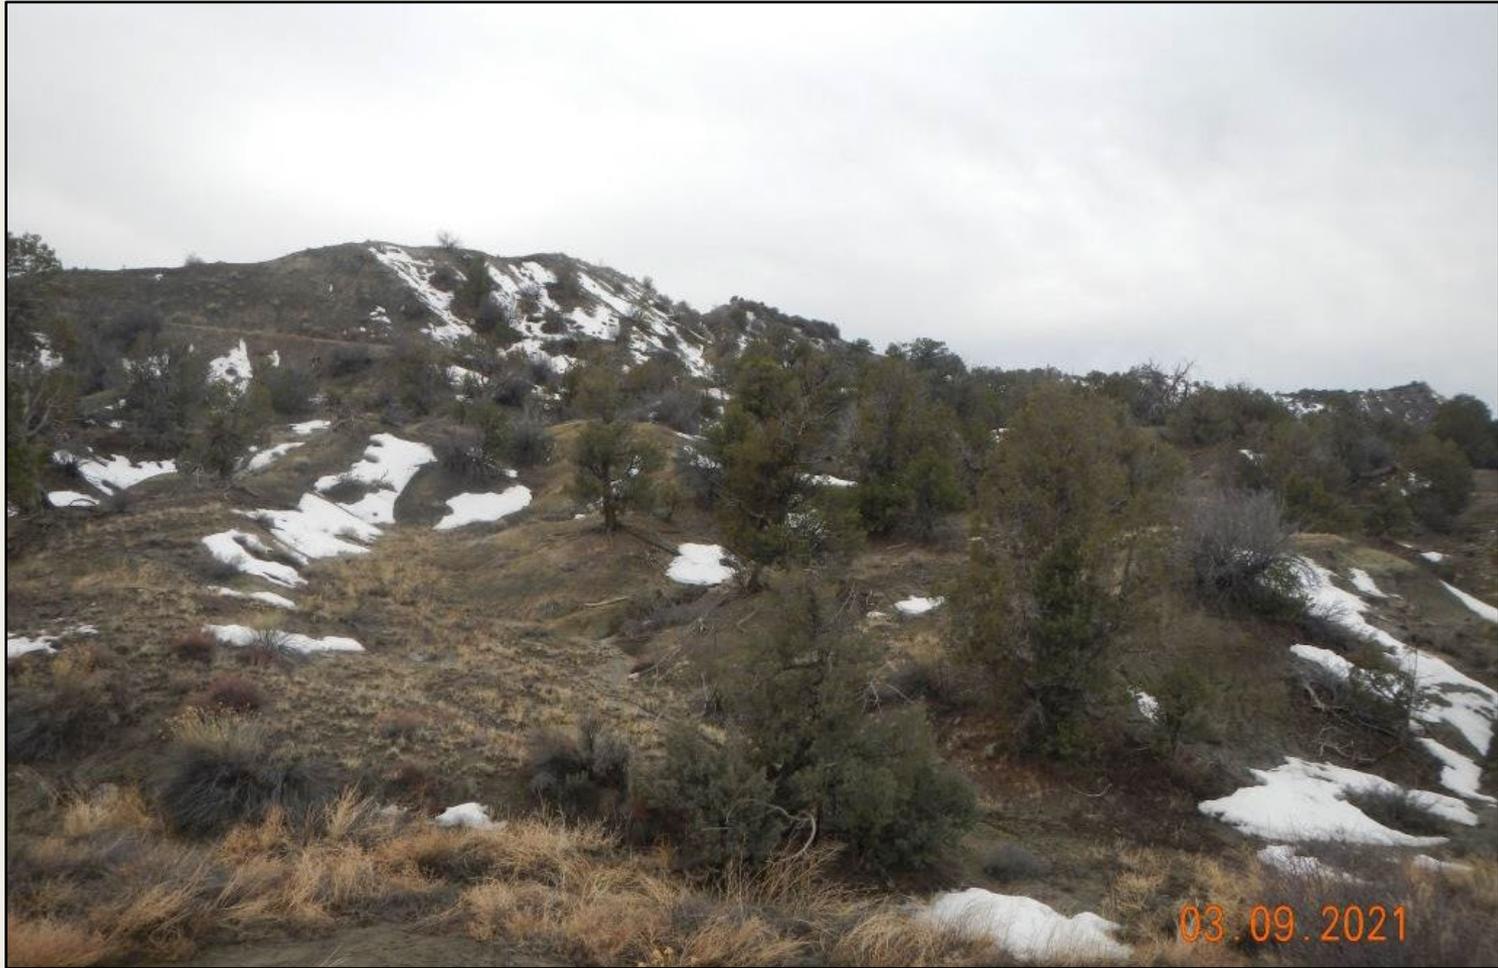
Photo 4. View of the reference area comprised of pinyon and juniper woodland, with understory of grasses and forbs such as Palmer's penstemon and Indian ricegrass.
